COST-EFFECTIVE STRUCTURAL CULVERT POINT REPAIR

Project Name: Yosemite Drive Drainage Project

Location: Anchorage, Alaska

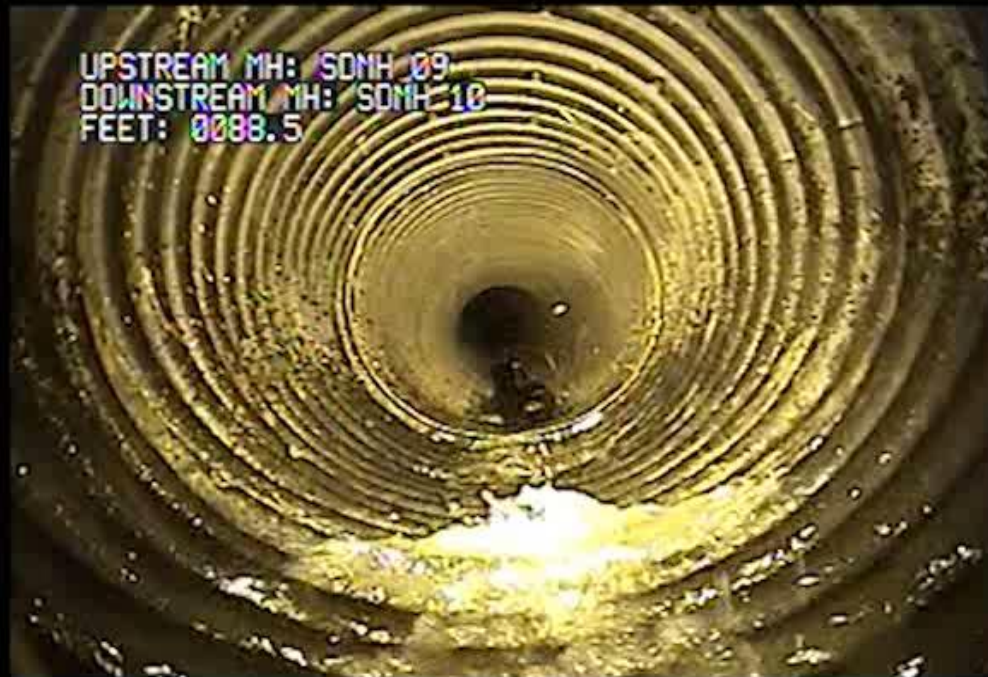
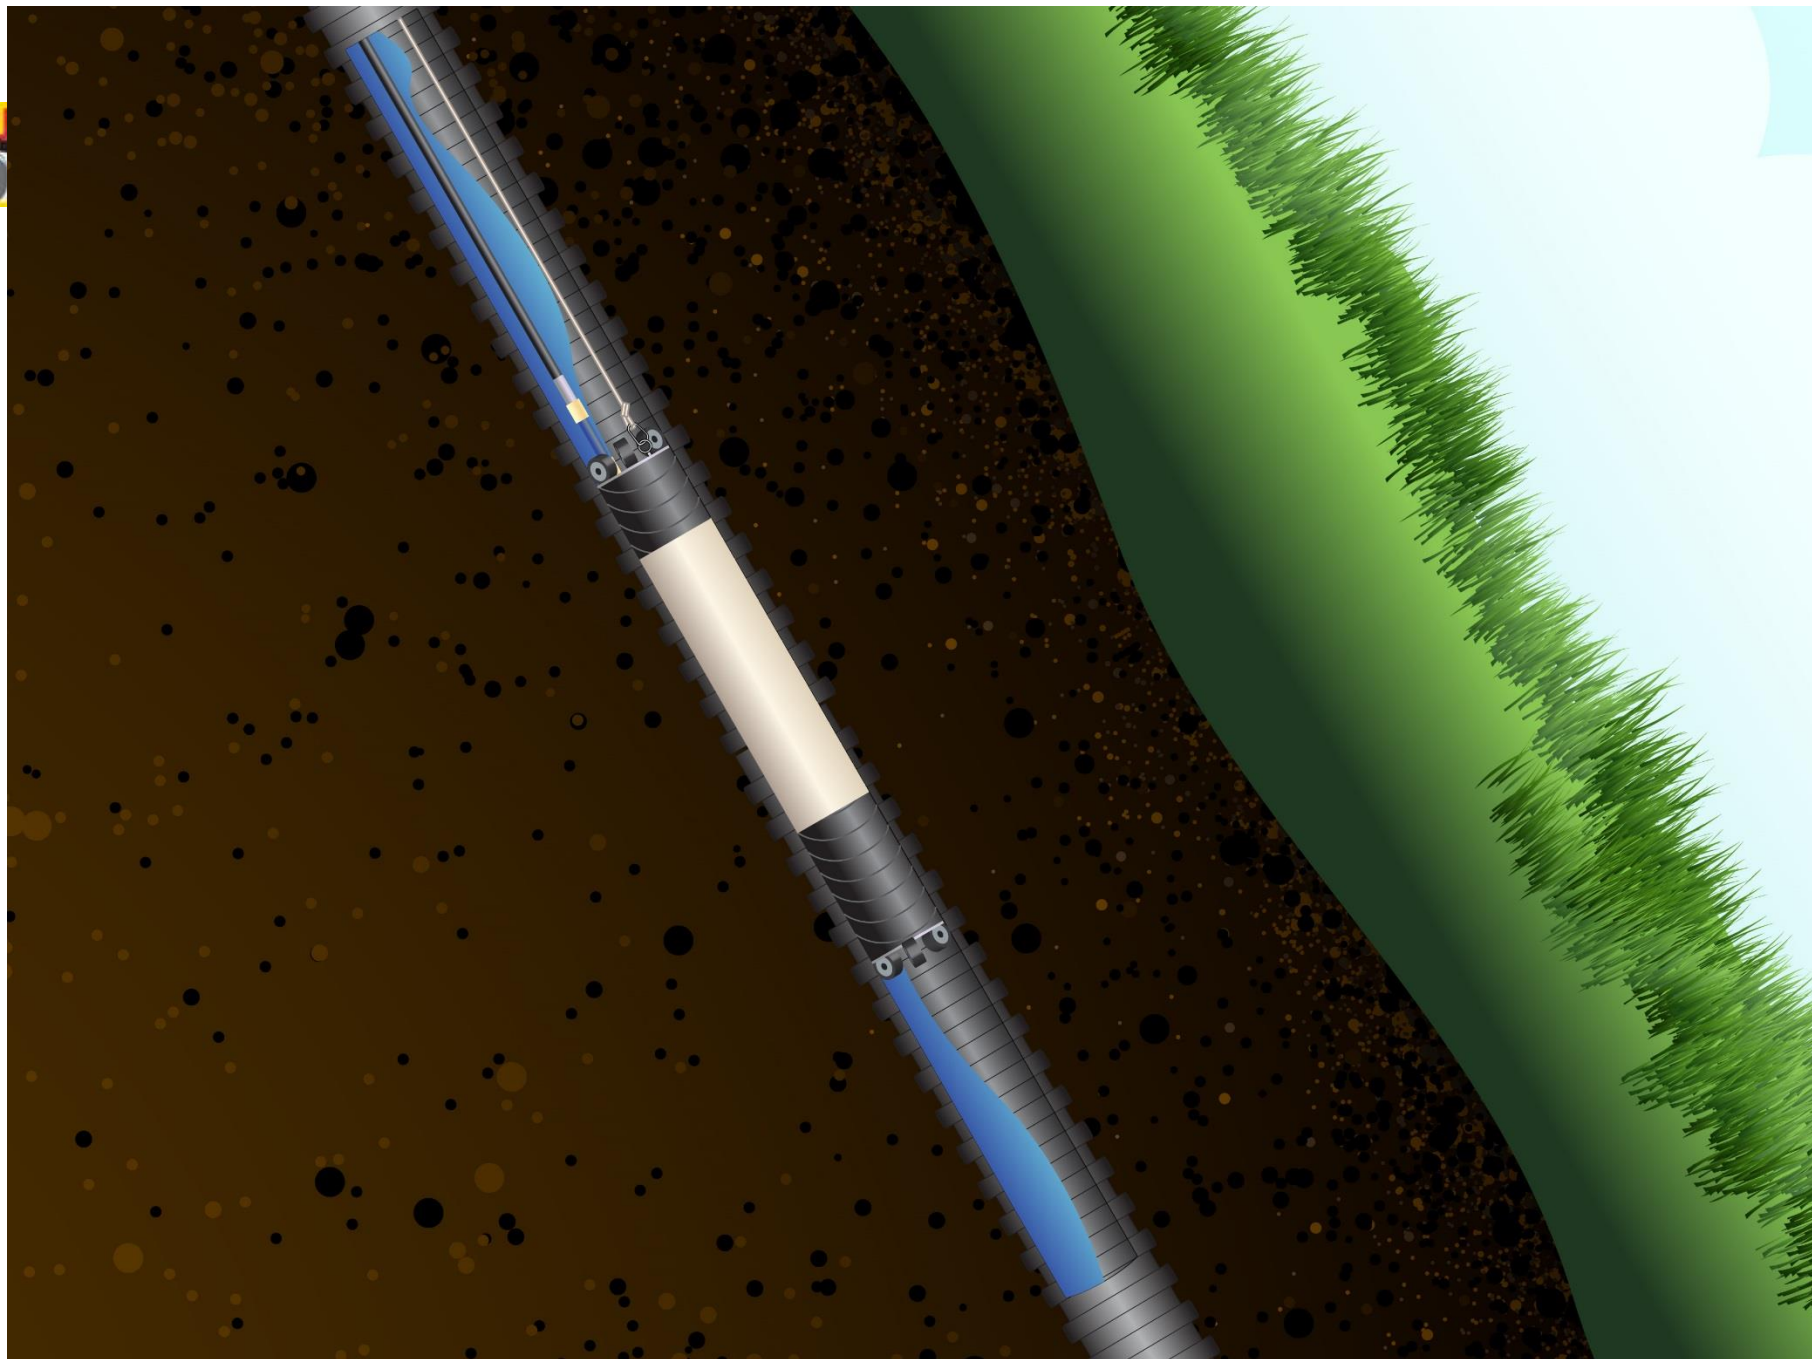
Sample of before repair

- 200' Section of 24" corrugated HDPE Pipe
- Multiple disjointed and offset joints – 100% water loss over the 200' section.
- 60% grade made open trench repairs unfeasible
- Environmentally sensitive area
