Geopolymer Liner Minimizes Culvert Rehab Impact Vista, California

Joe Royer, Ph.D. – Milliken Infrastructure Solutions

Business Park Drive Underpass

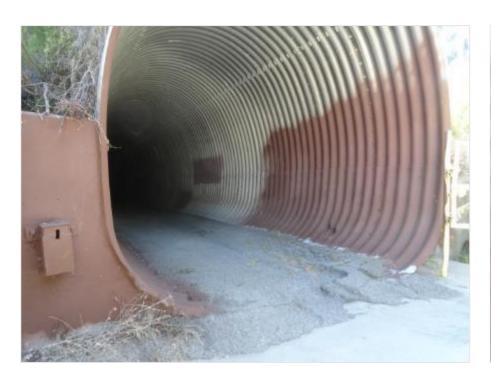
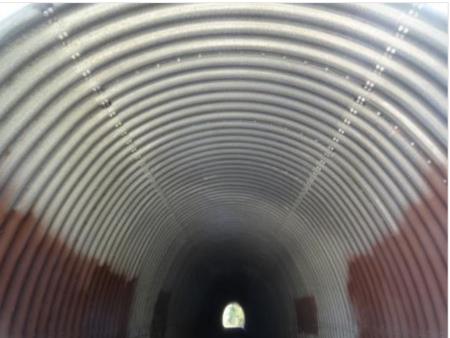
Initial views of the 14 ft high tunnel plate structure with asphalt invert

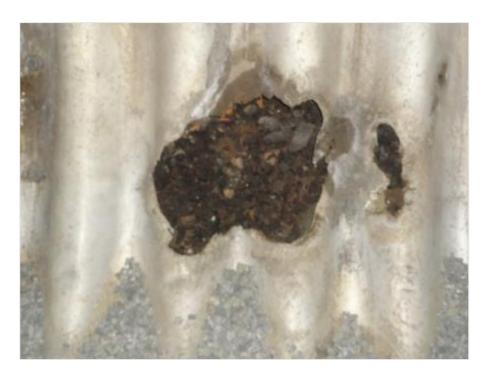
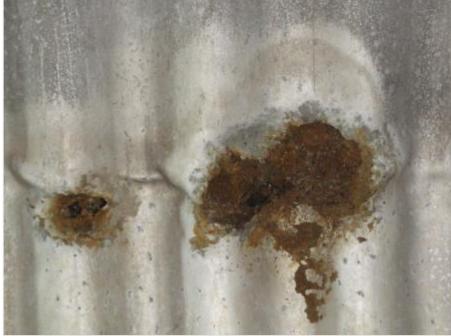
Typical infiltration points through out the structure

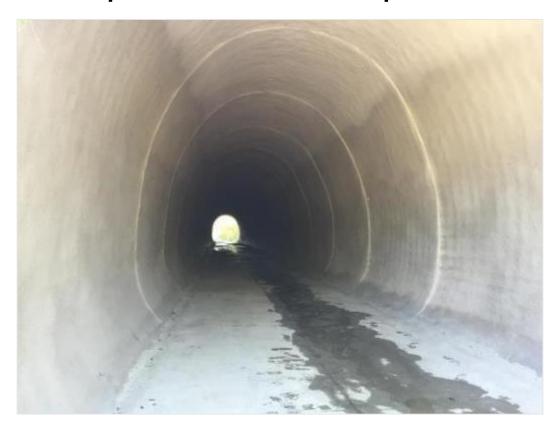
The finished structure, which included expansion joints, was inspected and accepted.

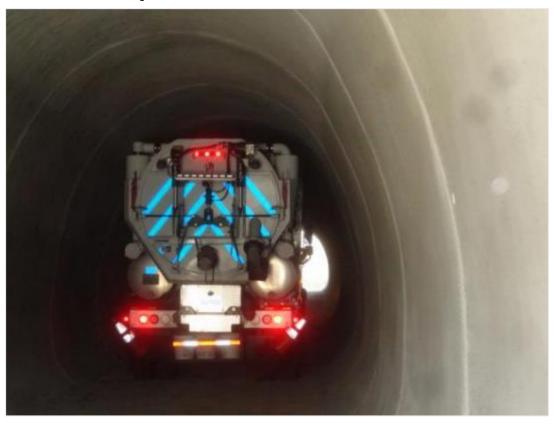
The final inspection had to ensure that a city Vac truck could still pass

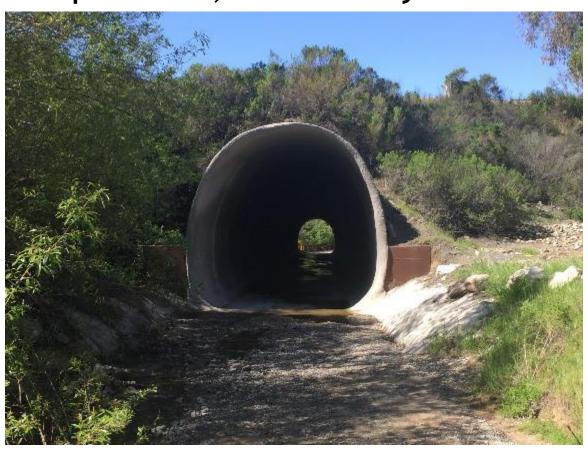
The rehabilitation is performing well after 2 years of inspections, with heavy rains in the area
