# **PIPELINE CONDITION ASSESSMENT & CLEANING “DEVIL IS IN THE DETAILS” CITY OF DE SOTO, KANSAS RAW WATER MAIN**

**Lisa S. Douglas, PE  
Division Manager  
Water Services  
Ace Pipe Cleaning, Inc.**

## **CASE STUDY OVERVIEW**

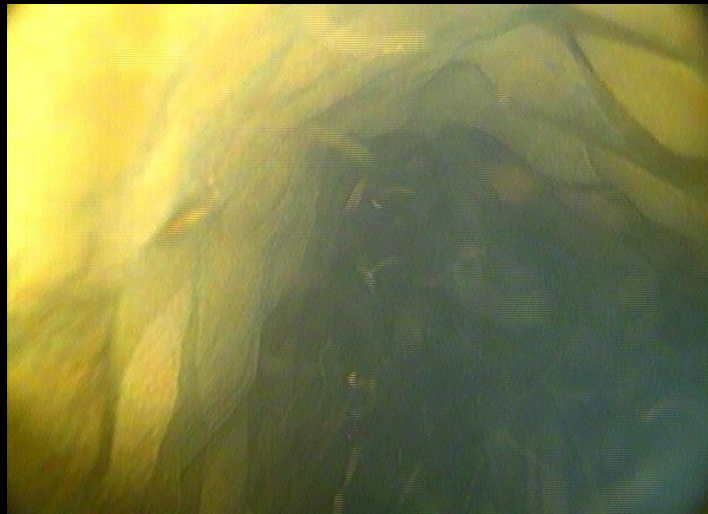
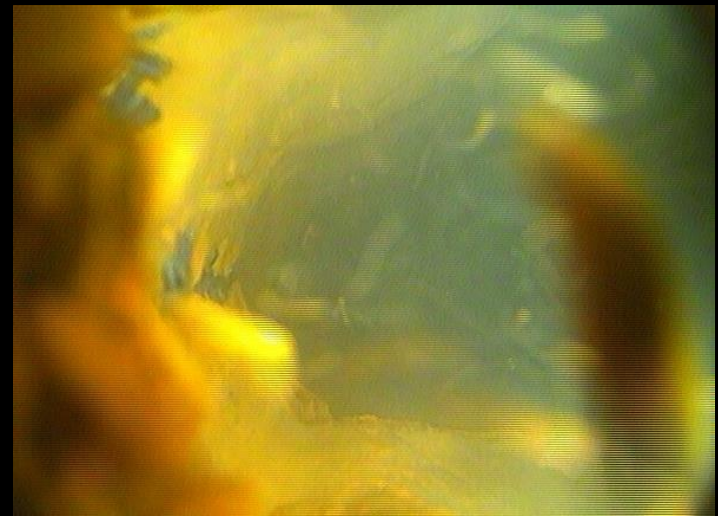
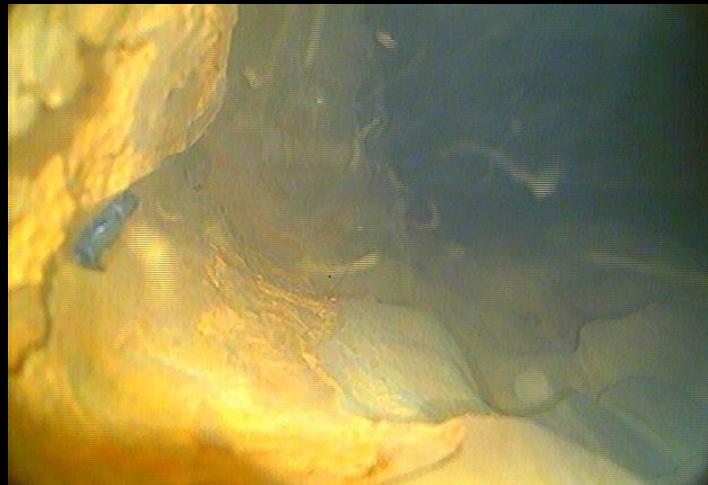
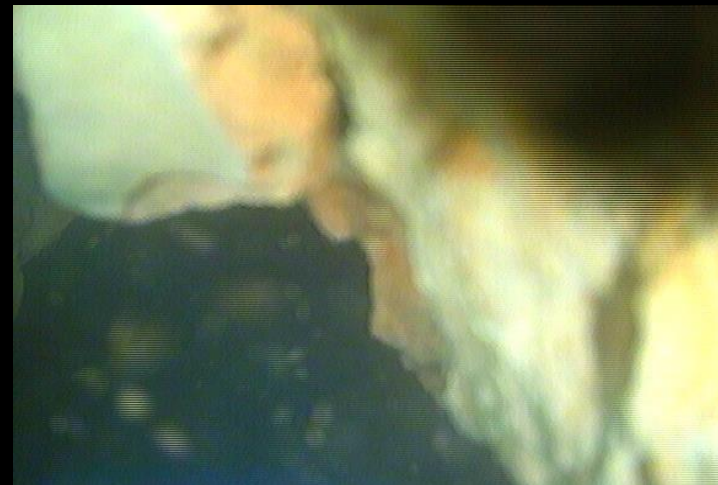
**Initial Results**

- **COULD NOT EVEN BEGIN THE INSPECTION**
- **PIPE HAD SILTED UP OVER 40+ YEARS**

- TRANSMISSION MAIN CLEANING PLAN
- TAKE WELL FIELD OUT OF SERVICE – COORDINATE WITH THE CITY
- DRAIN THE SYSTEM
- USE JETTER TRUCK TO REMOVE THE BUILD UP
- PUT SYSTEM BACK IN SERVICE
- PERFORM VIDEO INSPECTION UNDER THE RIVER

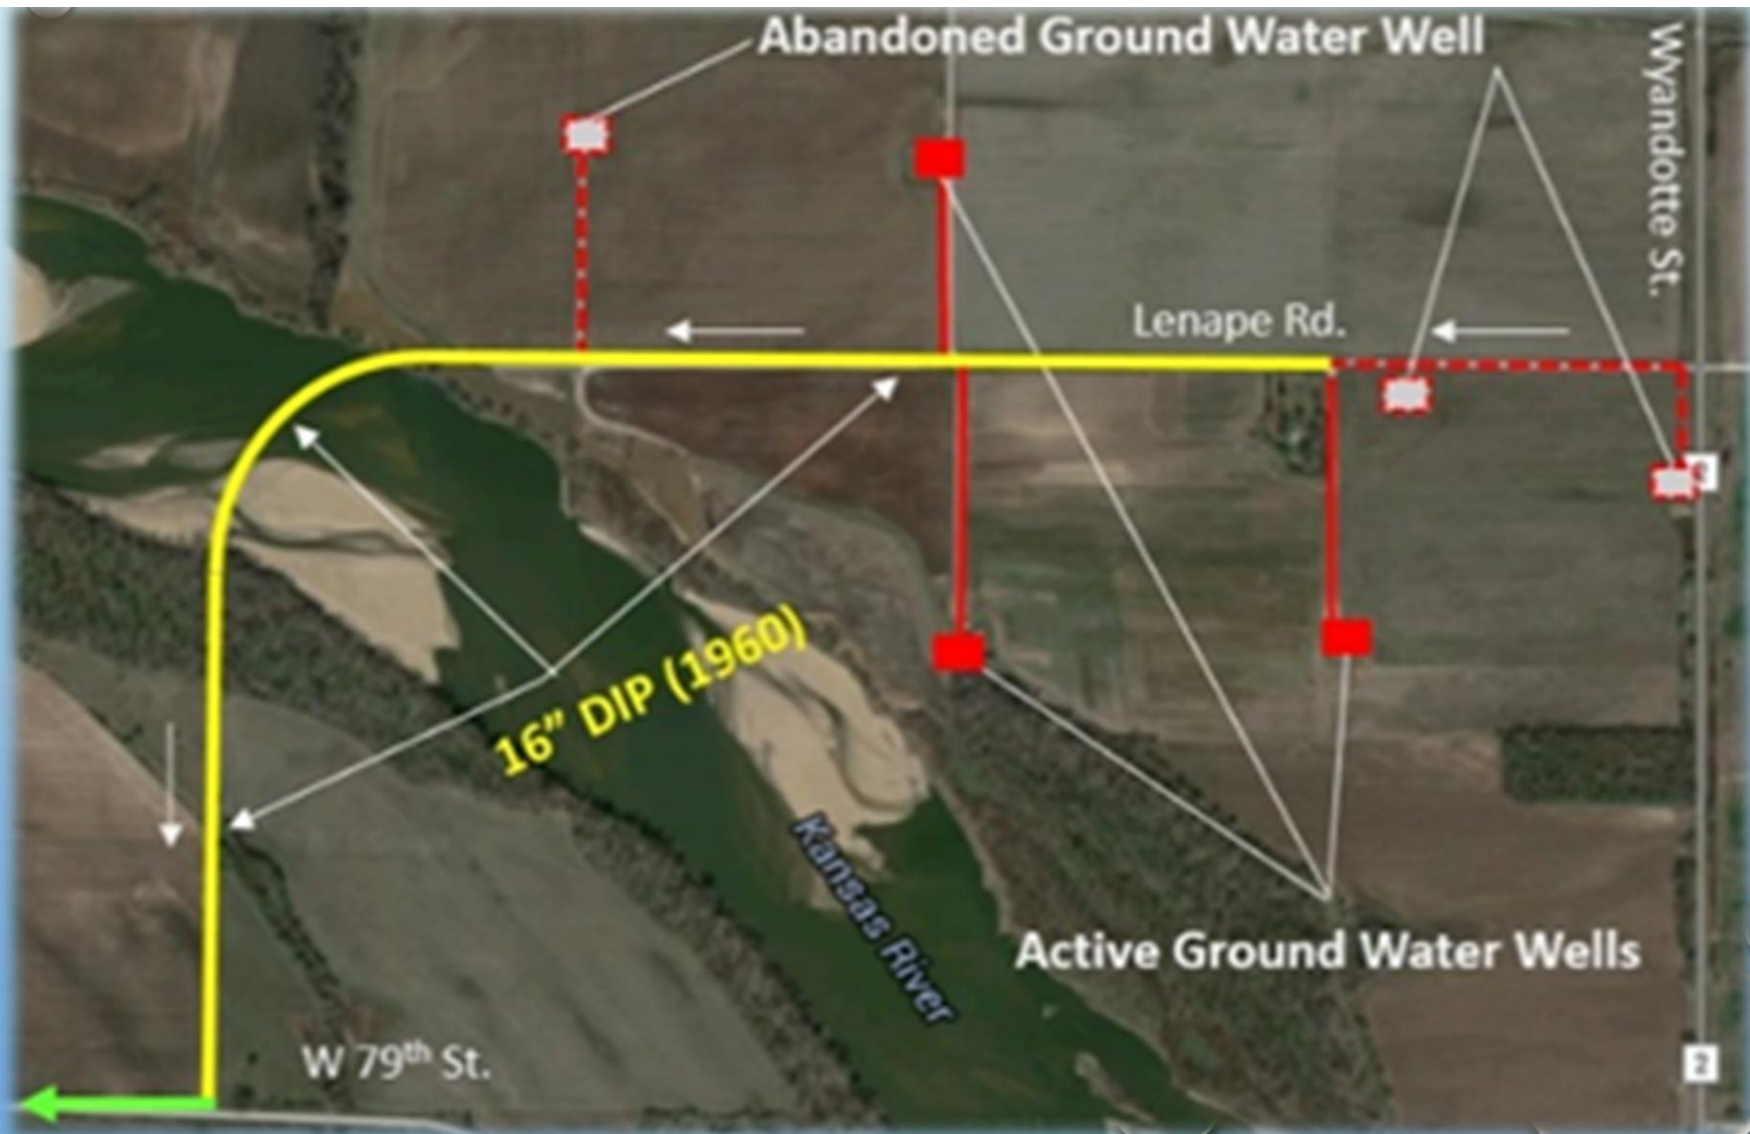
- CITY WATER DEPARTMENT FORCES
  - RESERVED WATER FOR 5 DAYS OUT OF SERVICE, BUT HIGH DEMAND PERIOD
  - DIDN'T TELL OTHER CITY DEPARTMENTS
    - PUBLIC WORKS – ROAD DUST CONTROL
    - PARKS – IRRIGATION
  - PUT WELL FIELD BACK INTO SERVICE BEFORE CLEANING COMPLETION
- 120 GPM JETTER WAS LIMITED IN ITS CLEANING
  - PERFORMED FOR LEVEL PIPELINE AREAS
  - LONGEST OVER 1700 FT CLEANED
  - ELEVATION CHANGES RIVER APPROACH JETTER COULD NOT ADVANCE
  - OTHER IMPEDIMENTS TO JETTING?

- ELEVATION CHANGES UNDER THE RIVER COULD NOT ADVANCE ANYMORE?
- WERE THERE OTHER IMPEDIMENTS TO JETTING?
- NEXT PHASE OPTIONS:
  - LARGER JETTER TRUCK VS.
  - PIGGING

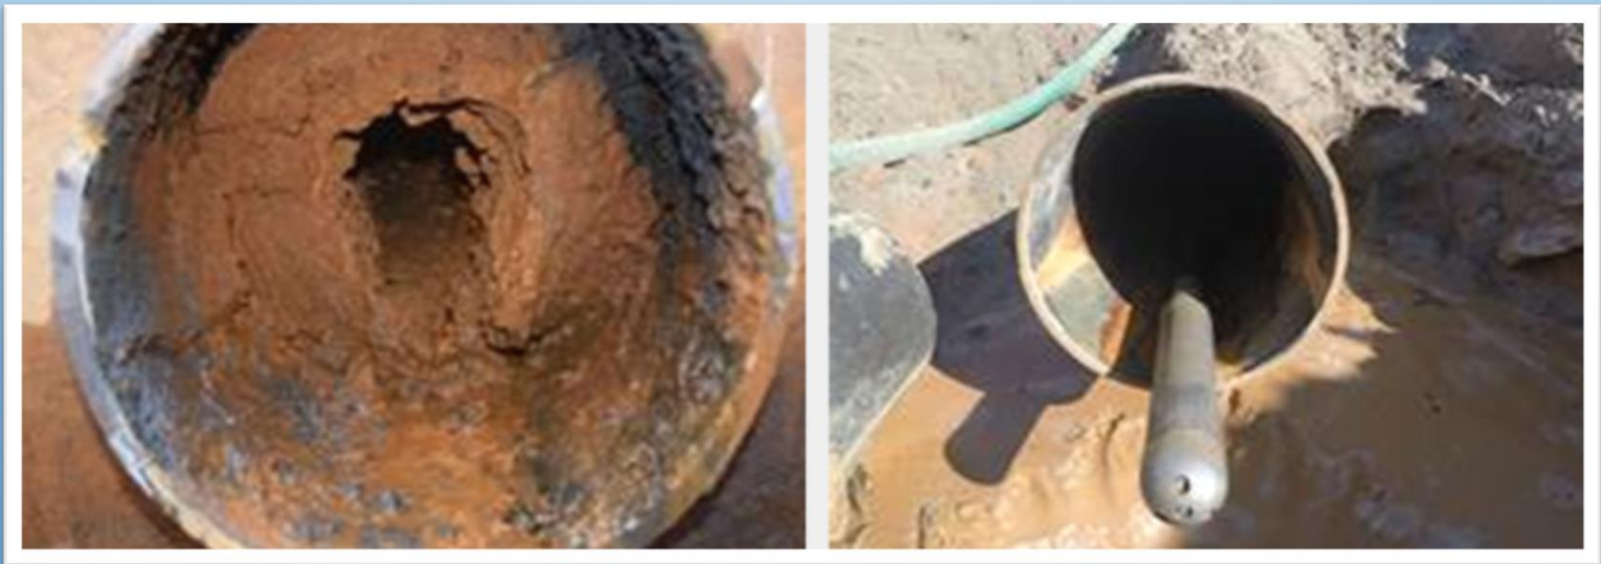
- BIGGER JETTER TRUCK
- CLEANING WAS SUCCESSFUL
- PIPE CONDITION WAS EXCELLENT

| Condition Category | Rating | RUL |
|---|---|---|
| Exterior of Pipeline | Very Good | >20 |
| Interior Pipe Wall/Barrel | Very Good | >20 |
| Interior Cement Lining | Good | 10-20 |
| Pipe Joints | Good | 10-20 |
| Well Laterals (north side) | Good | 10-20 |
| Valve Vault | Average | <5 |
| Hydraulics | Very Good | 160 psi |
