# Condition Assessment of NTMWWD 20" Water Supply Line

James Bryan, P.E.

Kimley-Horn and Associates, Inc.

- C-303 pressure class 150 pipe manufactured in 1975
- Approximately 81,000 linear feet (15 miles)
- Single water line providing supply to several customers
- Existing asset management data supported need to assess

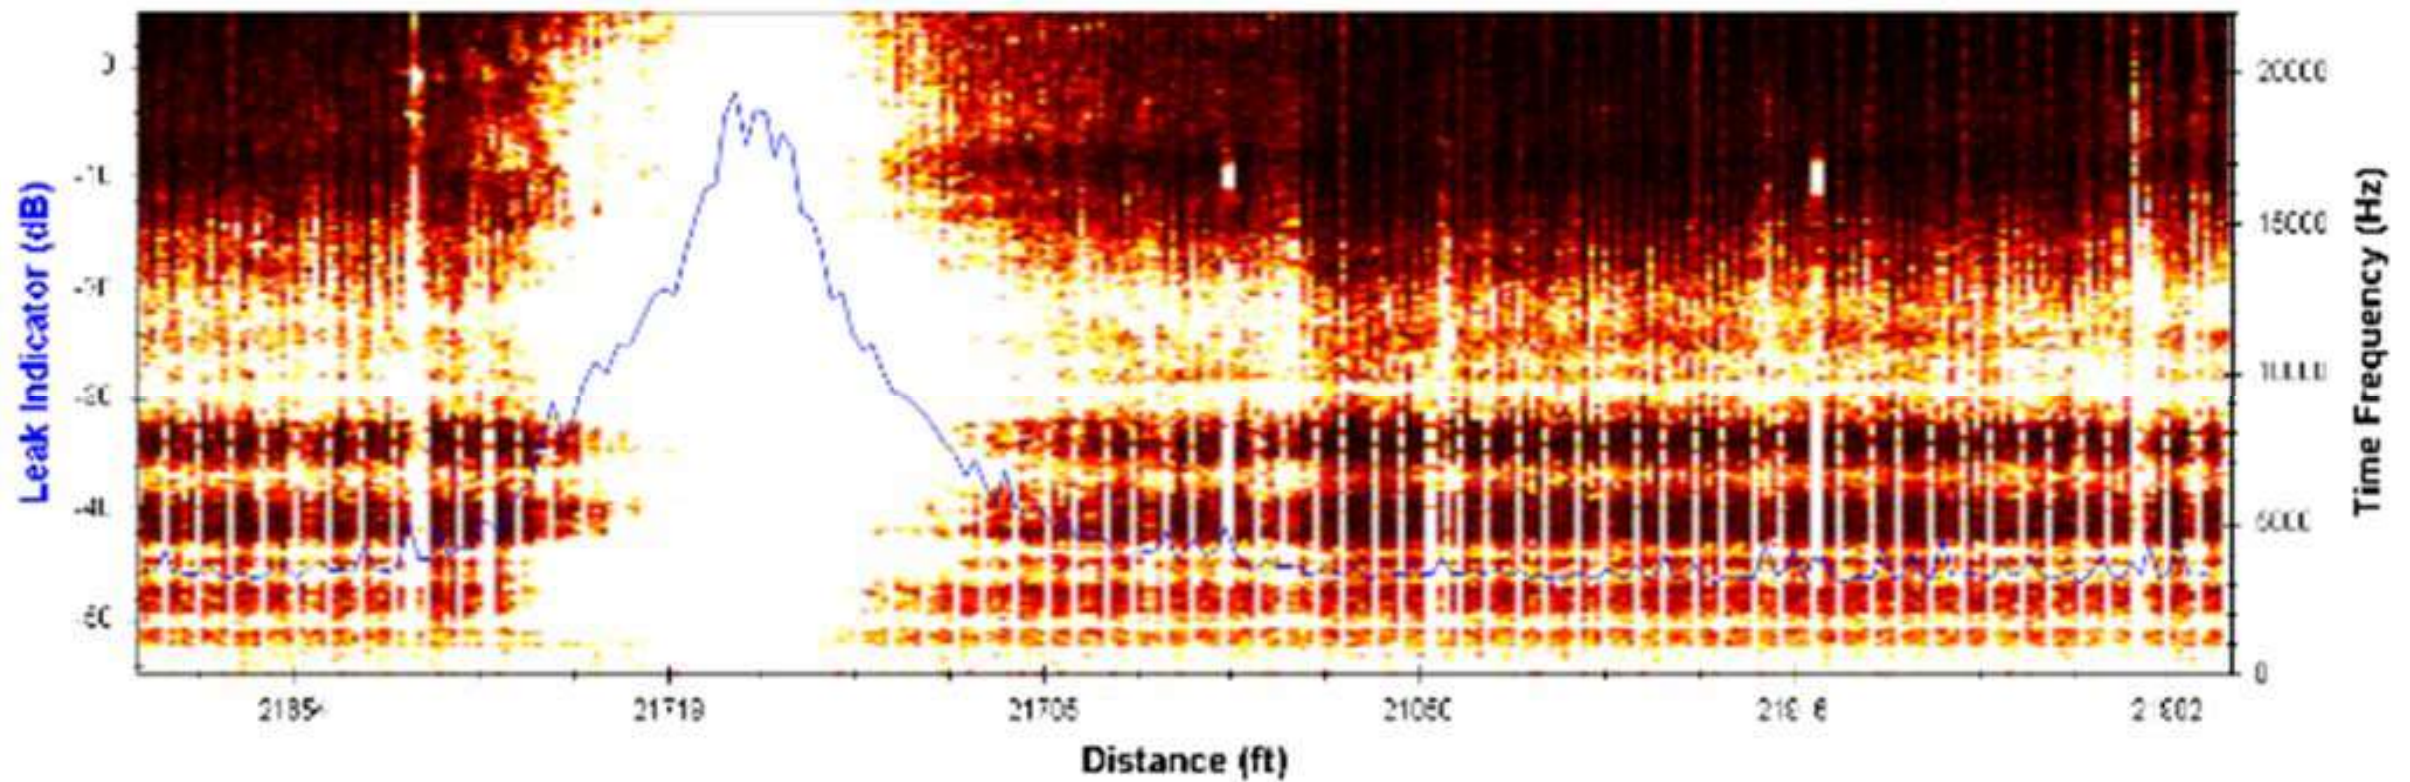
**Table 2.4: Leak #2**

| <b>Leak Location Description</b> | Event lines up on the side of Farm to Market Road 987 West Pyle Street along Kings Creek |
| <b>Leak Distance from Nearest Downstream Tracking Location</b> | 101 feet upstream of ARV A-25 |
| <b>Leak Size</b> | Large |
| <b>Leak Type</b> | Possible Joint Leak- Map and data show a small bend where the leak is located |

## Leak #2 – Large Leak at Pipe Joint

- Repair two leaks
- Repair 1 pipe segment containing up to 64 bar breaks
- Repair 6 pipe segments with combined bar breaks and corrosion
- Observe condition of excavated pipe segments to determine approach for remaining damaged segments

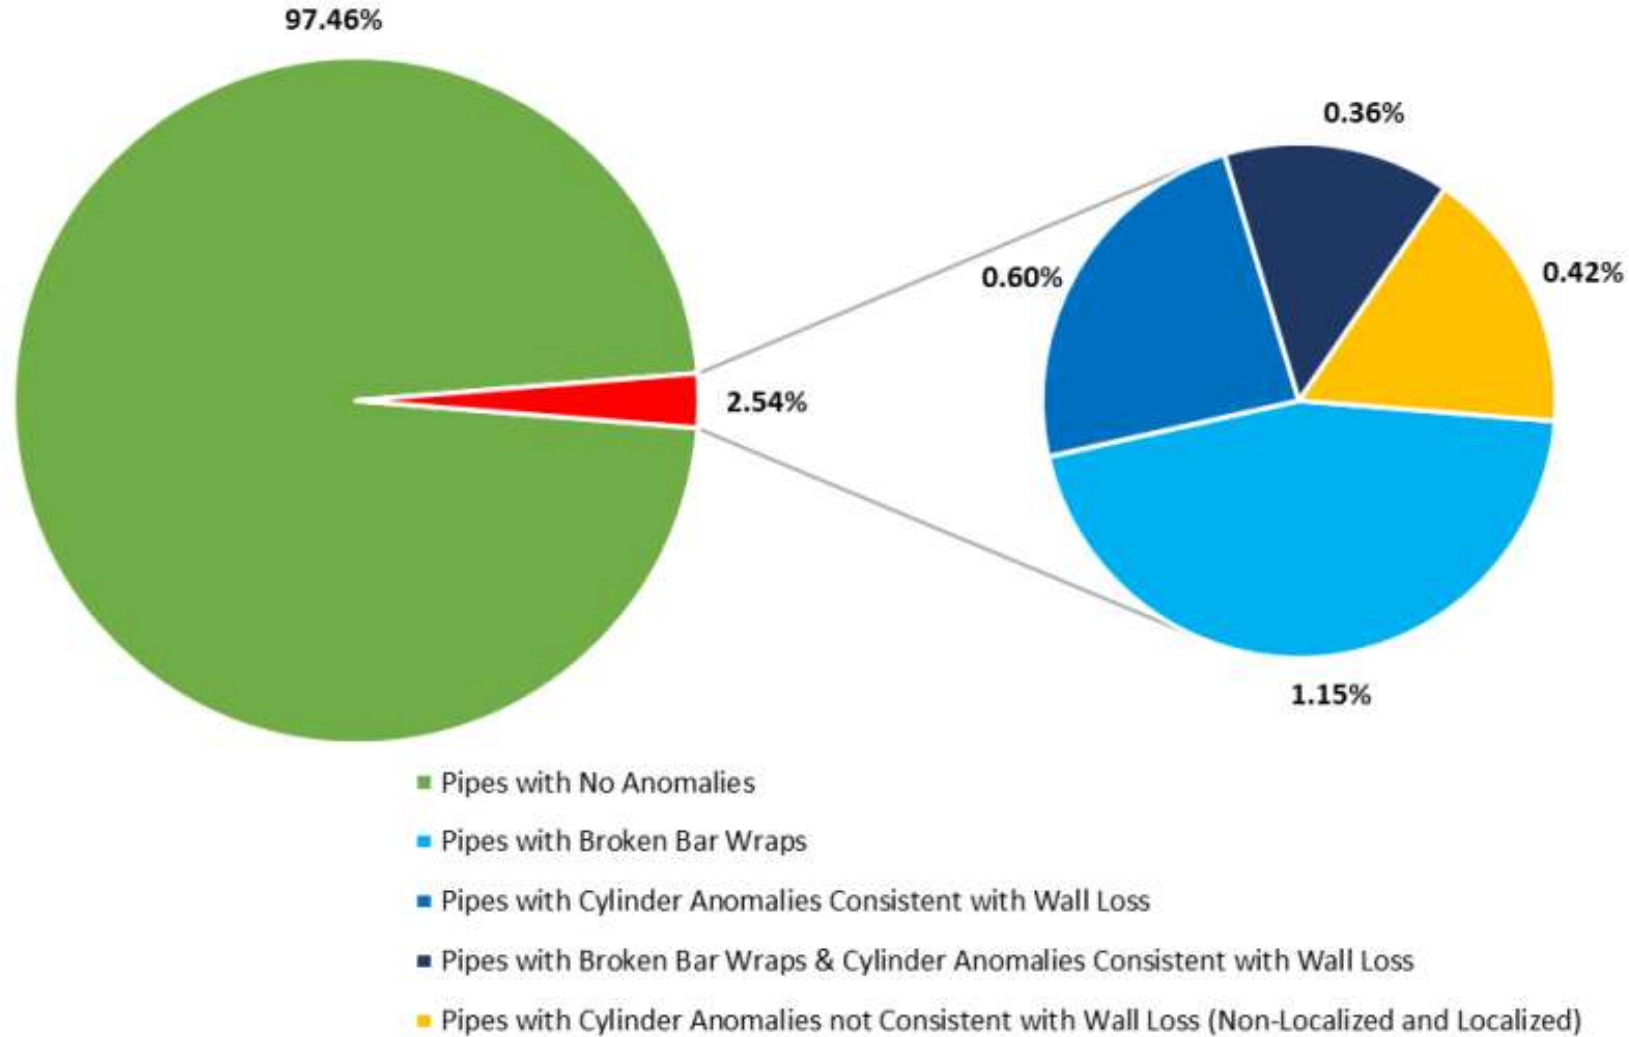
| Table 2.6: Summary of Analysis Results | | | | | | |
| Segment | Diameter (inches) | Number of Inspected Pipes | Pipes with Broken Bar Wraps | Pipes with Cylinder Anomalies Consistent with Wall Loss | Pipes with Cylinder Anomalies not Consistent with Wall Loss (Localized) | Pipes with Cylinder Anomalies not Consistent with Wall Loss (Non-localized) |
| 1 | 20 | 982 | 8 | 6 | 2 | 4 |
| 2 | | 674 | 17 | 10 | 1 | 0 |
| Total | | 1,656 | 25 | 16 | 3 | 4 |

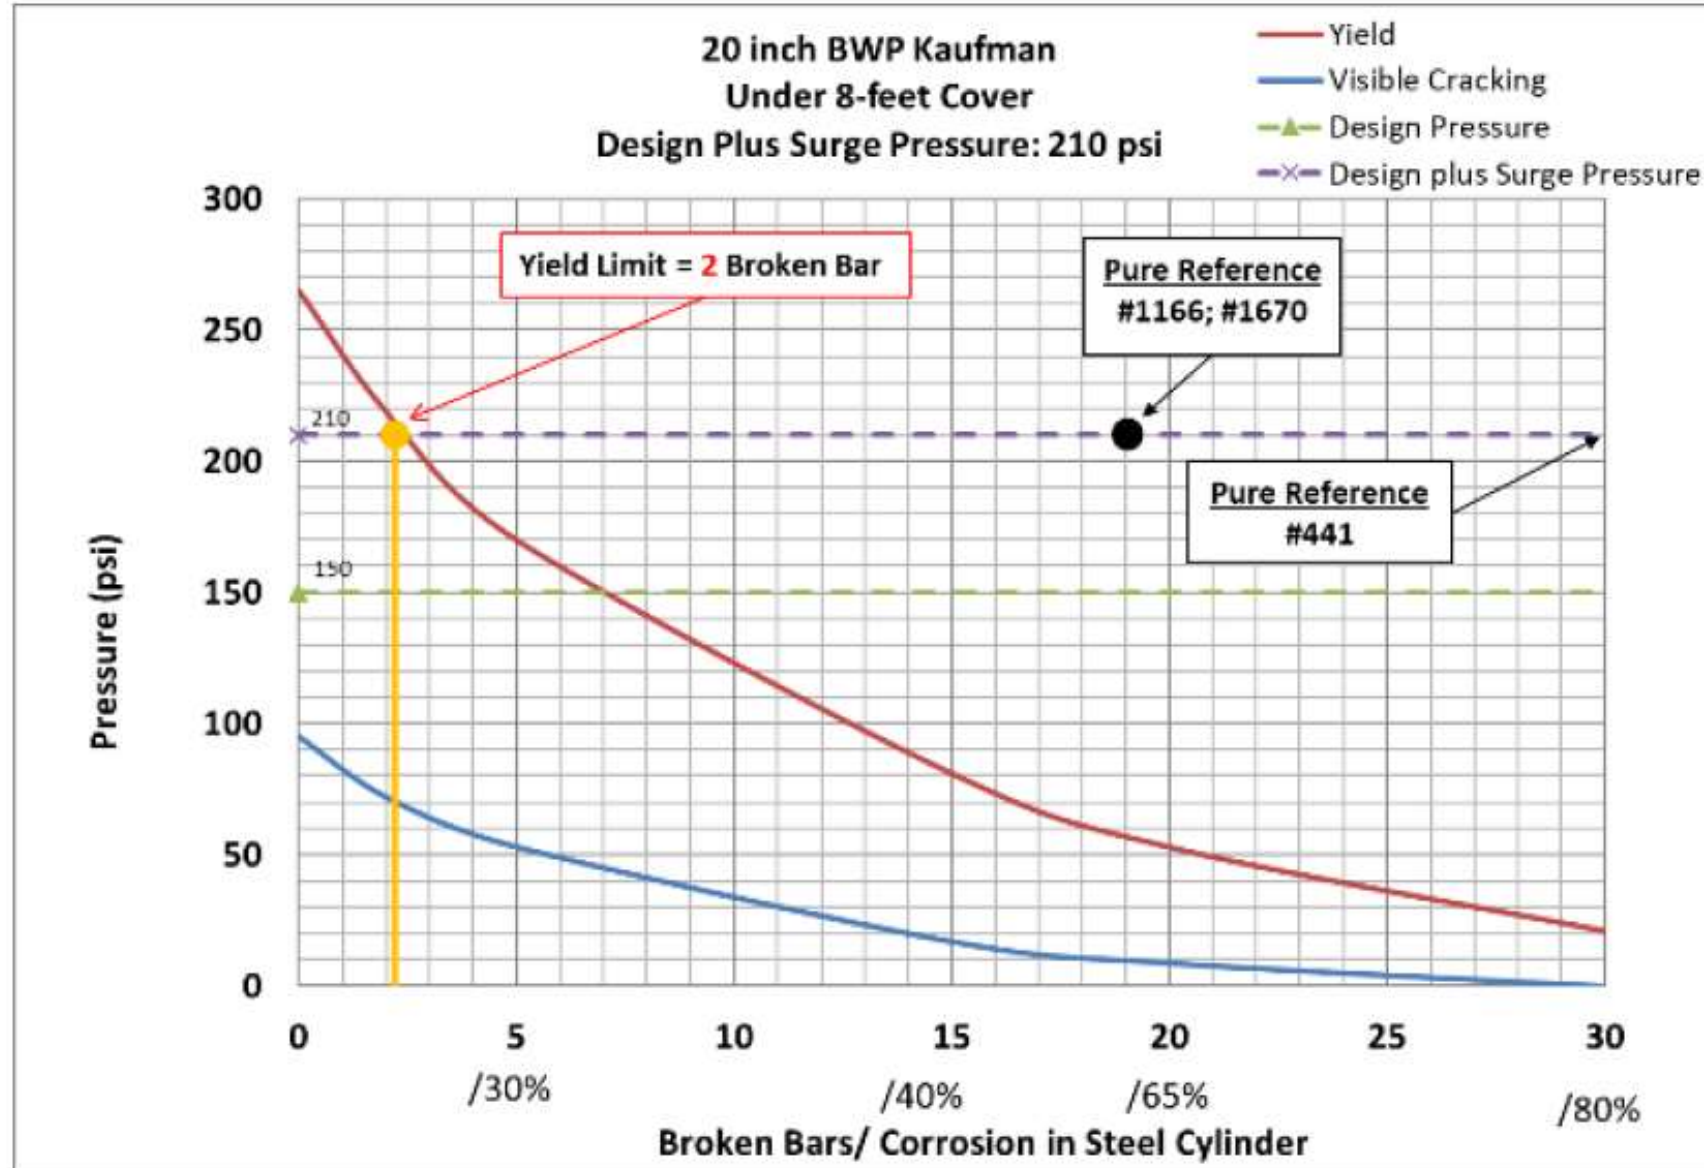
Figure 3.1: Performance Curve for the 20-Inch Class 150 BWP Under 8-Feet of Cover

- Three-dimensional, non-linear finite element analysis (FEA)
- Pipe performance curves based on FEA
  - Visible cracking of inner liner and steel yield limits
  - Design operating plus surge pressure
  - Various depths of cover based on as-built drawings
