Track I-A
Sewer Construction & Rehabilitation
(10:30 AM to 10:55 AM)
January 28, 2020

M-245 48-inch Sanitary Sewer Inverted Siphon Failure

Partial Collapse of 48-inch Single Barrel Siphon Crossing of the Trinity River Floodway

Chris Brooks, P.E.

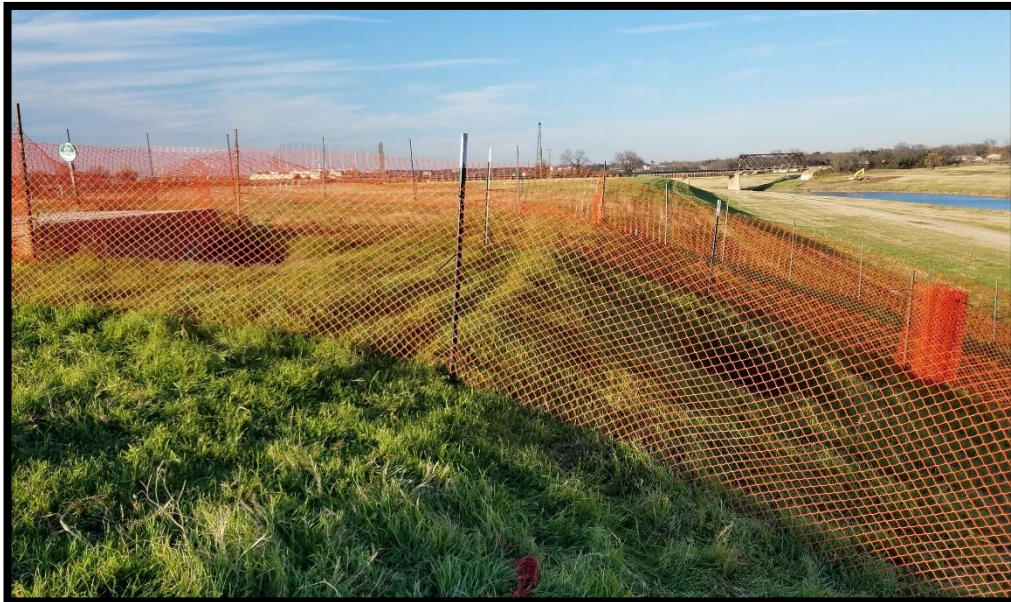
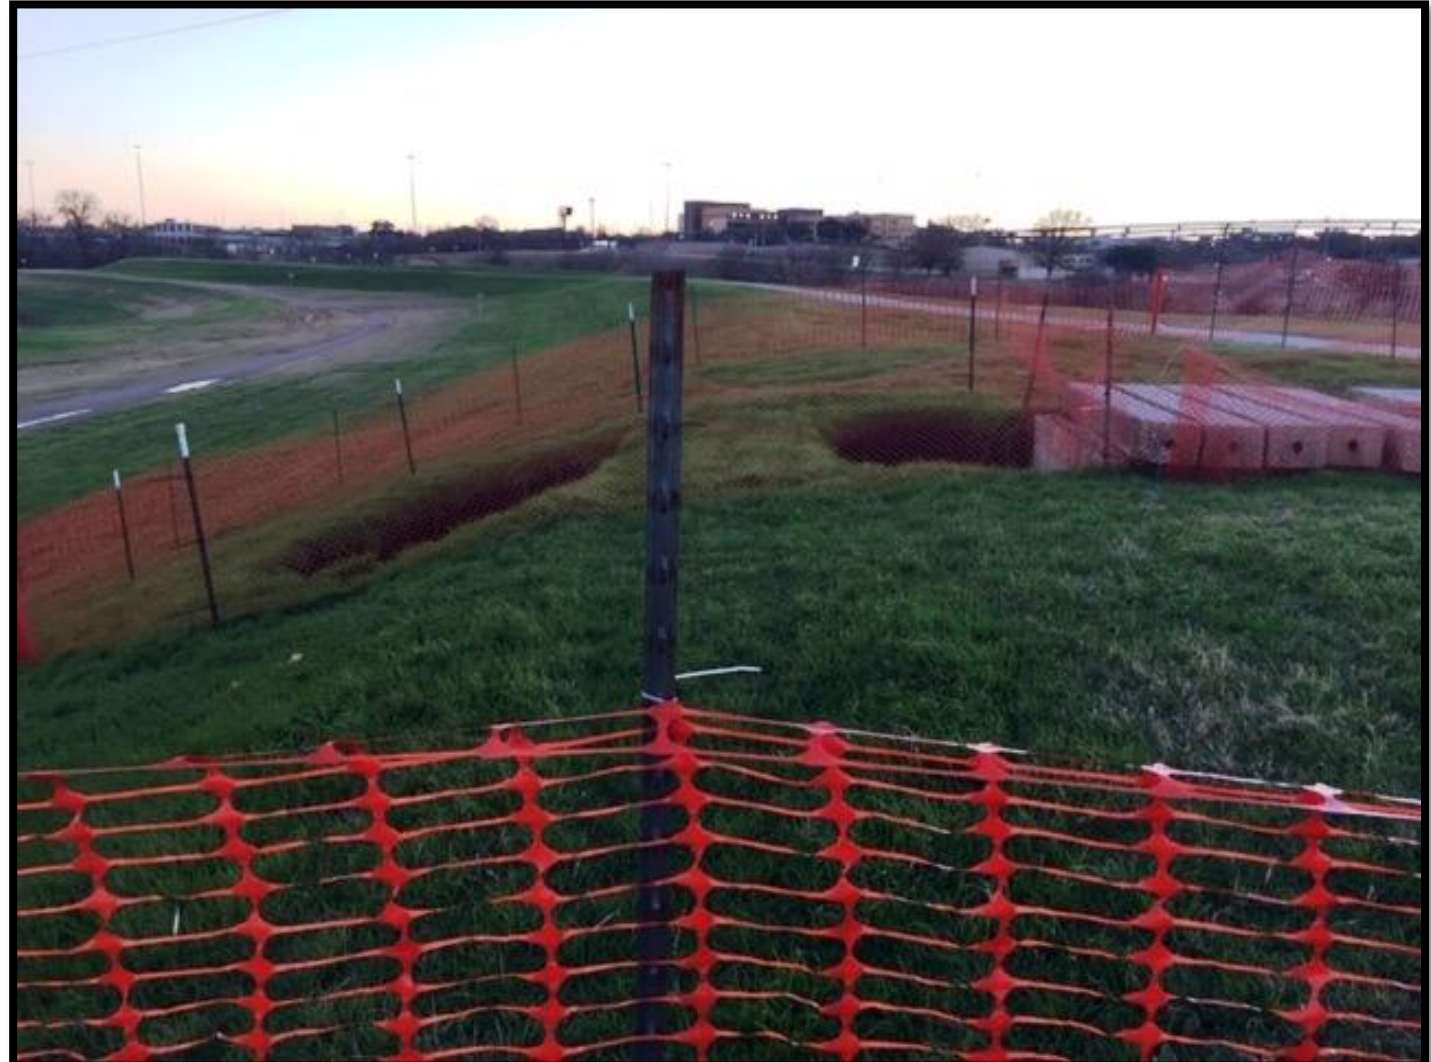
The Fort Worth Water Department (FWWD) was notified of two (2) sink holes in the WF Trinity River Floodway Levee by Tarrant Regional Water District (TRWD). Upon visiting the site, we observed this.....

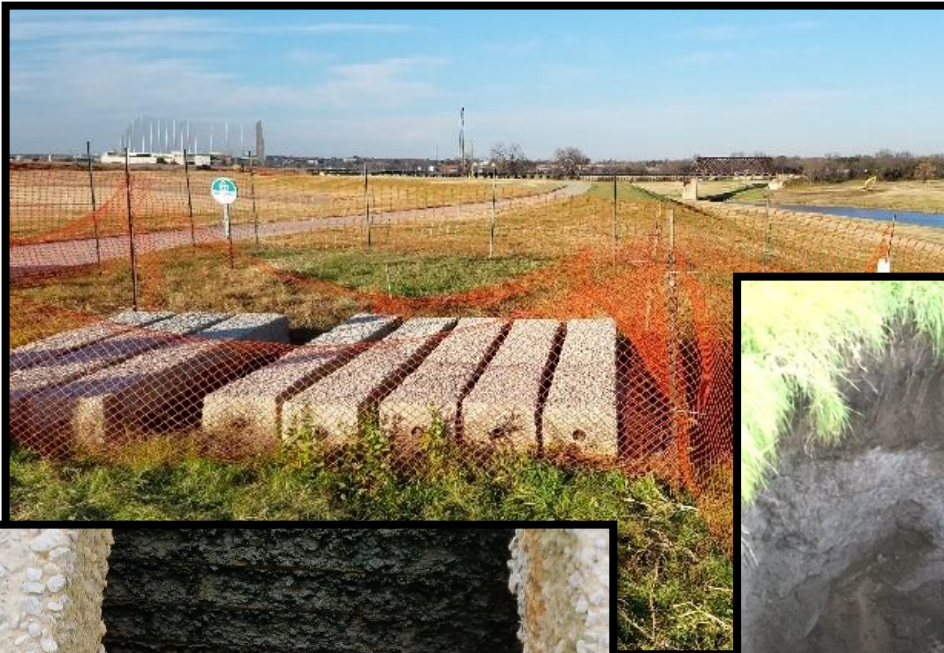
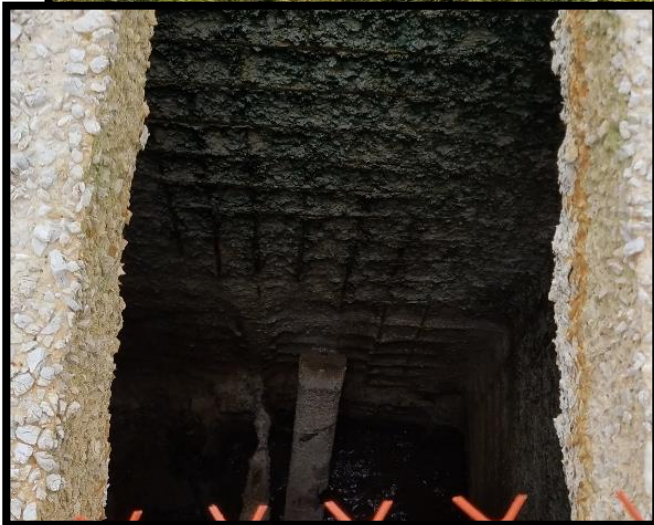
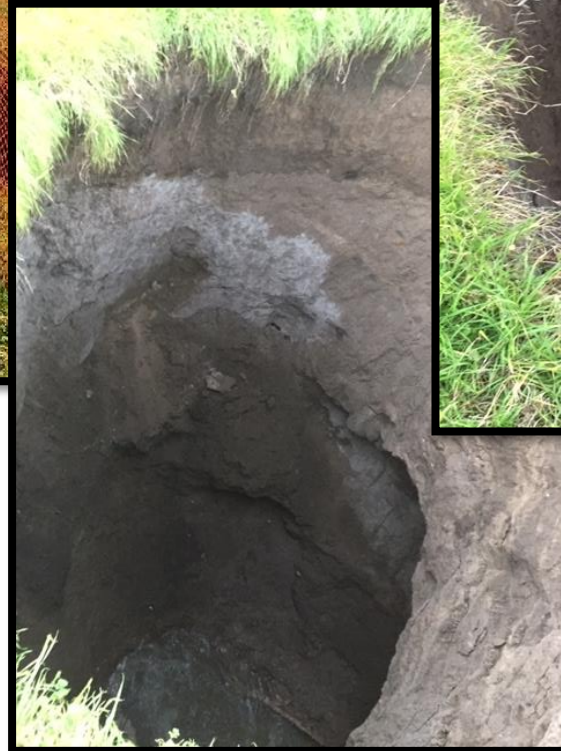
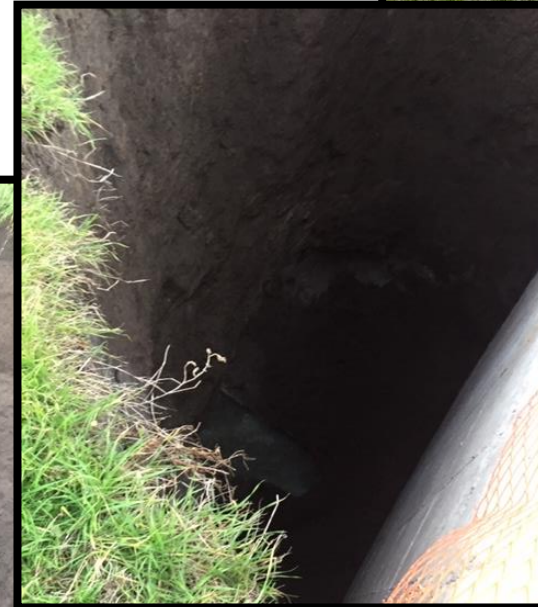
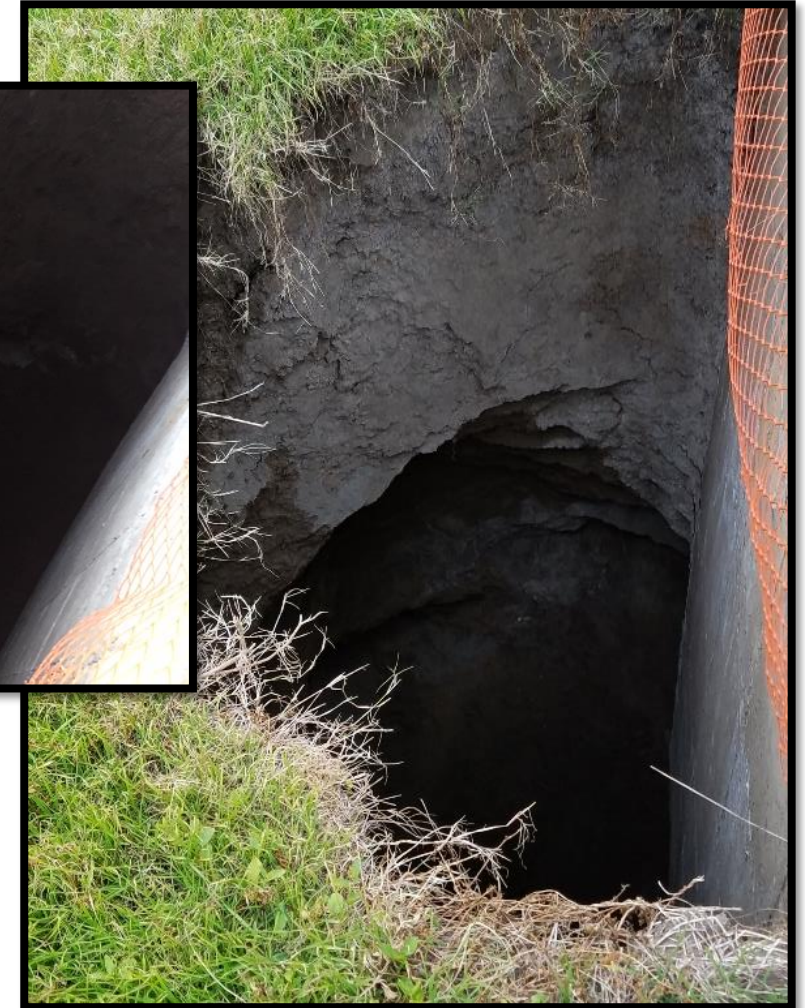
and More Unpleasant Images like these....

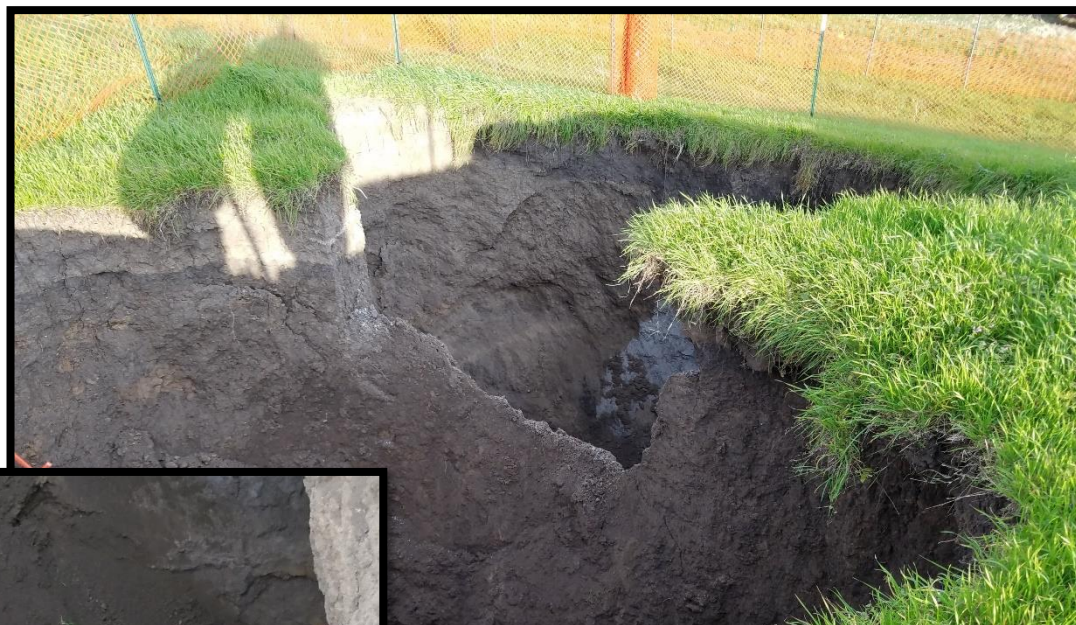
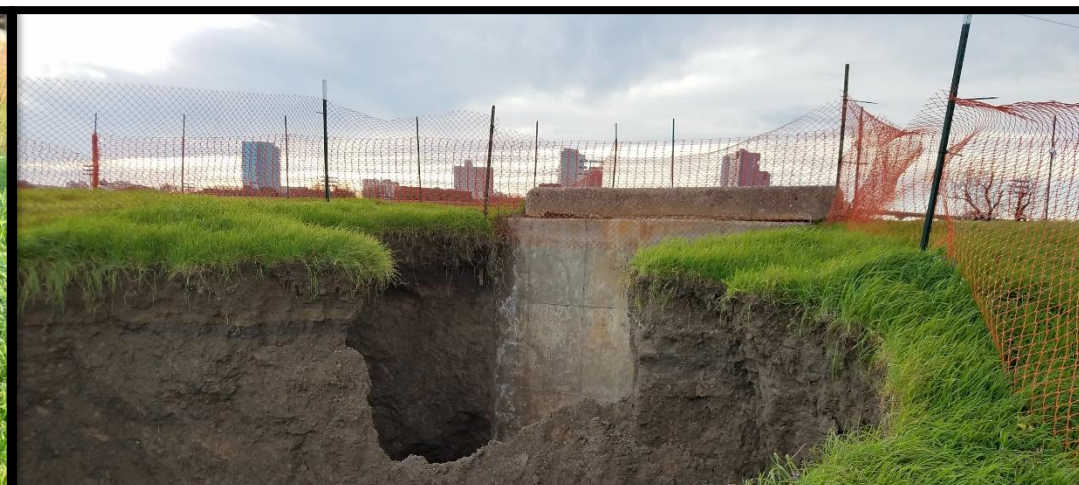
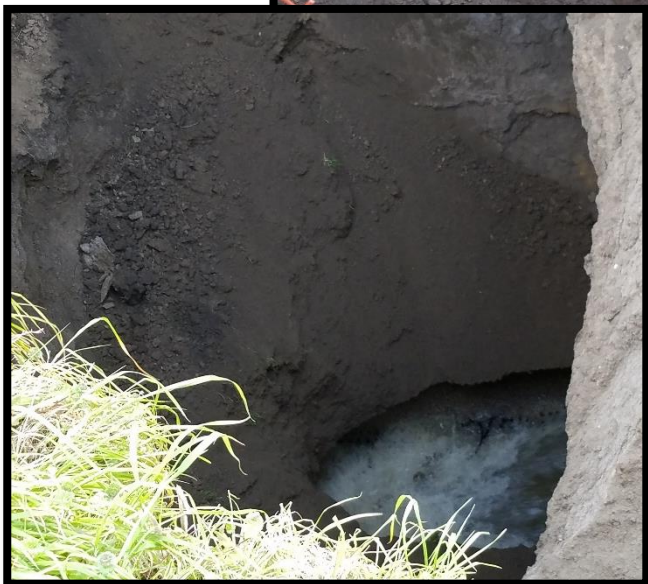
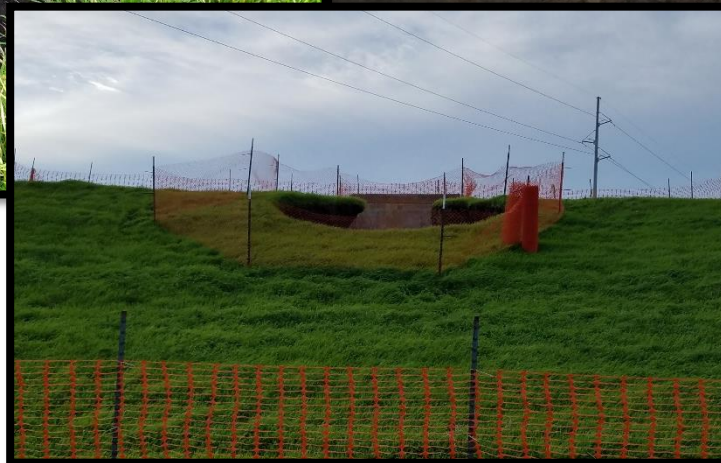
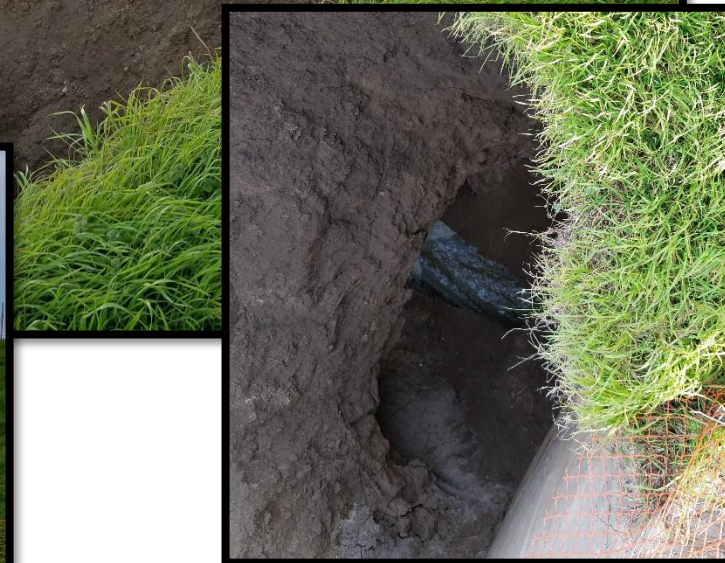
Sink Holes on the Move....
