Underground Construction Technology | January 28-30, 2020 | Fort Worth, TX

Manhole Rehab-What to do when there's a problem

Polymer Liners

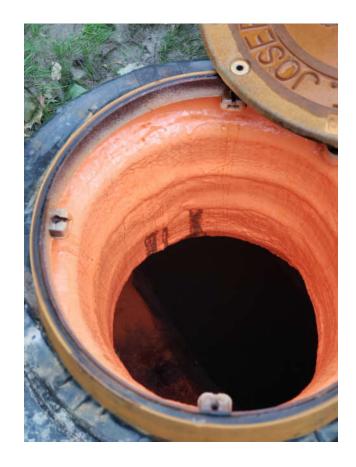
Coating defect
Polyurea
Multi-Layer System

Pinholes Allowing Infiltration –

Applicator error. Void was left open. Repair could have been avoided if a proper inspection were done after installation.

Corrective Action
Polyurea
Multi-Layer System

Abrade to provide a sufficient profile, clean surface, apply promoter and recoat.

In some cases removal of the intermediate layer may be necessary.

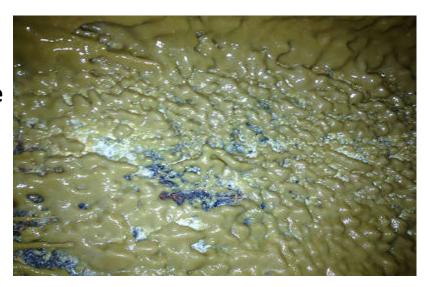
Coating defectsRigid Polyurethane

Poor Coverage—Due to contractor and applicator's poor quality control.
Coating not meeting specified mil thickness and exposed substrate.

Corrective Action Rigid Polyurethane

Abrade to provide a sufficient profile, cut coating termination keys around repair area, remove all dust, apply promoter and recoat with specified mil thickness or apply epoxy material as repair.

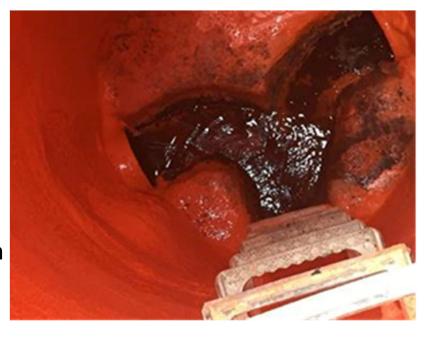
Coating defects

Polyurea

Multi-Layer System

Delamination –

Applicator error.

Cause could be one or combination of:

Active Leak or Moisture on the surface not allowing a bond.

Improper surface preparation/cleaning.

Corrective Action

Polyurea

Multi-Layer System

Remove affected area and beyond.

Address cause by stopping active leak, cleaning and drying the surface.

Abrade existing polyurea edge surface, apply promoter and reinstall the Multi-Layer system in the affected area.

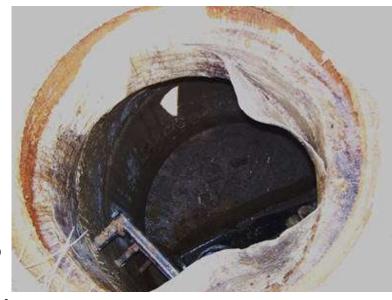
Coating defects Polyurea

Delamination –

Applicator error.

Cause could be one or

combination of:

Improper surface

preparation/cleaning.

Material may have shrunk due to

mix ratio being off.

Underlayment material damp and

uncured.

Active Leak or Moisture on the surface not allowing a bond.

Corrective Action Polyurea

Remove affected area and beyond.

Address cause by stopping active leak, cleaning and drying the surface.

Abrade existing polyurea edge surface, apply promoter and reinstall polyurea to the affected area.

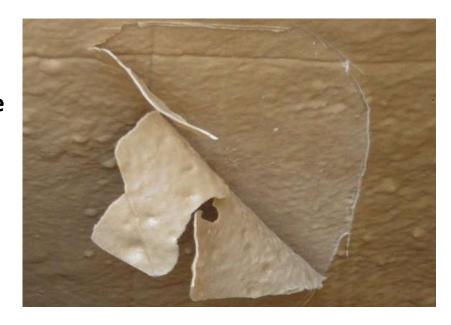
Coating defectsRigid Polyurethane

Blistering—dome shaped projections due to lifting or loss of adhesion. Blisters may contain liquid, vapor, gas, or crystals.

Corrective Action Rigid Polyurethane

Depending upon size and type of blistering, remove blistered areas or entire coating system and repair with epoxy or fully recoat, following manufacturer's recommendations.

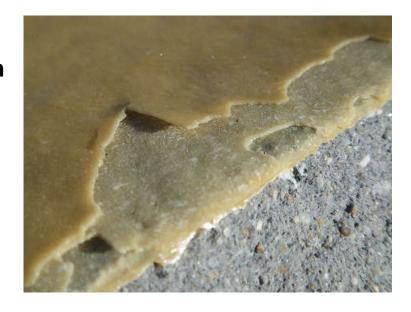
Coating defectsRigid Polyurethane

Delamination or Adhesion Failure—layer separation generally related to poor surface preparation or applying additional coat before prior coat is past tack.

Corrective Action Rigid Polyurethane

Depends upon the extent of adhesion failure.
Removal of defective areas will be necessary prior to adequate preparation and application of correct coating system to manufacturer's recommendations.
