City of Irving 48” MacArthur Line Repair With Carbon Fiber Wrap Materials

Tim Peterie – Business Development Manger
Insituform Technologies, Fibrwrap Construction Services

Underground Construction Technology | January 28-30, 2020 | Fort Worth, TX

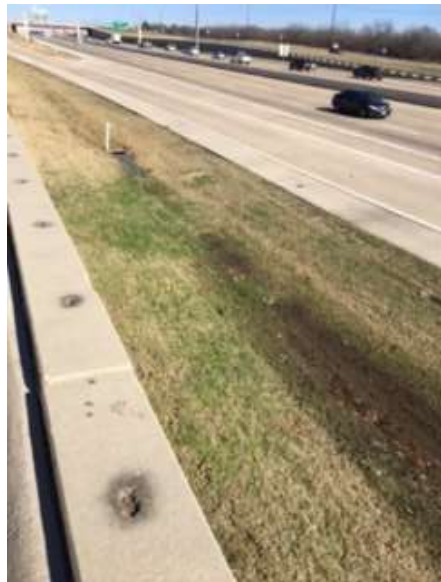
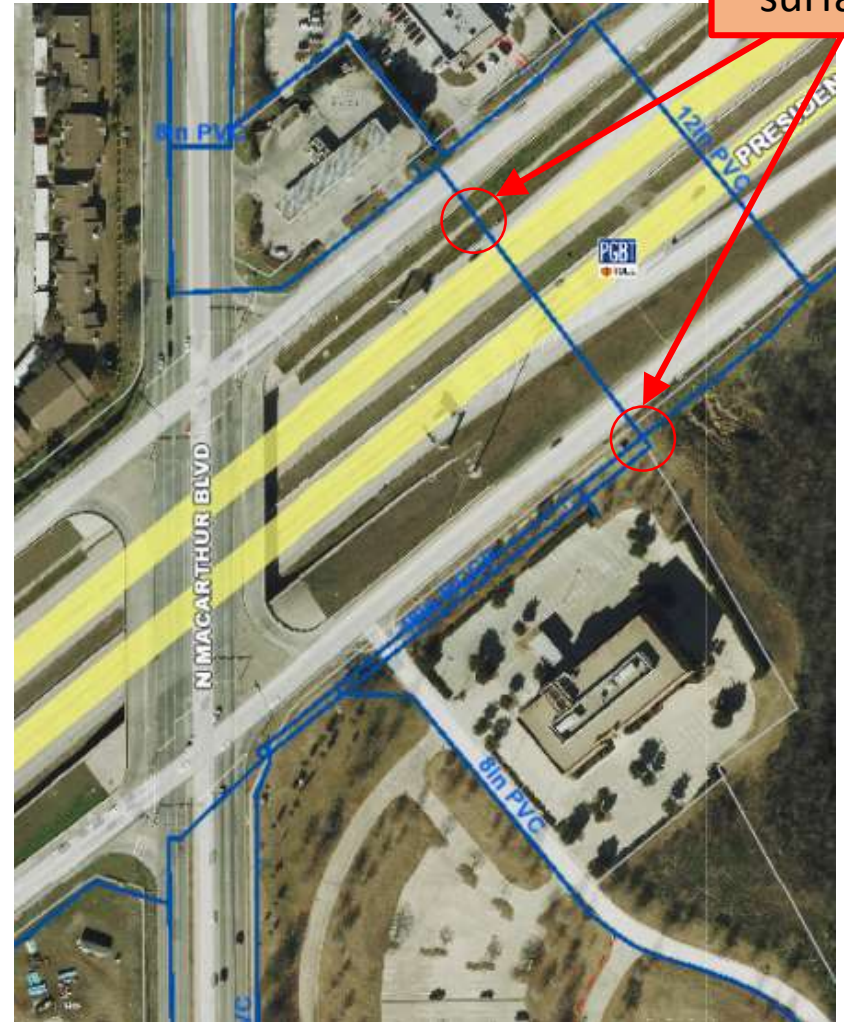
Visible water surfacing

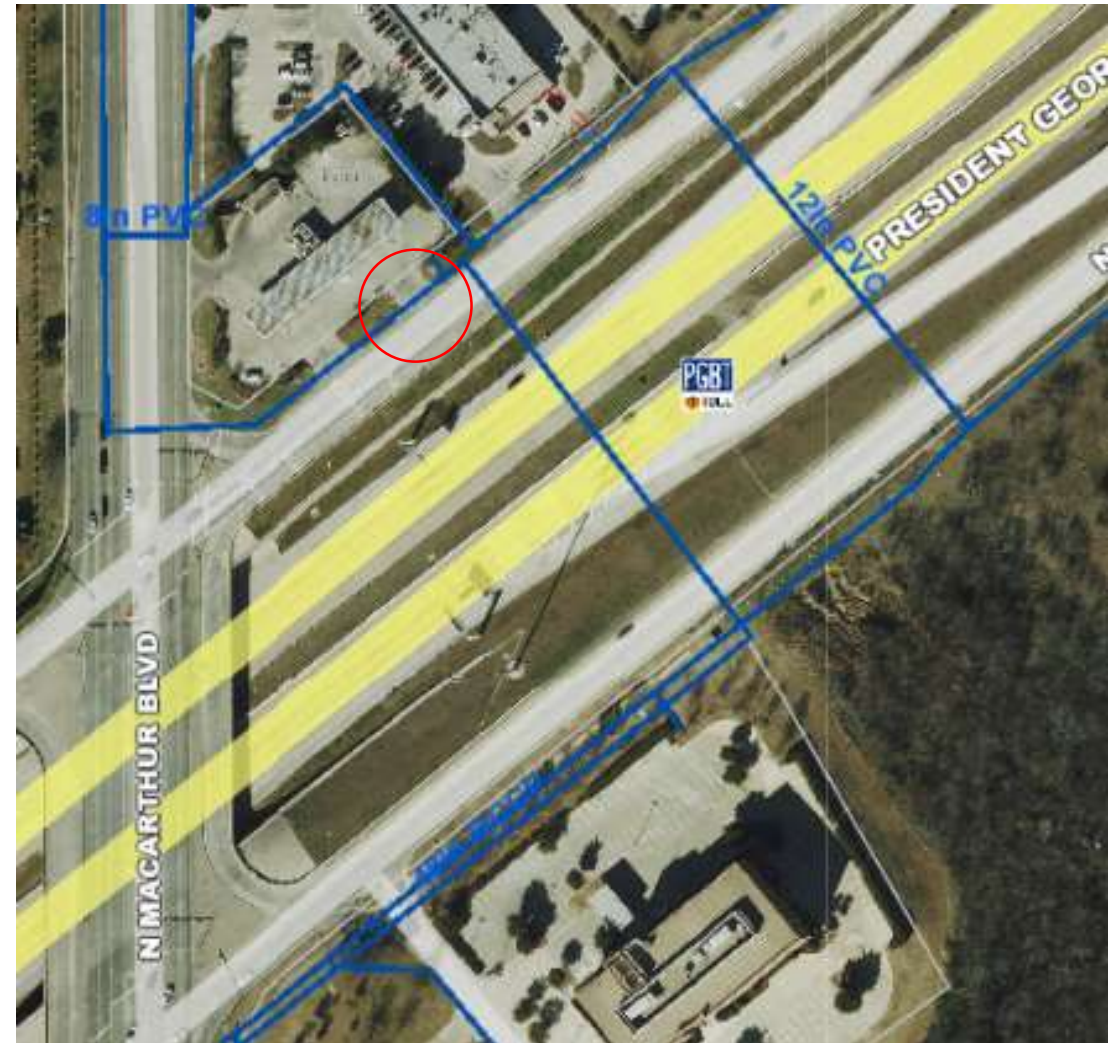
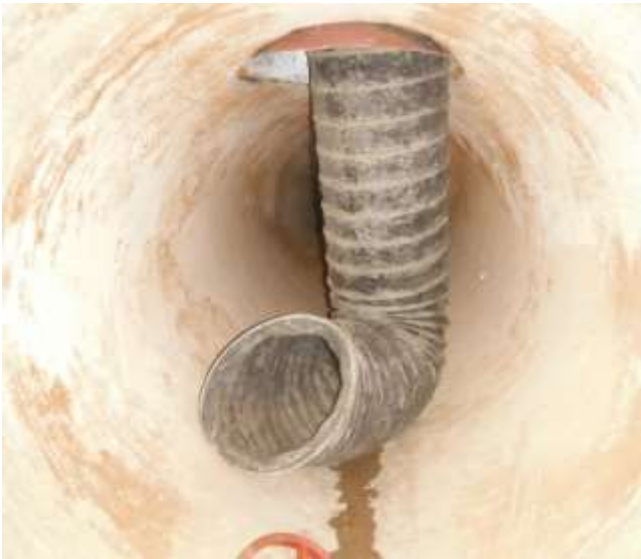
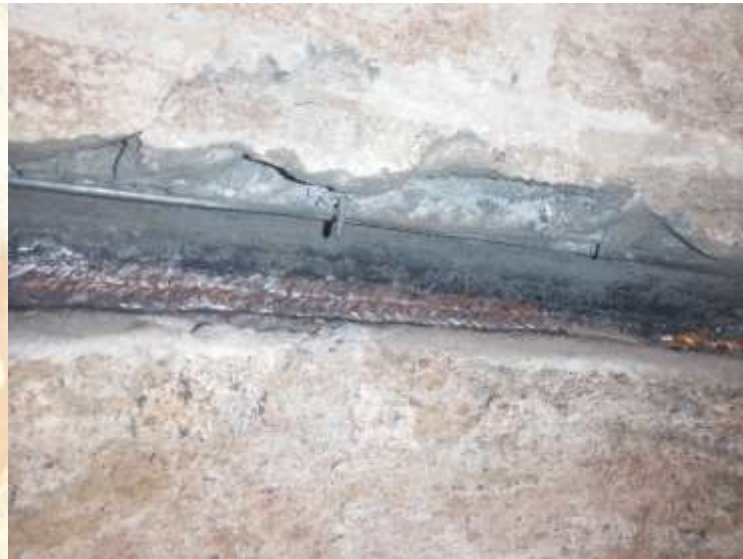
- Leak located by leak detection contractor in area of major underground utilities and access road
- Dewatered and manways constructed for forced air and ventilation.
- Pipe Segment (16 Feet Each) Identified with Wire Breaks and temporary weld repairs completed.
