Underground Construction Technology | January 28-30, 2020 | Fort Worth, TX

MH CIPP Liner/ CIPP Liner Coating Defects

Waterline Renewal Technologies

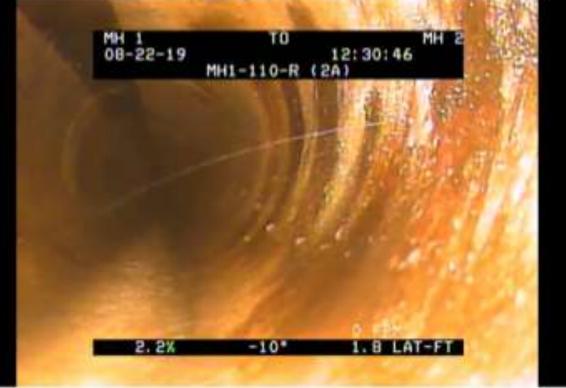
Pinhole Leaks

Pinholes formed in the manufacturing process when the coating is applied

- Stop the leak
 - mastic or grout
- Prep area
- Apply oversized patch

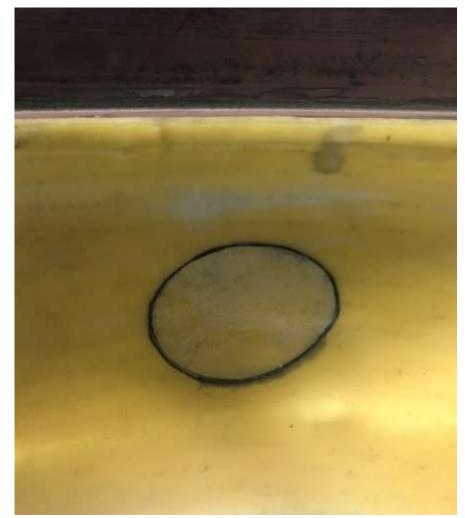
Pinhole Leakage Repair

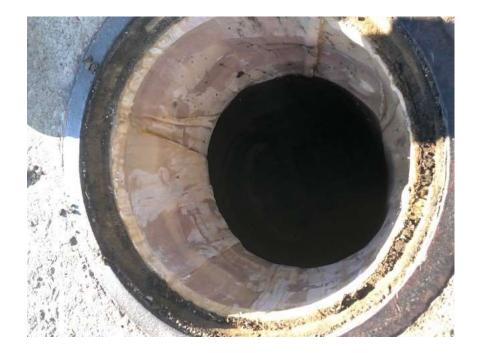
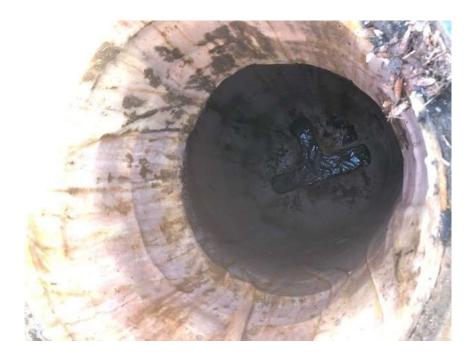
Staining

• Appearance that liner is leaking

- Visual Inspection
 - May not require action
- If leaking, again stop leak and patch over.

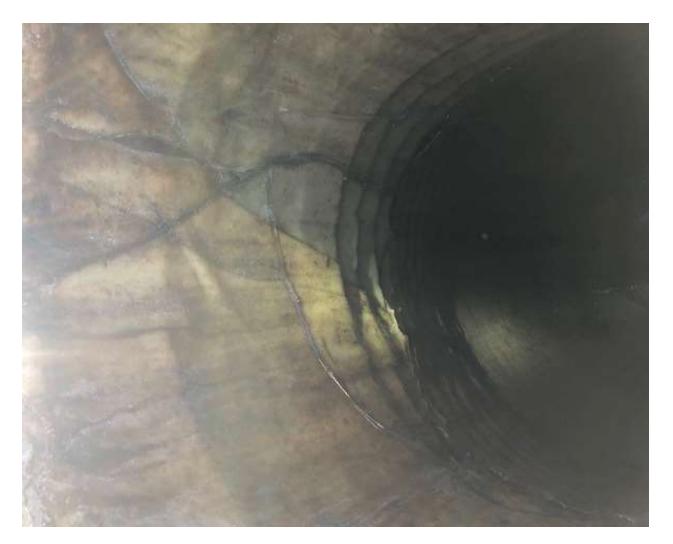
Staining Repair

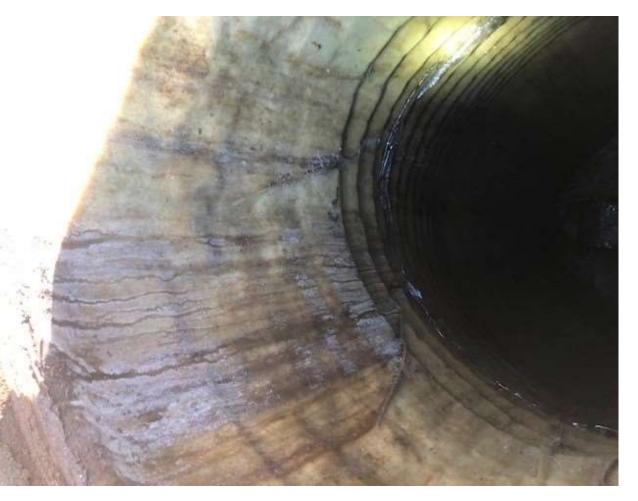
Staining Repair

- Visual Inspection
 - May not require action
- If leaking, again stop leak and patch over.

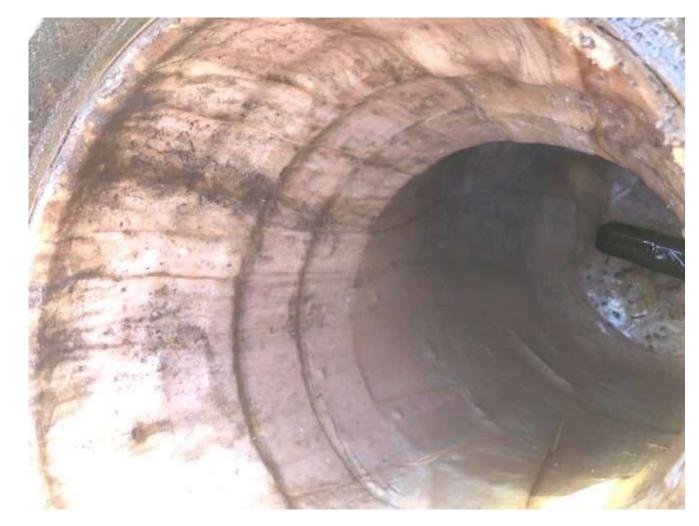
Staining Repair

- Visual Inspection
 - May not require action
- If leaking, again stop leak and patch over.

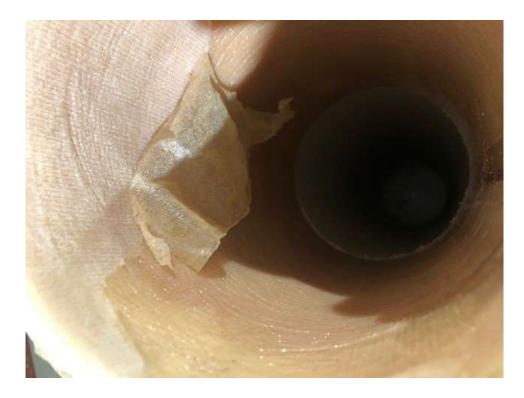
Delamination

• Coating of liner is peeling away from liner

liner. This can be related to overheating of the liner during steam cure applications or high exotherm from the resin.

- Remove all coating that is failing
 - If it doesn't leak
 - Option 1 leave as is
 - Option 2 install oversized patch

Depends upon the extent of the adhesion failure. Removal of the inspection afterwards shows no leakage. Adhering a patch to the defective area might be required if necessary.

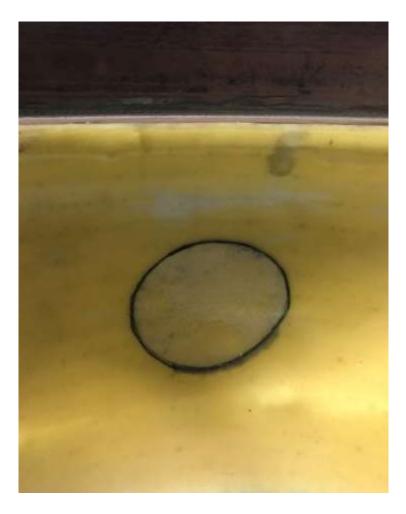
Delamination Repair
