MAIN AND CONGRESS

Slipline of a 20-inch Waterline in Historic Downtown Houston

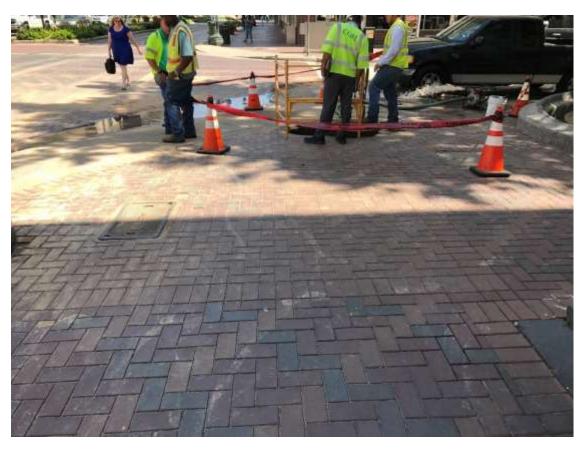
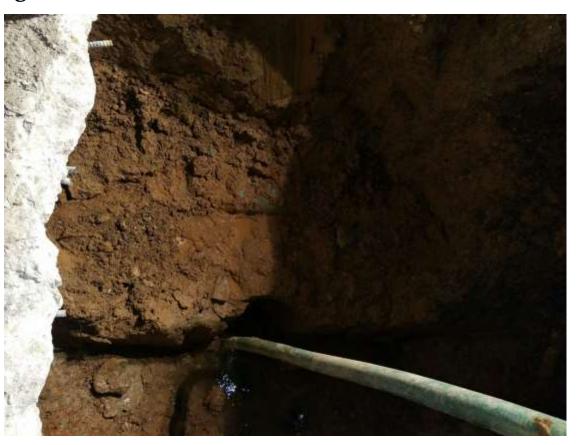
SEPTEMBER 2017

The first leak appears at the southeast corner of Main and Congress St.

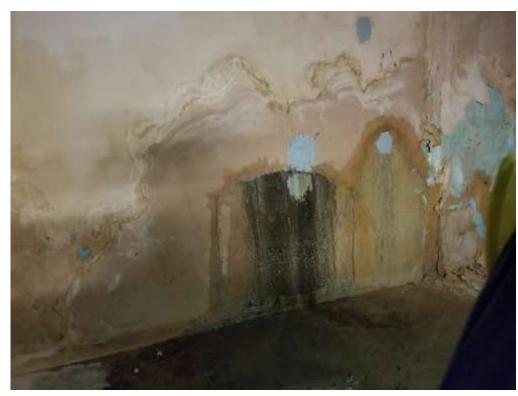
Second leak appears at the northeast corner of Main and Congress

Water falling into basement of nearby Hotel

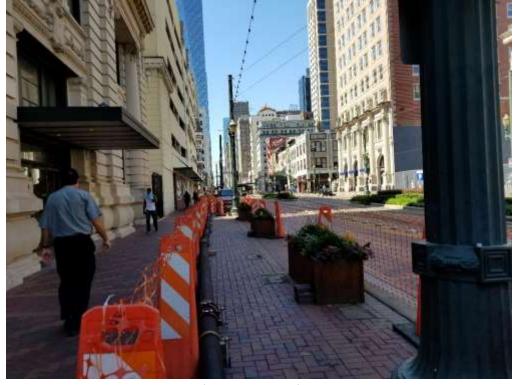
Temporary bypass to Supply Customers

To prevent damage to buildings, 20-inch water line was isolated and a temporary bypass was installed to supply customers.

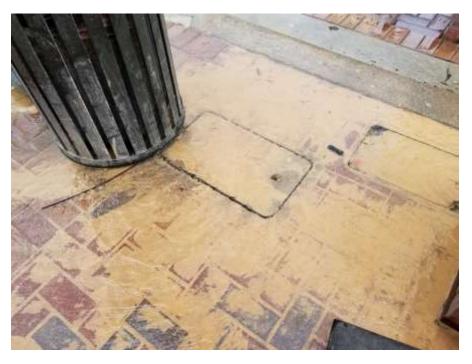
Soon after repair another leak appeared at a second location along the 20-inch waterline.

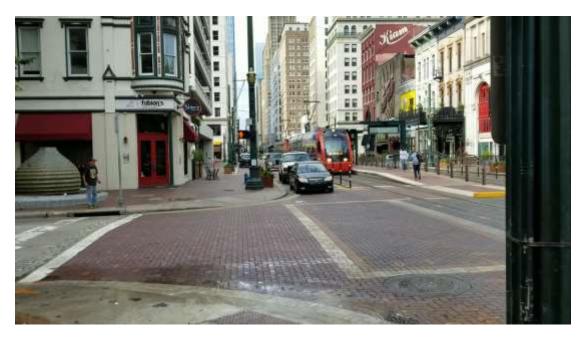
CONGRESS & MAIN STRAY CURRENT

Pipe to Soil potential readings were measured and recorded.

Data showed an electropositive trend in potentials during the hours the rail was in operation

And a current discharge was measured in proximity to the leak location at intervals.
