Replacement of Failed Corrugated Metal Pipe (CMP)

- South Burlington – Colchester IM CULV
- XUMU 17-1098B1 2018 Coast Road Culvert Repair
- Storm Damage Repair to Patricks Point Drive (3N010) PM 1.90

UNDERGROUND CONSTRUCTION TECHNOLOGY

THE UNDERGROUND UTILITIES EVENT | JANUARY 25-27, 2022 | FORT WORTH, TEXAS

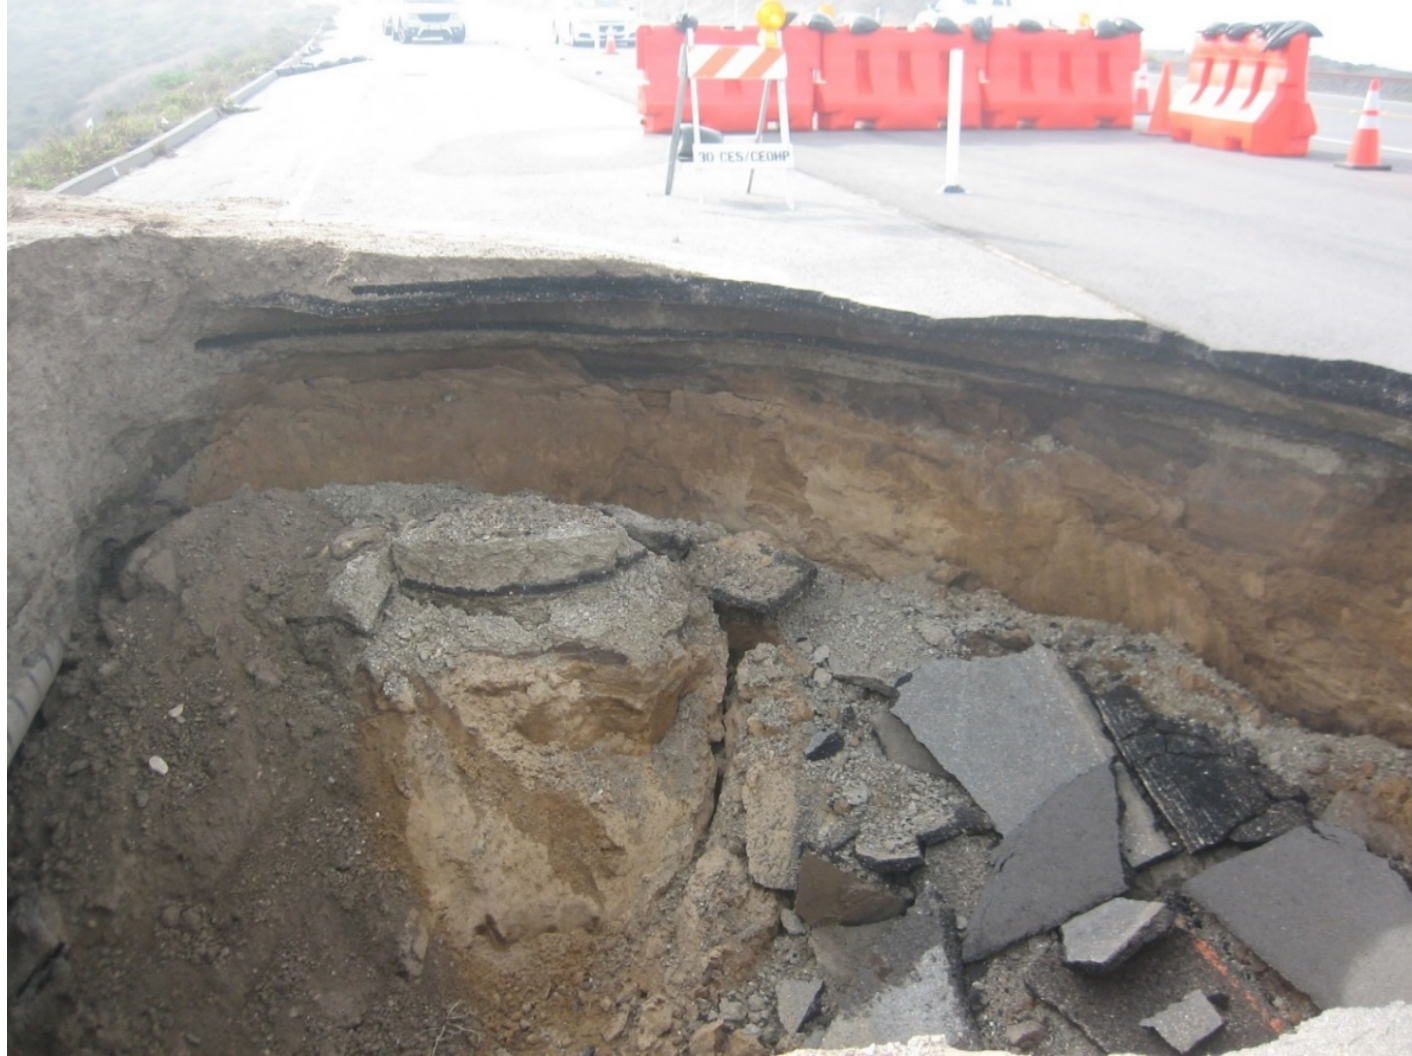
First Sinkhole

- Vandenberg Village, California
- 270 feet of failed CMP
- Terminated 50 feet below existing grade at concrete retaining wall
- Retaining wall at railroad ROW
- Sink Hole 1 in critical access roadway
- Sink Hole 2 near overhead power line pole
- 110-foot Radius Curve
- 94 feet Arc Length

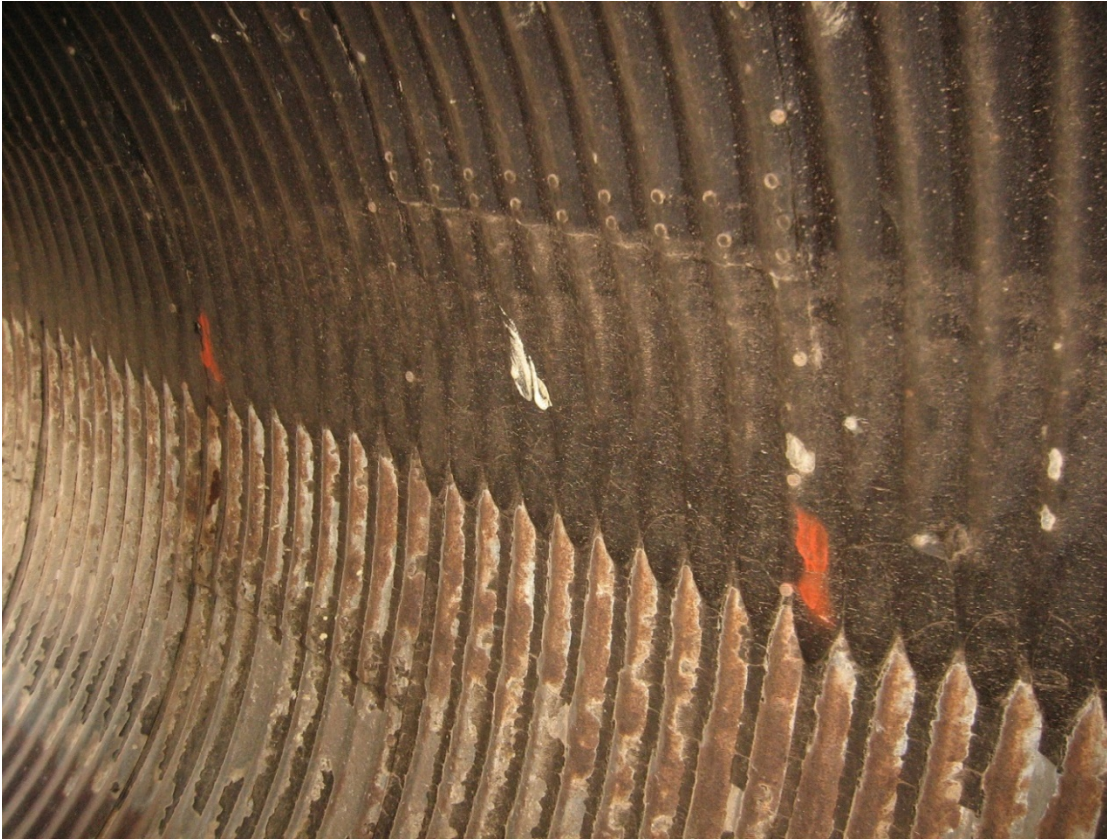
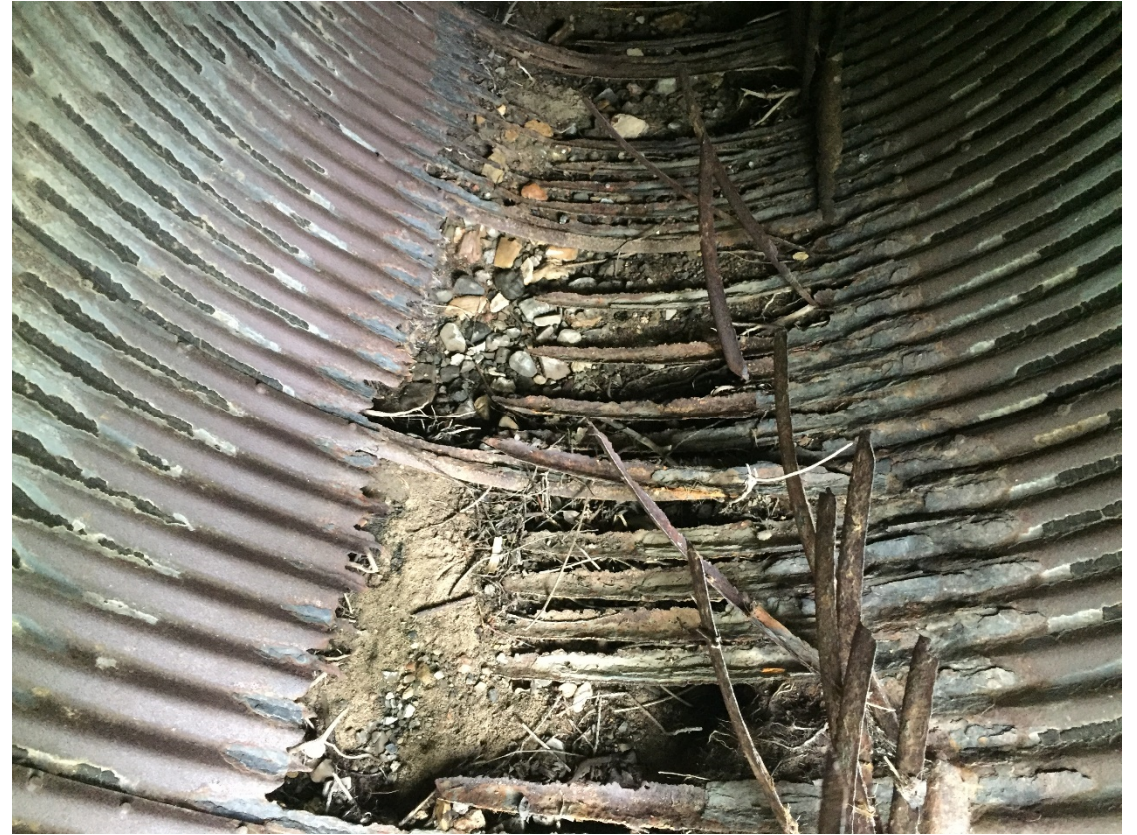
Existing CMP Condition

- August 2017 to November 2018 to design and construct
- Cannot further impact roadway, critical and limited access
- Cannot impact environmentally sensitive habitat
- Three grade breaks of approximately 2 feet fall over 2 feet run
- CMP had various profiles before failure, largest 7-ft diameter
- Failure required a minimum of 84-inch ID excavation
- Zinc and Bitumen Coating and Lining (hazardous and flammable)
- CMP had a cast concrete invert as temporary repair - Not shown
- Twin HDPE pipelines installed to limit further failure - Not shown

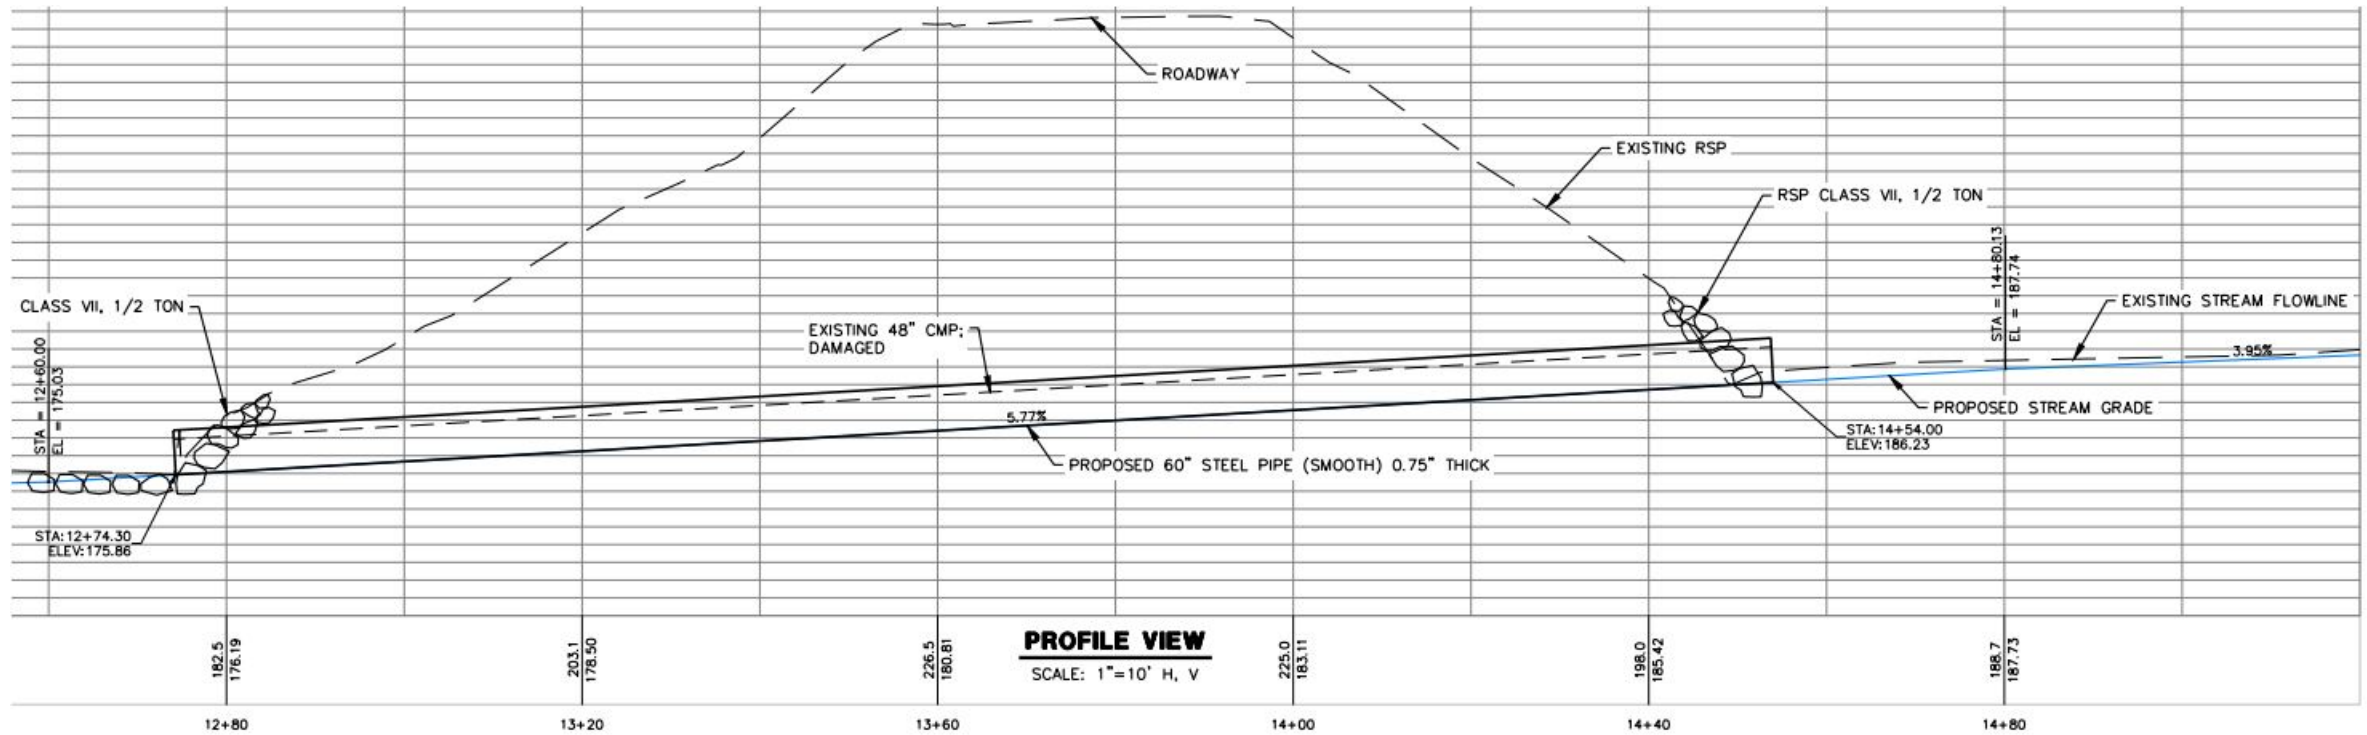
Patricks Point Drive - Elevation

- No impact to Patricks Point Drive
- Culvert immediately upstream is 60-inch CMP
- Increase capacity of failed 48-inch CMP
- Existing CMP within artificial fill
- Possible Redwood tree stumps along alignment, outside CMP
- Recent massive wildfires in Northern California
- Rural County with very limited financial resources

- Replace with 60-inch welded steel casing with 1.0-inch sidewall
- No additional corrosion protection currently proposed, 100-year life
- Steel casing is at a steeper slope than upstream CMP
- Allowed Pipe Ramming or Tunneling over CMP
- No torch cutting of CMP due to zinc coating
- Project bid with construction to commence shortly
