PVC Pipe Offers Two-Day Aerial / Over River Installation for Much-Needed Water Delivery

Craig Fisher, P.E.
Regional Engineer
Westlake Pipe & Fittings

Underground Infrastructure Conference

March 19-21, 2024 | Oklahoma City, OK

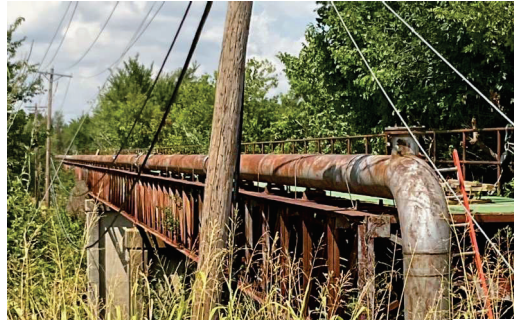
Project Background

The original 18” steel pipe was installed in the mid to late 1960s. It served the City well until the fiercely cold and long cold snap the south central US experienced in February of 2021. As you can see, the pipe was exposed to the elements. During what we called “SnowMagidon”, the City posted its lowest temperature since 1899. It hit 14 below zero. The numbers get even crazier if you factor in wind chill. Once things warmed up, the repair crews tried getting this line back in service. They went through six iterations of trying to repair the line. They installed a repair sleeve at a leak, then repressurized, and then identified another leak. This process repeated itself a total of six times at which point the line was deemed to be beyond repair. A project to replace the line was proposed and approved and was scheduled for installation in 2023. The replacement line was going to go under the North Canadian River instead of over it.

- 18” Steel Pipe w/ 0.25” Wall.
 - Mid to Late 1960s.
- Feb 2021. Fierce / Long Cold Snap. Wikipedia quote. OKC -14F. Lowest since 1899. Power outages across south central US. This 18” line one of the casualties.
- Summer 2021. Line beyond repair.
- Project Approved.

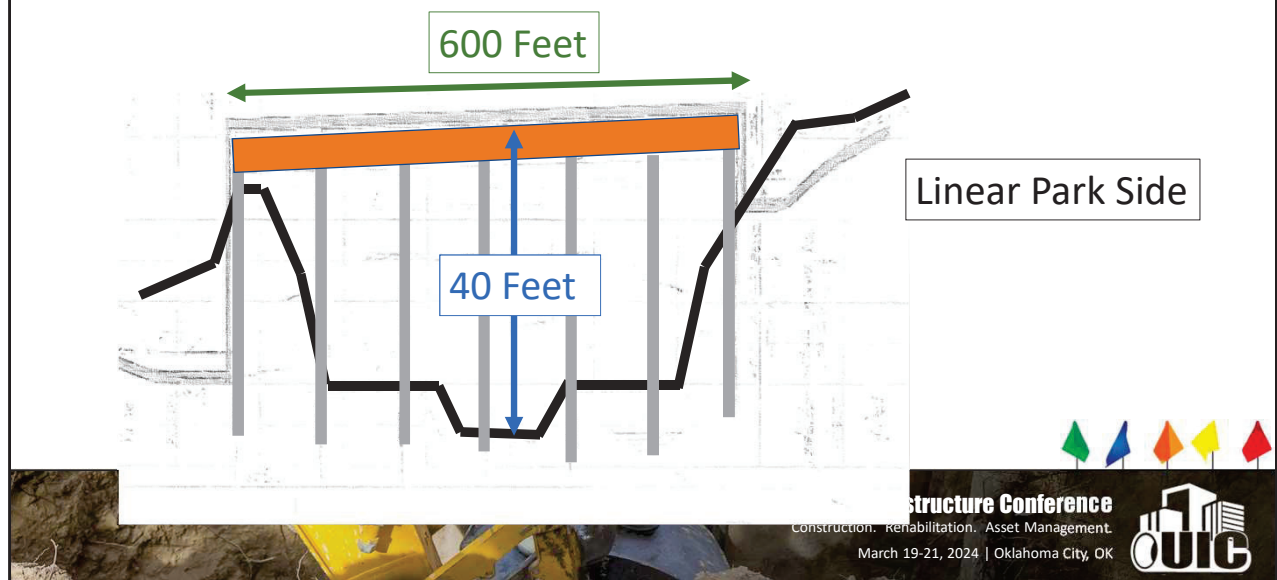
Pipe Bridge

This sketch gives the basic dimensions for the pipe bridge. In the background, you can see where I cut and pasted the bridge elevation view from the 1965 design drawings. That drawing was faint and busy, so I inserted some basic shapes to convey the key details. This orange rectangle represents the box truss bridge structure. These light gray rectangles are the piers and pilings. This black line represents the ground elevation after it had been regraded to a more rational cross section. From the bridge deck to the lowest point in the channel is 40 feet. This is approximately 600 feet of pipe on the pipe bridge. This grey area represents the 18" water main. The hike and bike trail and the parking lot are on the west side of the bridge structure.

Besides the horrible snow storm and the scorching drought, the City was also dealing with supply chain disruptions caused by Covid 19. Ductile iron and HDPE would have normally been part of the piping materials considered, but their delivery times eliminated them from consideration for this emergency replacement project. That left Fusible PVC and segmental PVC. The contractor opted for segmental for basic feasibility and ease of installation reasons.

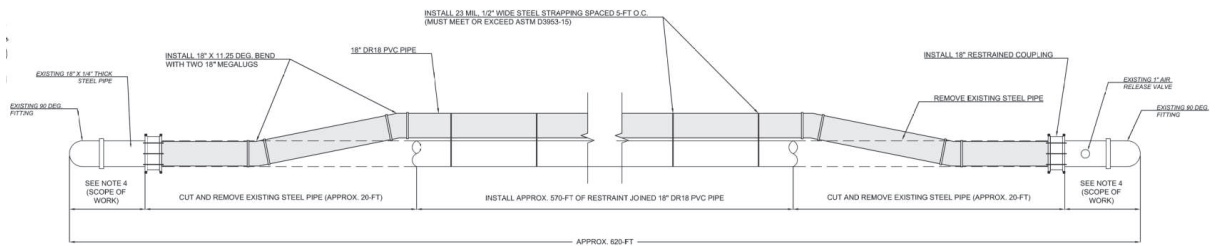
Pipe Alignment

The original plan was to only cut a few short sections of the existing 18" steel water line --- about 20 feet on either side. Two pairs of 11-1/4 degree bends were specified to accommodate a horizontal offset. The new PVC Certa-Lok was to be laid parallel to the existing line and then strapped to it.

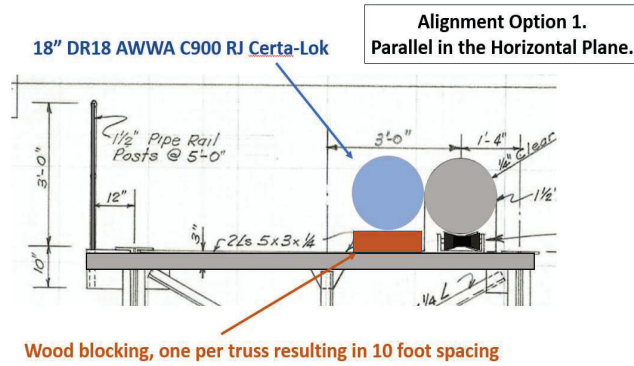
Pipe Alignment

This is what a cross sectional view of that would look like. The existing steel pipe is on the bow tie rollers. The new PVC pipe would be blocked to a similar height. The two parallel lines would be strapped together. The contractor had an alternate idea, and this is what made a two day installation of 600 feet possible. The option was approved and will be reviewed in the next few slides.

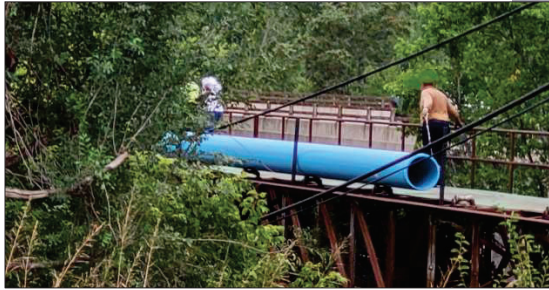
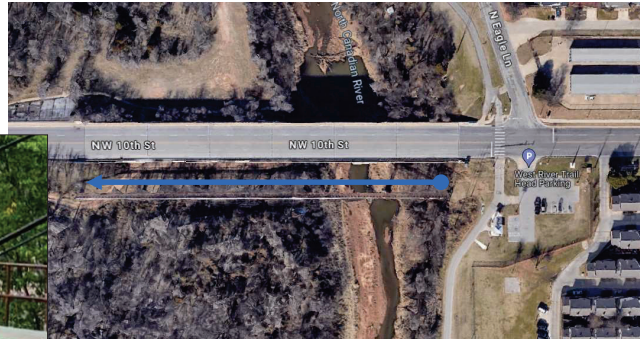
Job-Site Details

Once the existing steel pipe was removed, the bow tie rollers supporting it were in good shape. These bow tie rollers made it very easy to manually move the pipe on the bridge deck. The photo on the right shows the entirety of the 600 foot long pipe bridge. If this project had gone fused, pre-fusing that 600 foot long pipe string would have blocked several side streets interesting NW 10th from the south. Also, fusing the 11 or so joints would have added to the installation time. Pulling that 600 foot length up on to the bridge deck would have been a complicated process. The segmental solution was the best for this project site.

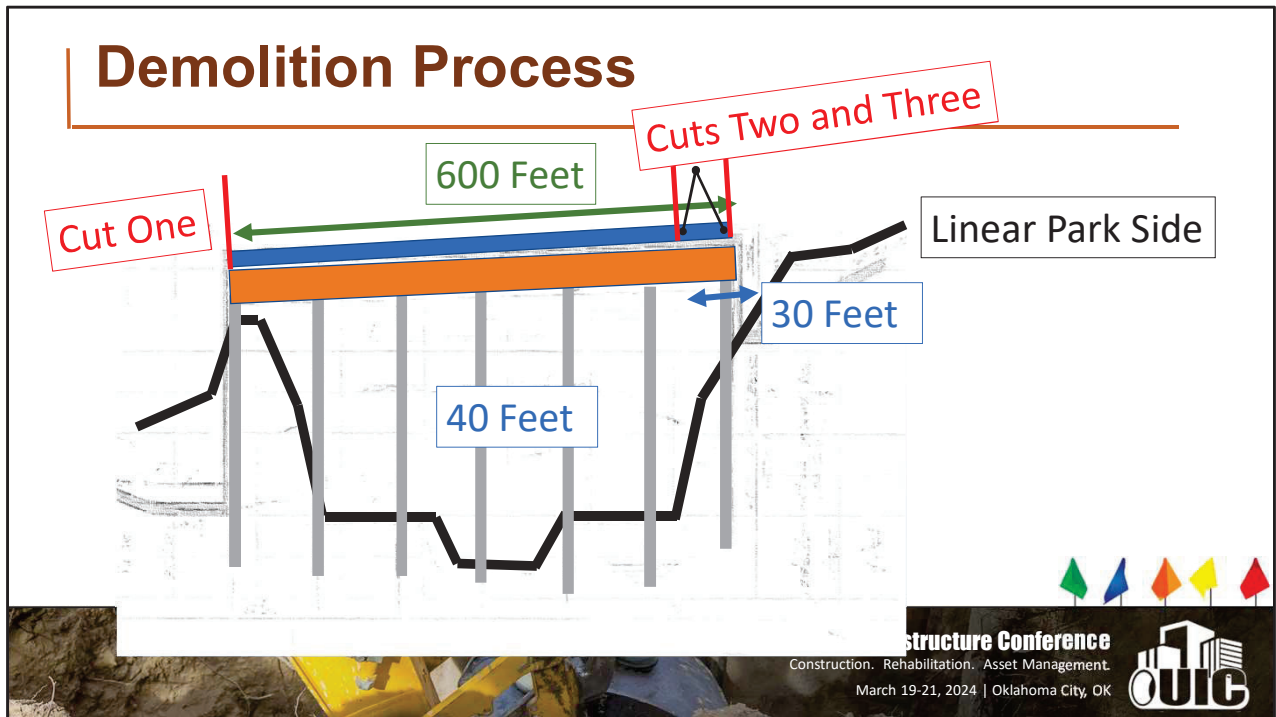
Remember one of those initial design questions? What are we going to do with the existing 18" steel pipe? Turns out Wade had an easy solution. Cut and remove the existing pipe 30 feet at a time. First cut the west end (far end) of the pipe shown here by cut one. Then rig the last 30' of the pipe to the backhoe. Make two more cuts to free that 30' section. Swing it onto the waiting tractor trailer.

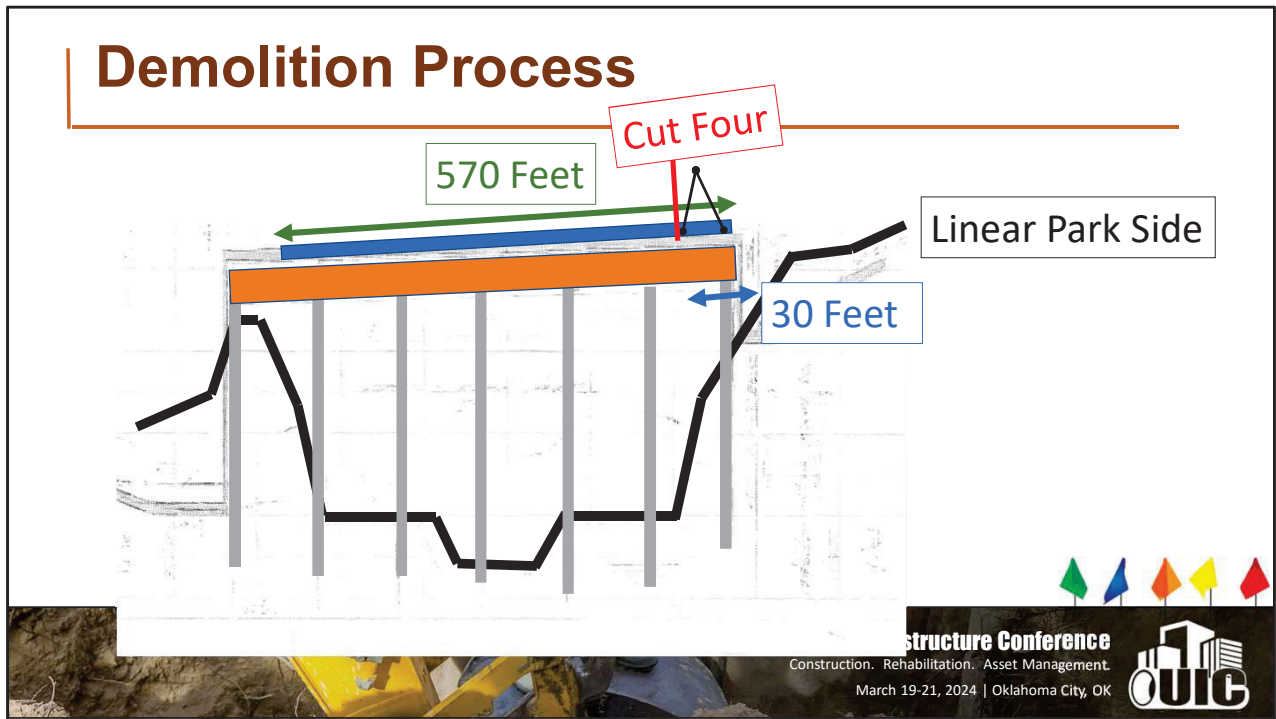
Wade repeated that operation 19 more times. This freed up the original alignment for the new 18" Certa-Lok, and it made it much easier to move the pipe when on the pipe bridge.

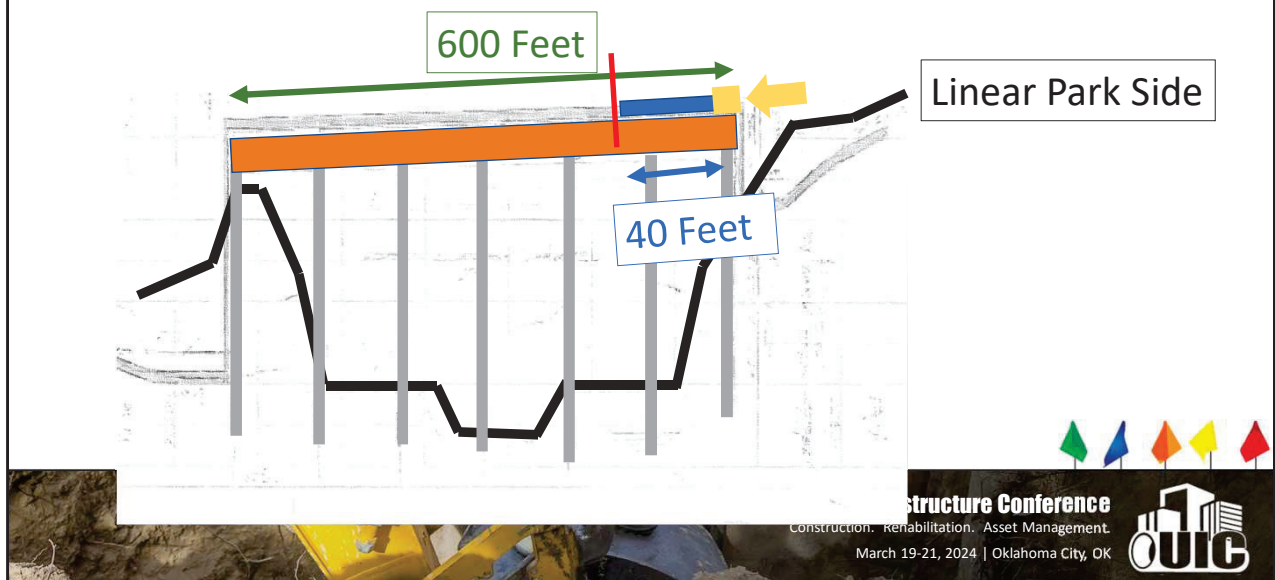
Assembly Process

The assembly operation of the new pipe was almost the mirror image of the demolition process. Swing a 40 foot length of Certa-Lok onto the rollers. Position the Certa-Lok coupler. Brace one end of the pipe against the super structure. Use the backhoe bucket to push the coupler onto the pipe. Insert the nylon spline.

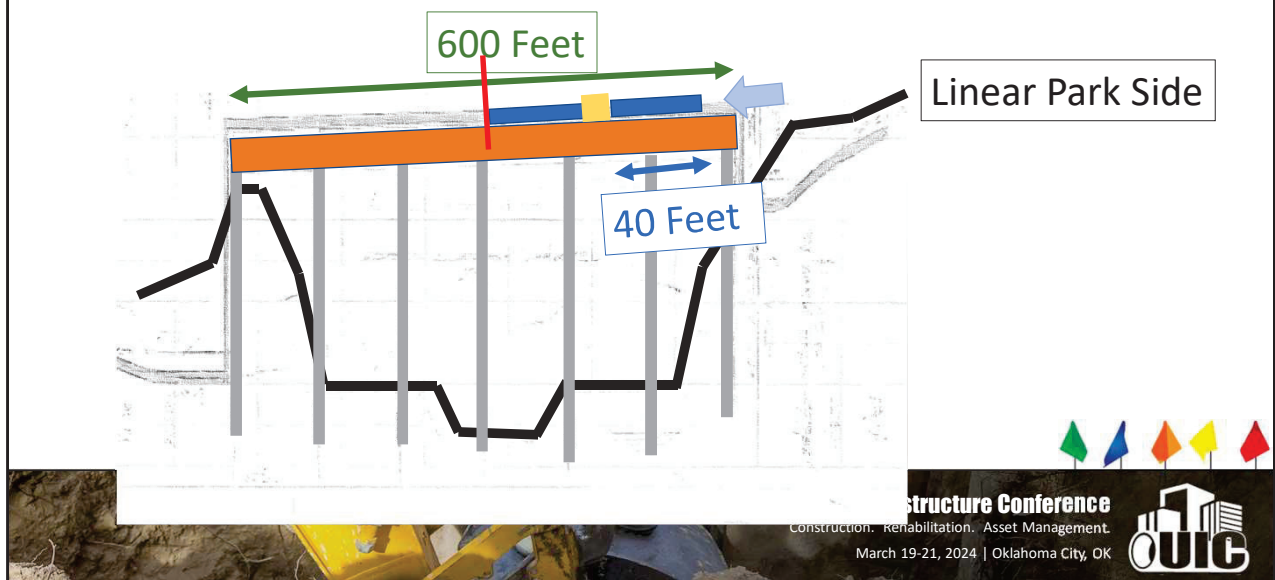
Assembly Process

That pipe and coupler assembly was then rolled 40 feet down the bridge to make room for the next length of Certa-Lok pipe. Use the backhoe bucket to push the spigot into the coupler. Spline lock the assembly together.

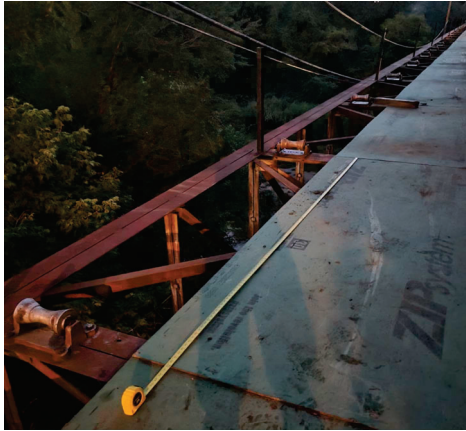
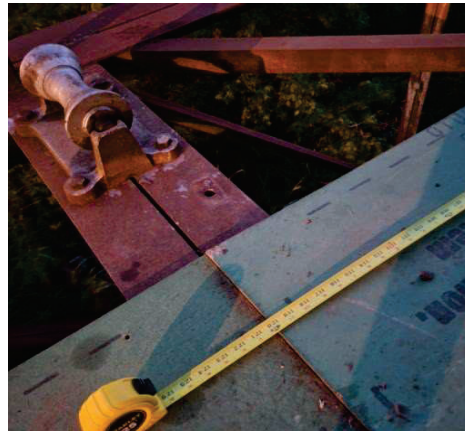
Bow-Tie Roller System

Here are two photos of that bow tie roller system. The tape measure is there for scale. There was one roller every ten feet. That spacing coincided with the horizontal segments on the box truss bridge. A close up of a single roller is shown on the right.

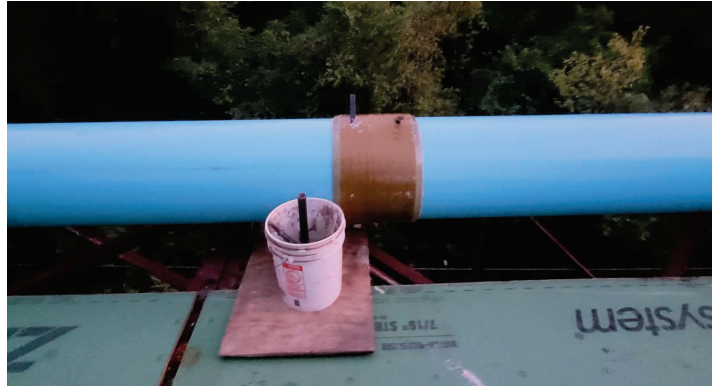
Assembled Joint

Remember to orientate the access ports so that they are easily accessed. The nylon spline is inserted into these holes to lock the joint together. We have a spline insertion tool that makes this installation step simple.

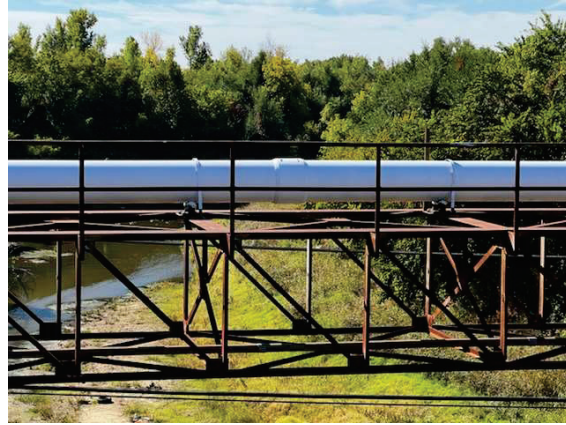
Completed Project

When PVC is used above ground, there are two options. One option is to use PVC formulated for above ground use, as is the case with vinyl siding. The product line we have for that is called YeloMine. The other option is to either wrap it or coat it. The contractor went the coat it route. We provided him some guidelines for accomplishing that.

1. Clean the surface thoroughly by scrubbing with warm, soapy water.
2. Lightly scuff the exterior surface in order to promote the paint sticking to the PVC.
3. Rinse and wipe thoroughly to remove any dirt and dust.
4. Primer is likely not necessary but could be considered if adhesion issues are encountered.
5. The primer should be water or latex based. Oil or solvent based paint could cause material degradation.
6. Sherwin-Williams Extreme Bond Primer would be a suitable primer.
