Assessment of a Glass-Lined Digested Sludge Force Main

Kristopher Embry, PICA Corp.

Underground Infrastructure Conference

4.7-mile 8" Whites Creek DIP Sludge Force Main Inspection

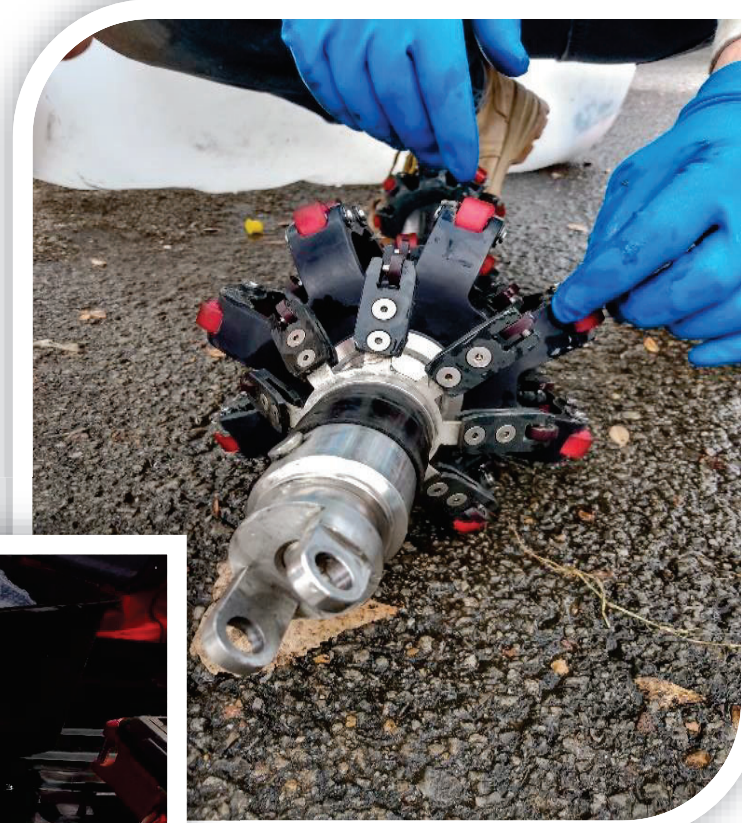
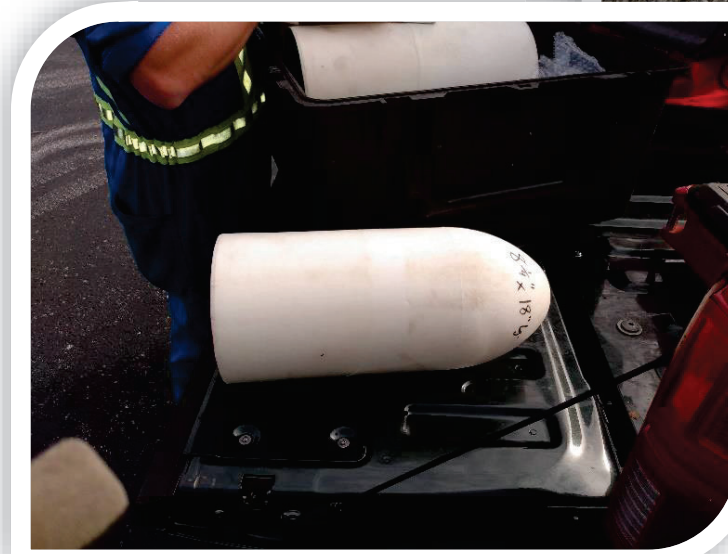
- All pigs were removed in satisfactory condition
- Launched gauge - 4.5 hours
- The gauge plates had minimum bending, indicating no major bore restrictions.
- After the pig and gauge runs
Nashville MWS now has a clean pipe!

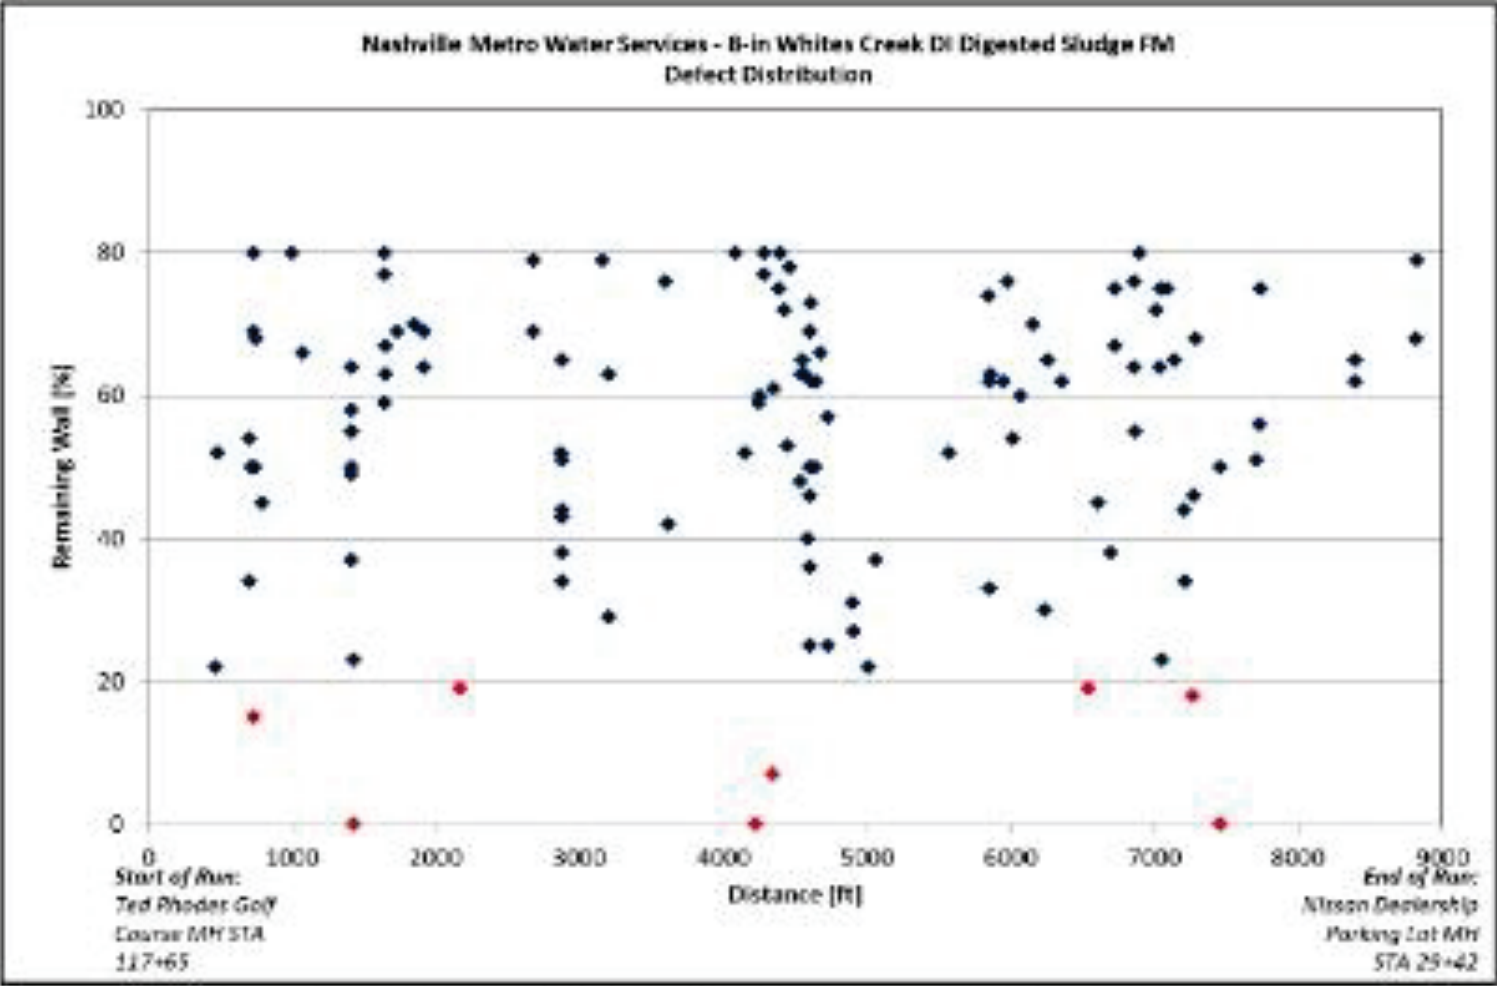
Figure 1. Distribution of localized wall loss with respect to remaining wall for the inspected portion of the 8" Whites Creek DI Digested Sludge Force Main.

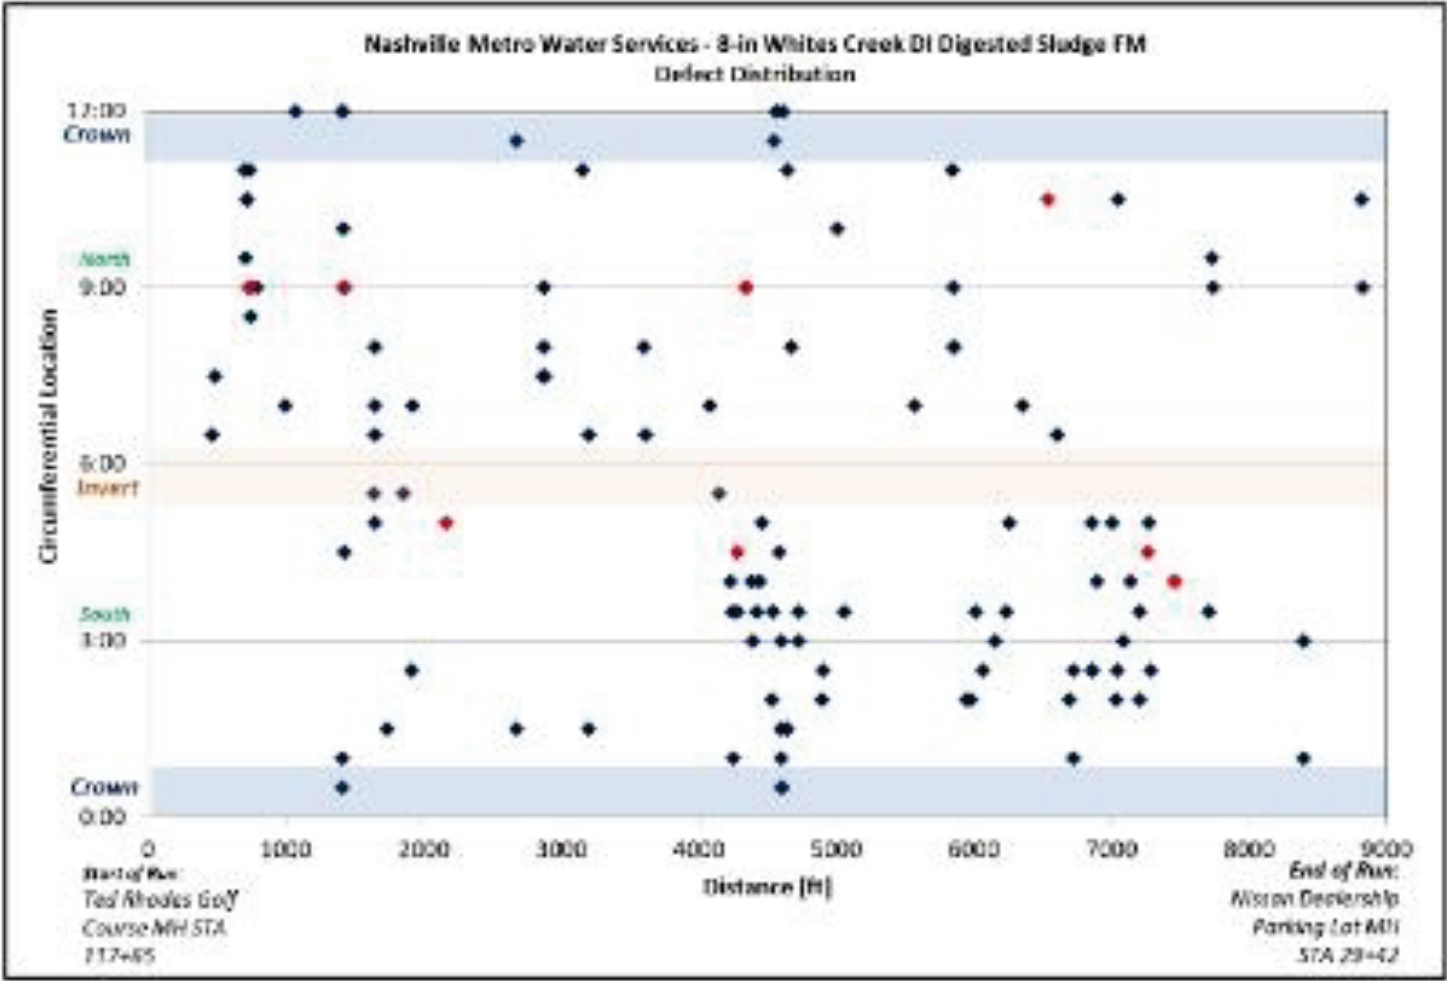
Figure 2. Distribution of localized wall loss with respect to circumferential location for the inspected portion of the 8" Whites Creek DI Digested Sludge Force Main.

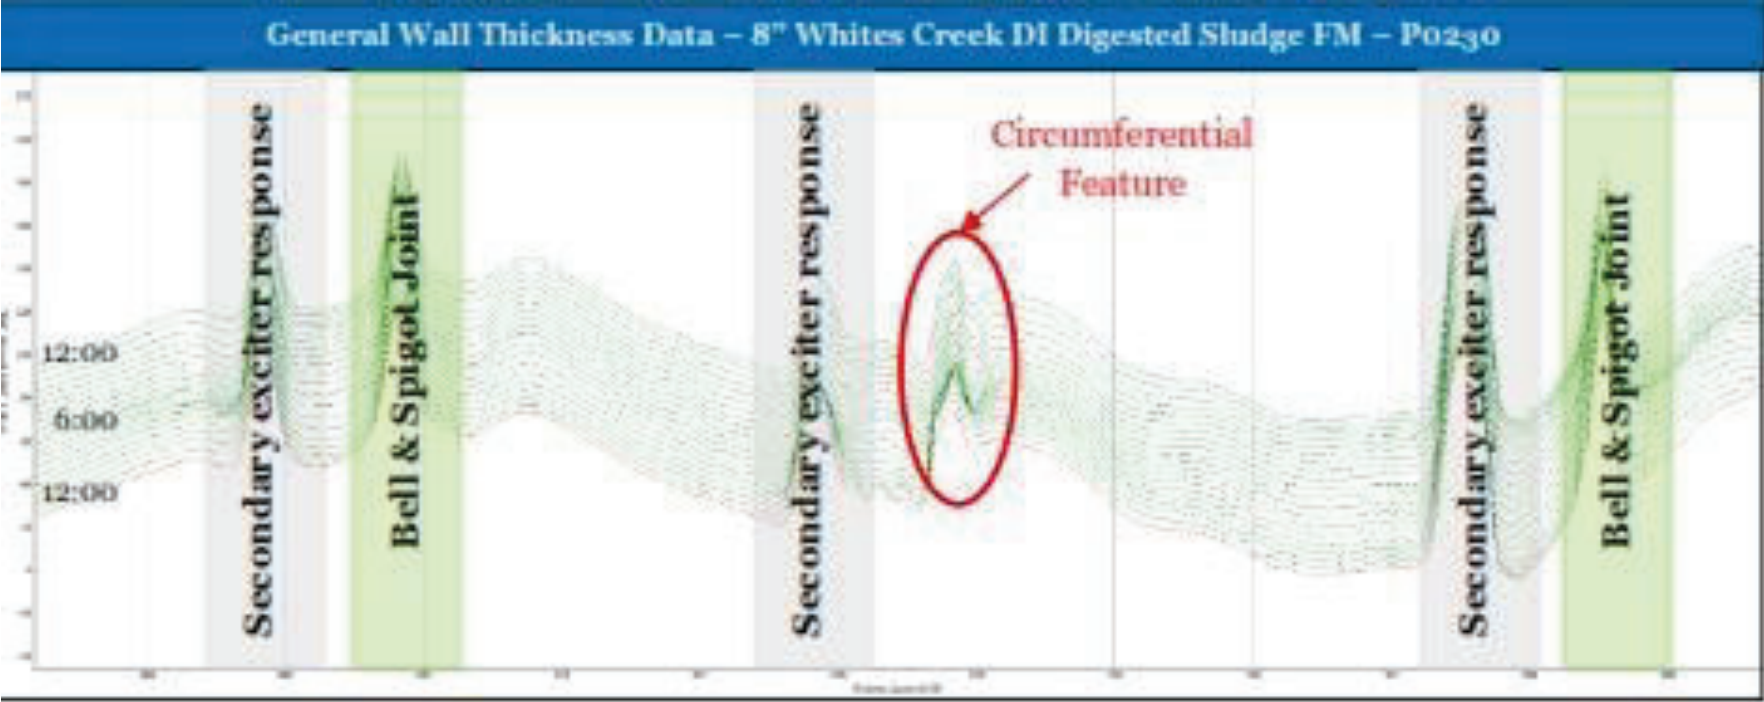
RFT strip chart data highlighting a circumferential signal located in P0230, 397.75 ft from the launch barrel. This signal was unique in the RFT data and did not correlate with any pipeline features in the provided drawing records. PICA suspects the signal is the result of a previous pipeline repair, or undocumented pipeline feature.
