Let's Go Deeper DWU's Cedar Crest Water Line Replacement

Justin Reeves PE, LEED AP

- 72-Inch AWWA C301 (PCCP) Pipe
- 1989 Installation
- Located in South Dallas
- Crossing of the Trinity River
- Catastrophic Pipeline Failure

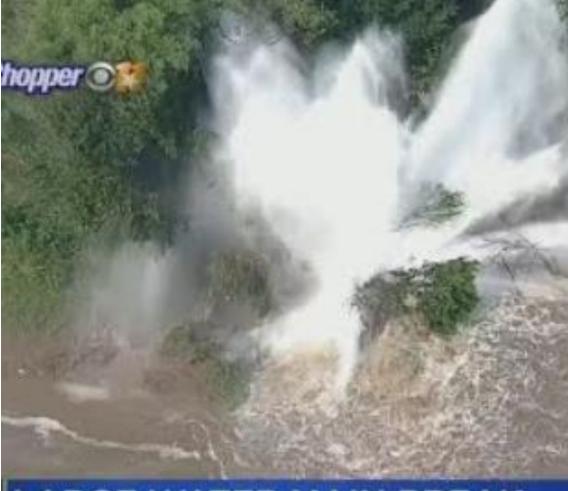
- 72-Inch AWWA C301 (PCCP) Pipe
- 1989 Installation
- Located in South Dallas
- Crossing of the Trinity River
- Catastrophic Pipeline Failure

LARGE WATER MAIN BREAK Near I-45 -- South of Downtown Dallas

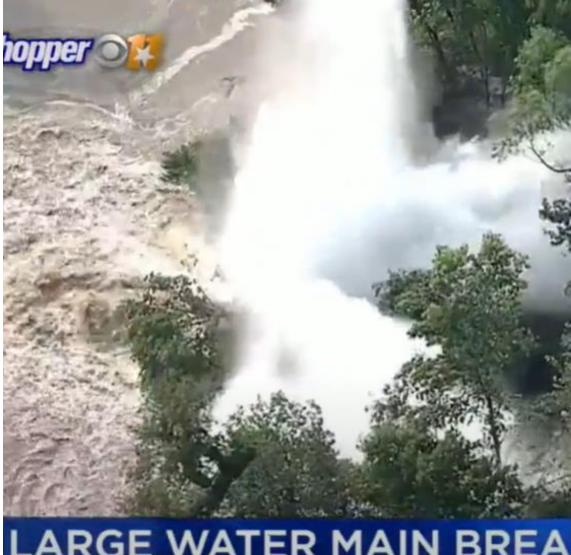
- 72-Inch AWWA C301 (PCCP) Pipe
- 1989 Installation
- Located in South Dallas
- Crossing of the Trinity River
- Catastrophic Pipeline Failure

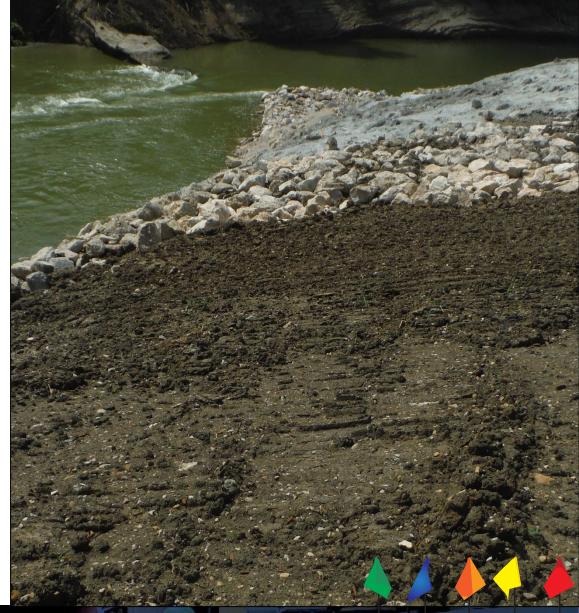
- Emergency Response
- Pipe Repair Performed
- Bank "Stabilization" Completed
- Temporary Solution
- Pipe Remained Compromised

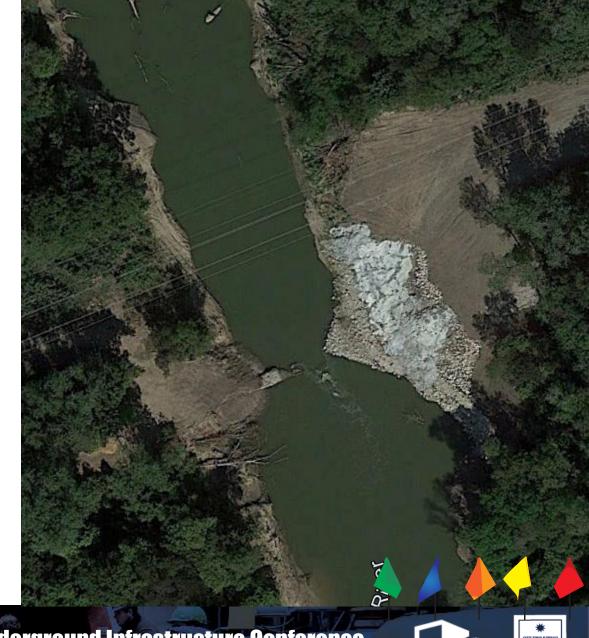
- Emergency Response
- Pipe Repair Performed
- Bank "Stabilization" Completed
- Temporary Solution
- Pipe Remained Compromised
