Utilizing MOP 145 Design for the Front Street Interceptor(FSI) CIPP Rehabilitation Project

Chris Macey – AECOM
Andrew Costa – Azuria

Front Street Interceptor (FSI)

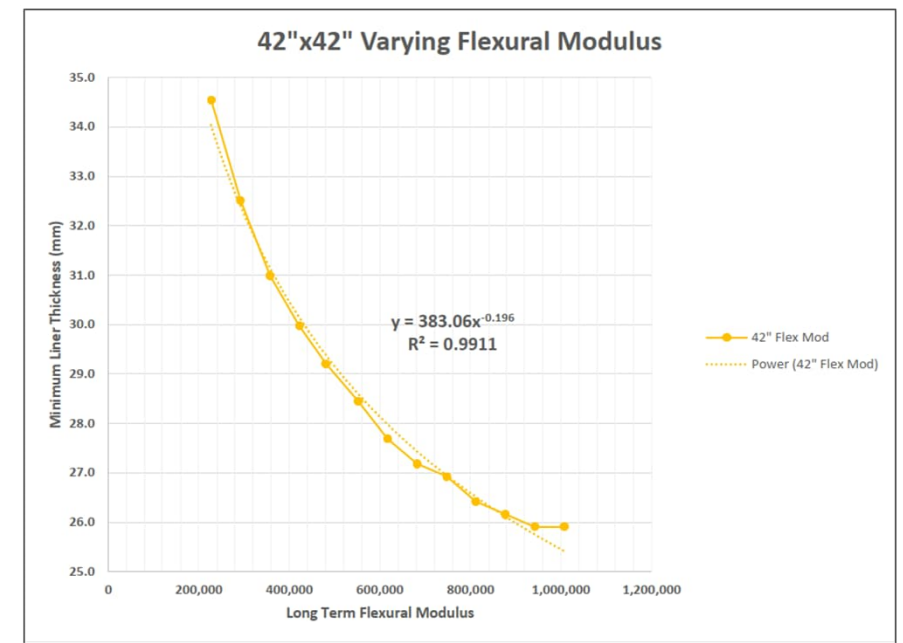
Figure 4: Thickness vs LT Flex Mod (42" Section)

- Designers need to do some design
- For this project:
 - Ran over 2000 load cases to clarify range of limit states that would control design over a range of CIPP products
 - Developed "Rating curves" to relate mechanical properties to minimum design thickness for base Bids.
 - Included Contract mechanism for any major change in liner thickness due to a change in cross section or design conditions after bidding
 - Articulated all of the above clearly in a Technical Memorandum
- Need to articulate enough of controlling design parameters for Bidder to understand risk
- Need to balance that with the ability to manage change and fully meet more complex design objectives

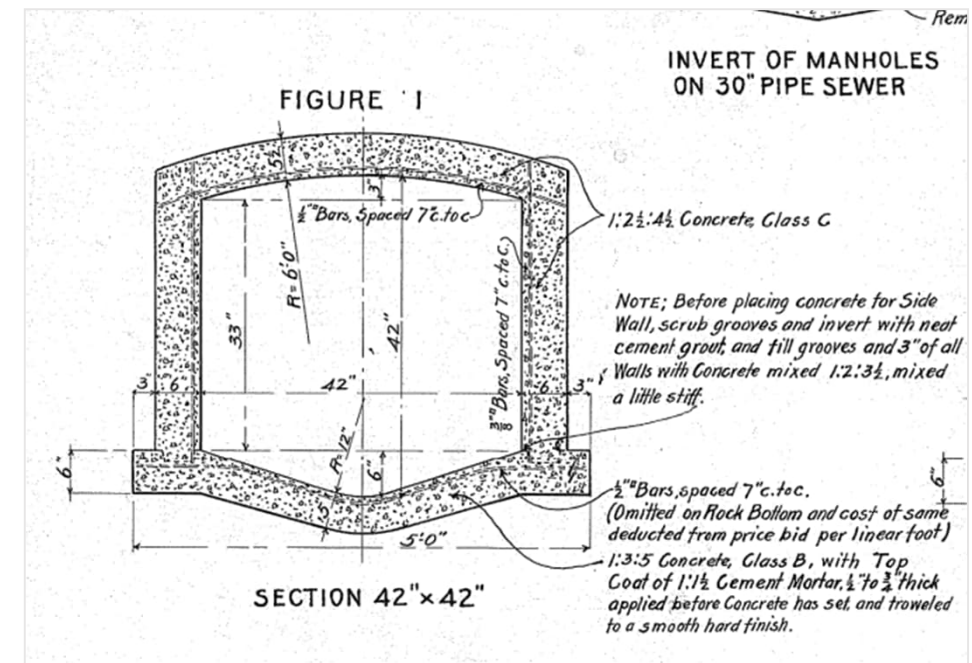
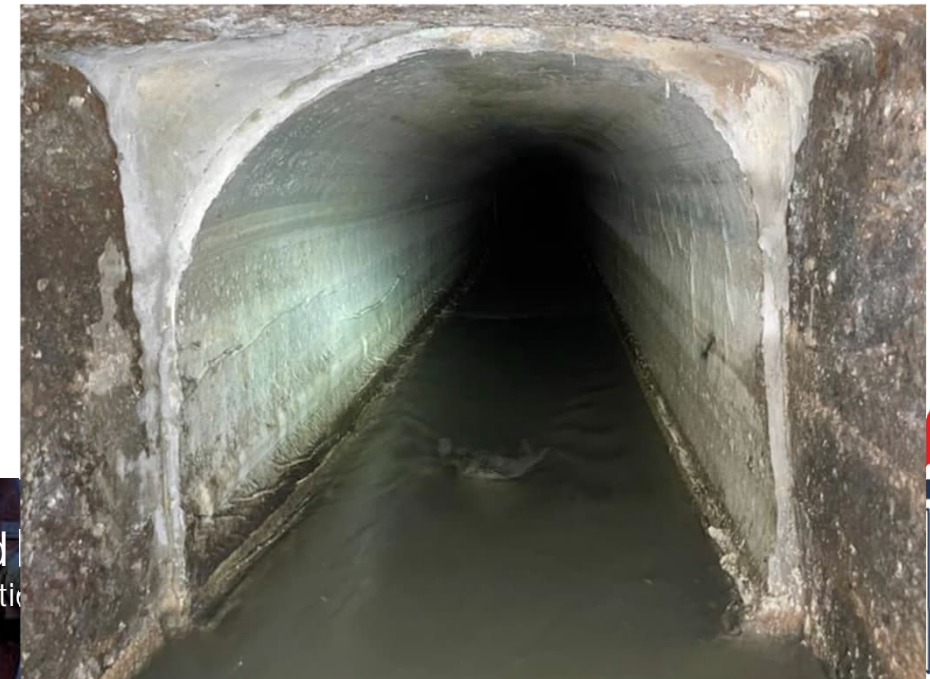
- ASTEE 3R-2014 and MOP 145 have minimum corner radius checks for stability
- A flexible close-fit liner needs curved corners to be structurally stable
- Preformed corners were initially required but successfully Bidder knew something unique about CIPP
 - It doesn't snap to corners with proper process control
 - Actual radius is a function of thickness design and "other" factors
- Bid process was modified by Addendum
 - Contractor option to pre-form or grout post-install
 - Verification checks at Contractor risk for dimensional stability, post install
 - Grouting spec added for grouting post-install

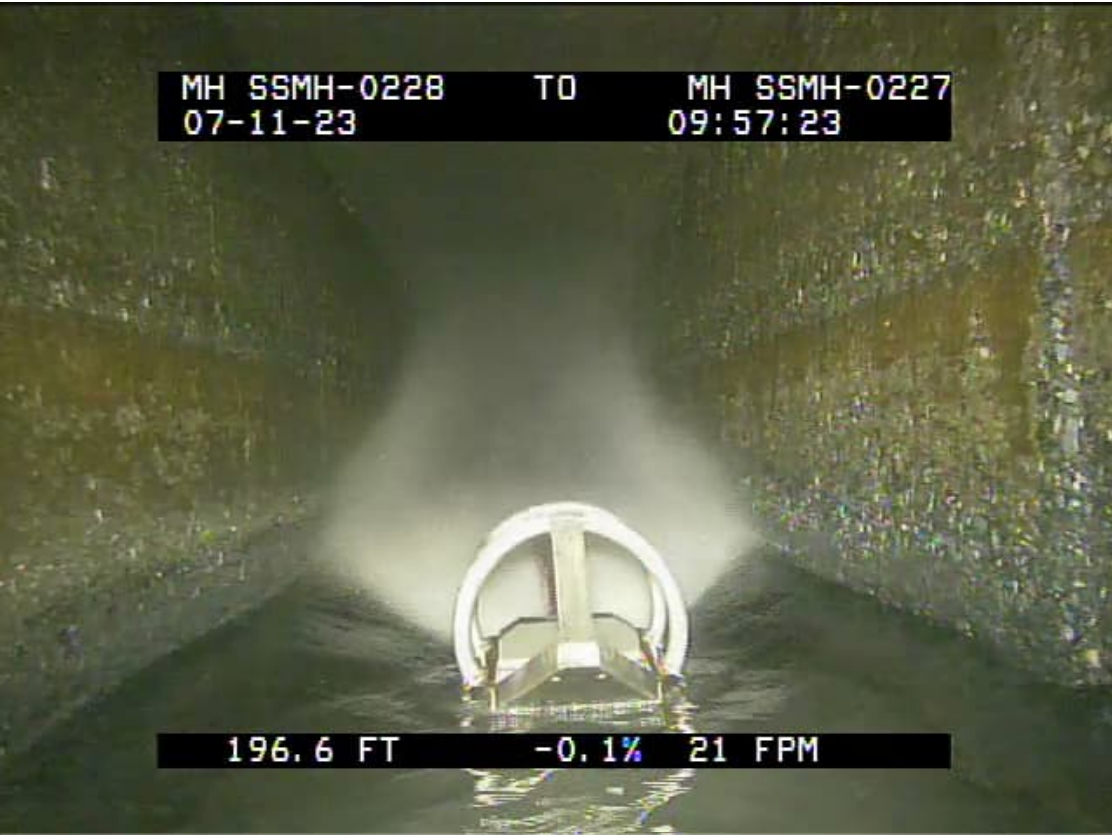
After

- Structurally Rehabilitate 111 yr. old interceptor (100-year design life)
- Minimal excavation and impacts - 725,000 pounds of resin in 28 shots (27 of those, the complex “box” from 1911!)
- Constructed without a single OTH Wet-out
- Design Objectives Fully Verified in Construction Phase
- Meet requirements of EPA Partial Consent Decree
