Preserving Casper's Infrastructure: Large-Diameter Pipeline Trenchless Rehabilitation Project

Mark G. Wade, P.E.
BlueWater Solutions Group, Inc

Underground Infrastructure Conference

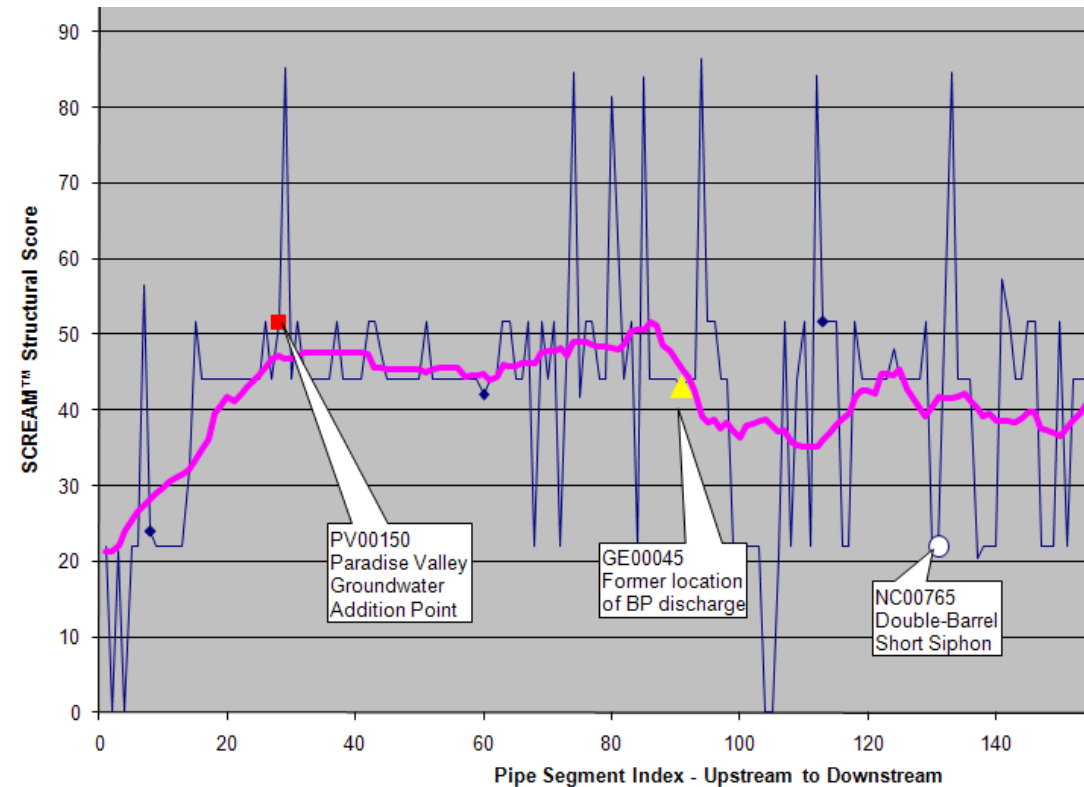
- Pipeline vs. manholes
- 1" + concrete loss
- Atmospheric H₂S levels (up to 20 ppm)
- Effect of groundwater injection evident

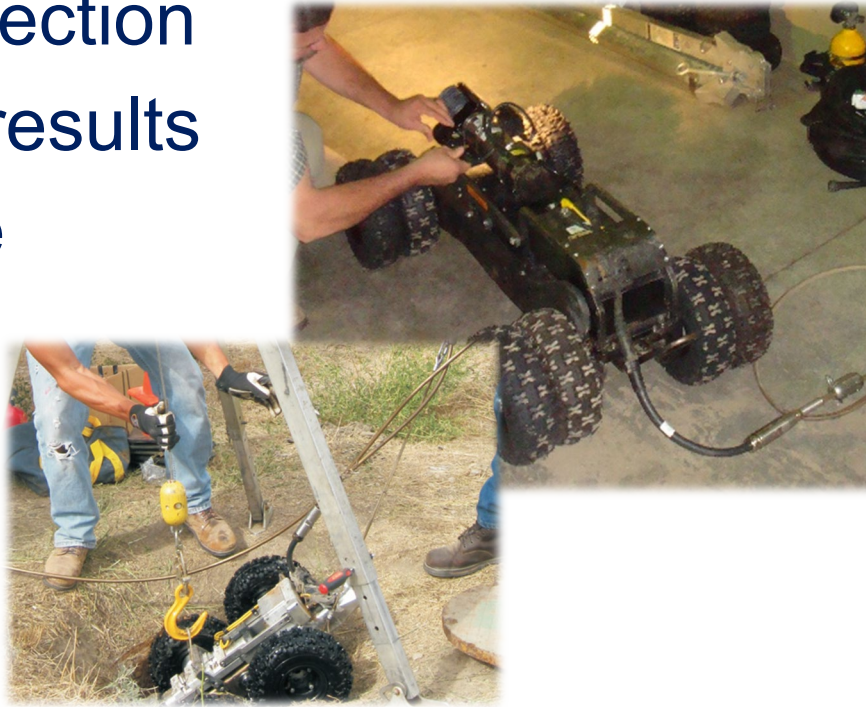
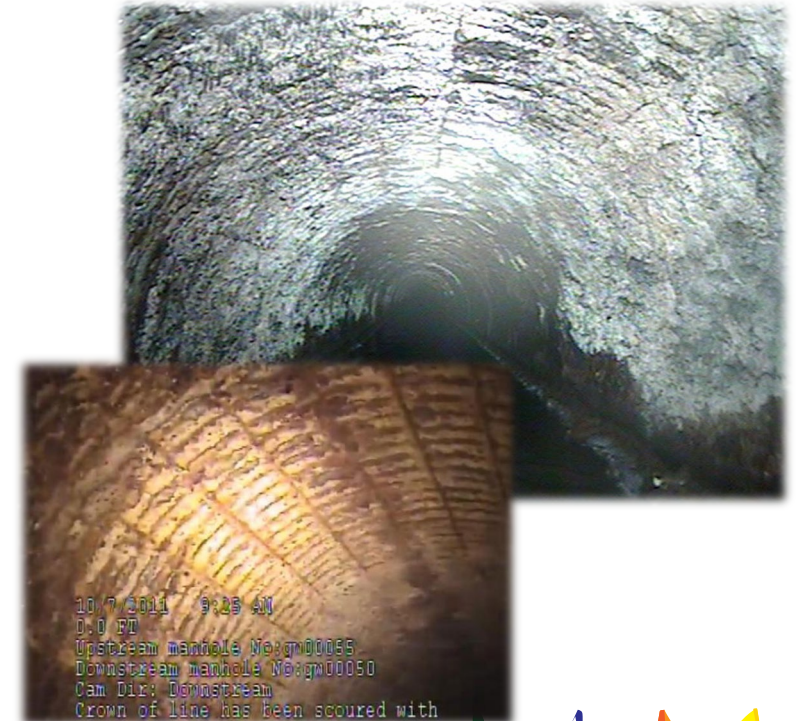
- Internal CCTV inspection
- Pipe samples and results
- Analysis of pipeline

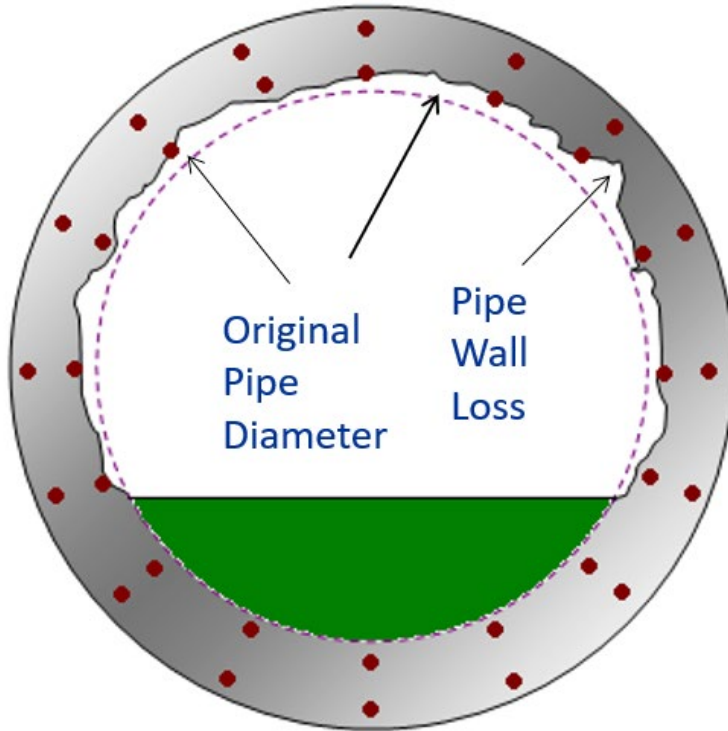
Exposed rebar will corrode and provide no structural support
