Scanning Critical Host Pipes through Carbon Fiber, CIPP & SIPP Applications Using BEM Technology

Underground Infrastructure Conference

March 4-6, 2025 | Houston, TX

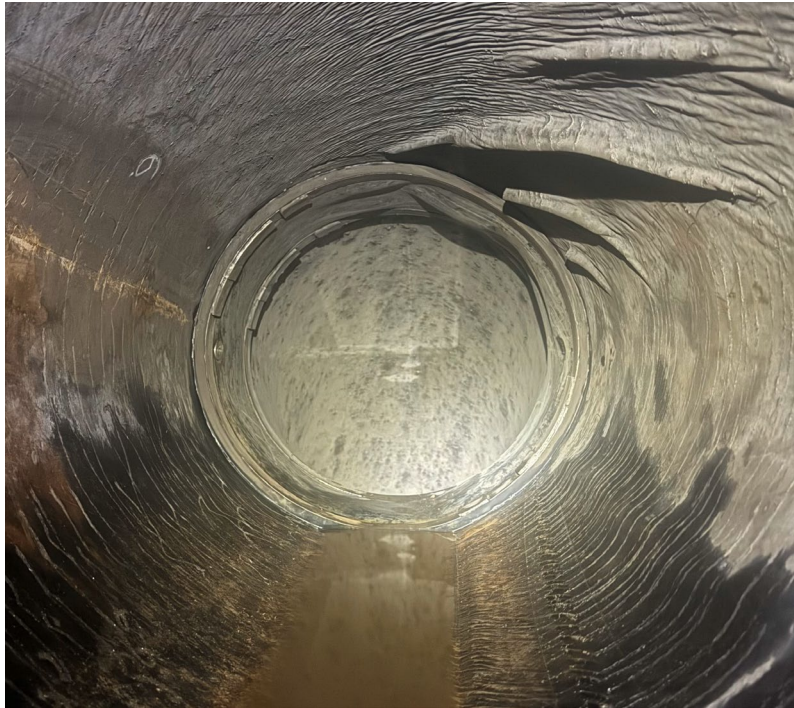
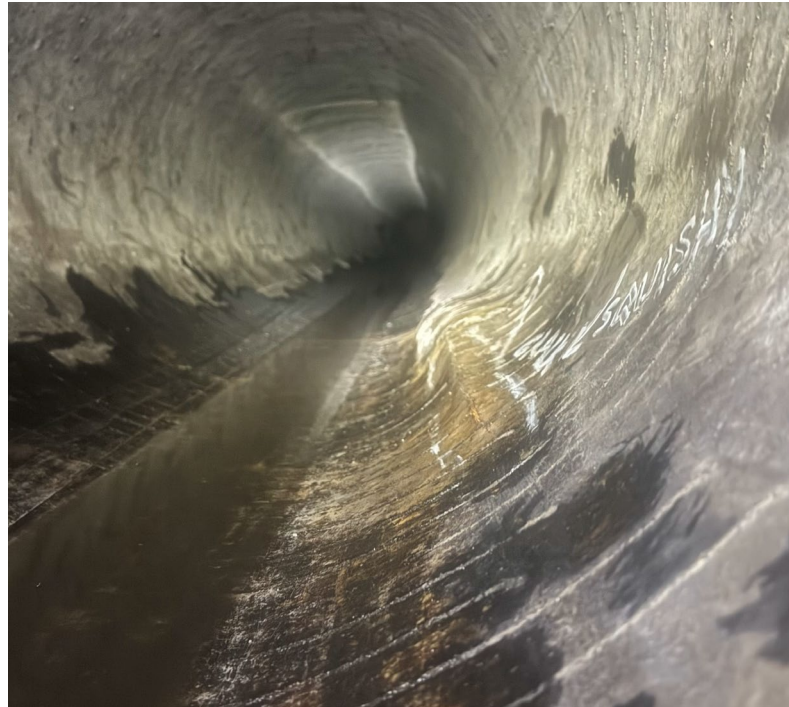
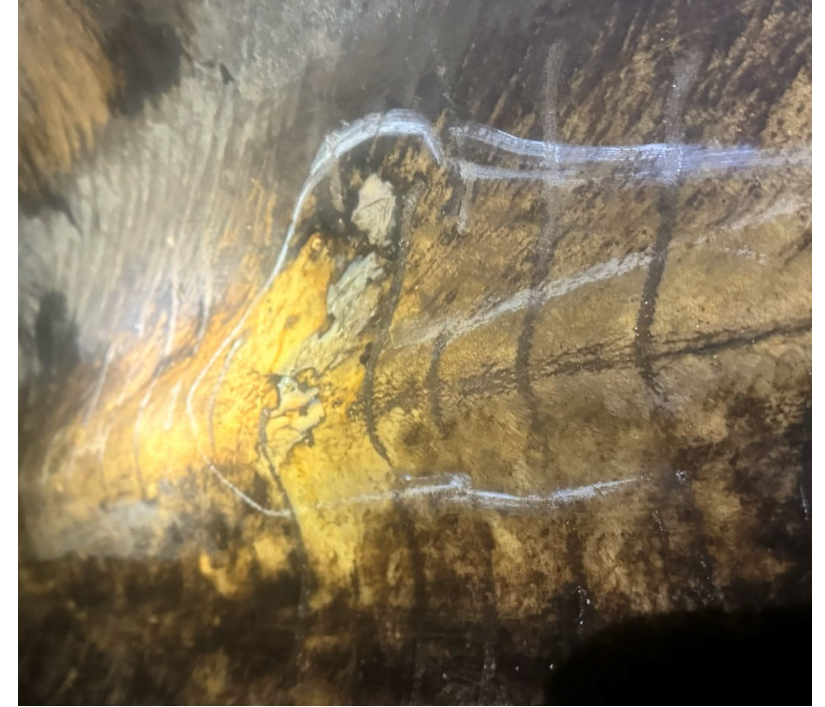
30+ Yr Old CIPP – Host Pipe 24"

- Liner is hard in good condition
- Minor bubbling

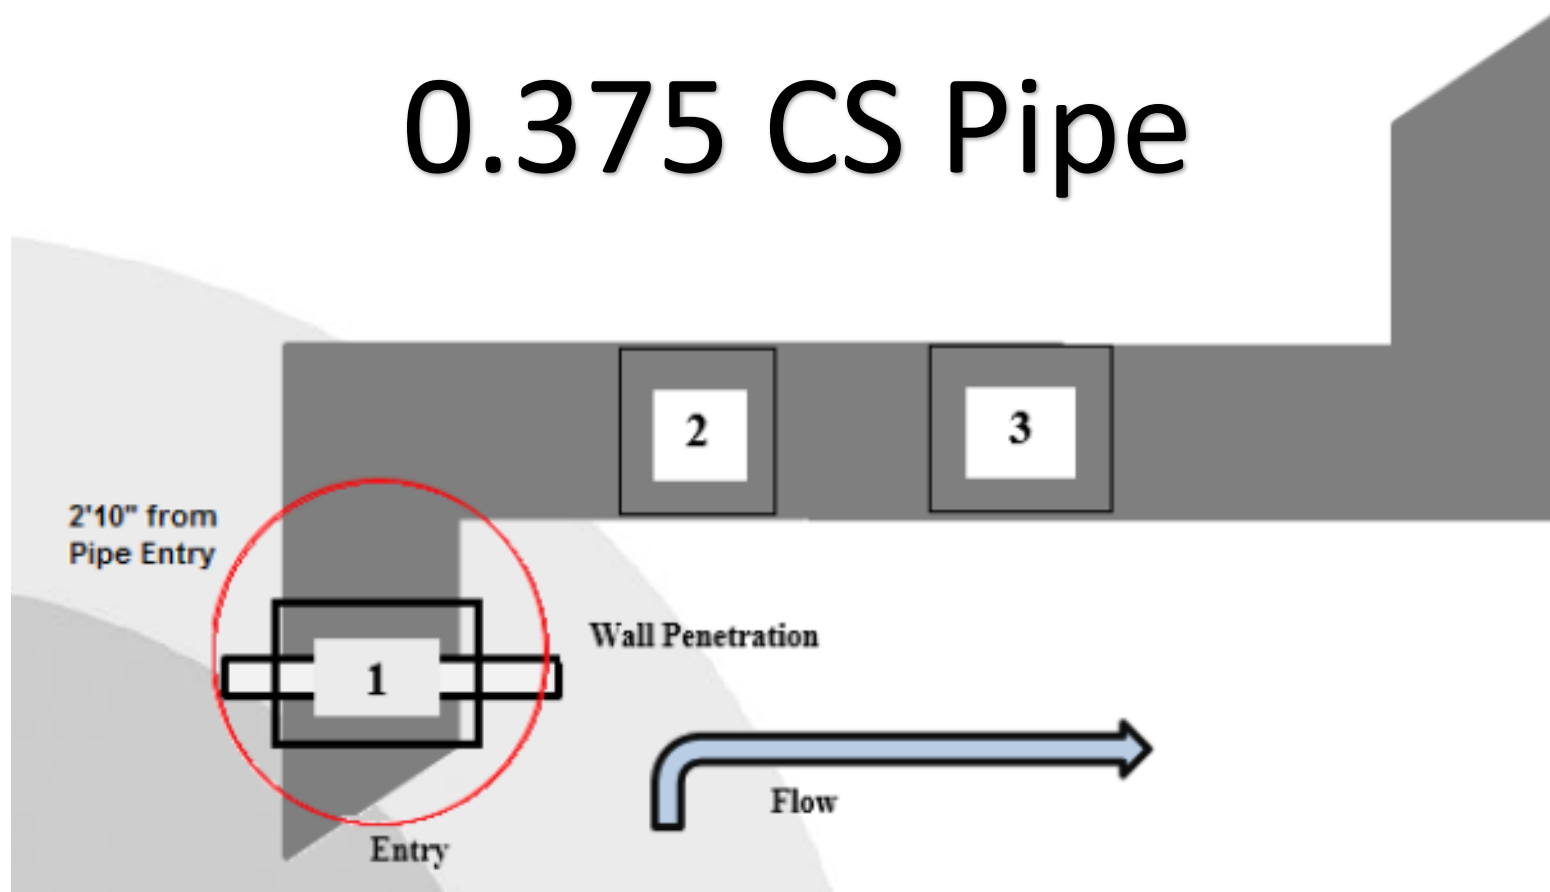
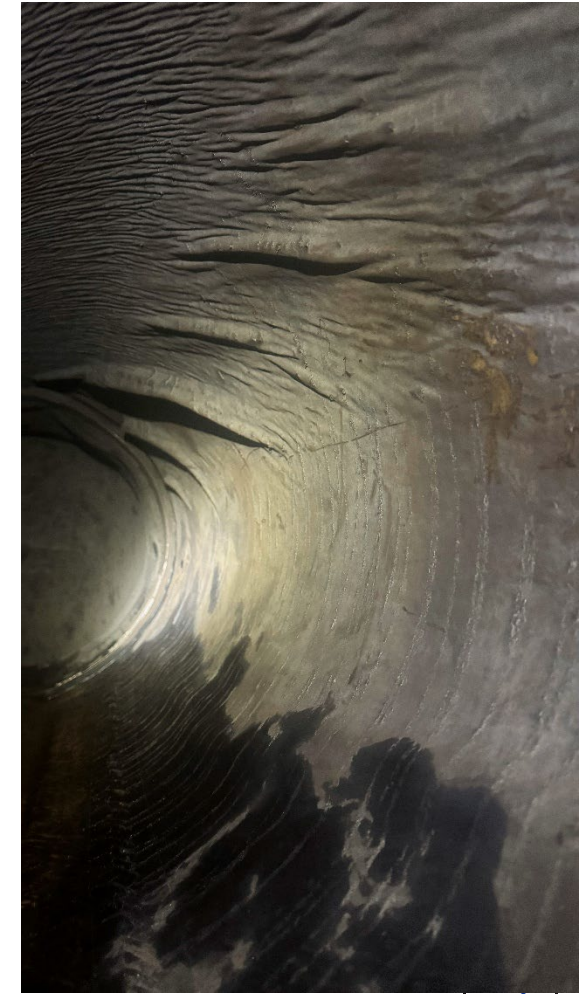
3 Test Locations – Scanning Through CIPP

0.375 CS Pipe

PRELIMINARY
APPARENT WALL THICKNESS

5 ft Section No.2

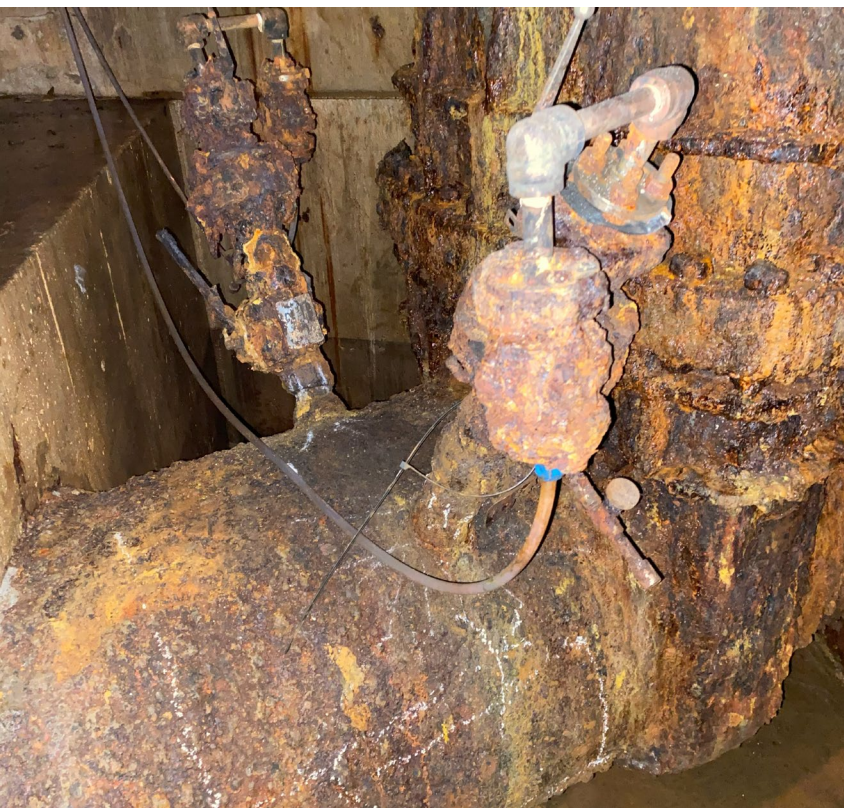
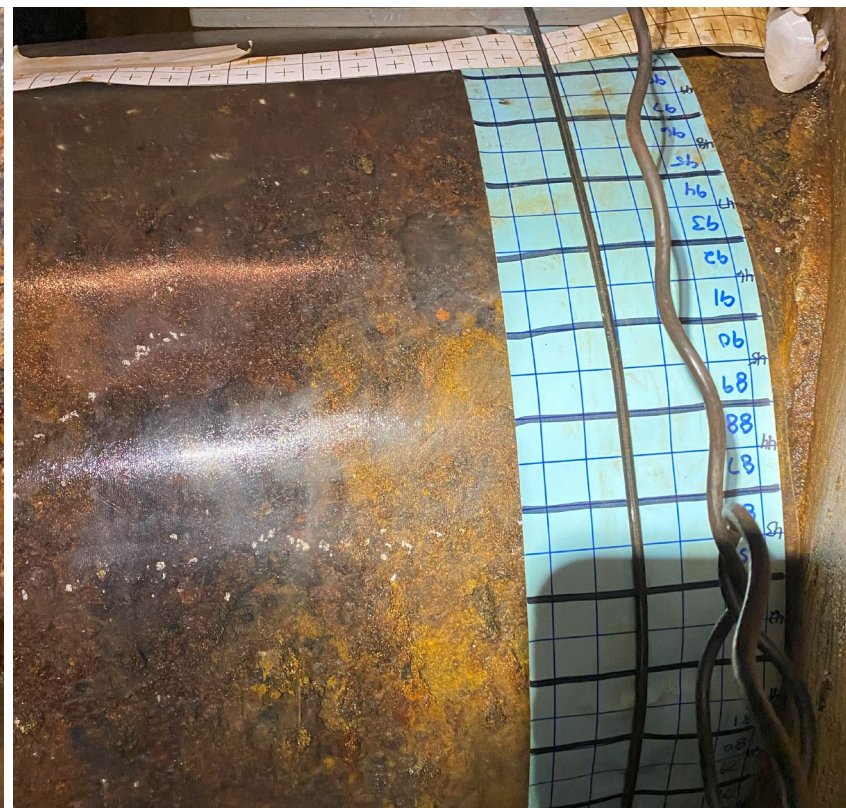
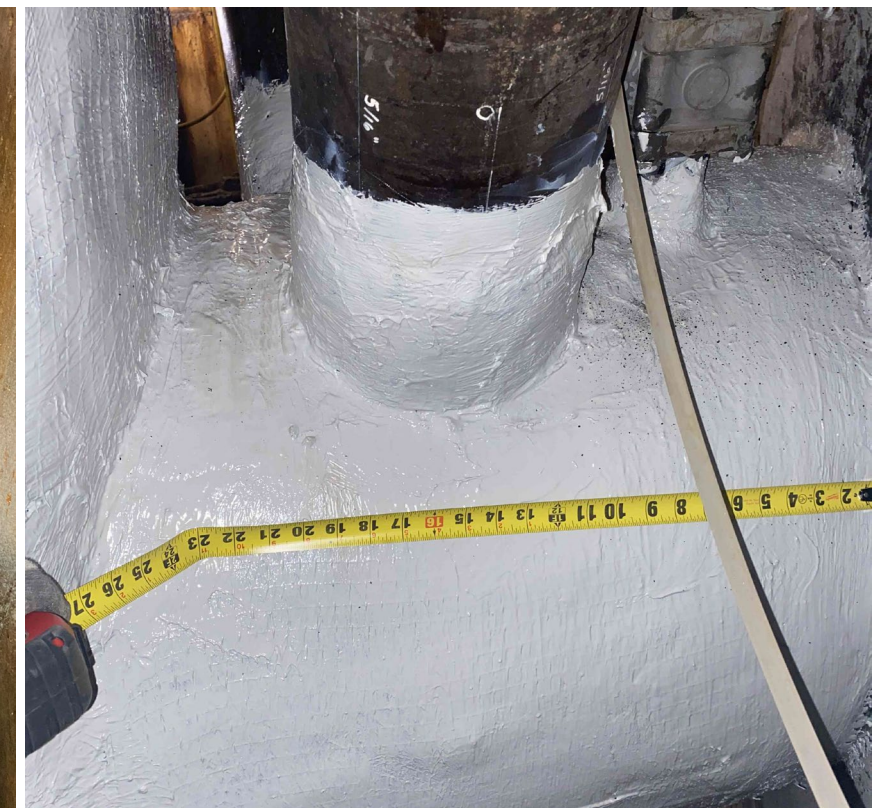
- Corrosive Pit (Chlorine Feeders)
- Base scan to confirm BEM - 2018

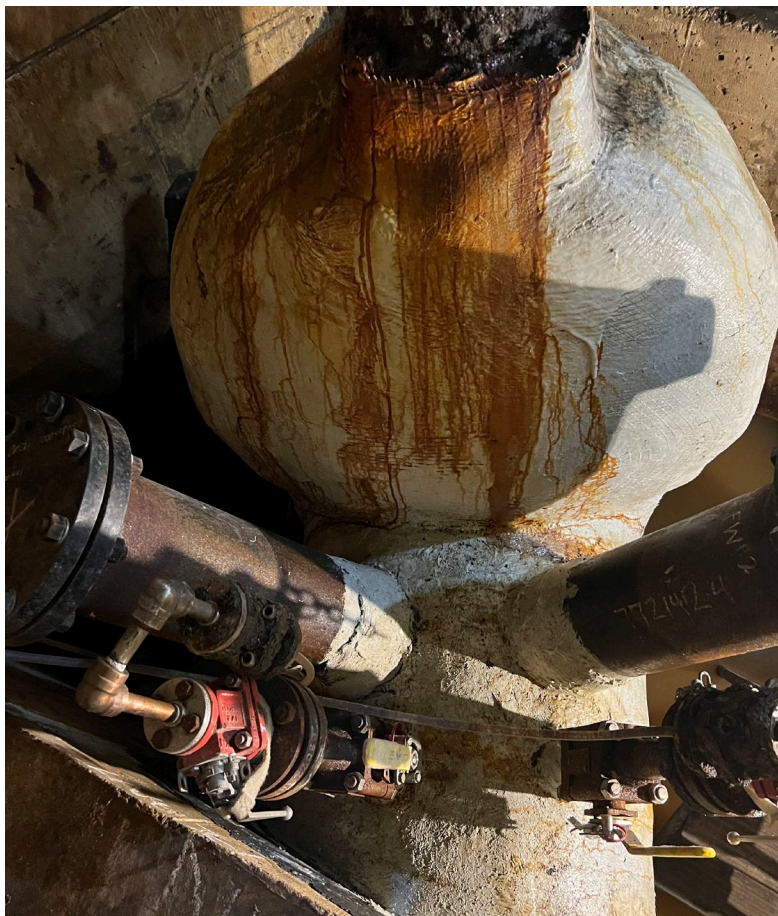
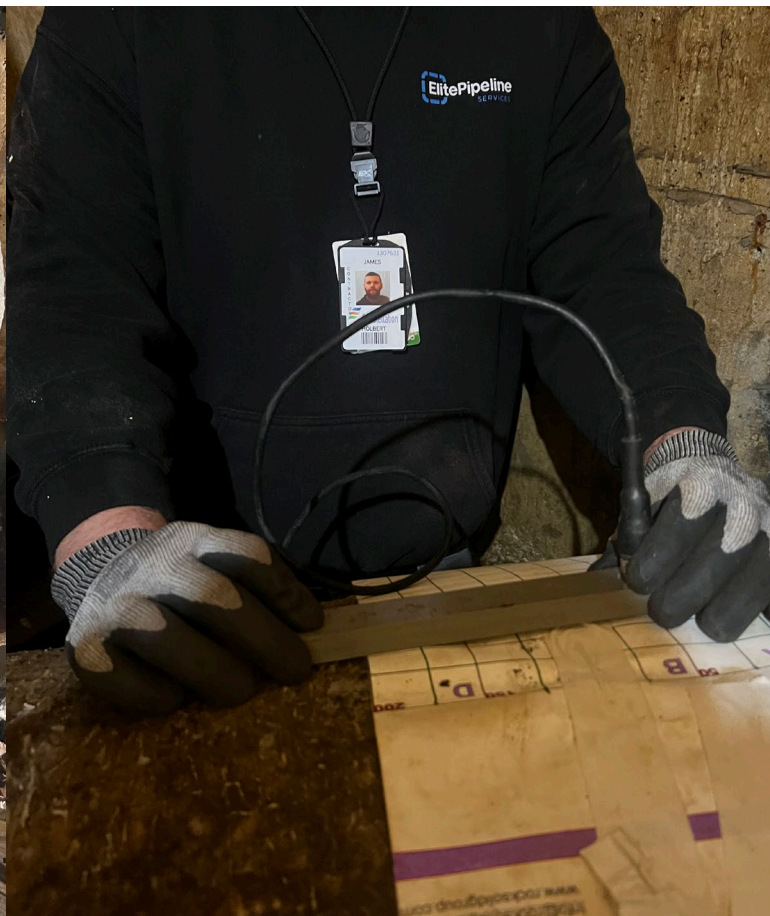
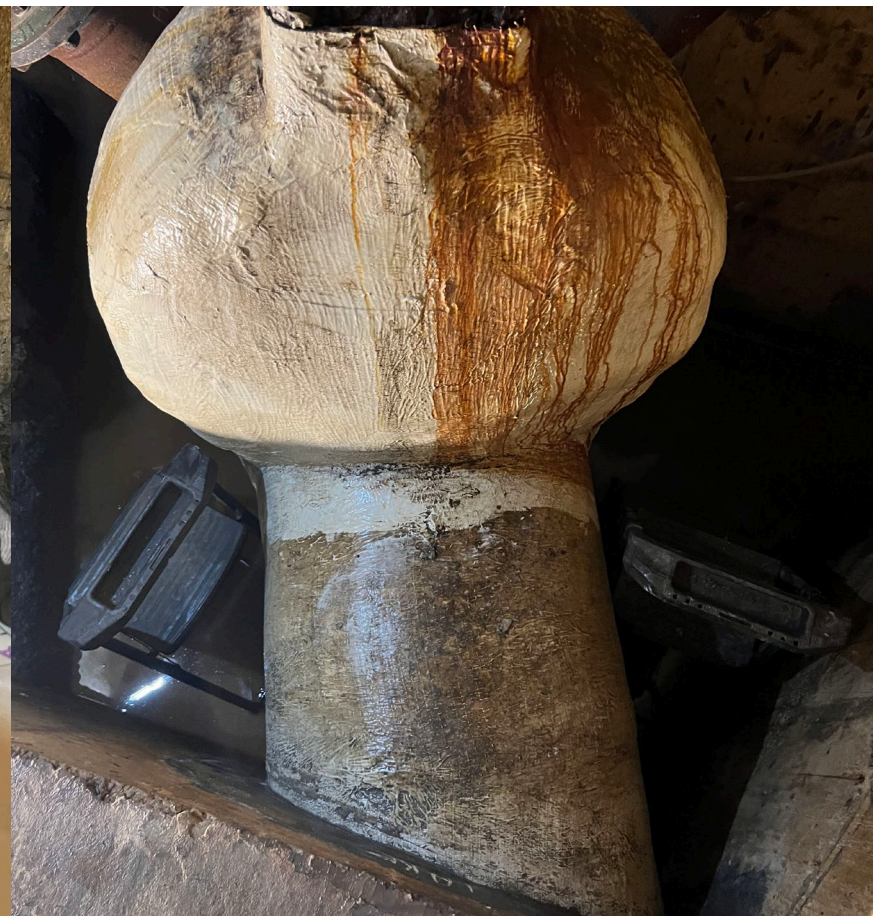
- Re Scan 2021 & 2024

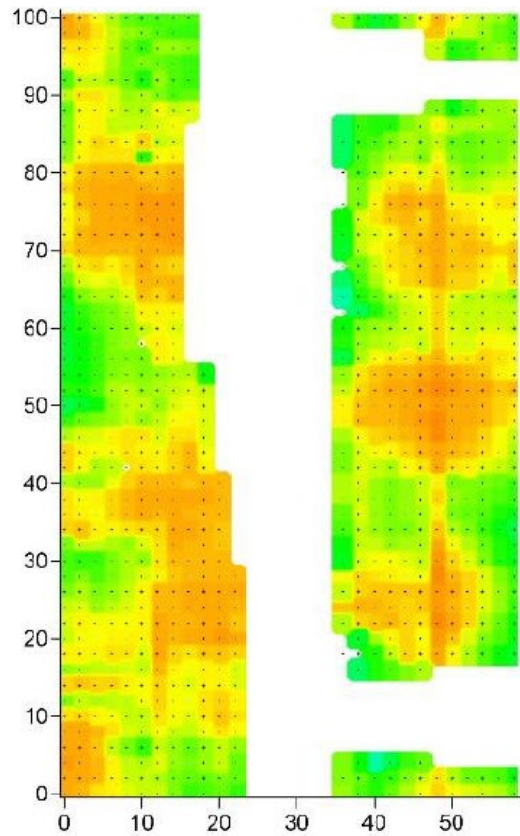
2021 POST CFC (50392)
C-main-PIPE-2i-HD
AWT Plotting

2024 (50445) Minimum AWT	2021 (50392) Minimum AWT
0.294	0.303
0.315	0.311
0.290	0.287
0.293	0.280
0.309	0.303
0.297	0.291
0.281	0.307
0.289	0.311
0.309	0.299
