India Street Force Main Condition Assessment

India Street Force Main

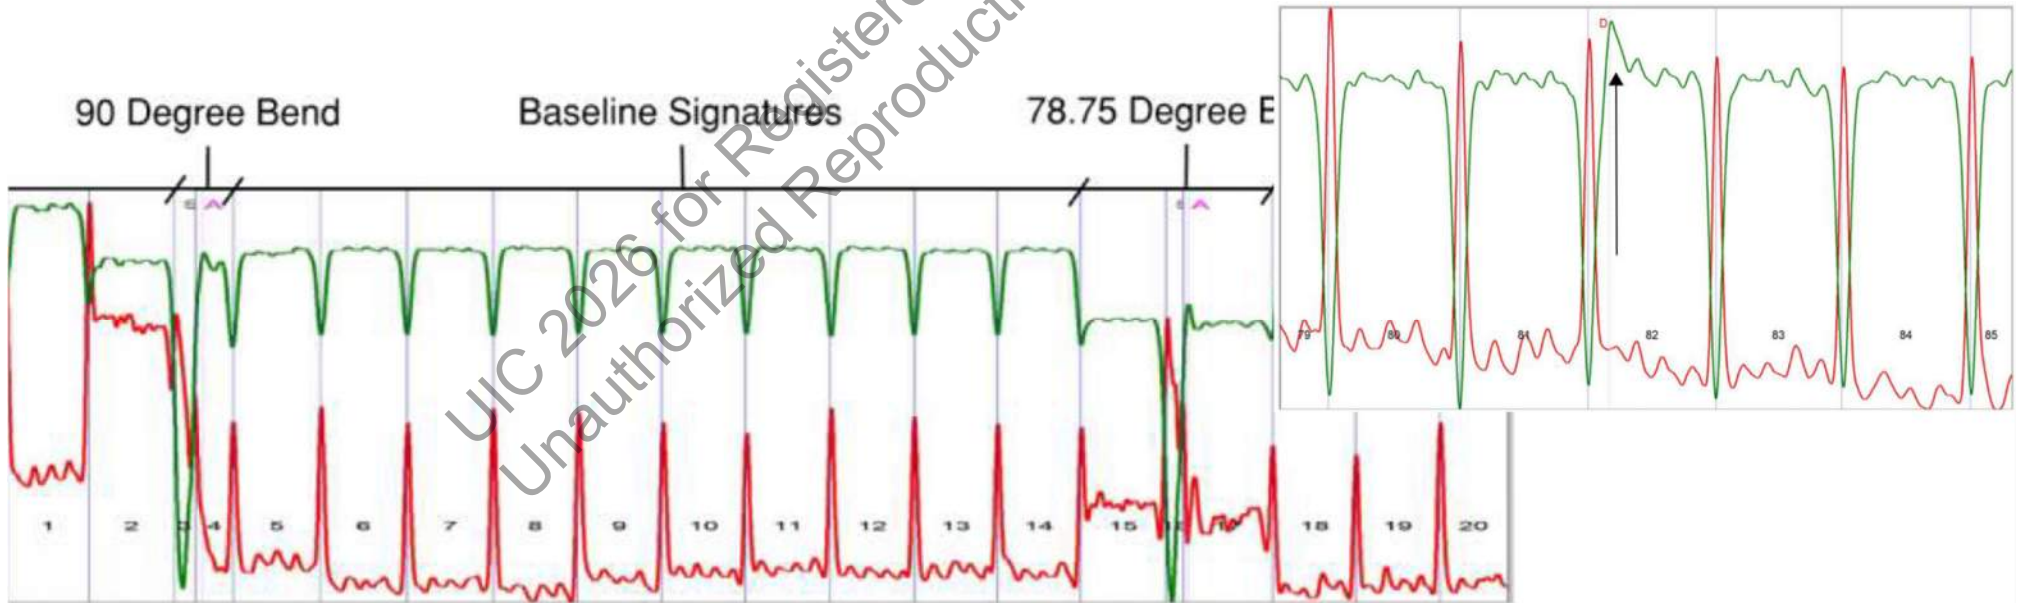
Electromagnetic Signals

- Pipes without damage provided consistent repeatable signal
- One pipe reported with broken wire wraps (est. 5 BWW)

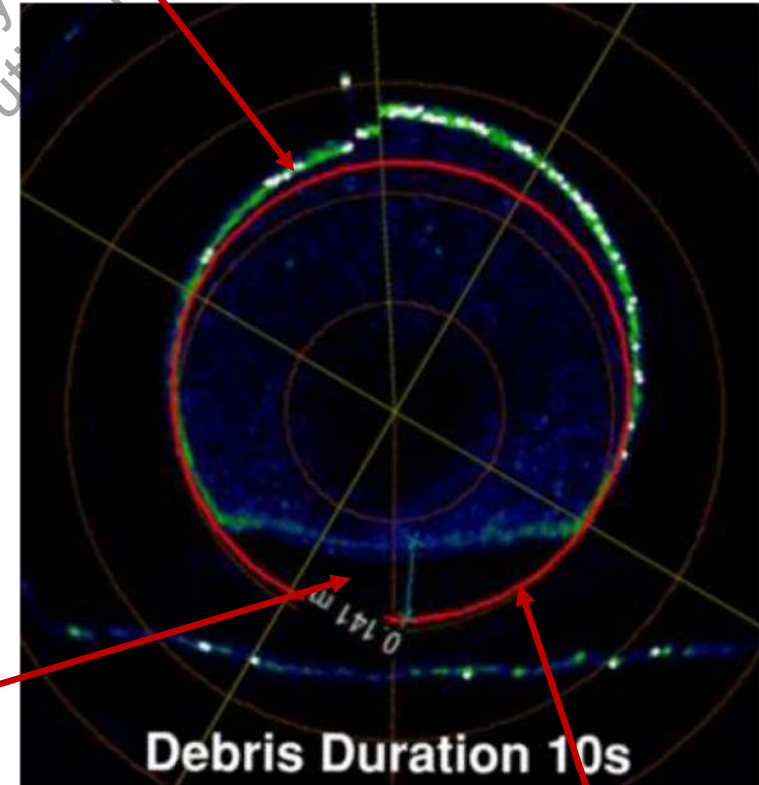
Sonar data

- 14 locations with debris build up
- Largest debris pile was 30 feet long with maximum depth of 5.6 inches
- Small debris pile reported was 2-inches deep, 2 feet long
- No gas pockets detected

Debris depth = 5.6"

- Investigate root causes of surge and mitigate
- In the future, if debris build up affects hydraulics, remove debris
- If pipeline modifications are performed, sample wire and mortar coating
- Reinspect in 7 years to evaluate growth in deterioration

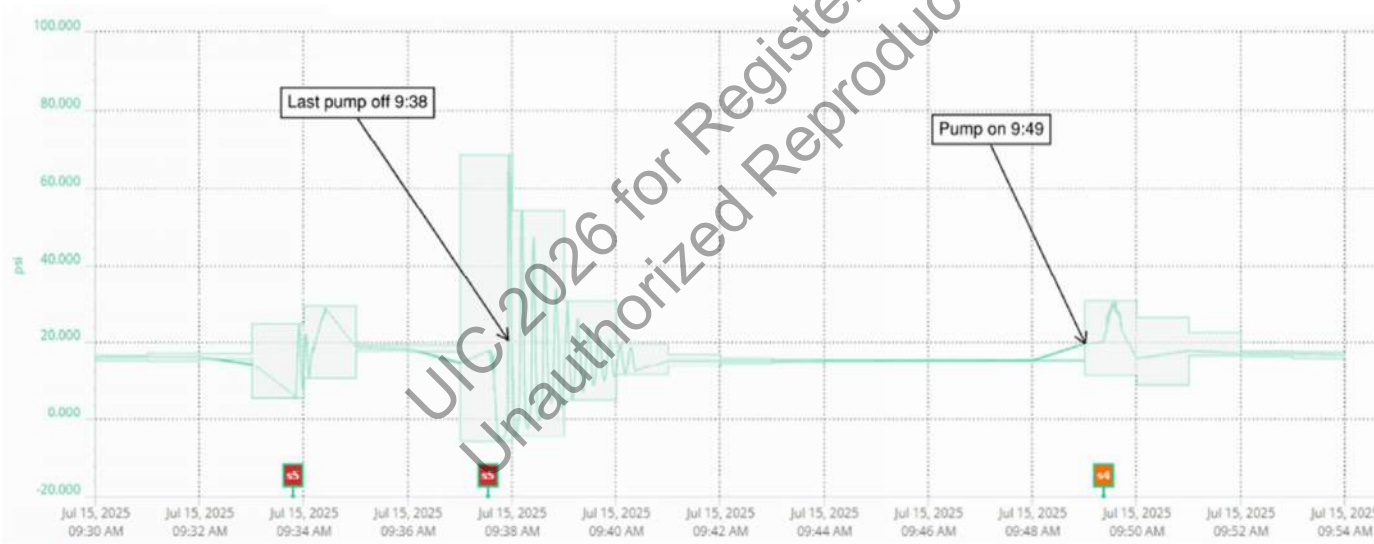
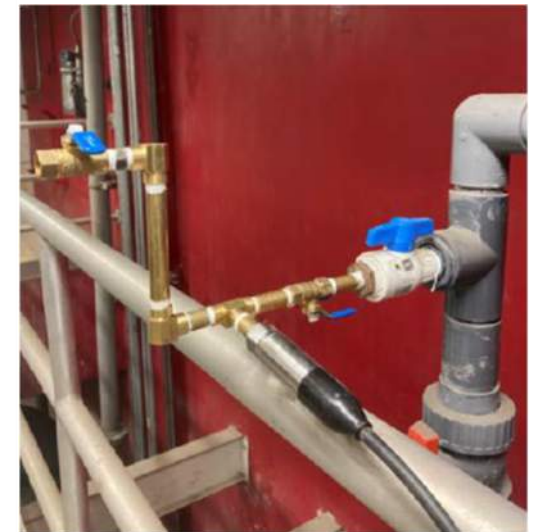
Findings of High Speed Pressure Monitoring

- Pressure monitoring:
 - Operating and transient transients were within allowable limits
 - Two surges detected, (below allowable limit)
