# Preserving Mid-Century Water Infrastructure:

## CFRP Upgrade of 1949 Cast Iron Pipe Beneath Cedar Springs Road Culvert

MIKE LARSEN, ASSOC. DBIA

January 27 – 28, 2026

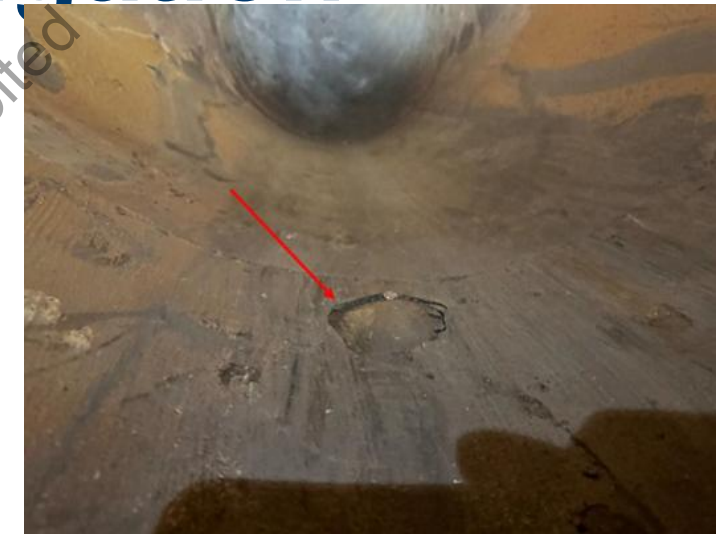
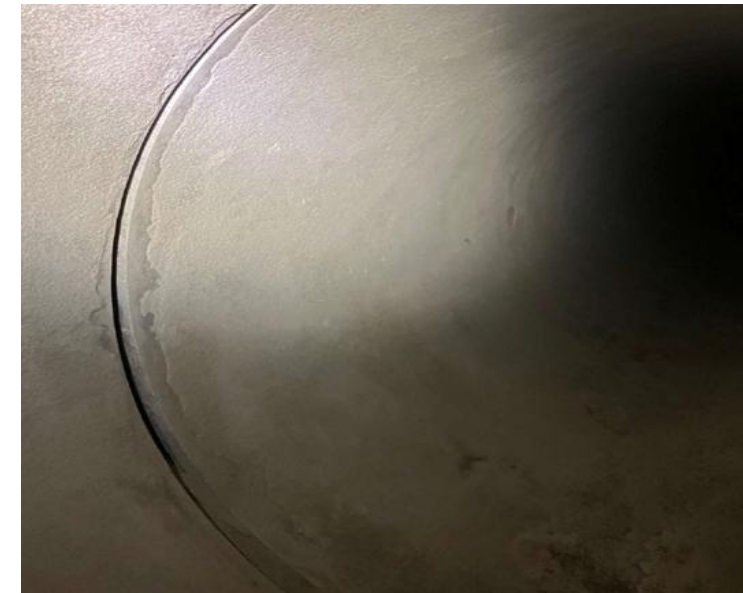
- Pipeline drawings indicating joint locations or other features did not exist, probable leak locations could not be established.
- SGH Performed an internal V&S inspection of the pipes to check for signs and potential source(s) of leakage and assist in determining the final repair scope.

- Four 45-degree vertical bends, two on each side of the culvert.
- CIP wall thickness is approximately 1 in., lined with an approximately 0.25-in. thick cement mortar lining.
- 8-in. diameter blow-off in Pipe 10.
- Pipes 9 to 11 sounded different from the others, with the sounding characteristics of encased pipes.
- CML had spalled, exposing CIP in small areas in Pipes 16 and 18.
- Pipe joints were not mortared, with joint openings ranging from zero to 4.5 in. wide.
- No signs of active or recent leaks, the joint openings, especially the wider ones, were the most likely location(s) for leakage

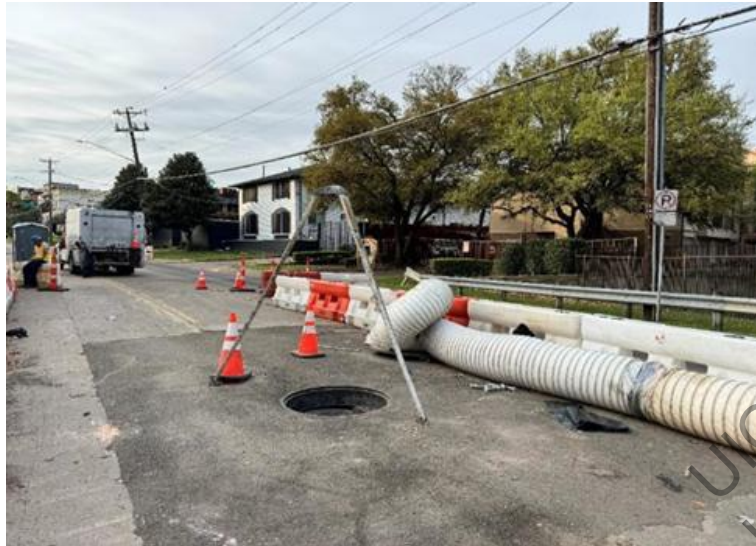
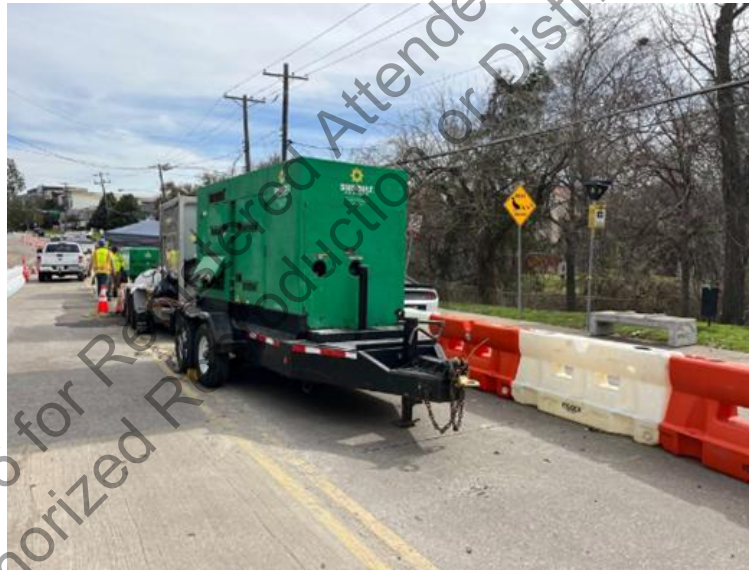
*New access manholes  
in Pipe 2 and 23*

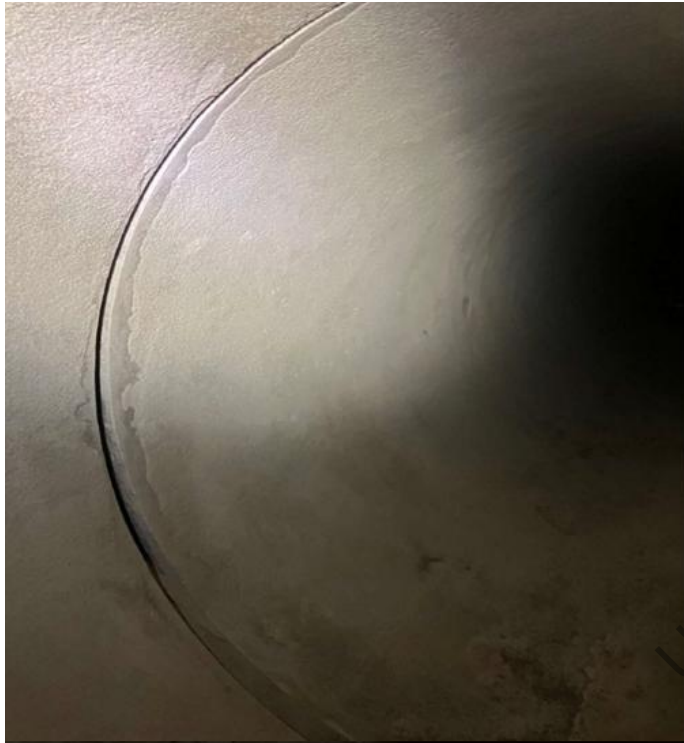
*Surface prep on Cement  
Mortar Lining*

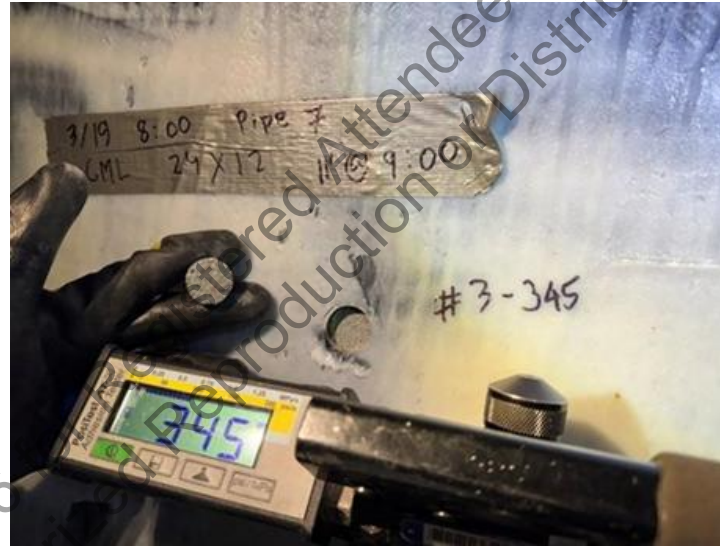
*Mockup panel installed  
on CML surface*

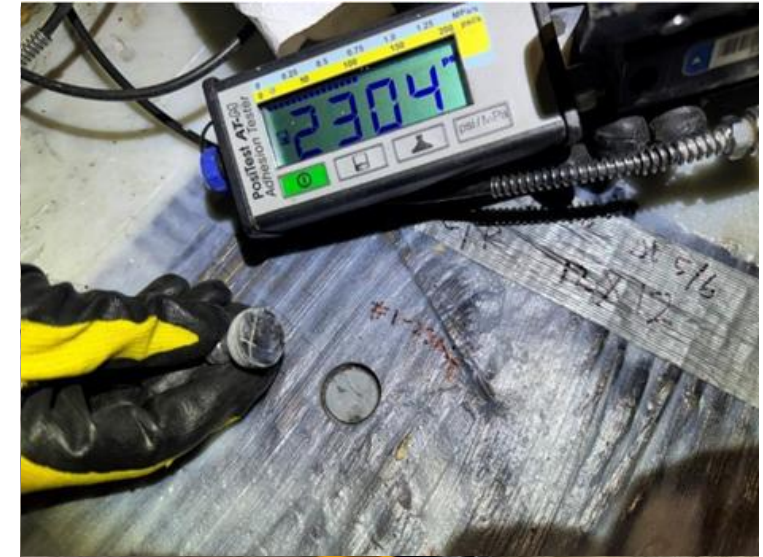
*Mockup panel installed  
on CIP surface*

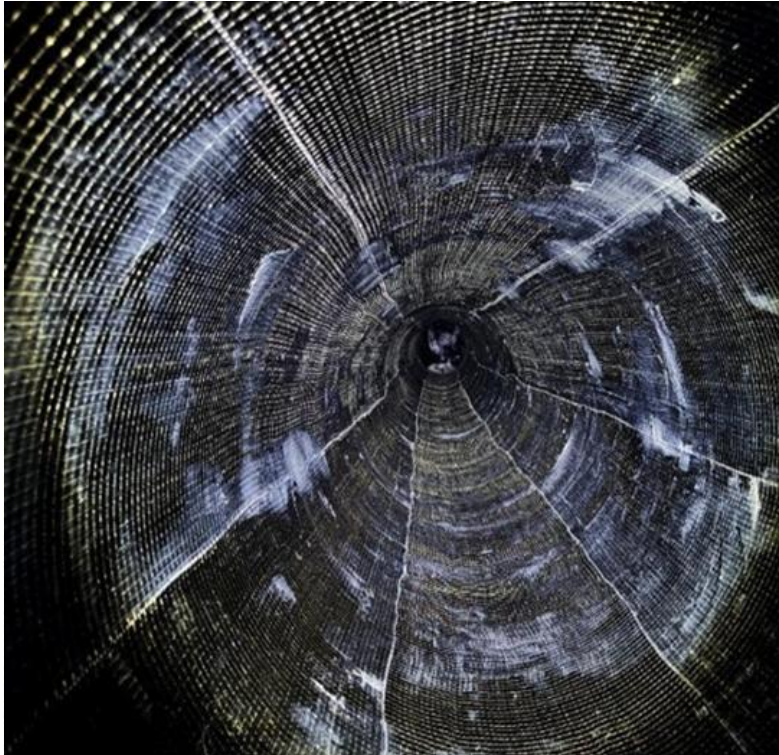
*Hoop & Longitudinal layer installation*

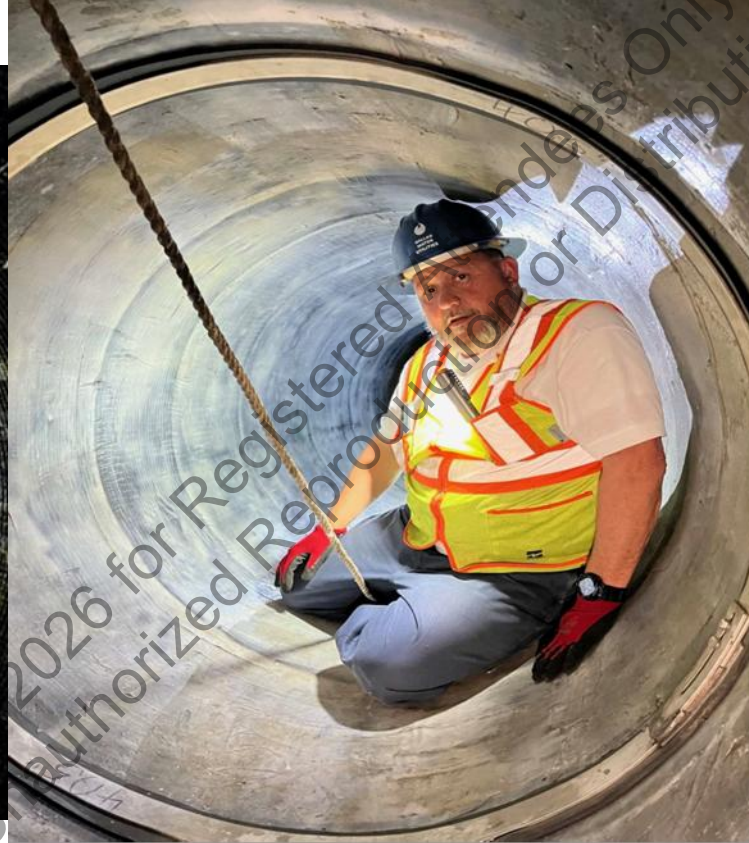
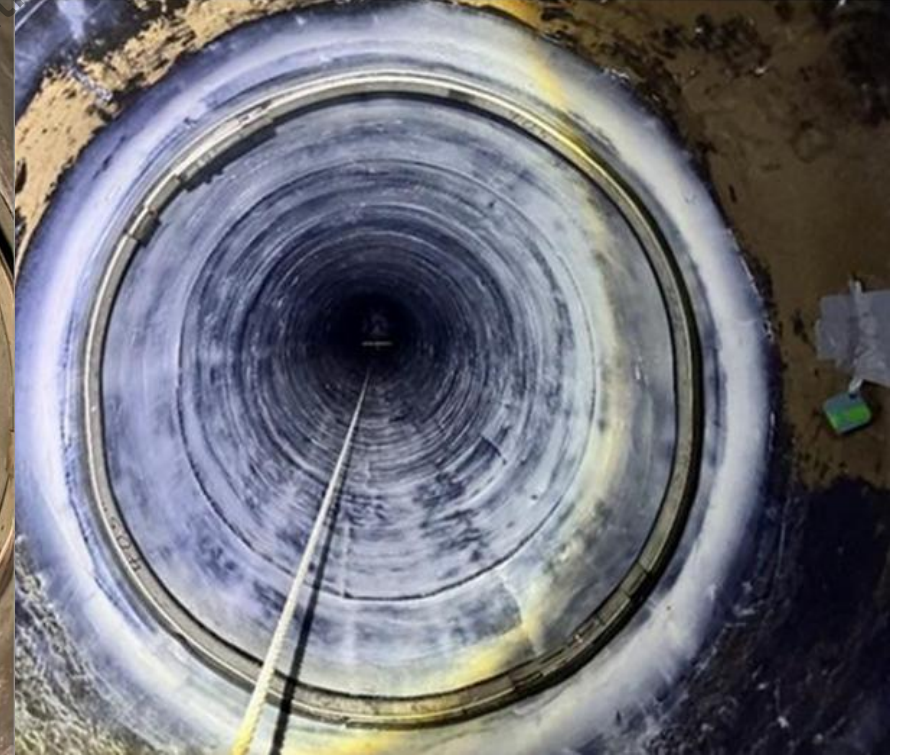
*Watertightness layer & final topcoat & expansion ring termination*
