Underground Construction Technology | January 28-30, 2020 | Fort Worth, TX

Identifying Defects in MH Coatings and How to Fix Them

Presented by: Jeremy Sukola, PCS Madewell Products Corporation NACE Coating Inspector- Level 3 #9442 SSPC Protective Coating Specialist

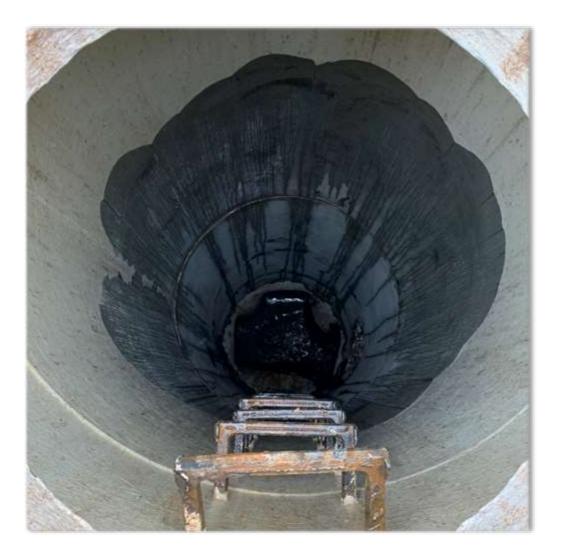
Delamination:

- Defined as a loss of adhesion, either to the substrate or between individual coats.

- Inadequate surface preparation
- Contamination
- Exceed coating recoat window
- Incompatible coatings

Depending on the extent, abrade and recoat or completely remove the delaminated coating and reapply.

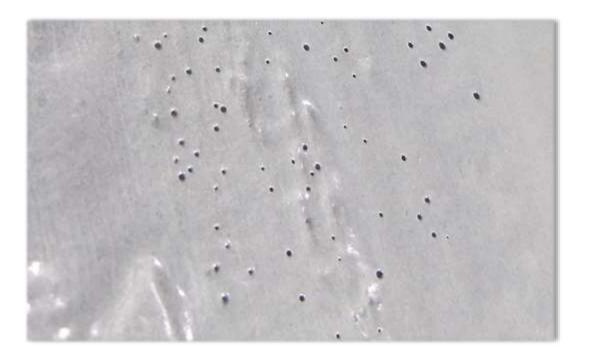
Pinholes:

- Small holes or craters in the dried coating film.

- Air entrapment in porous substrate
- Outgassing (moisture vapor)
- Solvent entrapped in coating film
- Incorrect spray application

Abrade, clean and apply one or more coats as necessary.

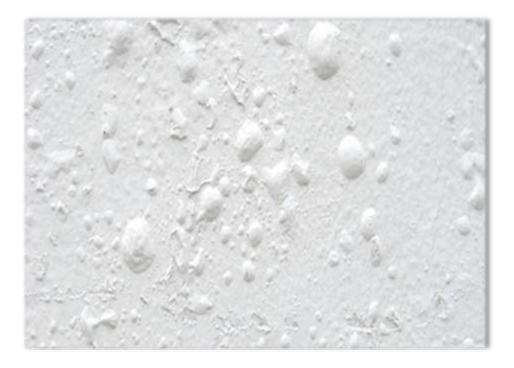
Blisters:

- Dome shaped "bubbles" in the dried coating film (local loss of adhesion).

- Excessive moisture in substrate
- Solvent entrapment
- General poor adhesion

Remove excessive moisture condition if present. Abrade, clean and apply coating(s) as necessary.

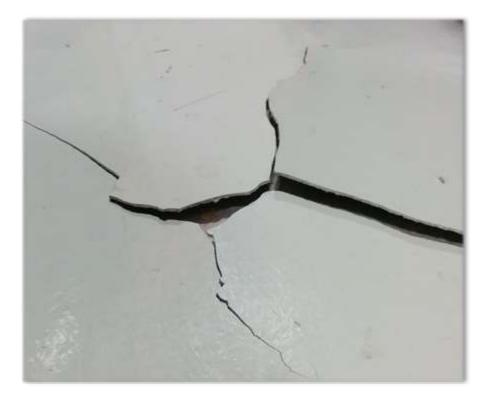
Cracking:

- The splitting of the coating film that may penetrate down to the substrate.

- Surface movement
- Lack of flexibility
- Traffic load

Abrade to remove. Reapply coating or use more flexible system if continued movement is anticipated.

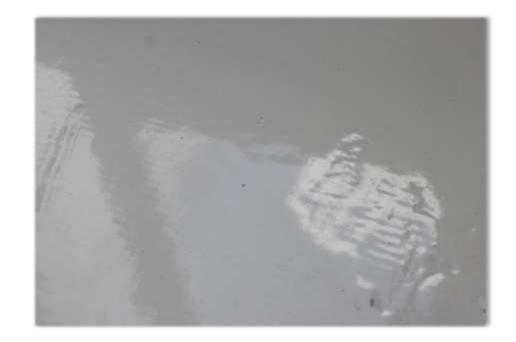
Uncured Coating:

- A coating that has not cured or is soft, tacky and easily deformed.

- Insufficient dry time
- Poor environmental conditions
- Incorrect mix ratio
- Wrong hardener

Remove uncured coating and recoat. Large areas may require removal.

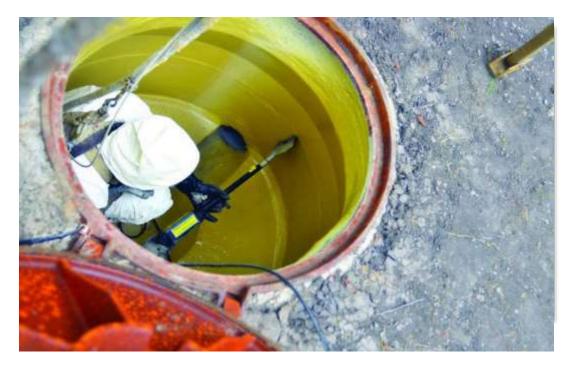
Holiday:

- A discontinuity in the coating film exposing the substrate.

- Application error
- Pinhole

Apply additional coatings to the missed area.
