Underground Construction Technology
International Conference & Exhibition

Condition Assessment Breakthrough for Asbestos Cement Pipes

The Broadway Street Everett, WA Pipe Penetrating Radar and Multi-Sensor Condition Assessment

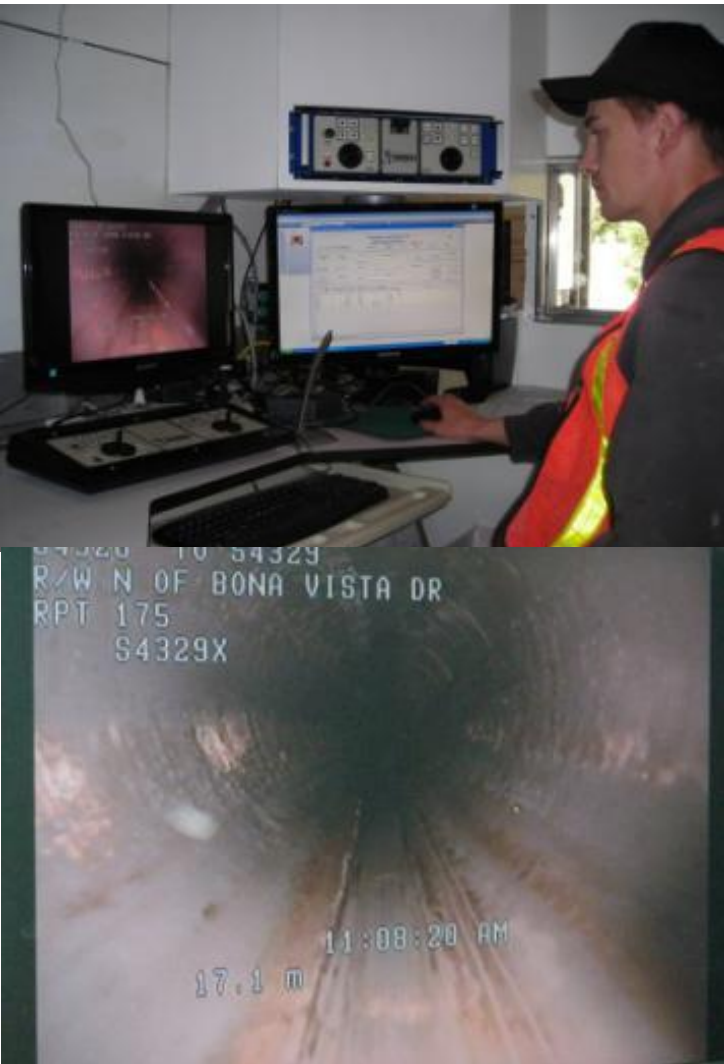
CCTV

- Visual only
- Qualitative
- Operator dependent
- Often unreliable, especially in large diameter trunks and interceptors

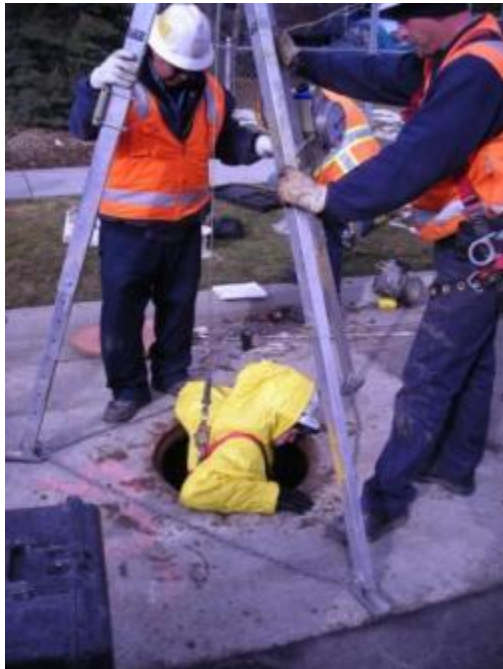
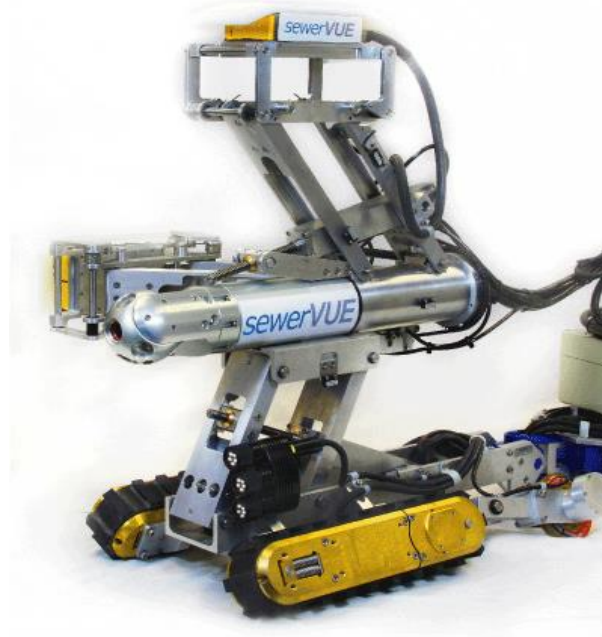
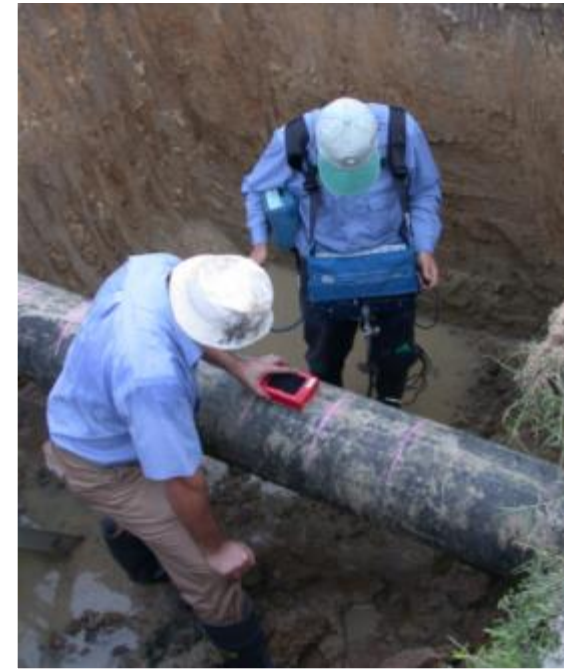
PPR Deployment

Manned entry

- Large diameter water pipes
- Where manned entry is safe

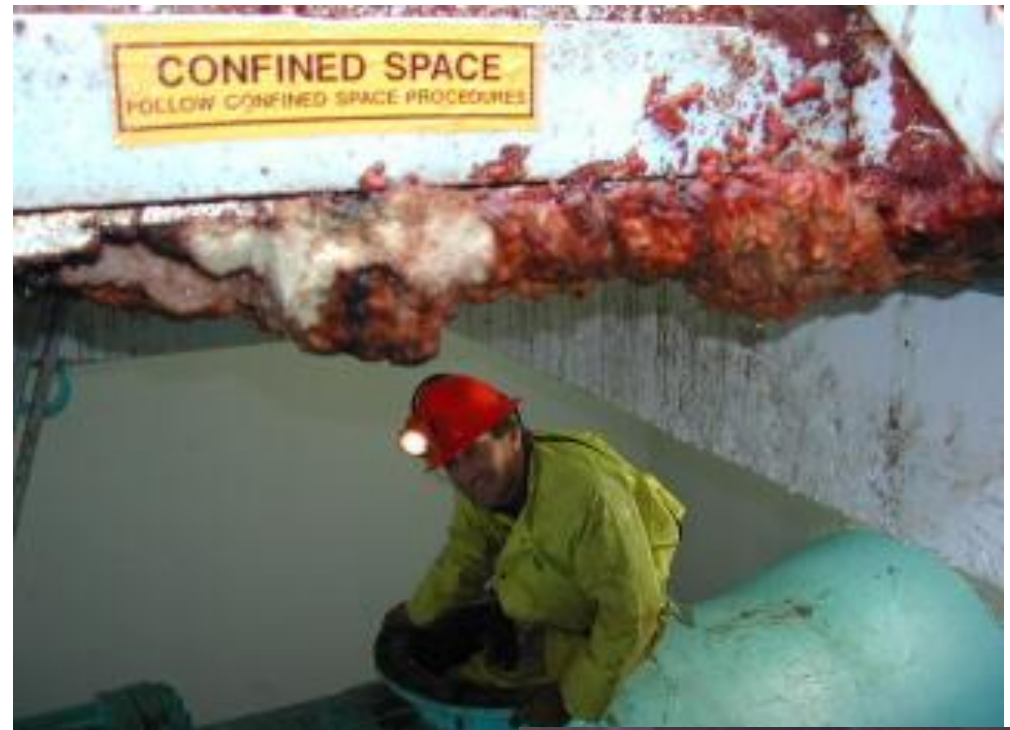
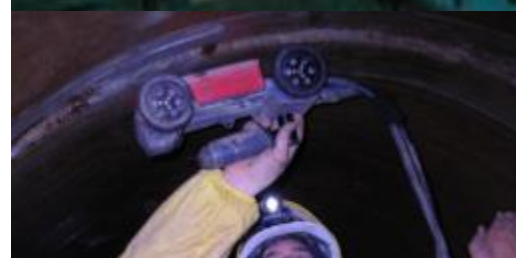
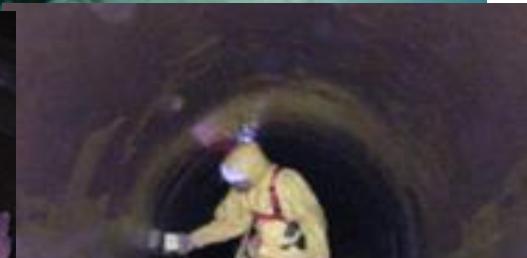
Robotic PPR Inspection

- “Swiss army knife”
- 21-60 inch, (520-1500 mm)
- 6000 ft deployment capability
- 30 ft/min inspection speed

- High frequency PPR antennae
- LIDAR scanner
- CCTV (pan, tilt, zoom)
- No bypassing required

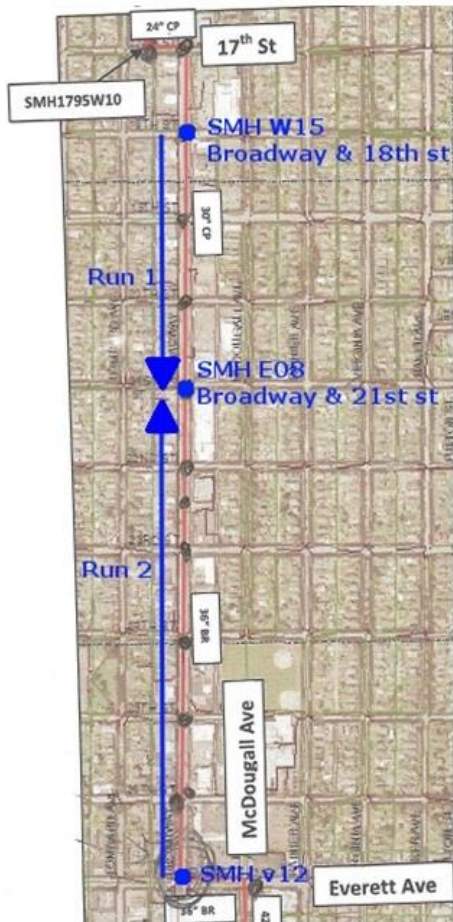
Broadway Sewer Main

- 1430.8 ft of 30 inch RCP
 - Circular
 - 2793 ft of 36 inch brick line
 - Circular
 - 2 courses of bricks
- Task:
- Quantitative condition assessment

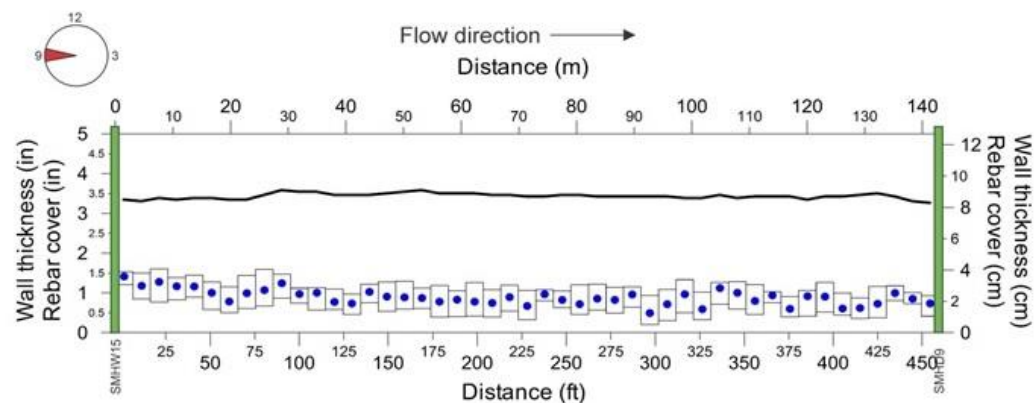
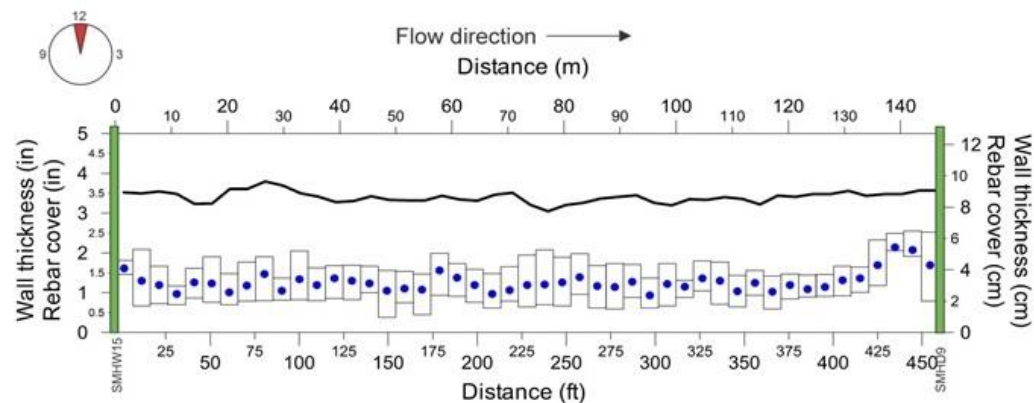
30" RCP Results

- 4223.8 ft of pipe inspected
- 3 to 4 inch wall thickness for RCP, sufficient rebar cover, no significant corrosion, no voids
- Brick “wall thickness” is in 7.12 and 8.25 inch range, with varying thickness range at the 11 and 12 o’clock positions (construction artifact)
- Void type anomaly at 997 ft at 12 o’clock (6” deep and 9” wide)
- Actual diameter is 34.5”

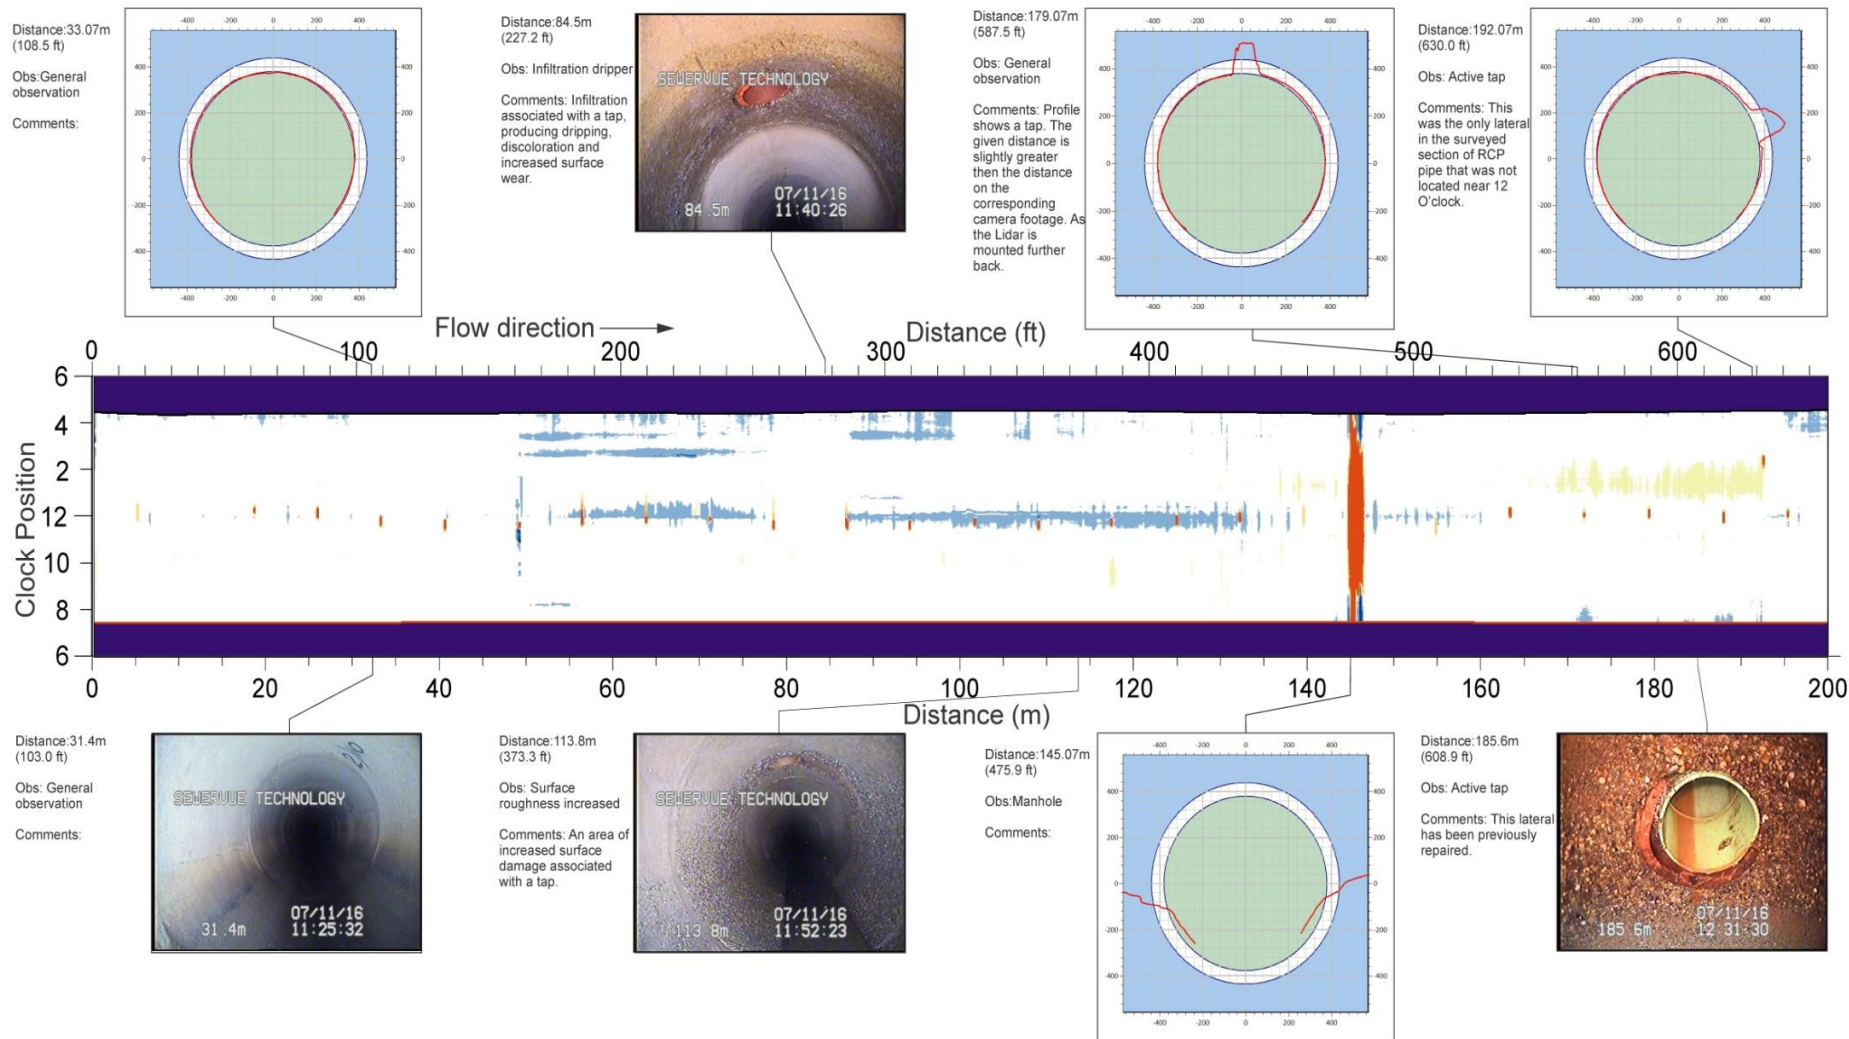
Scale of pipe loss or build up. The reference (0") is a 34.6" (880mm) diameter pipe. The color blue means build up, the color yellow/red means pipe loss in the inspected pipe compared to the theoretical 34.6" (880mm) diameter pipe. Solid purple indicates no usable data (e.g. flow).

Measured pipe profile

760mm (29.9') and 870mm (34.3') diameter reference profiles

LiDAR Survey Overview
Broadway sewer main,
Everett

LiDAR Results, Run 1-1
30" RCP, SMH W15 to SMH E8, Downstream
Lidar Profiles, 0m-200m (0-656.2 ft)

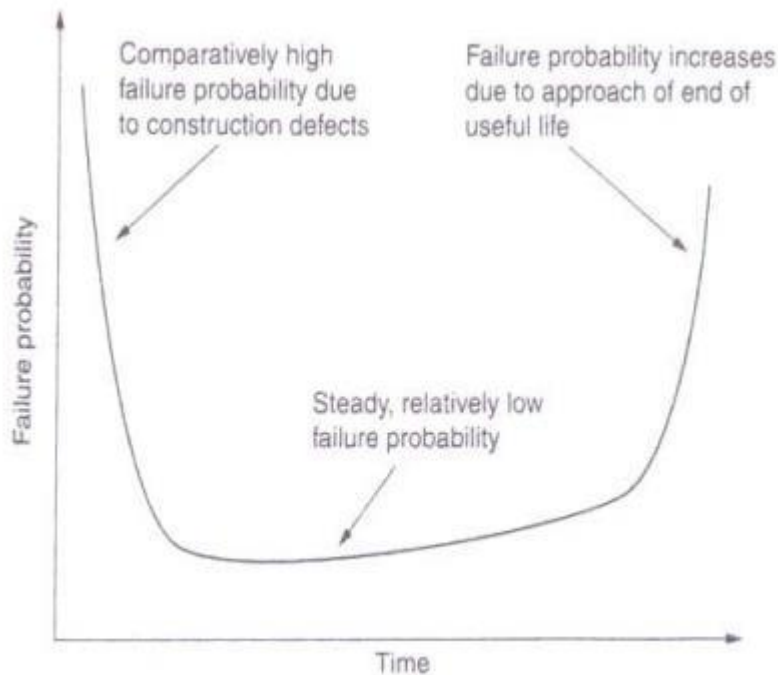
FIGURE 3.3 Bathtub curve of pipe performance with age.

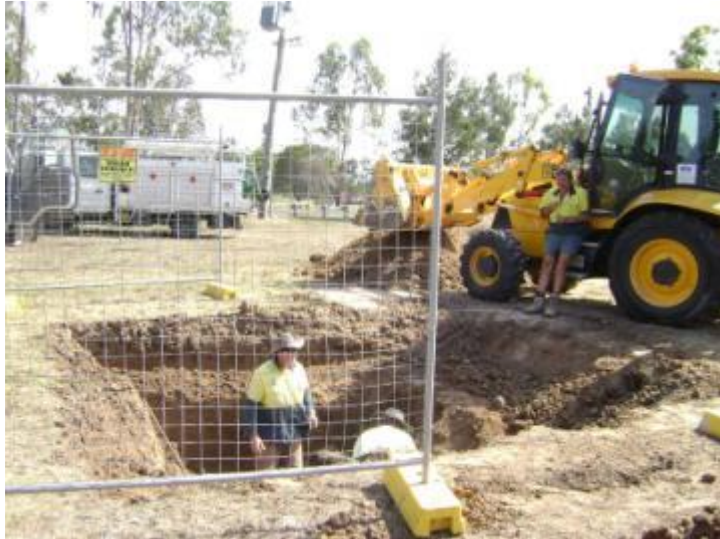
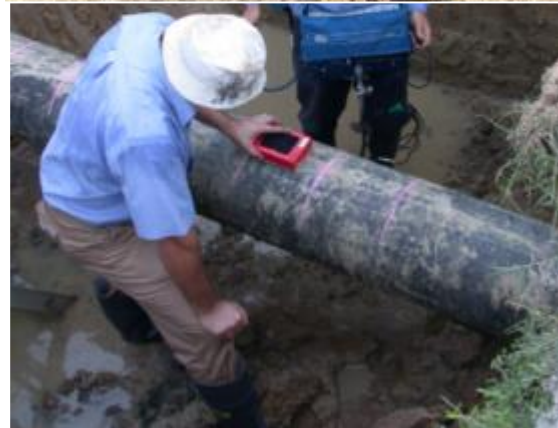
Evolution of PPR for AC Pipes

- Richard Yelf, 2008
- Limited but safe access
- No size limitation
- Hand held scanner
- Good results from longitudinal and circumferential scans
- No need for confined space entry

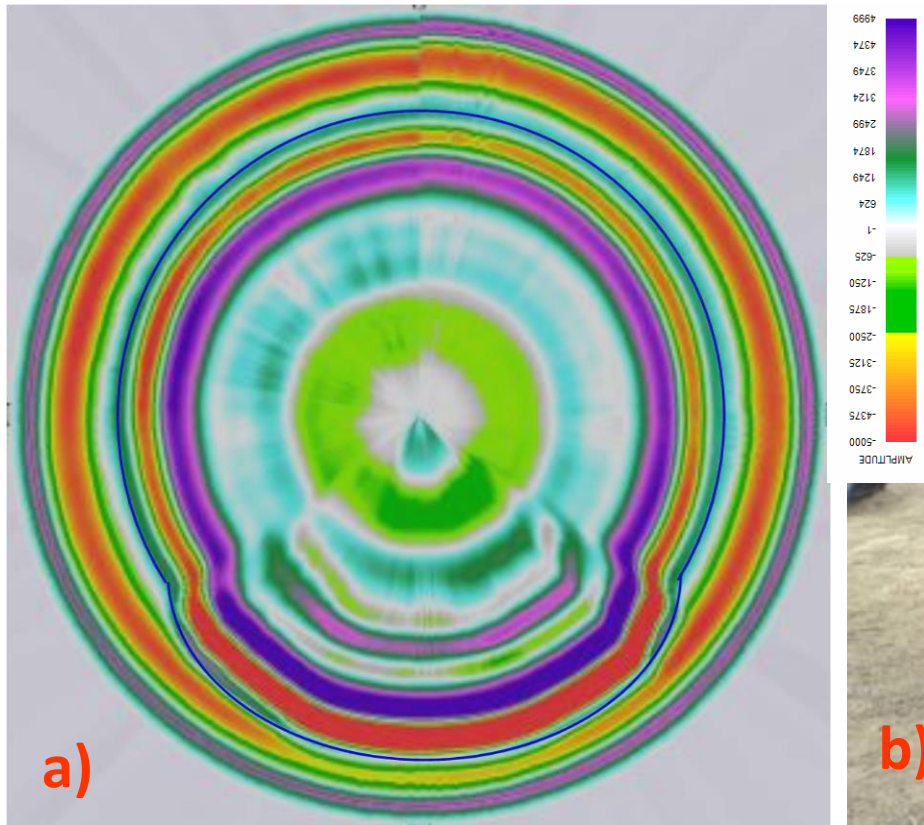
a) Radargram of a 27 in (675mm) diameter, 1.6 in (40mm) wall thickness AC pipe. The pipe was empty with an $\frac{3}{4}$ in (18.5mm) scour at the bottom.

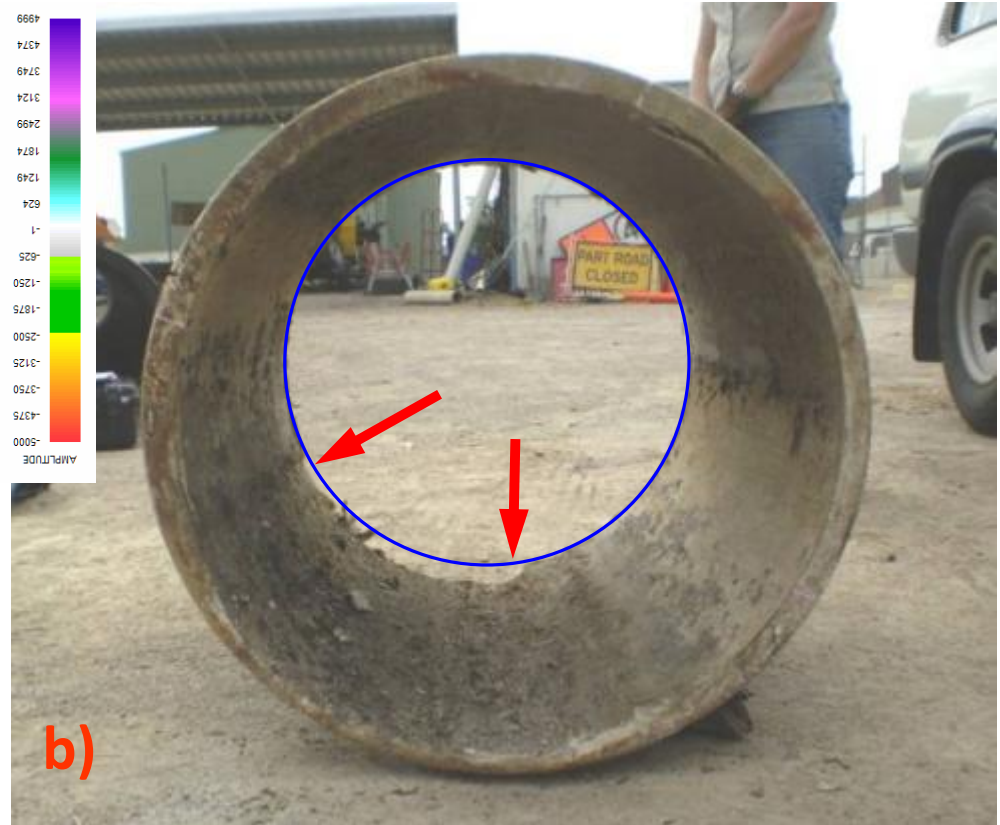
b) Photograph of the inside the pipe in Figure (a).

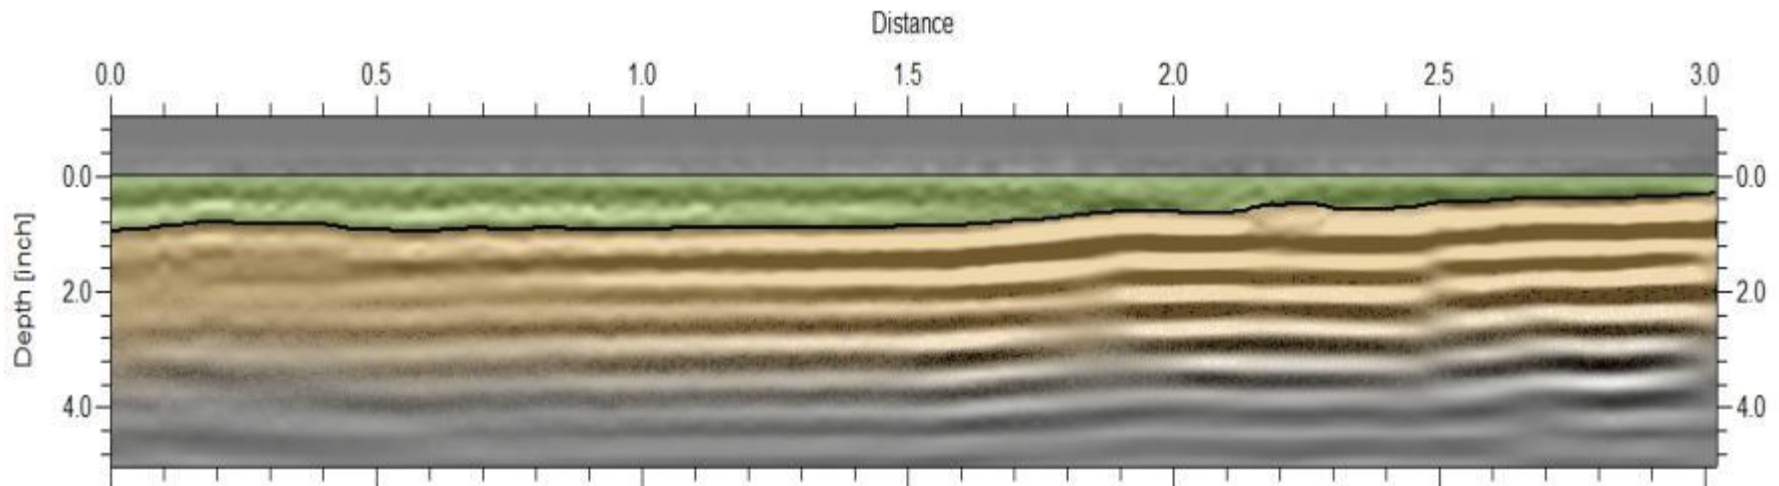
SewerVUE Lab Test

- Laboratory test on 8" AC pipe sample with thinning wall

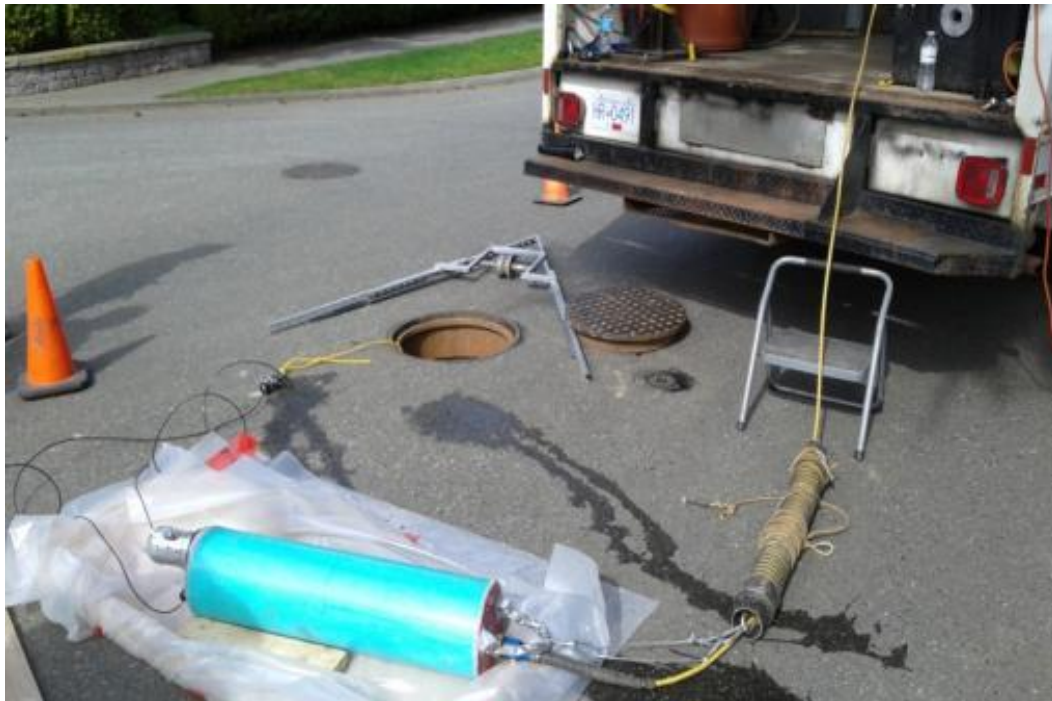
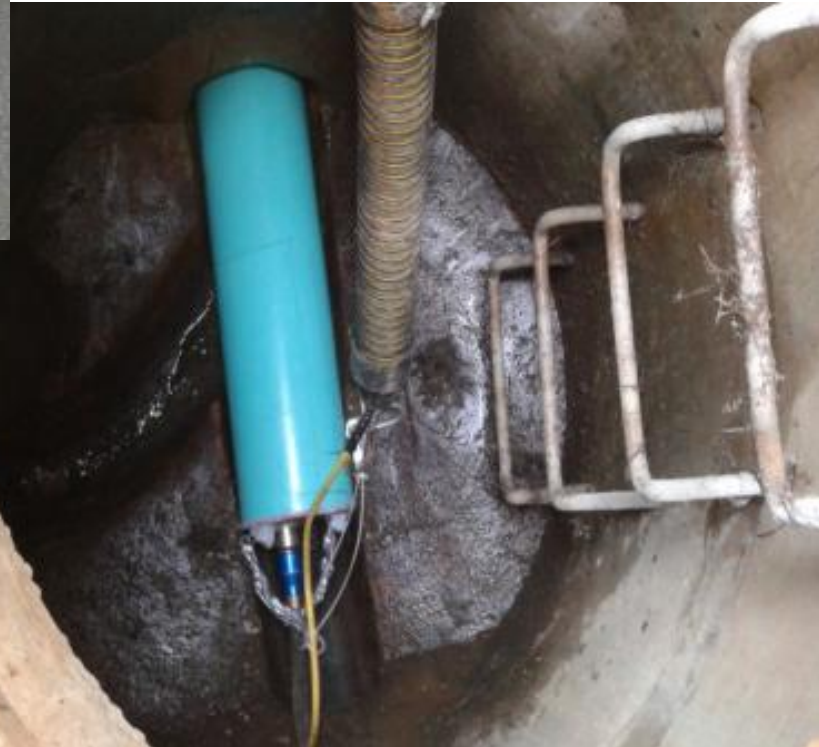
AC Pipe Results

- 10" AC sewer pipe in service
- Excellent wall thickness reading, no corrosion or voids
- Anomalies in bedding at 6 o'clock

- High frequency PPR can accurately image AC pipe wall thickness
- PPR can quantify wall loss
- PPR can provide repeatable, quantitative and actionable condition information
- SewerVUE received a \$484,000 grant to commercialize the technology
- Pilots scheduled for Sacramento, CA and Phoenix, AZ
