Clearing Blocked Force Mains

The City of Houston experienced an unusual occurrence

Houston, We Have a Problem!!!

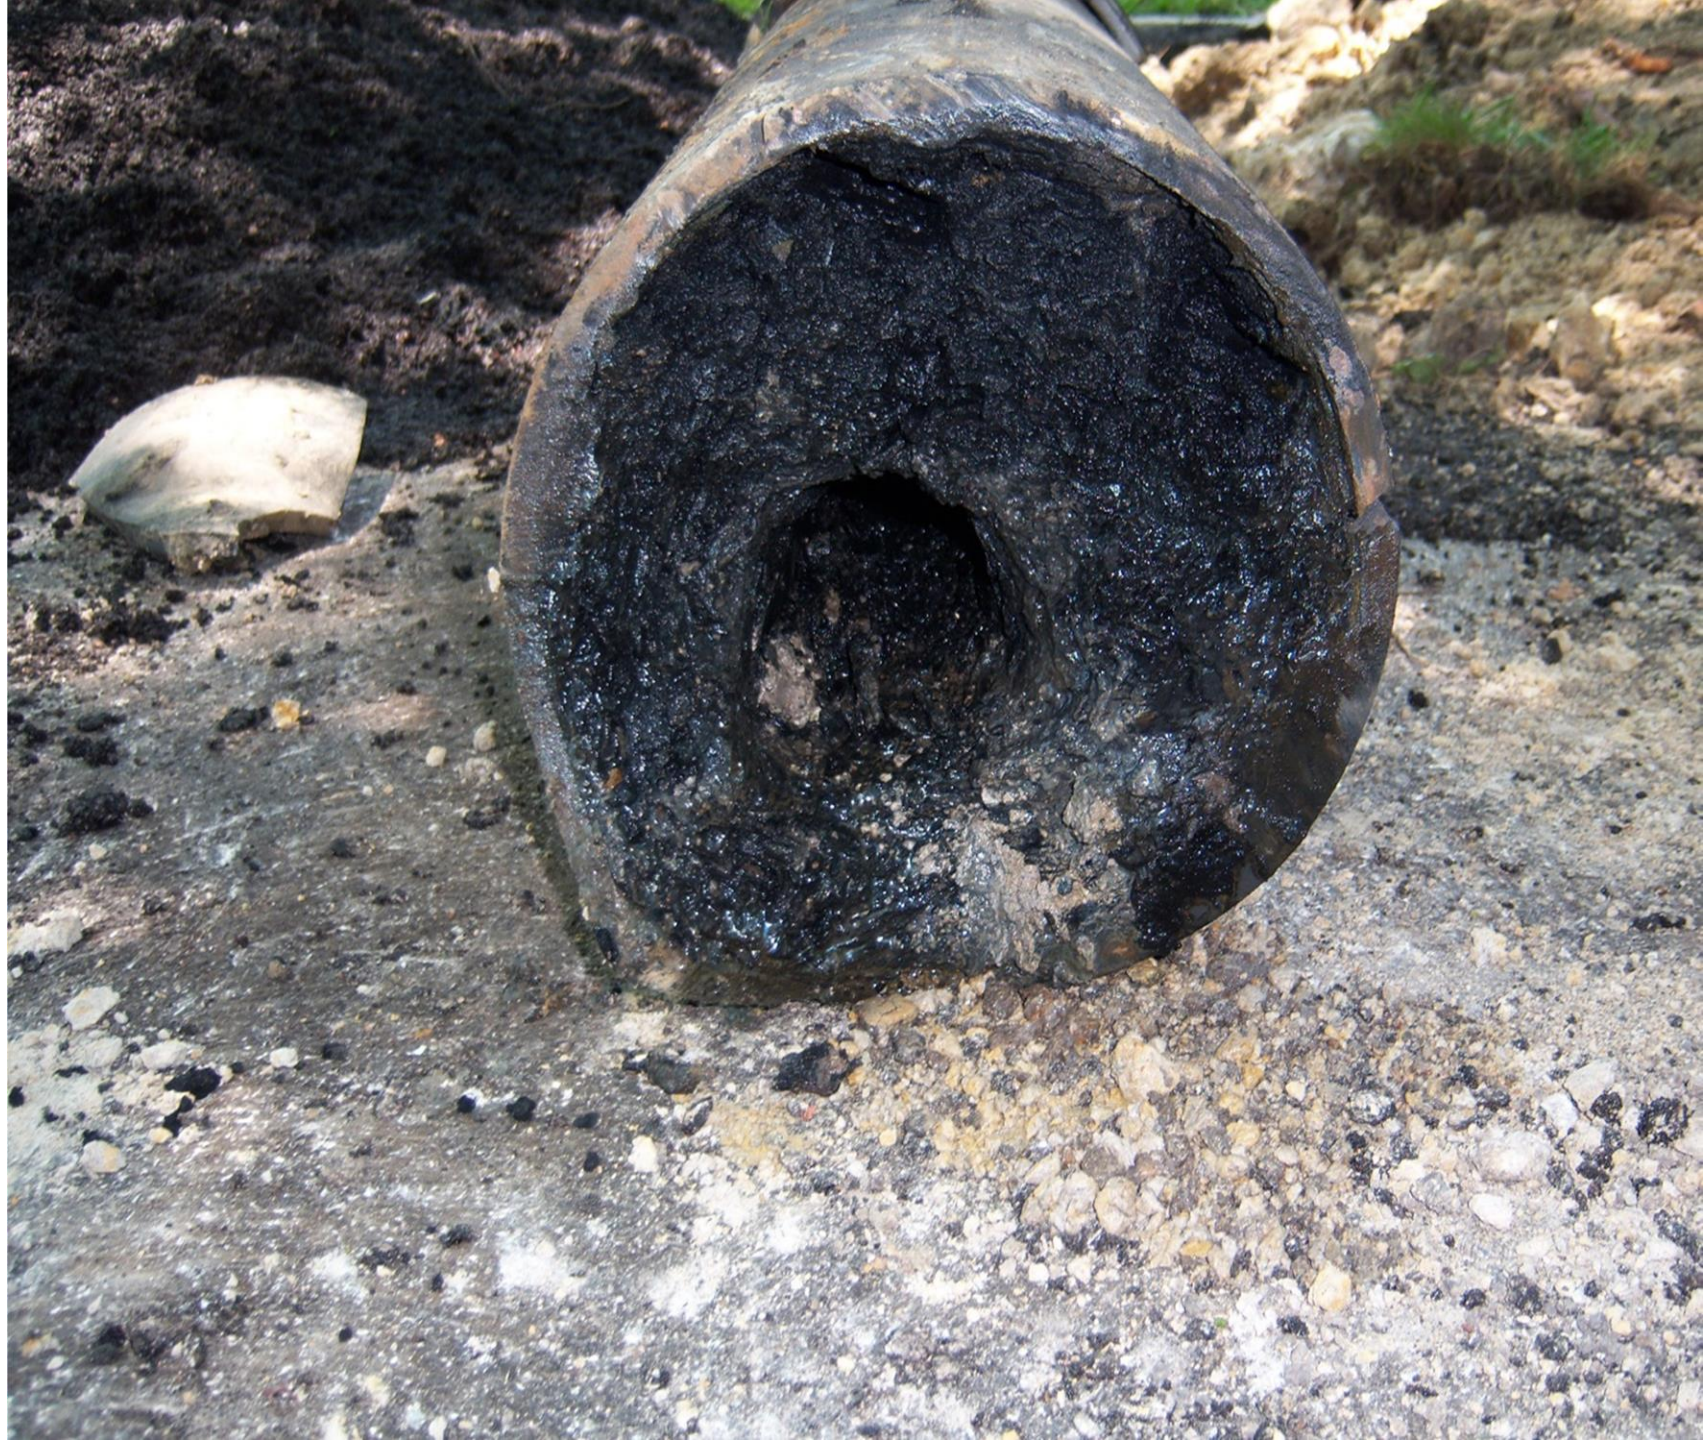
Force Main Section

Removed

- 10" Steel Pipe
- Reduced to 2.5"
- 1,500 LF

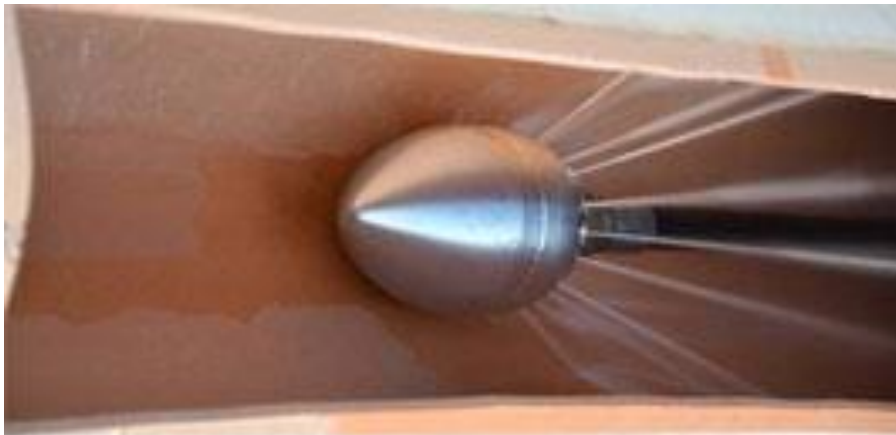
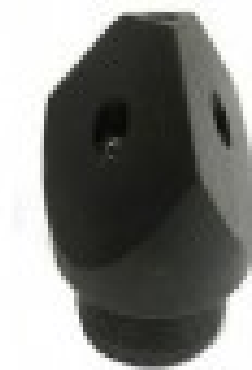
The first project was a 1,500 foot long, 10" dia cast iron. There was no alternate path for the flow, so bypass was necessary. T Construction set up bypass and operated it each day. Flow was pumped from the wet well to a manhole just downstream of where the force main ended, leaving access for cleaning.

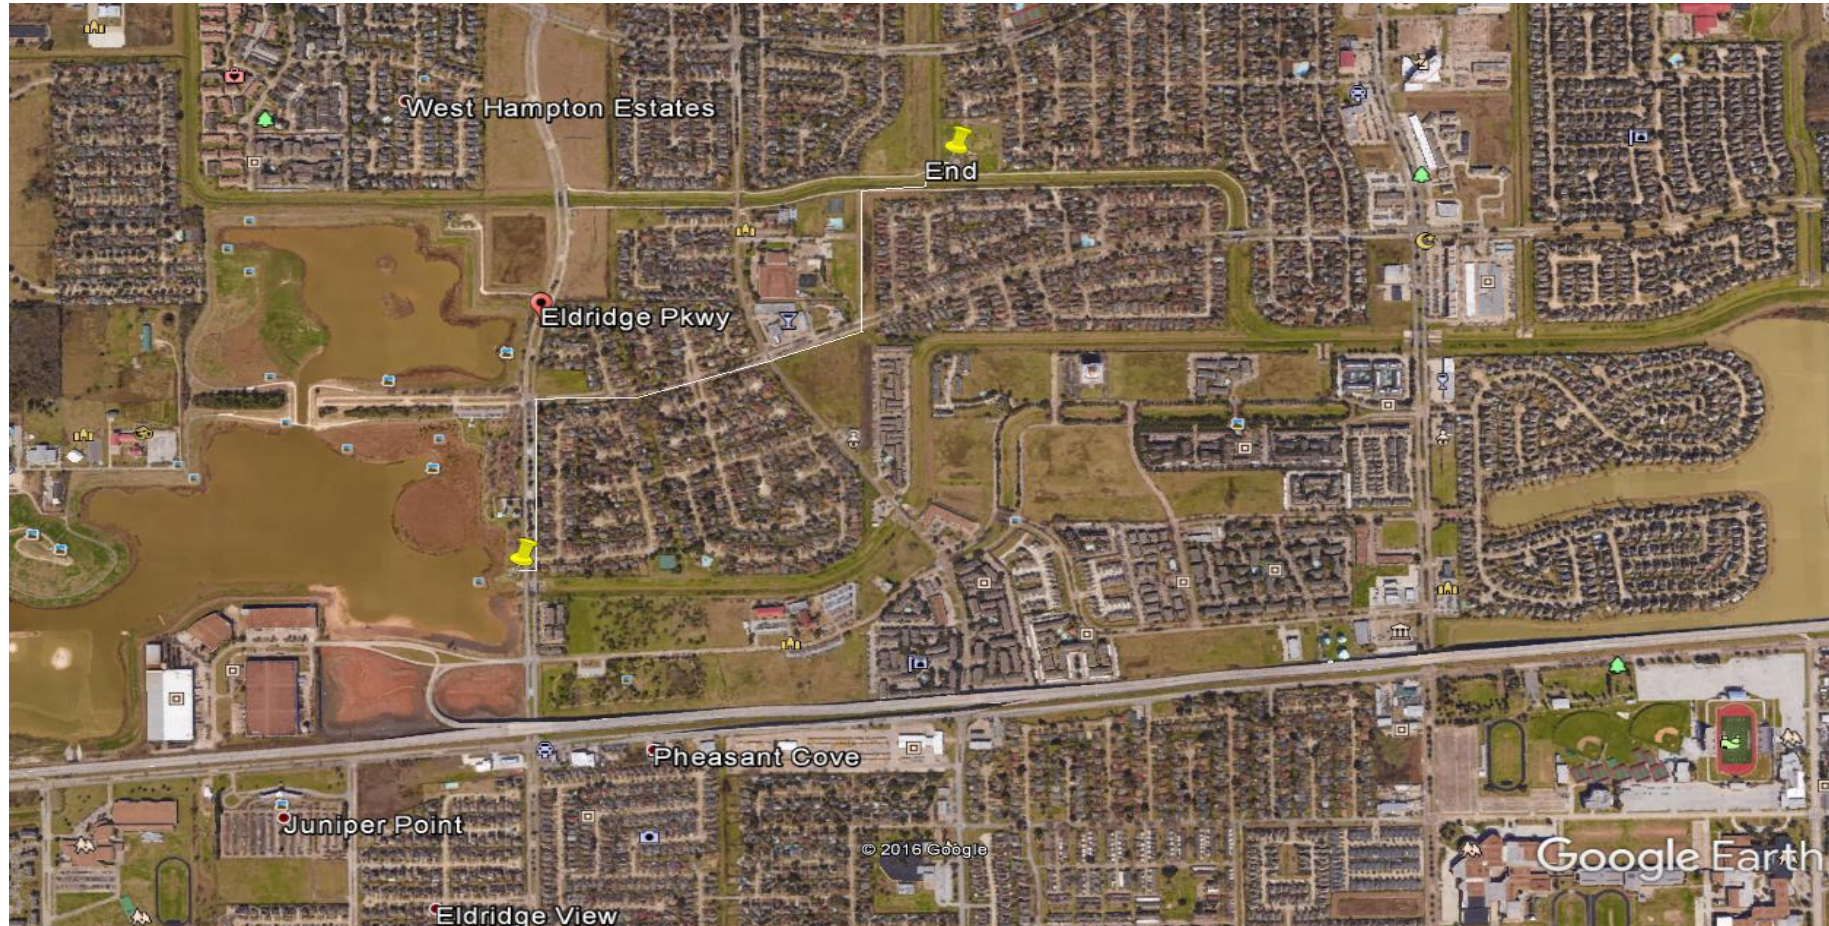
The second project was 5,800 feet of 12" cast iron. There was not nearly enough access.

T Construction added access points and performed bypass as needed.

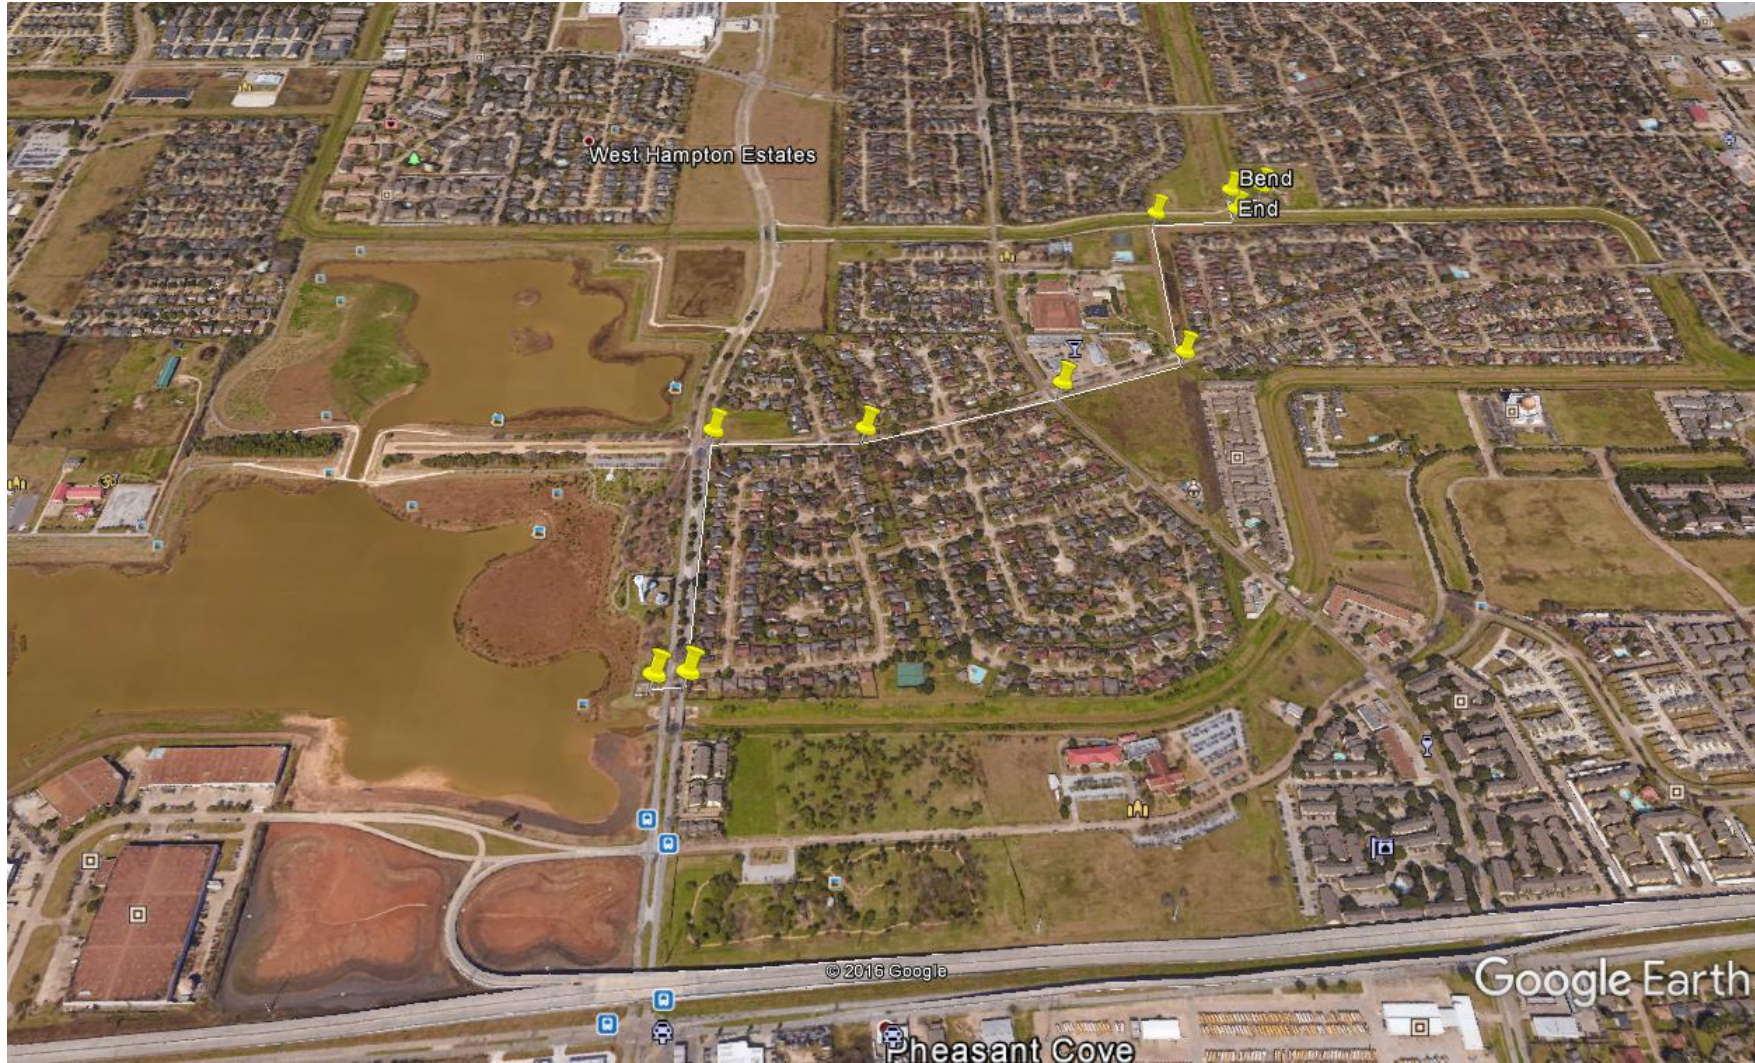
Building on the knowledge gained from the first project, CleanServe restored the line to 95% of capacity in 15 working days, removing nearly 120 cubic yards of debris.

The material is believed to be a combination of the particular chemistry of the waste in the line and chemicals which were added to reduce odors.
