Underground Construction Technology  
International Conference & Exhibition

# Failing to Flawless in a Day: How Pre-chlorinated Pipe Bursting Invigorates Arlington Water Utilities Main Replacement Program

# City of Arlington & Water Main Background

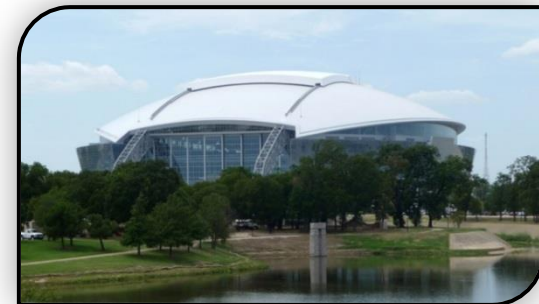
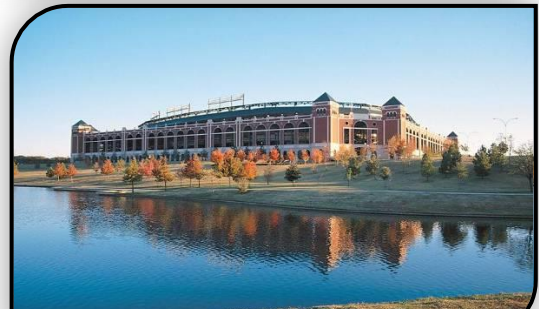
- Population over 370,000 (50th Largest in USA)
- Daily Water Demands 35 MGD to 115 MGD
- 1,425 miles of public water main
  - 588 miles of asbestos cement (AC) mains
- Average 450 water main breaks annually
  - 2015 – 72% of 533 water main breaks were on AC pipe

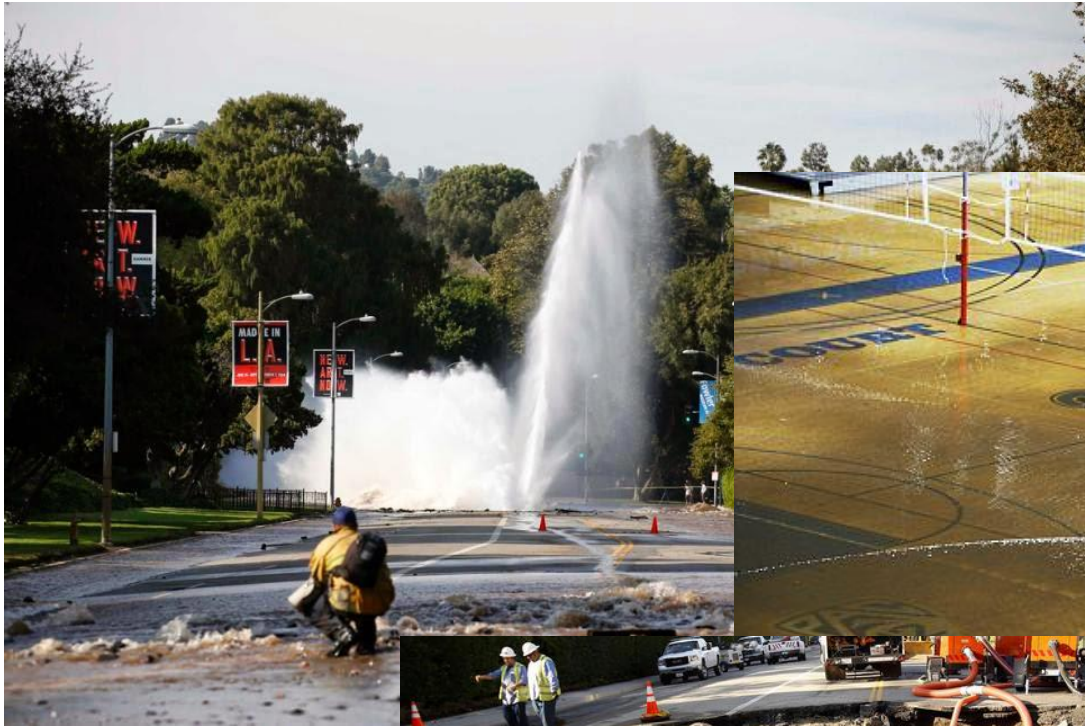
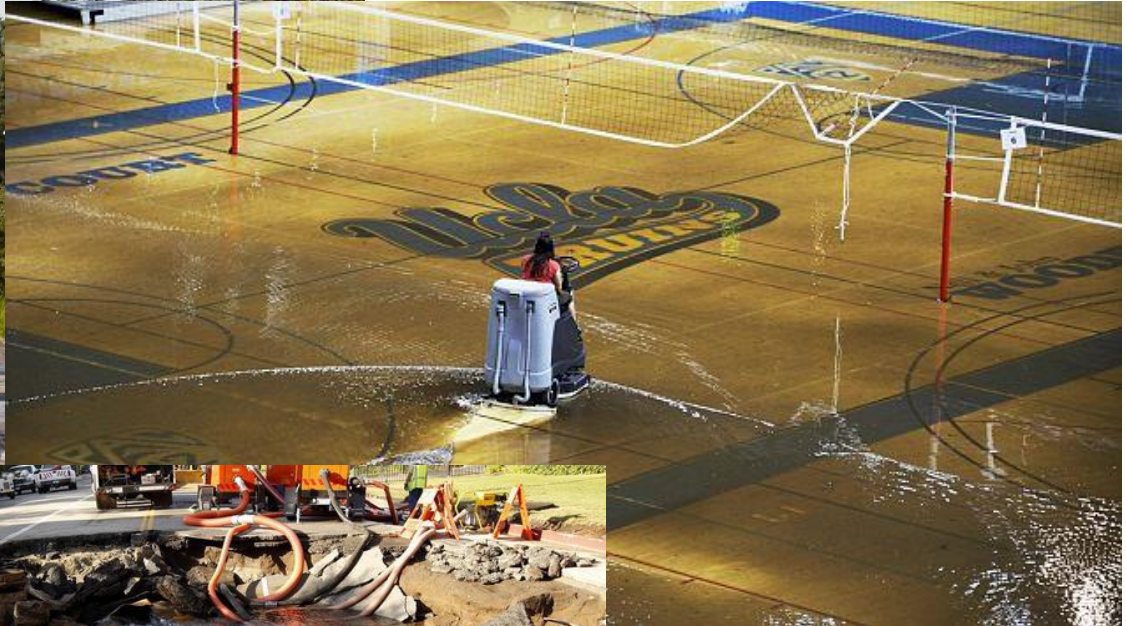
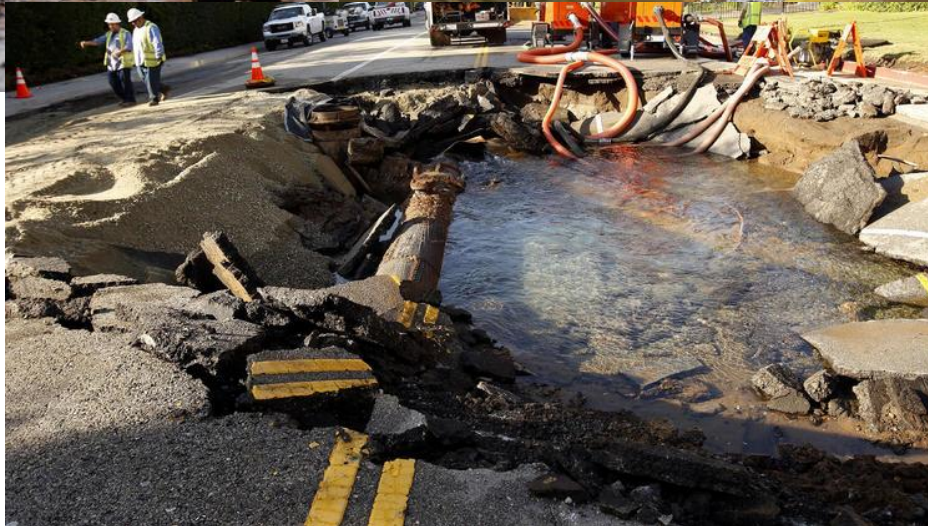
# Economics of WM Failure - UCLA

UCLA Campus, Los Angeles, California – 30 inch steel

- 93 year old steel pipe
- Substandard isolation valve controls – 4 hours!
- Flooded athletic fields, underground garages and various walkways on the University of California in Los Angeles.
- 160 firefighters responded and searched 200 cars
- 75,000 GPM = 48 Million Gallons of water lost
- Significantly increased travel delay due to repair time – 238 hours to repair the 30” steel main!

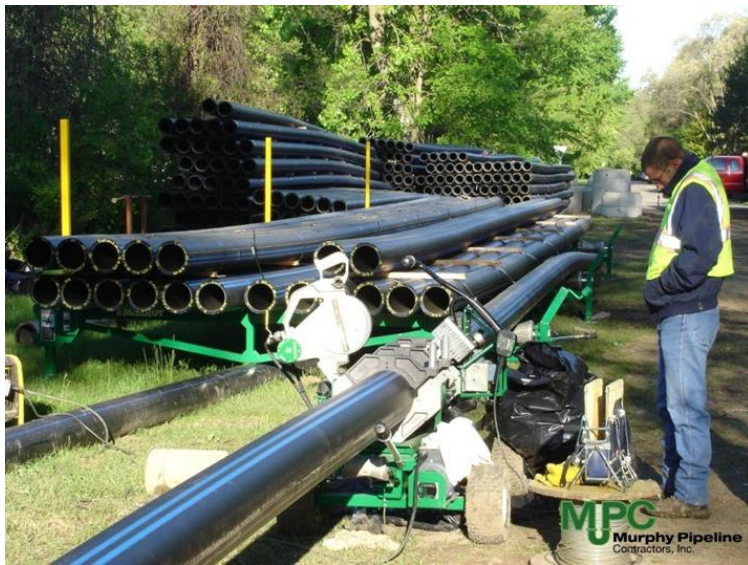
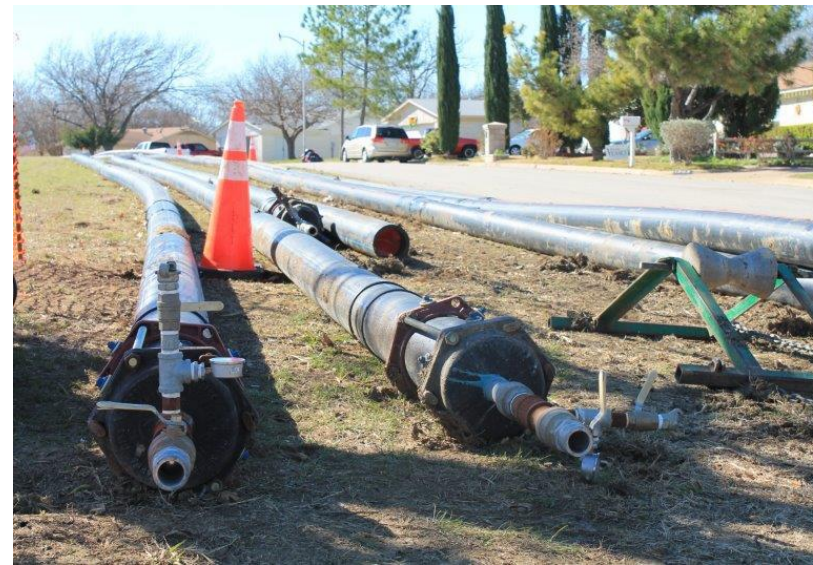
## Fusing & Pre-chlorination of HDPE

- Staging area located away from burst locations to minimize site impact
- Butt fusion is used to connect pipe sections to corresponding burst lengths
- Pressure testing
- Lines capped and disinfected with hypochlorite solution of at least 25 mg/L
- Two consecutive days of samples, taken 24 hours apart

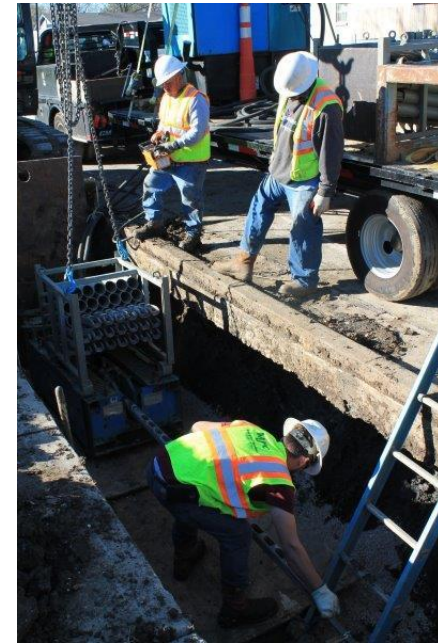
## Pipe Bursting Operations 8:00 AM

- Entry and exit pits excavated 4' x 12'
- Service connections pits 3' x 3'
- 8:00 AM – Decommission Main
- Bursting equipment is set in pit and rods are shuttled through host pipe

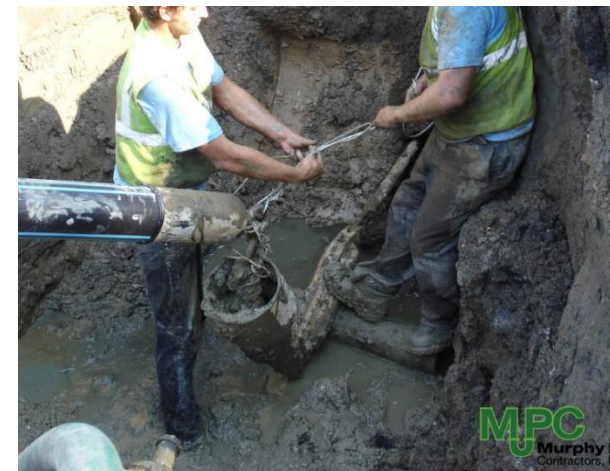
## Pipe Bursting Operations 10:30 AM

- 10:30 AM – Bursting head (or ductile splitter) and expander are attached to the rods which have reached the entry pit
- Pre-chlorinated and sealed HDPE pipe attached to the expander
- Pull back begins

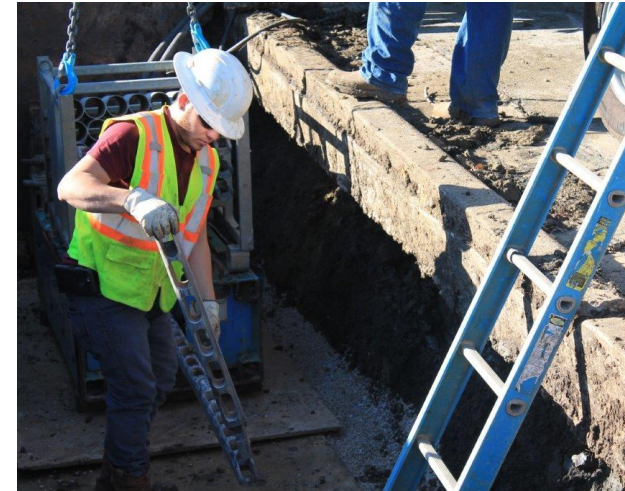
## Pipe Bursting Operations Noon

- Rods are removed from the exit pit as pipe is pulled into place
- Noon – New pipe is installed

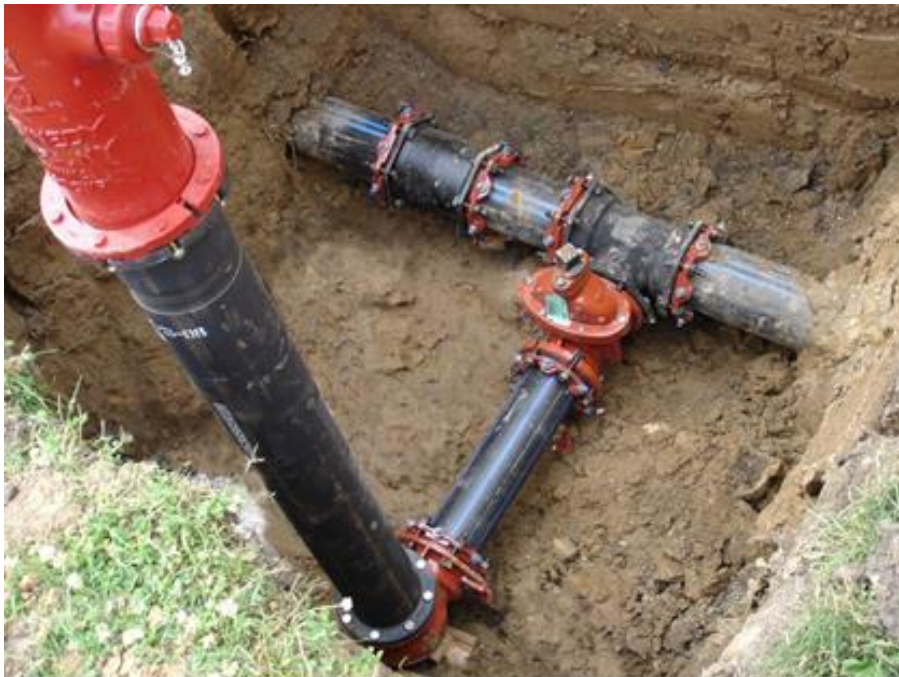
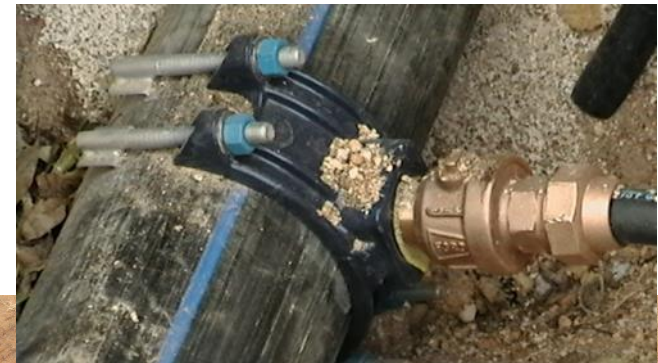
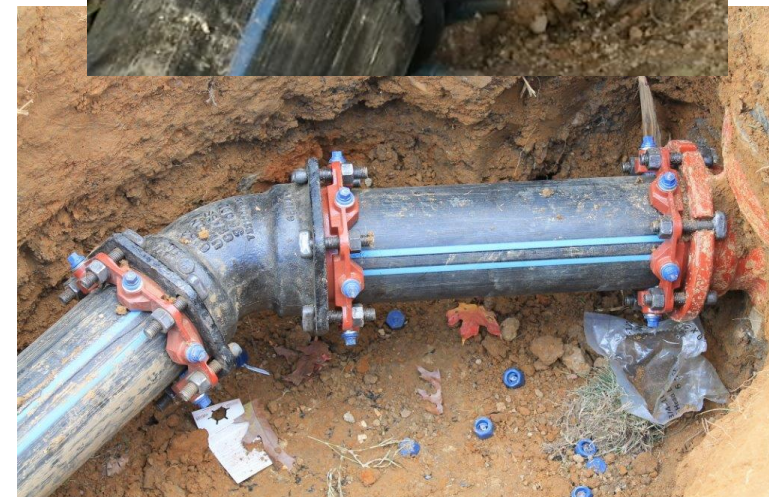
## Pipe Bursting Operations Noon to 3:00 PM

- Noon to 3:00 PM – Connections made
- Ductile Iron fittings, mega lugs, stainless steel inserts, mechanical service saddles

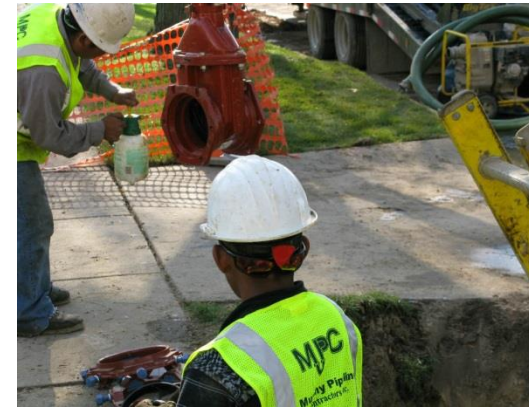
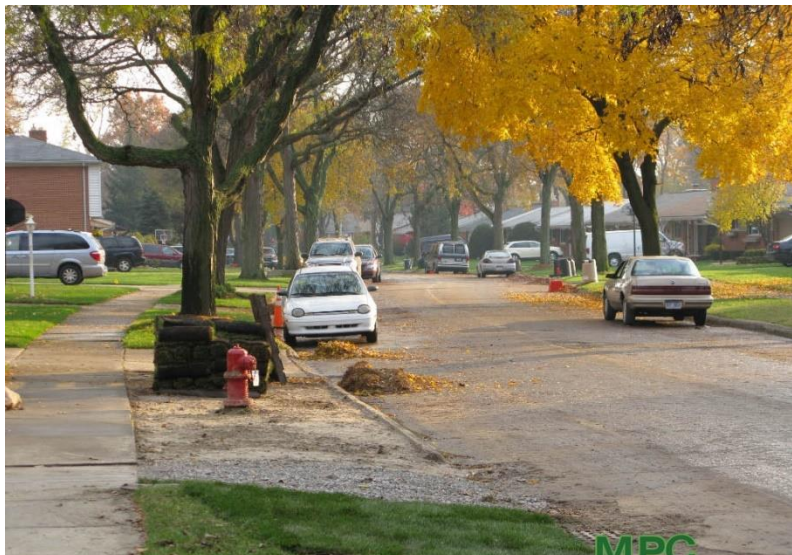
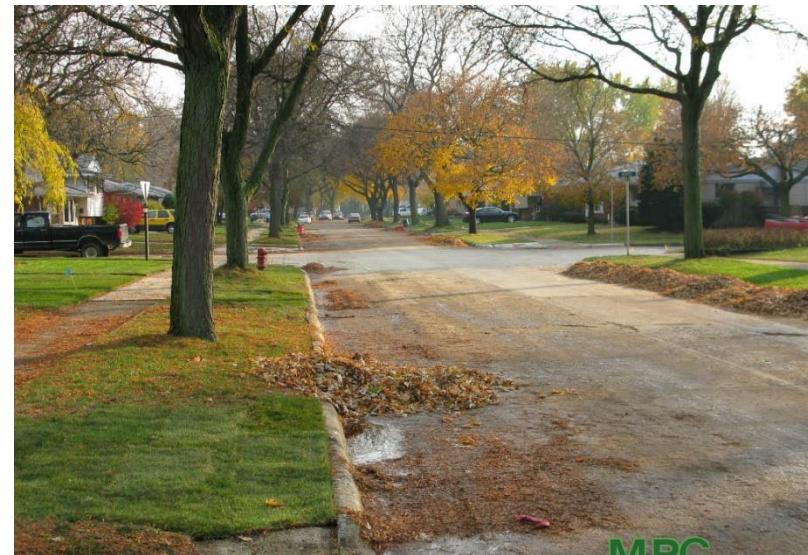
## Pipe Bursting Operations 3:00 PM

- 3:00 PM – Post Chlorination Process
- Hypo-chlorus solution sprayed on all connections
- Super-chlorinate new pipeline with slug of chlorine to 300ppm
- 4:00 PM – New main back live
