Underground Construction Technology

Baton Rouge's Sewer System

Background

Lessons Learned on Baton Rouge SSO Comprehensive Rehabilitation Program

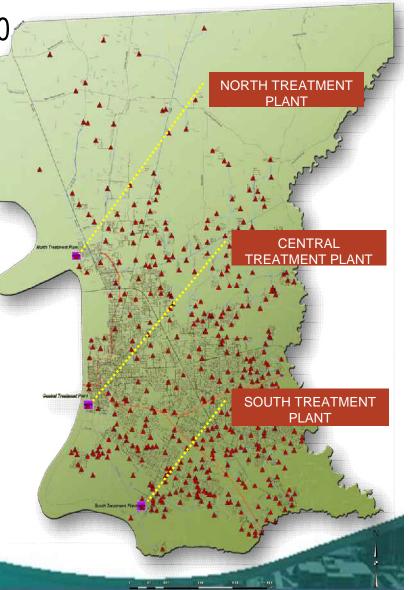
- Over 1,650 miles of sewer line
- o 37,500 Manholes
- 468 lift stations
- o 200 miles of sewer force main
- o 3 Treatment Plants
 - North 130 MGD
 - South 120 MGD (Increased to 200MGD)
 - Central 65 MGD (Decommissioned)
- It includes the Cities of Baton Rouge, Baker,
 Zachary and Central

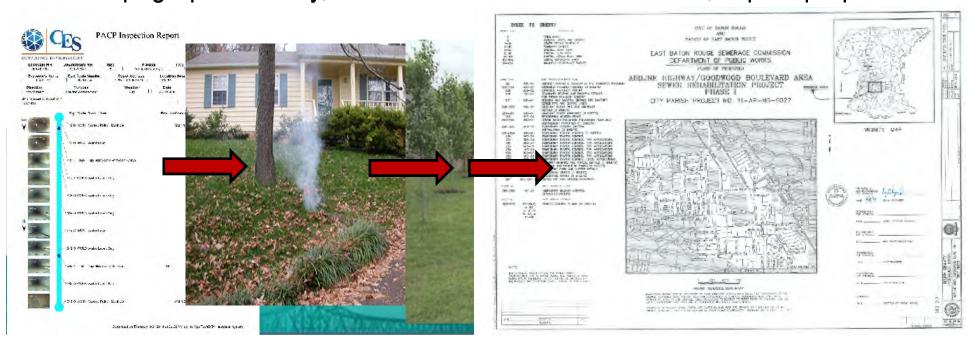
- Design (4 6 months)
 - Review of CCTV & manhole inspection data
 - Basin Observations field visits
 - Pipeline, lateral, & manhole condition characterization & preliminary rehabilitation recommendations
 - Topographic survey, final rehabilitation determination, & plan preparation

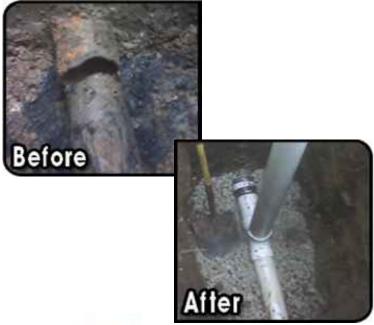
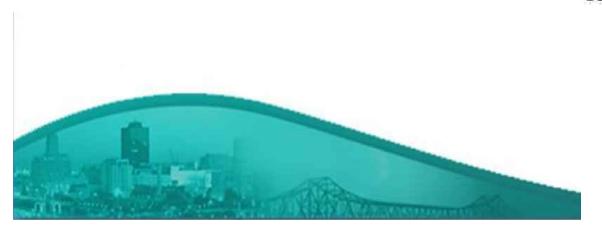
- Construction (12 18 months)
 - Up to 12 construction crews per project
 - Need 1 Project Engineer
 - 1 CM assigned to project
 - Utilize trenchless construction
 - Other utilities are major conflicts
 - Average construction price ~ \$8 M

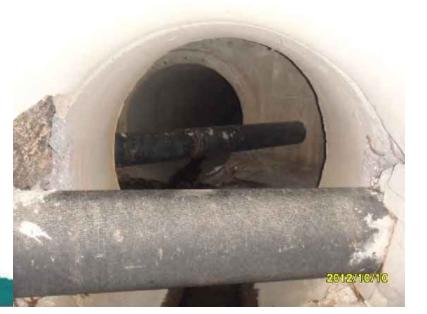
- 1. Utilize unit price contract & include flexibility in pay items to account for unknowns & variability in field
 - Separated pay items for excavation by depth range from pipe pay item
 - Allows for payment of potholing as directed
 - Allows for over-excavation to extend repair if needed
 - Include SD pipe diameter pay items incase encountered
 - Add point repair diameter pay items based on CIPP diameters & vice versa

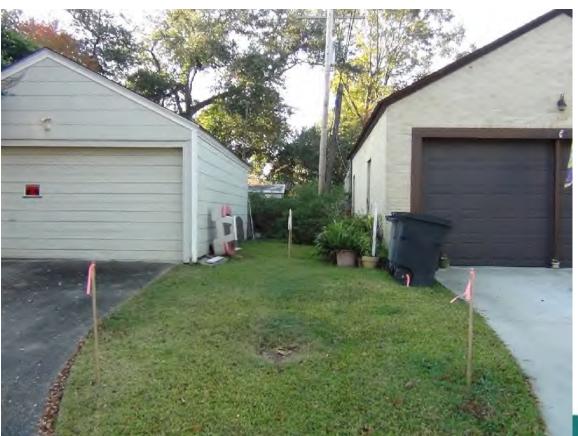
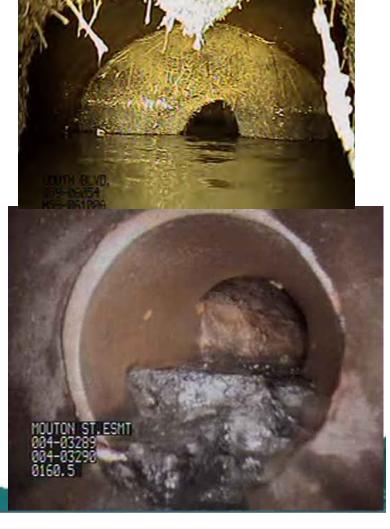
2. Stake servitude limits and repair limits to demonstrate to homeowners need for

moving structures and pipe defect screenshot.

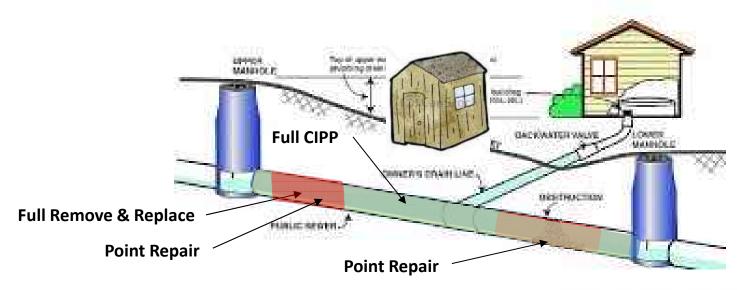
3. Creative rehab implementation to avoid conflicts and/or obstructions

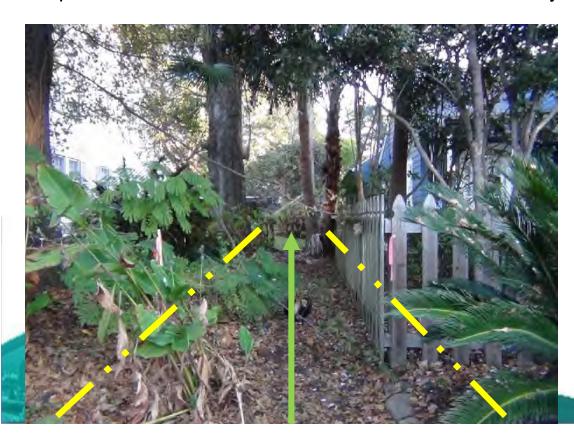
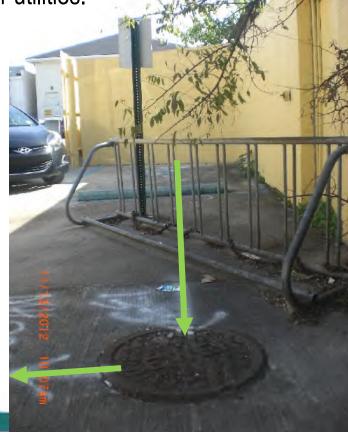
1. Rehab typically occurs on sewers within long established, developed areas and neighborhoods.

2. Many property owners have built fences and infrastructure across public servitudes without

permits. In addition, these servitudes are shared by other utilities.

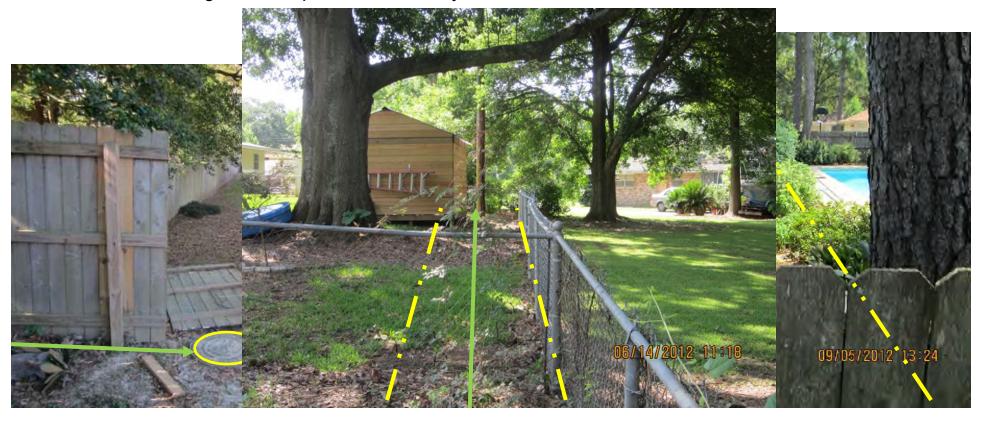
- 5. This presents potential conflicts with fences, trees, sheds, pools, decks, landscaping, watering systems, etc.
- 6. These are costly to remove and restore, difficult to identify/quantify prior to construction, and causes logistic and production delays for contractors.

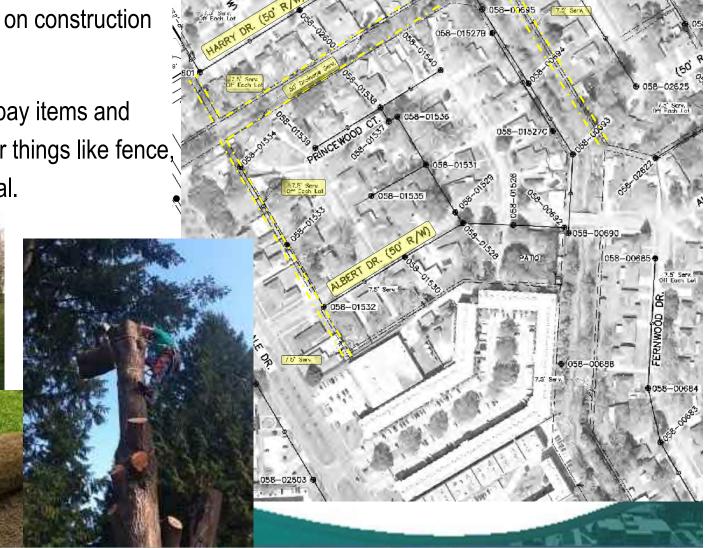
Include aerials and identify servitude locations and widths on construction plans.

2. Include appropriate pay items and adequate quantity for things like fence, sod, and tree removal.

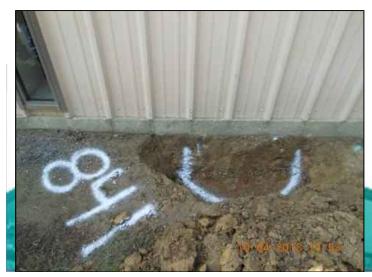
- 1. Typically sewers are first utility installed & at greater depths.
- 2. Private utilities are installed subsequently above sewers & locations are not typically recorded.
- 3. Private utilities have little motivation, resources, or budget to locate, relocate, or even coordinate their existing utilities or proposed utilities with others.
- 4. Utility companies will not locate utilities in field for engineering or survey crews, only construction crews (digging). This made planning during design problematic.

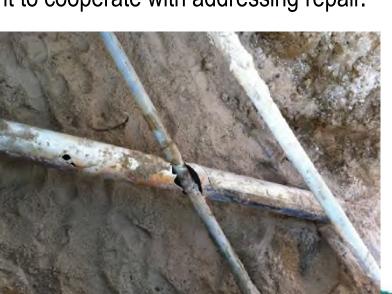
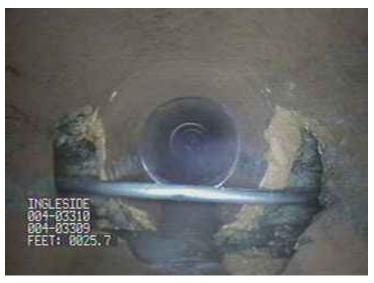
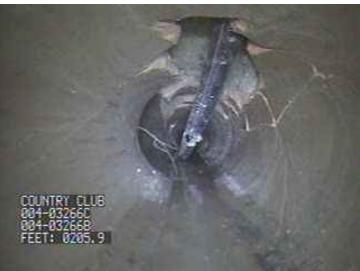
- 5. Typically utilities would not do anything in the field until construction started & contractor was mobilizing to site of conflict this presented unknown construction delay.
- 6. Difficult to identify utility type & owner when utility was identified as damaging sewer pipe. Even then they were reluctant to cooperate with addressing repair.

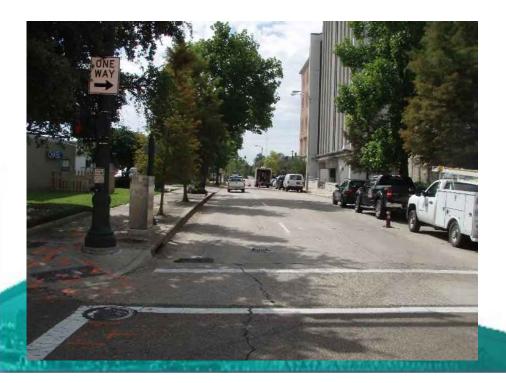
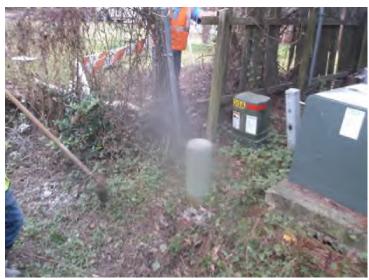
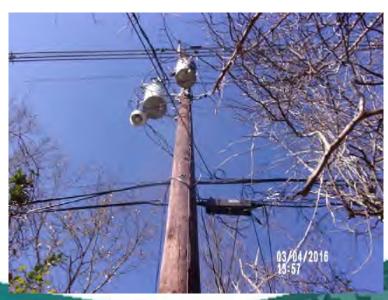
- Identify & locate possible utility conflicts visible above ground during design phase through field investigations & topo surveys.
- 2. Designated a Program Utility Manager to serve as one POC for utility issues.

- 3. Began collecting screen shots of visible utility conflicts from CCTV reports, providing physical address for conflict points, working with Utility Manager to identify utility owner, & coordinate these conflicts specifically prior to construction.
- 4. Provide clear language in contract documents related to required utility coordination by contractor, likelihood and difficulties of utility conflicts whether identified or not, & how these instances should be handled by all parties.

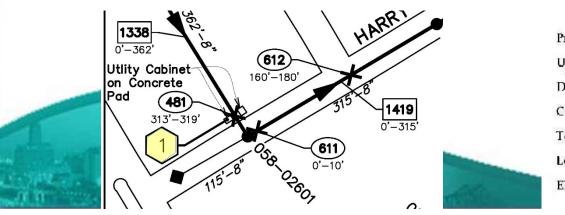
DESIGNATED REPAIR NUMBER 481 HAS A VISIBLE UTILITY THAT PASSES THROUGH THE SEWER PIPE AS DETERMINED BY CCTV INSPECTION REVIEW AT FOOTAGE 315.6 LF FROM USMH. THE CONTRACTOR SHALL COORDINATE WITH THE APPLICABLE UTILITY COMPANIES WITHIN THE FIRST 30 CALENDAR DAYS AFTER THE ISSUANCE OF THE NOTICE TO PROCEED AND ALLOW EACH TO VERIFY, EXCAVATE, AND RELOCATE ALL EXISTING UTILITY CONFLICTS WITHIN DESIGNATED REPAIR IN ACCORDANCE WITH THE GENERAL NOTES SHOWN ON SHEET 2.

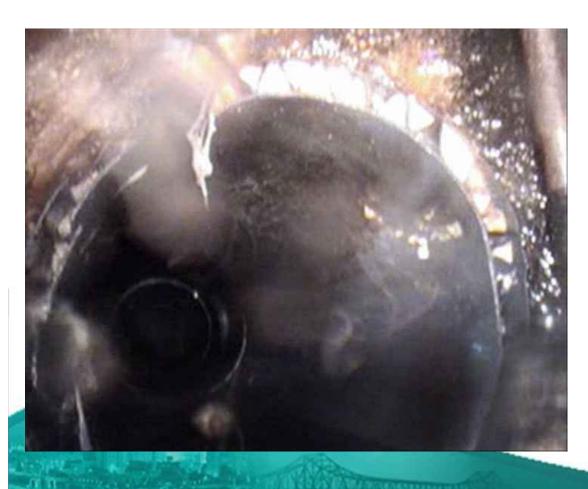
1. Truss Pipe repair recommendations are limited to either "leave as is" or a full remove and replace.

1. CIPP liners were installed in truss pipe as long as certain criteria was met.

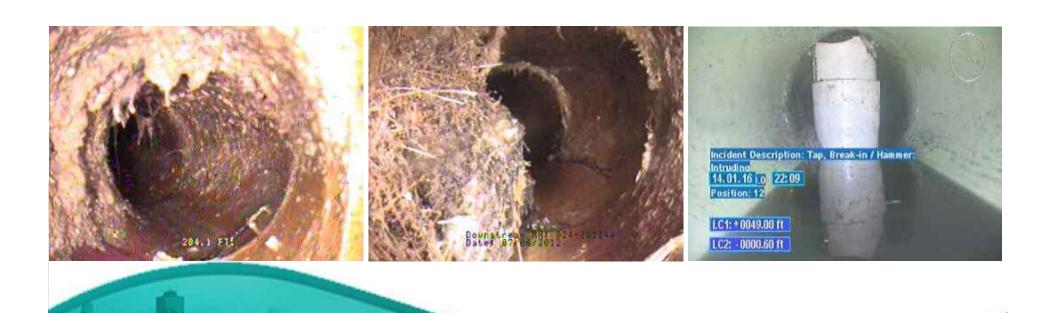
- 2. Roots in laterals require a replacement of the lateral (digging).
- 3. Portions of pipe with sags greater than 20% require replacement.
- 4. Intruding service laterals require a point repair (digging).

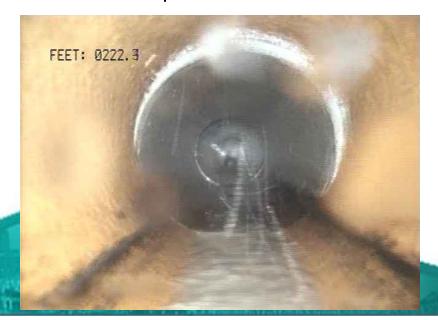
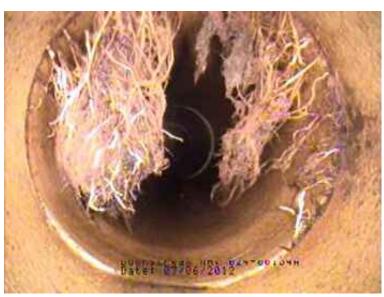
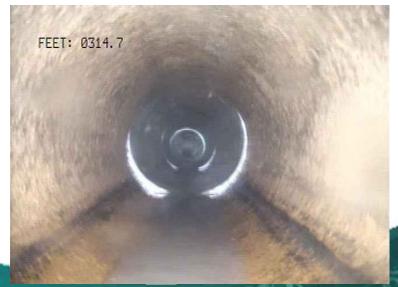
- 5. All joint offsets must be repaired (digging) before installing a CIPP liner.
- 6. Roots at joints require a point repair before installing a CIPP liner.
- 7. Any defects on existing lined pipe require a full remove and replacement.

- 5. Many joint offsets do not prevent the installation of a CIPP liner.
- 6. Most roots at joints can be trimmed & lined over. Only large tap roots require a point repair before installing a CIPP liner.
- 7. Defects on existing lined pipe are repaired with a point repair & partial CIPP liner.

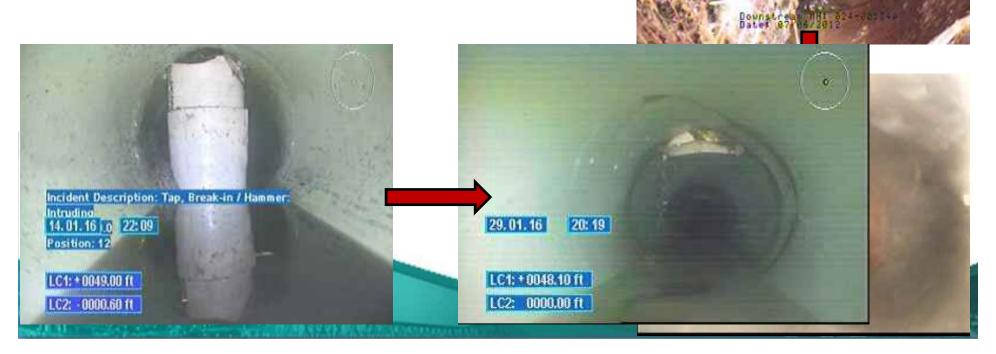
2. Roots inside laterals were able to be removed internally along with the installation of a top

hat.

3. Portions of pipe with sags greater than 40% require replacement.

4. Intruding service laterals are able to be trimmed internally.
