Underground Construction Technology International Conference & Exhibition

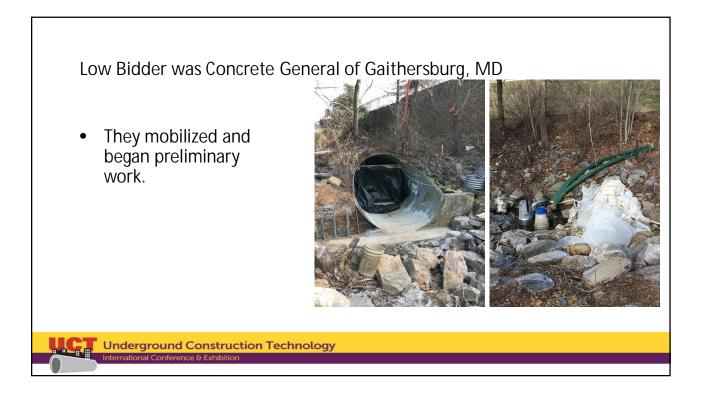
A 20' long section of the 96" host pipe shifted

- Workers were inside that section at the time
- Soil arch had sheared
- Safety of workers became a higher risk
- New 84" pipe no longer a clean fit

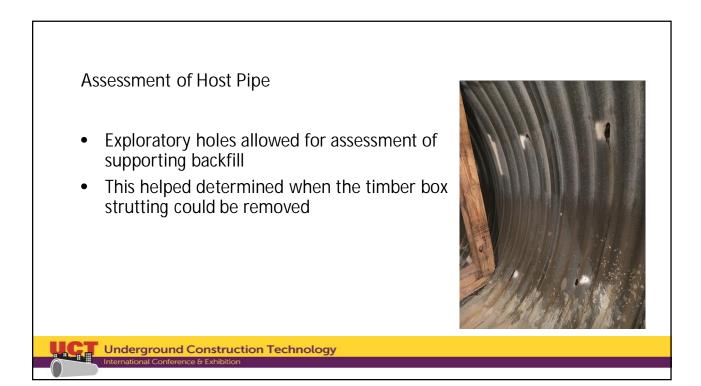
Assessment of Host Pipe If voids were found, a 'U' shaped cut allowed for the host wall to be opened up at the time of liner plate assembly and blocking Openings were located at top of voids Openings allowed grout to fill the voids during liner grouting
