PCCP Problems Potential Solutions in Sewer Applications

Brett Todd, Director of Sewerage, Jefferson Parish
Rob Delaune, P.E., Digital Engineering, Jefferson Parish
Sewerage Capital Program

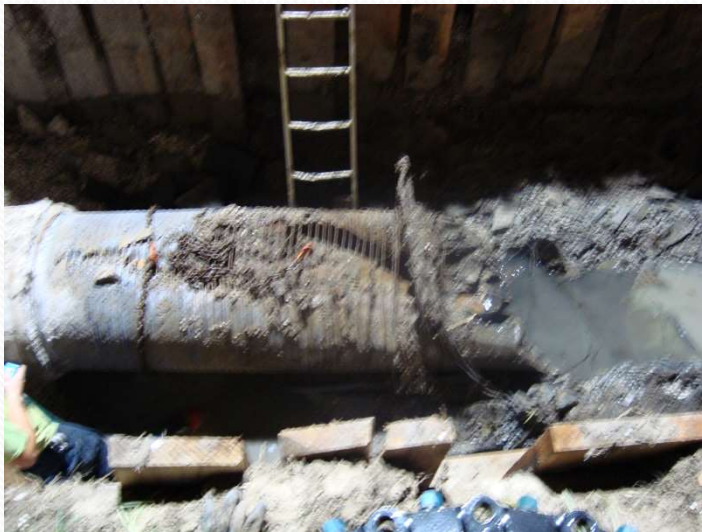
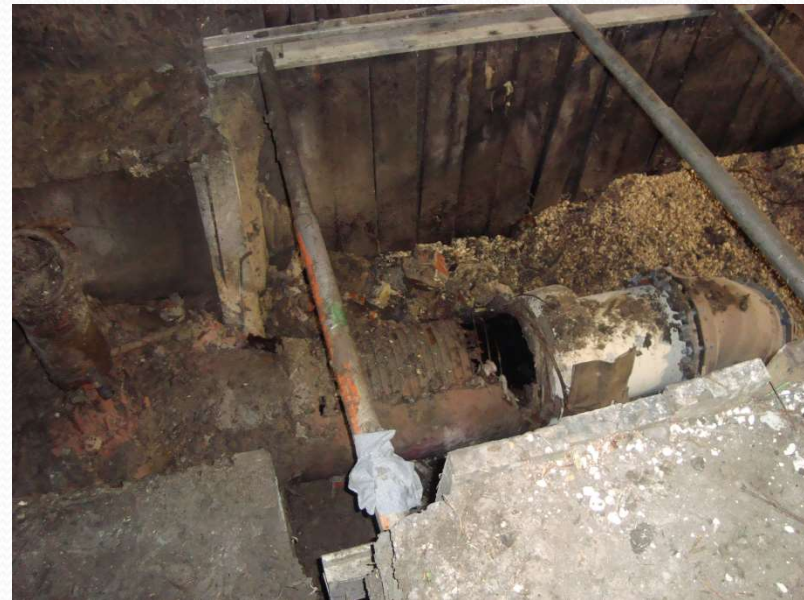
Causes and Modes of Failure

- Failure - loss of use of a pipe section or reduction in confidence in that pipe section to remain in service.
- Three categories or models of PCCP failure:
 - Catastrophic ruptures and leaks
 - Significant deterioration or structural weakness discerned by inspection
 - Loss of service

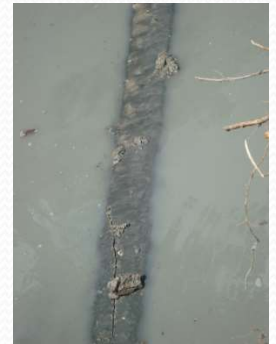
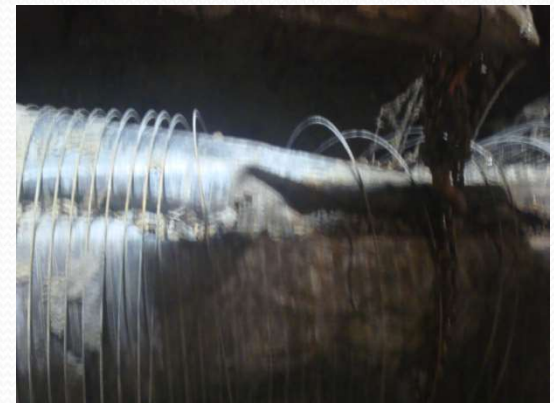
Some Common Reasons for Failure

- Rupture or break – broken wires found after the failure – many causes
- Leaking at joints – many causes including out-of-roundness of joint and construction damage
- Cracks in core – many causes including alkali-silica reactivity of the aggregate
- H₂S (force mains) – unlined
- Cracks in cylinder welds – poor cylinder fit-up
- High chlorides in soil – corrosive/aggressive soil Inadequate joint restraint – pipe moved exposing joint to environment
- Construction damage – coatings damaged and not repaired
- Inadequate prestress – wires broken and spliced without retensioning
- Cantilever (bending or broken back) – many causes including poor bedding
- Settlement – general and at structures
- Poor bedding – not corresponding to design assumption
- Surge – unanticipated and above design value
- Excess external load – greater than design assumption

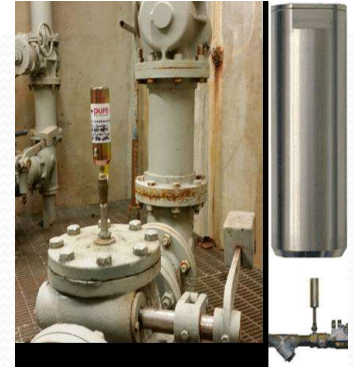
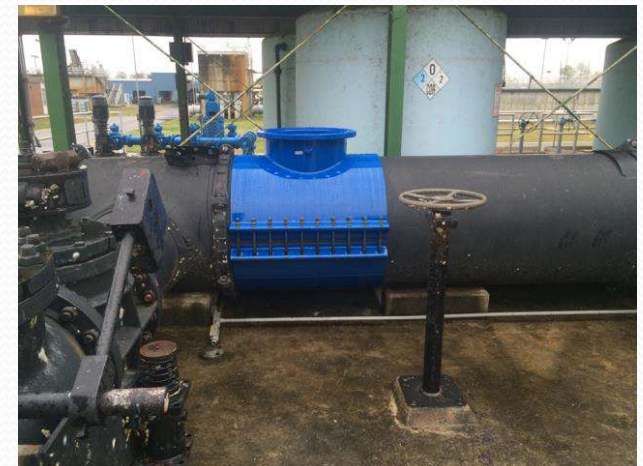
Inspection Technologies

- Visual Exterior Inspections
- Utilize the wires within the pipe as a radio-frequency measurable coil antenna
- Acoustic monitoring of in-service EC-PCCP pipelines to identify actively breaking wires
- Inductive scan imaging
- Above ground leak detection
- External electromagnetic assessment
- Transient Pressure Monitoring
- Closed Circuit Television Inspection
 - Requires access point
 - Requires taking pipeline out of service

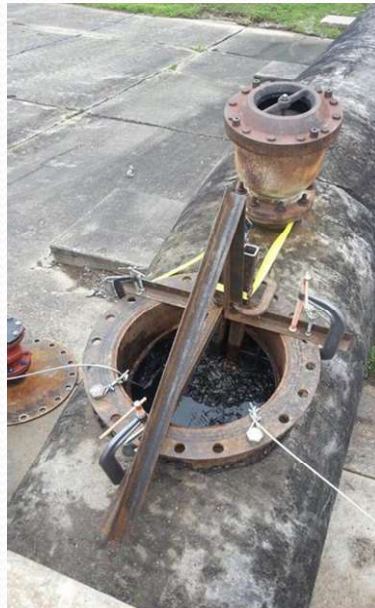
Inspection Technologies (Cont.)

- Acoustic condition assessment
 - Requires access point and retrieval location
 - Detects leaks and air pockets of trapped gas
 - Leaks do not typically present themselves within the acoustic data at pressures less than 10 psi

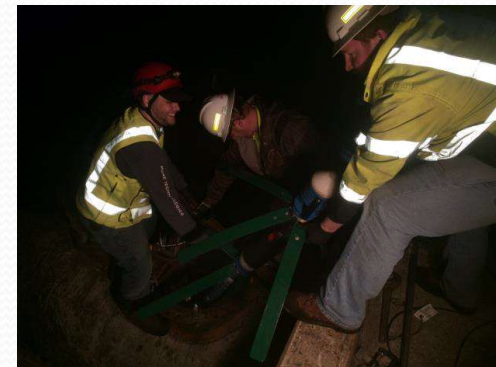
Example FEA Performance Curve

- Internal free-swimming electro-magnetic condition assessment
 - Requires access point and retrieval location
 - Provides the location and quantity of broken pre-stressed wire wraps (the primary structural component of PCCP)
 - Finite Element Analysis model under known external loading conditions while increasing the internal pressure and varying the number broken wire wraps
 - Develop a FEA performance curve, which defines specific performance limits for a distressed PCCP
 - Yield Limit shown on the performance curve as the threshold for rehabilitation recommendations

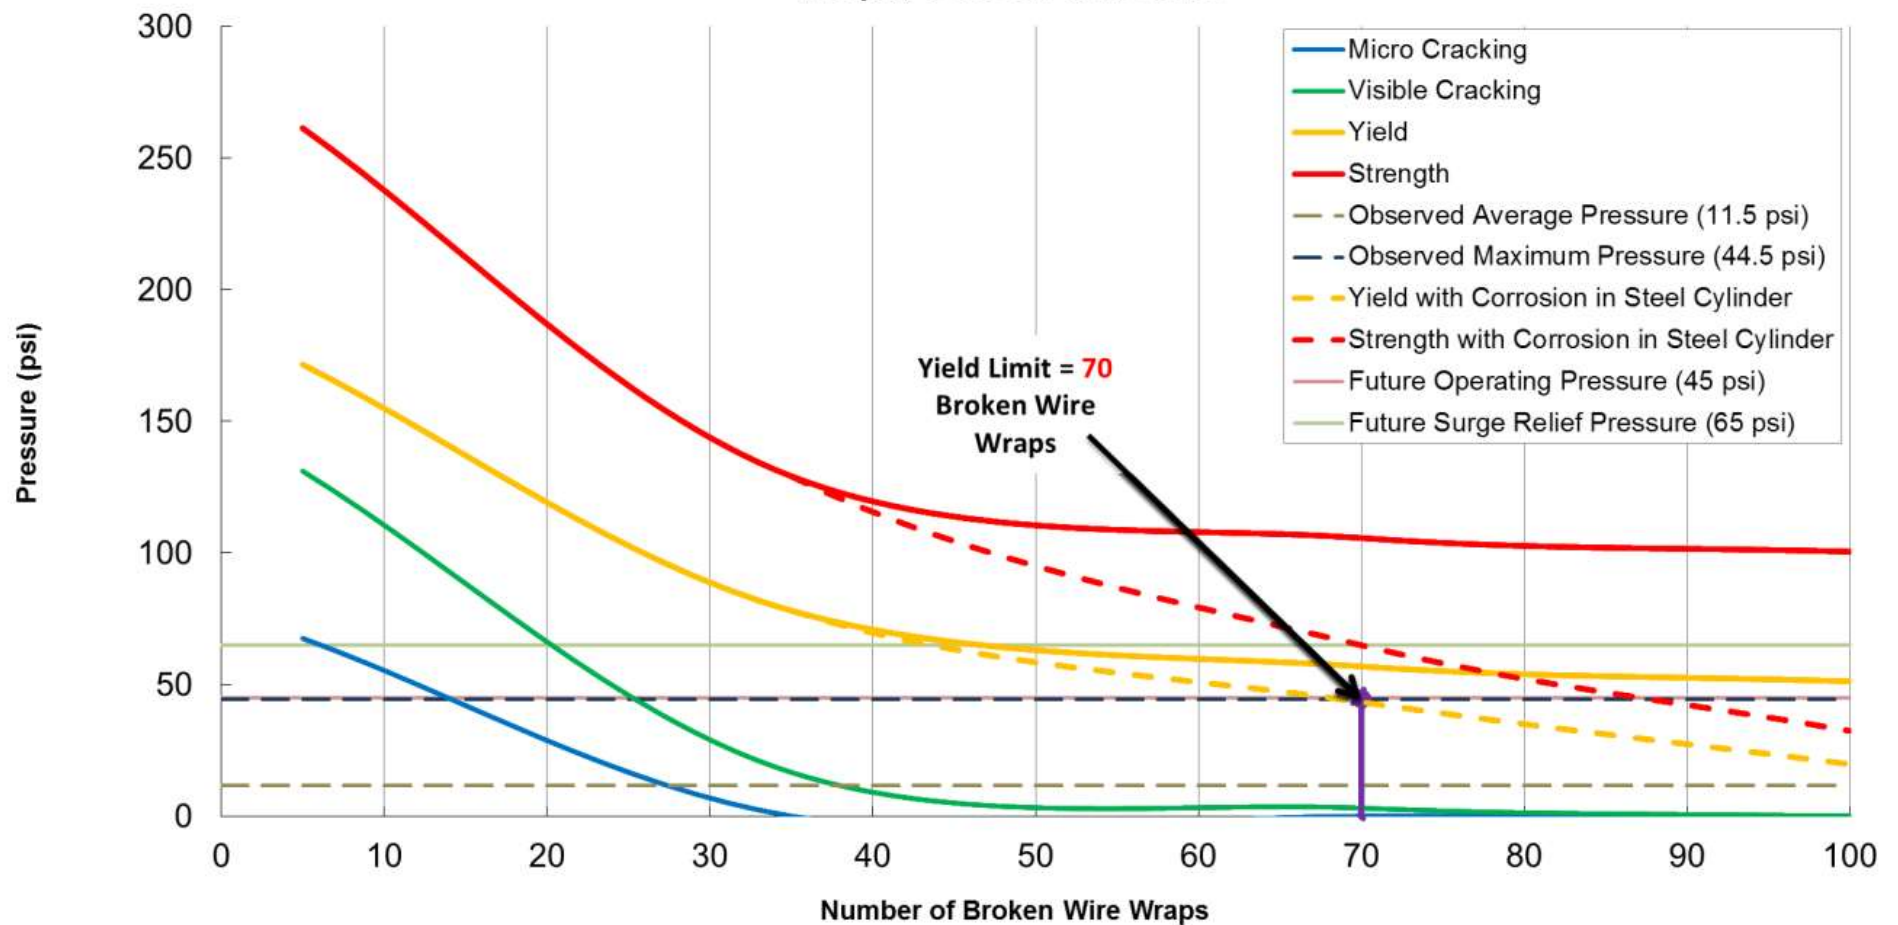
48-inch LCP City of Kenner
44.5 psi; 6 feet of Earth Cover
