Standard Cement Materials, Inc.

**GEOPOLYMER CEMENTS
ELIMINATE RISKY TRENCHING ALTERNATIVES
FOR MANHOLES & SEWERS...**

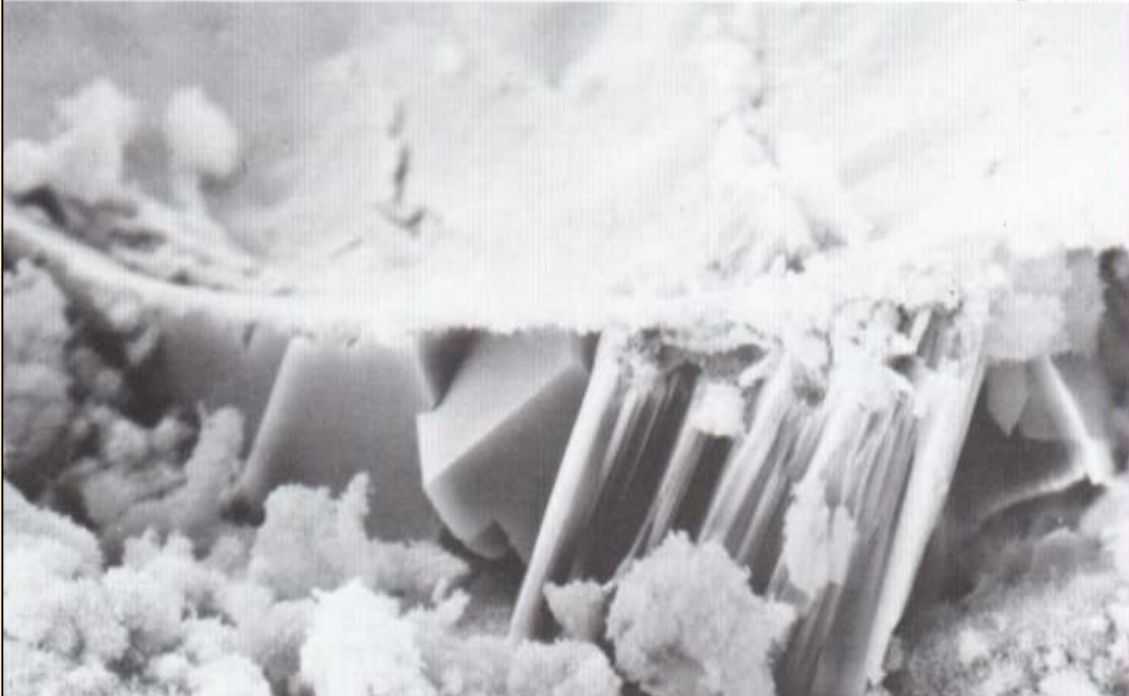
Figure 2.

Concrete Without Microsilica

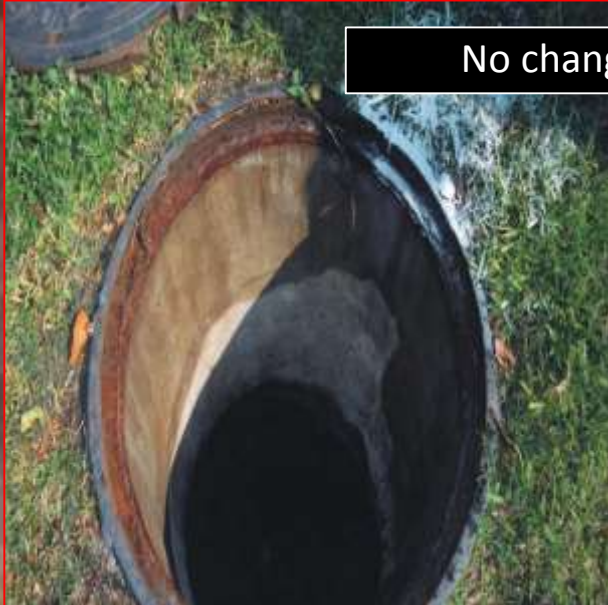
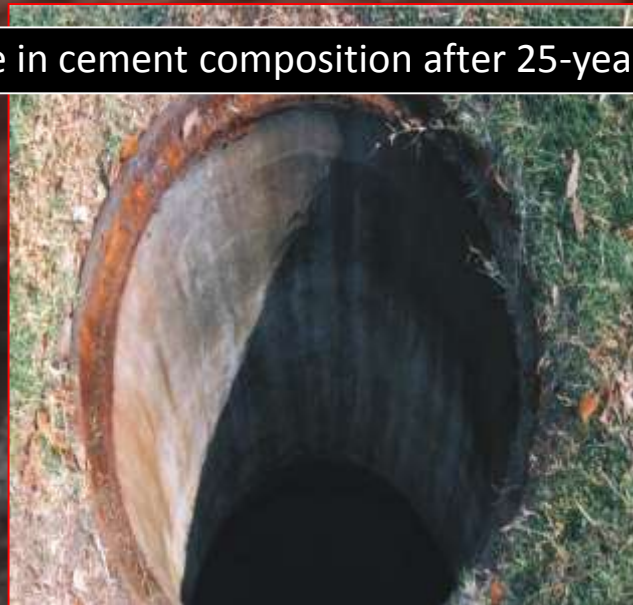
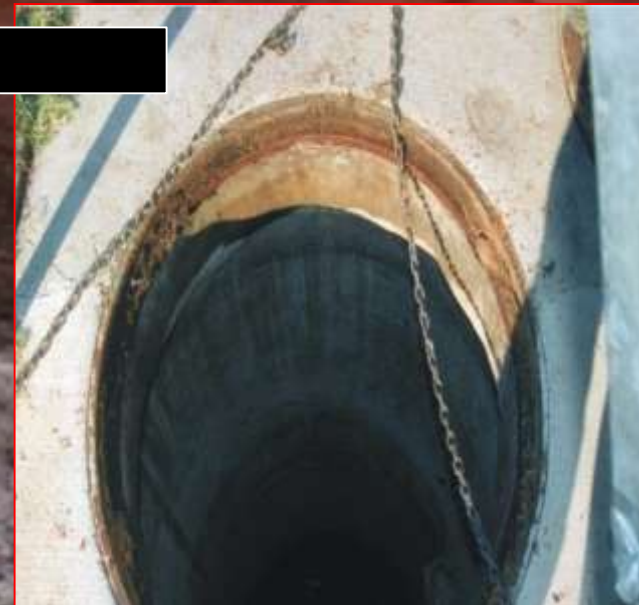
HOW LONG DOES MICROSILICA CEMENT LAST?

25 - Years

15 - Years

1 - Year

No change in cement composition after 25-years

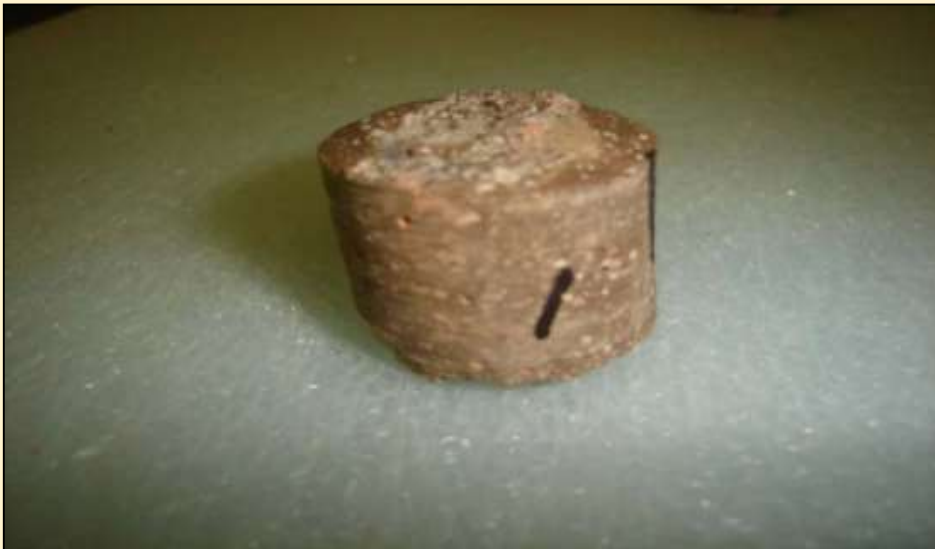
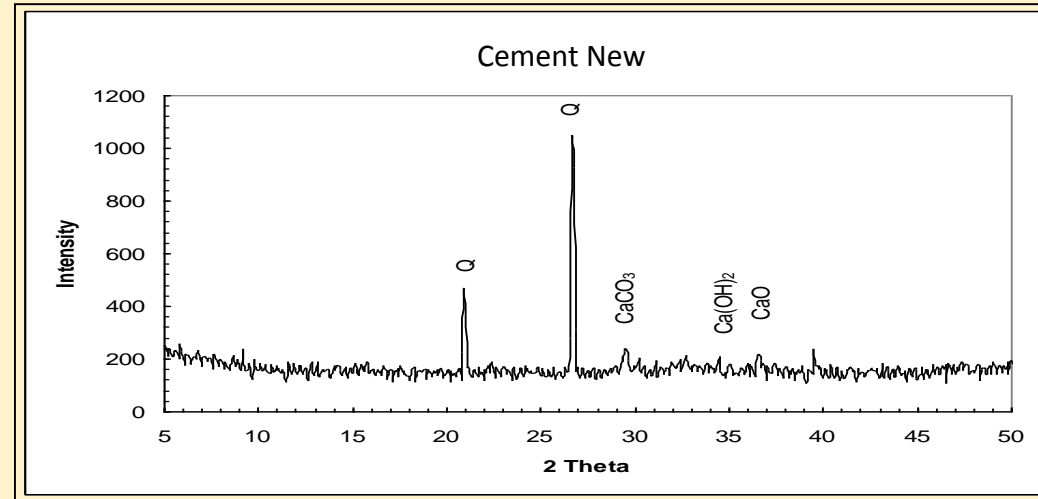
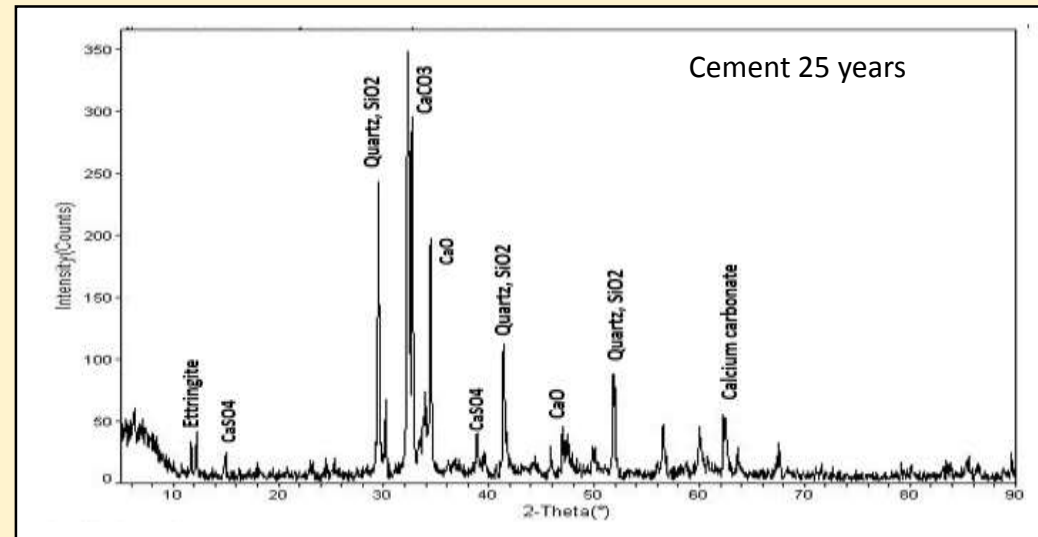
Long Term Durability...

- No change after 25-years:
- No change in cement composition- stable.
- TGA/XRD Analysis – validate the cements high usage, specimens in good condition after active service.

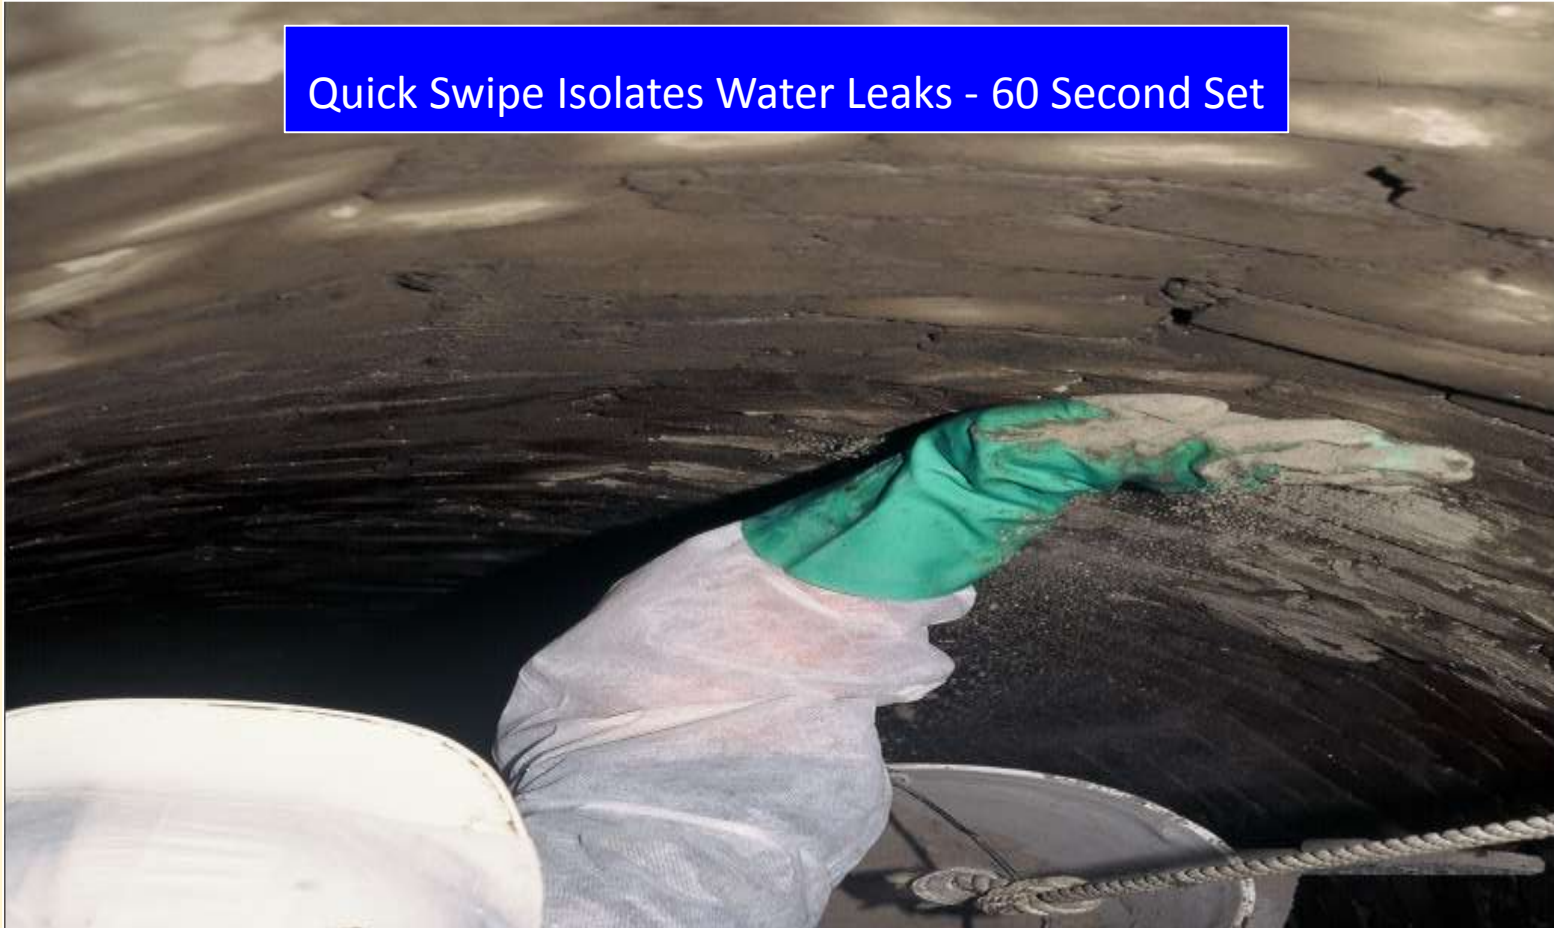
STOPPING I&I...

Quick Swipe Isolates Water Leaks - 60 Second Set

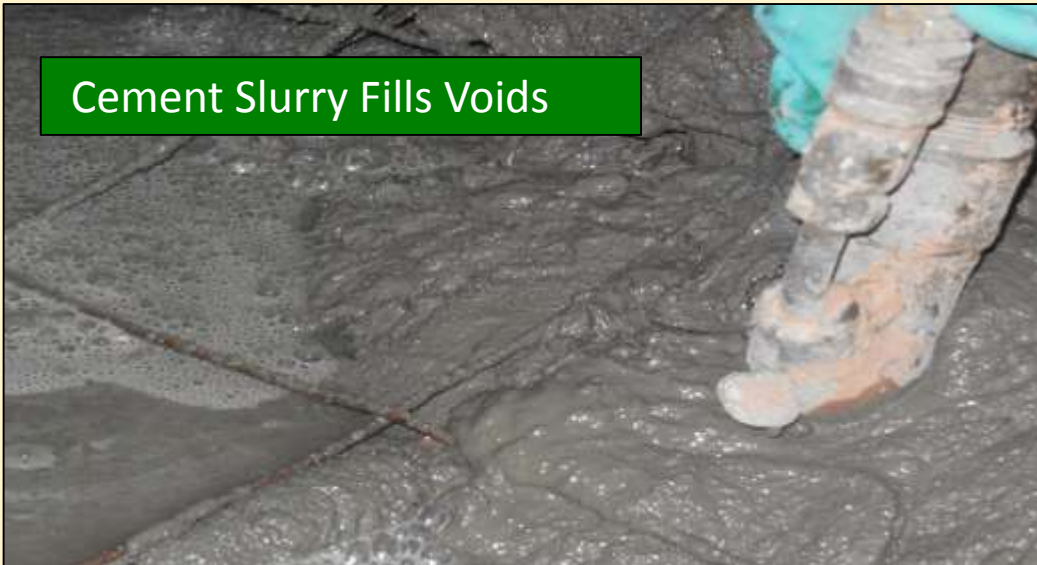
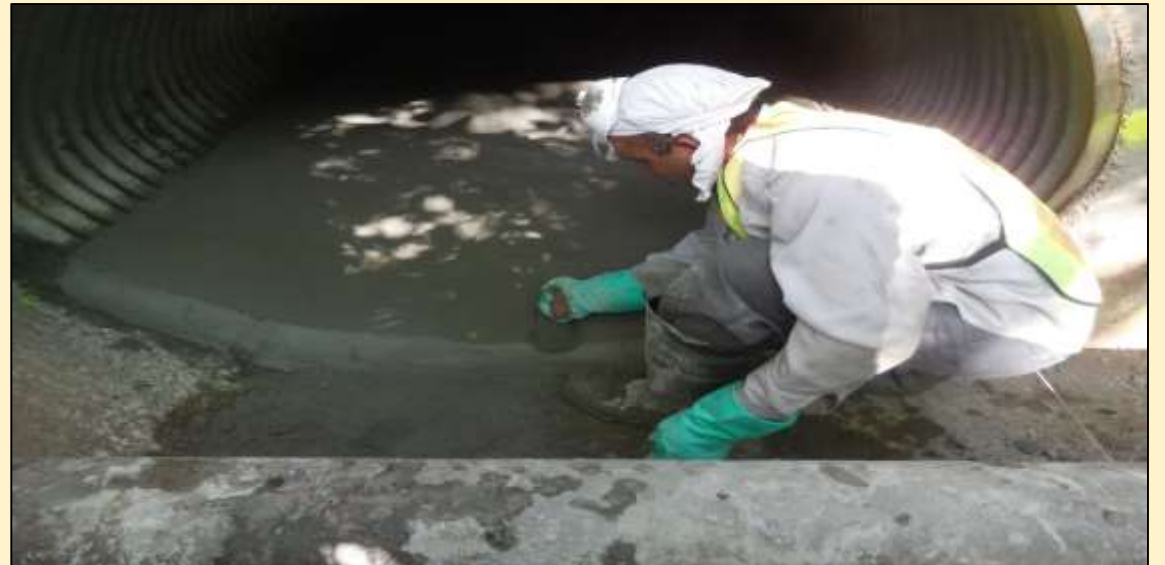
Cement Slurry Fills Voids

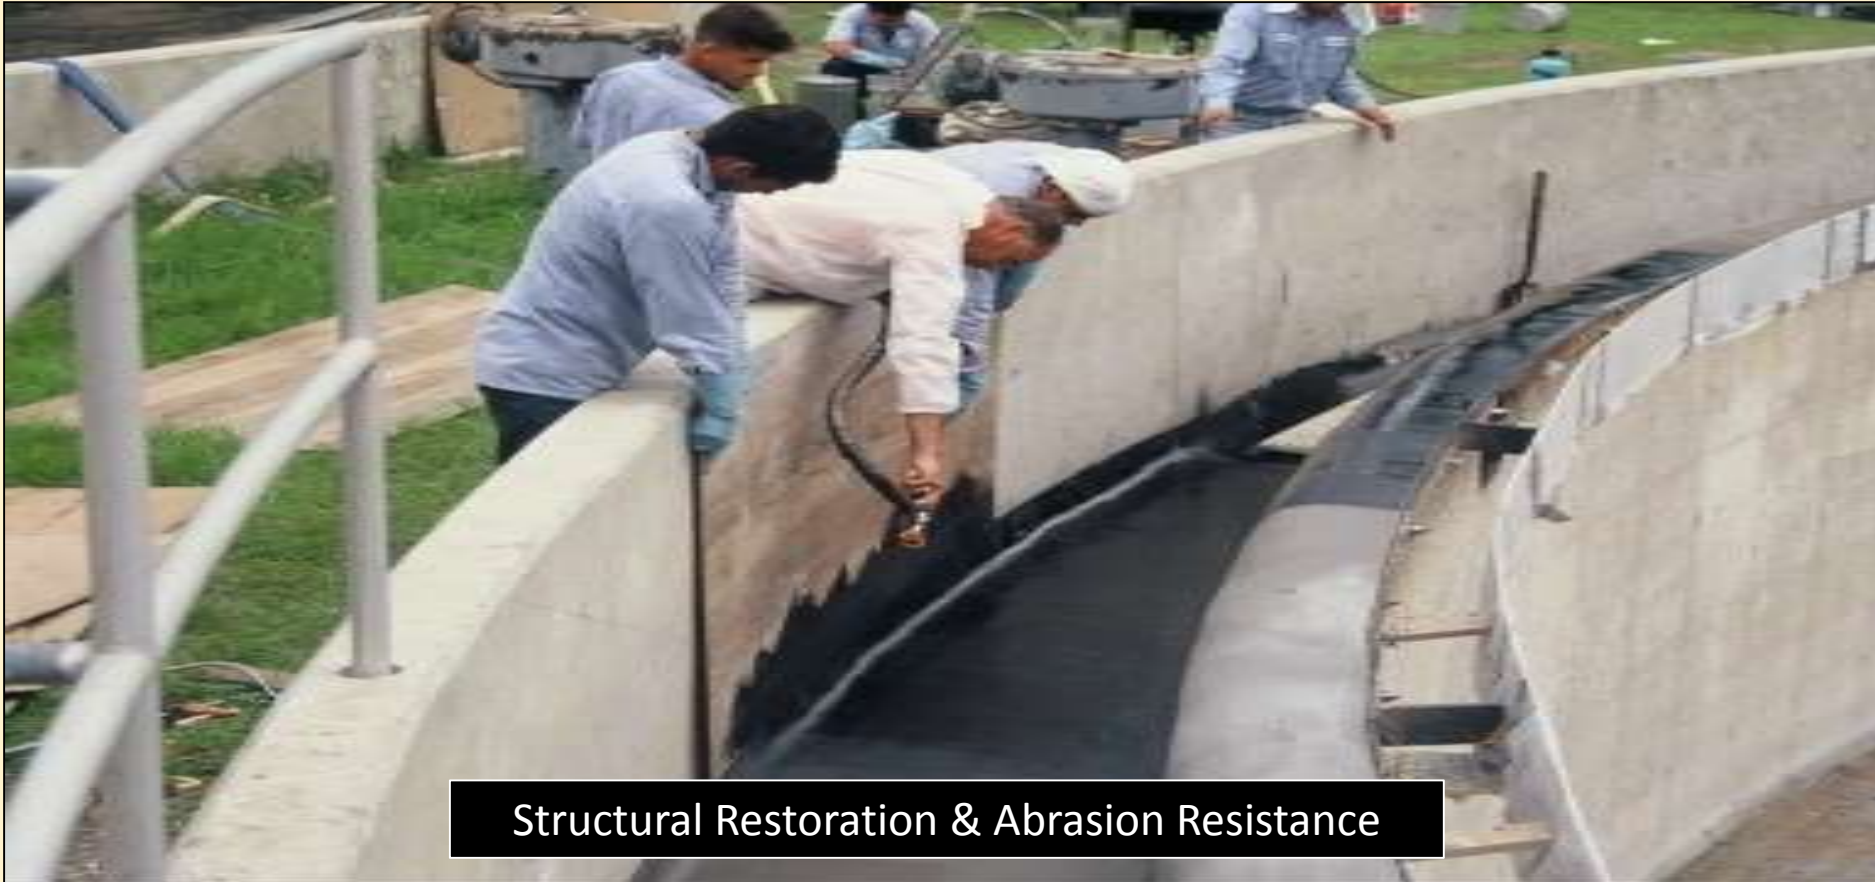
CONCRETE CLARIFIER REHAB WITH EC...

Structural Restoration & Abrasion Resistance
