# *Clean Water* Challenge on Sanitary Sewer Project

David Ellett, BRH-Garver

## LIFT STATION RENEWAL/REPLACEMENT PROJECT

CONSOLIDATION OF NORTH POST OAK LANE (FN 546),  
STALBE WOOD (FN 127), AND BUCKINGHAM (FN 028) LIFT  
STATIONS

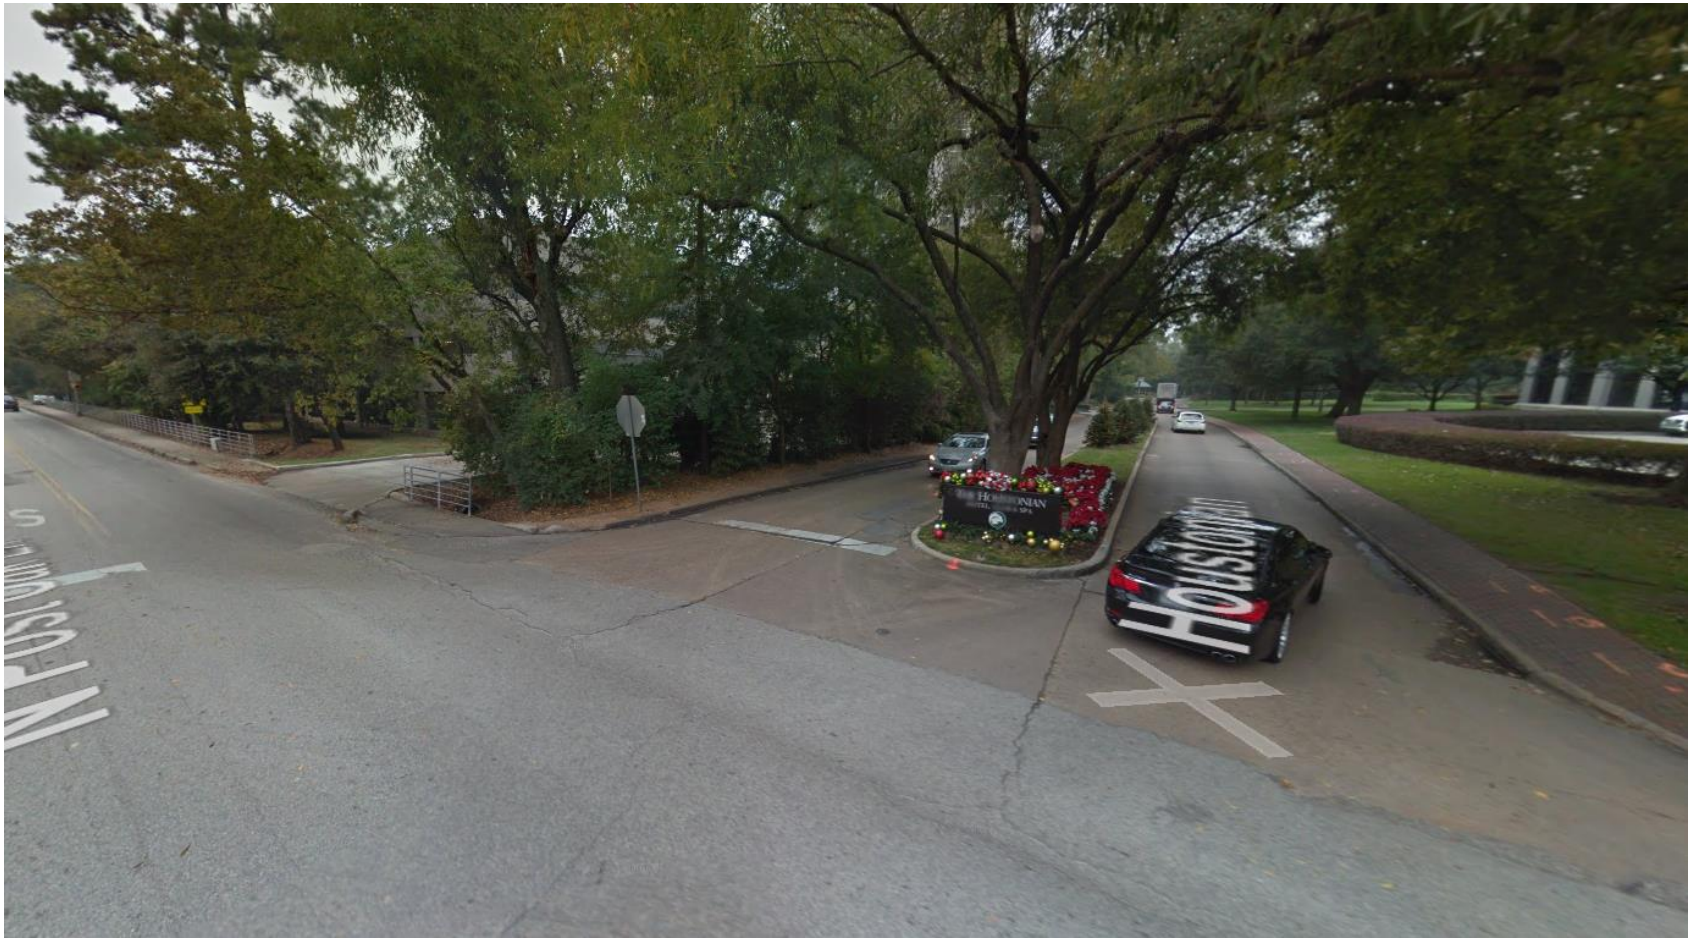
North Post Oak; 35ft deep

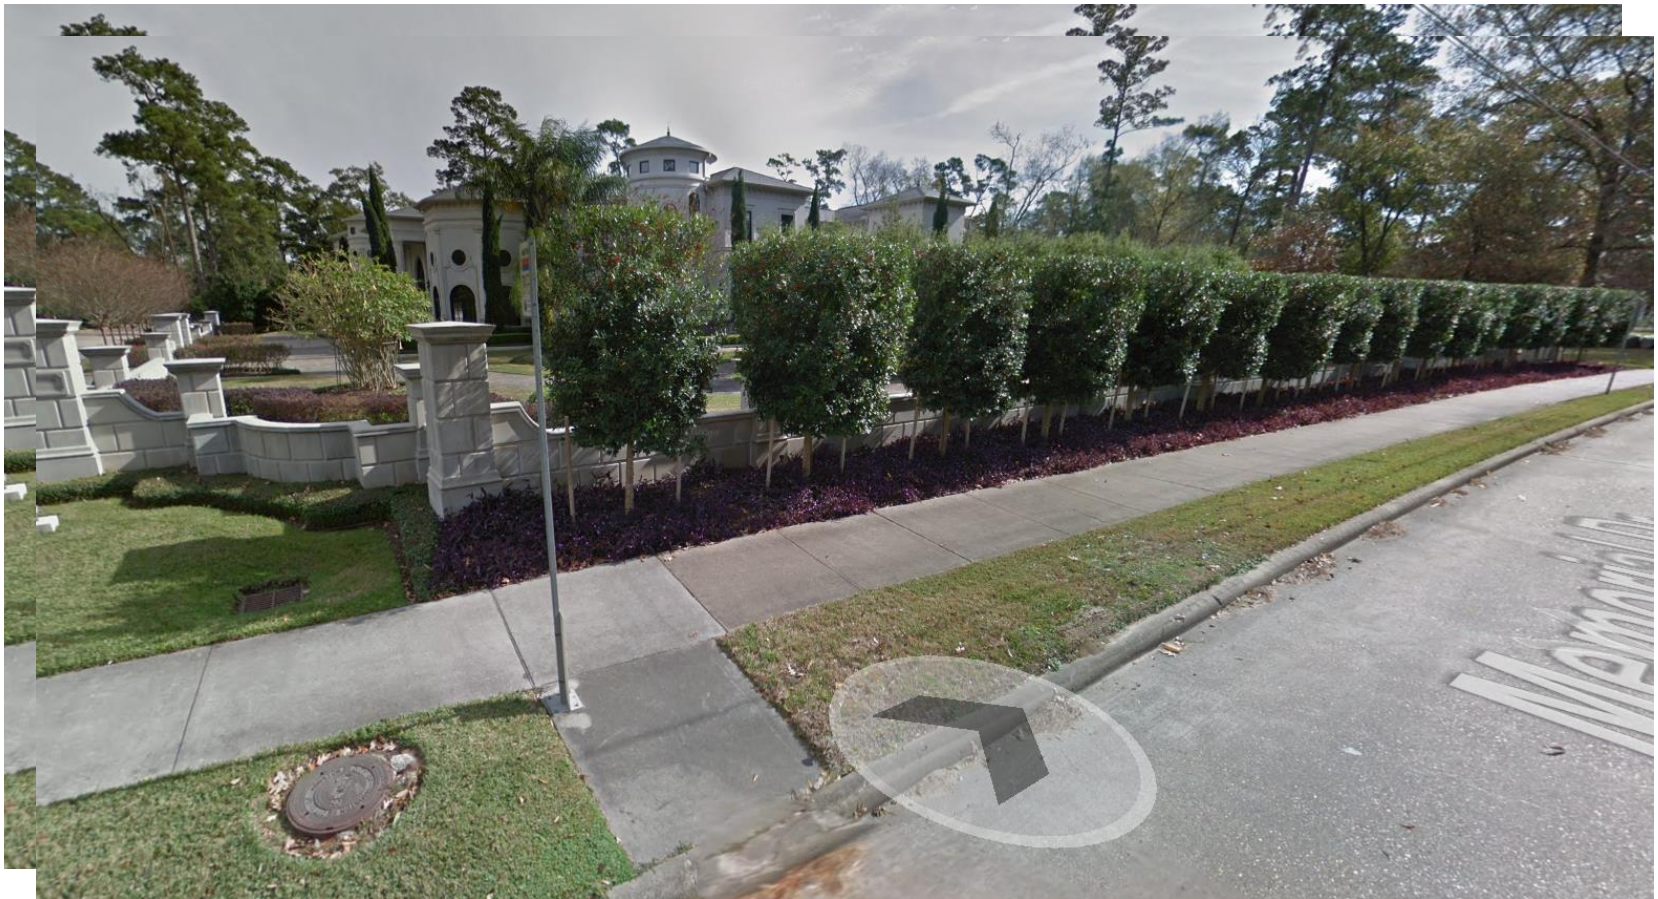
Memorial Drive; 28ft deep

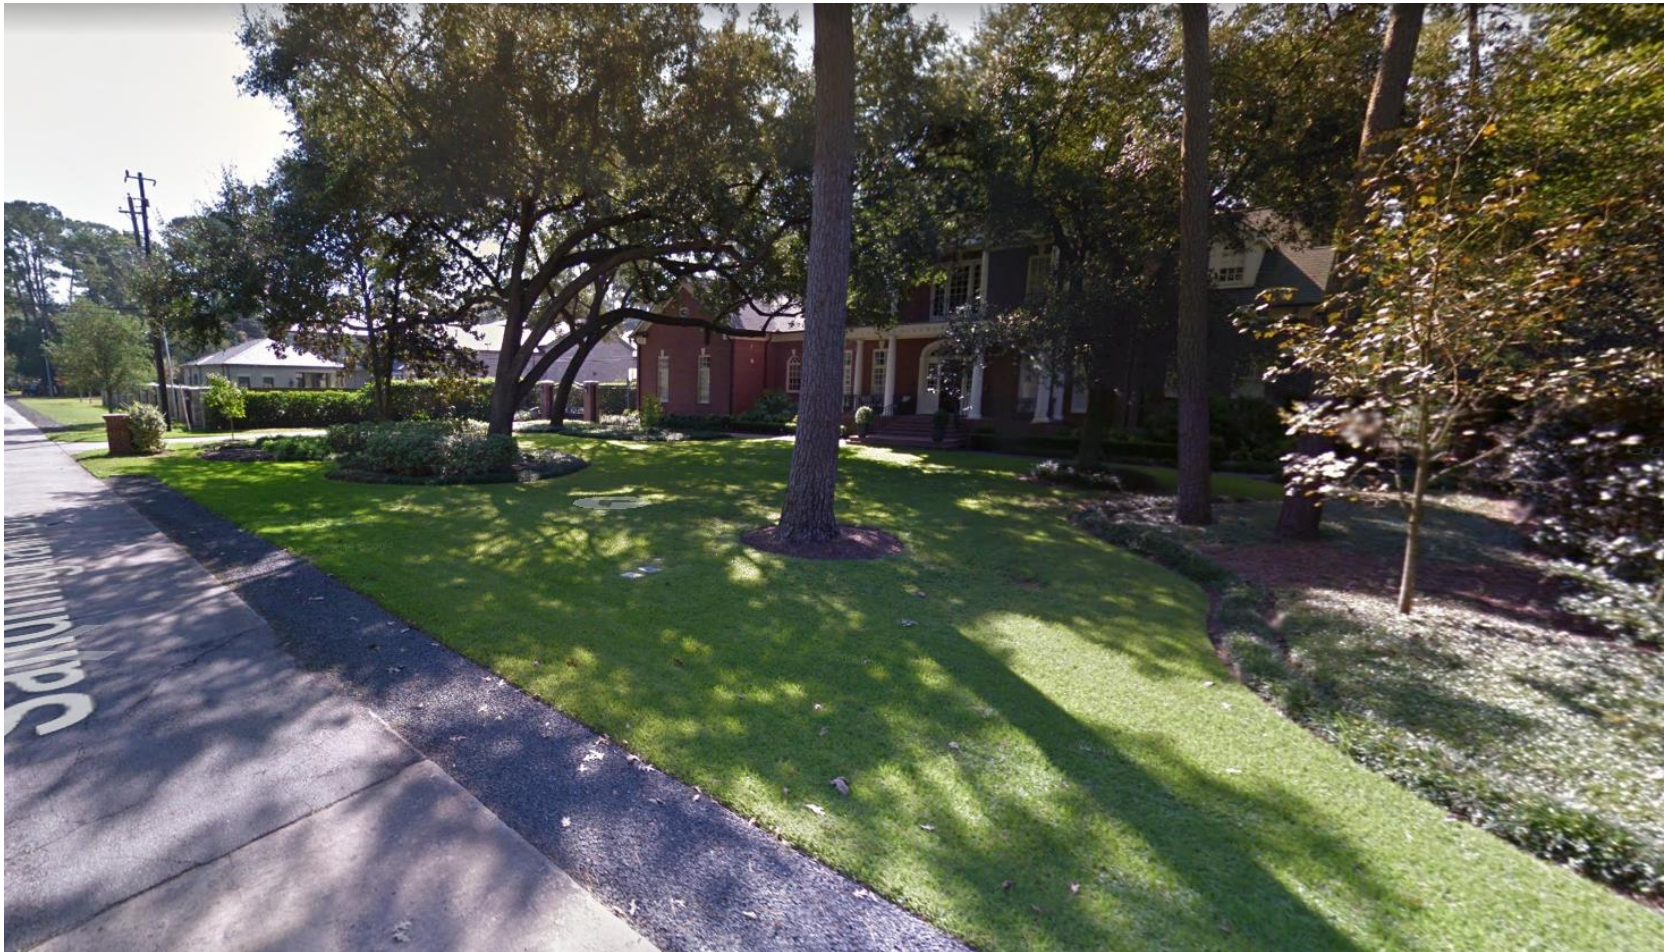
Sandringham Drive; 26ft deep
