Underground Construction Technology

How to Economically and Accurately Assess the Condition of Small-Diameter Water Mains

Dan Ellison January 29, 2019

Project 4471: Leveraging NDE

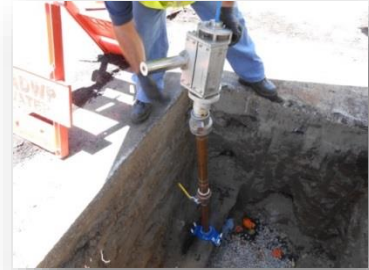
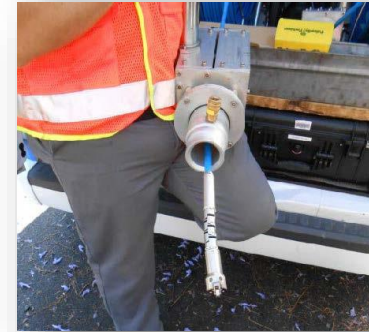
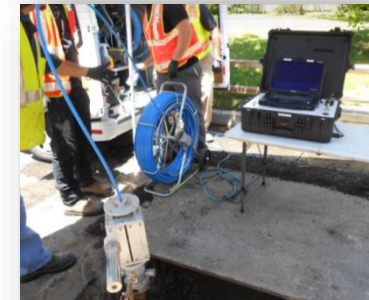
Push-in probe (Investigator)

- » Entry through 2-inch tap
- » **Video / audio (Wachs Water Service / Genivar)**
- » Advantage: little disruption of operation
- » Limitations:
 - Can only be pushed a hundred feet, more or less
 - Time consuming; degree of inspection is limited
 - Provided no condition information

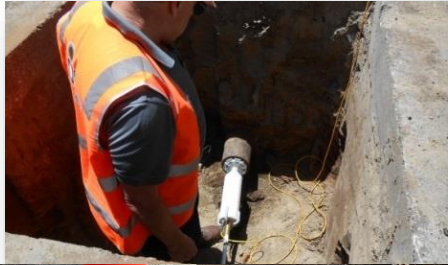
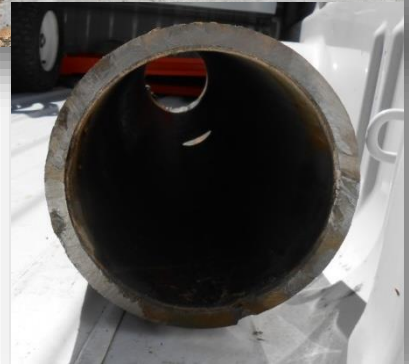
Broadband electromagnetic (Rock Solid)

- » External scanning using vacuum-excavated keyhole
- » Internal scanning of drained pipe
- » Limitations
 - Limited coverage
 - Time consuming
 - Dry, straight pipe needed for in-pipe inspection

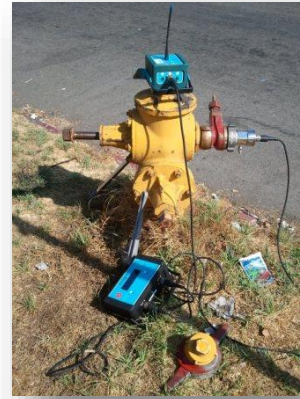
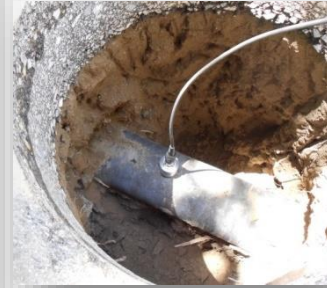
Acoustics velocity testing (Echologics)

- » **Non-Invasive.** Pipe access using existing appurtenances or vacuum-excavated keyholes.
- » Provides **average thickness** between transducers
- » Limitations:
 - **Does not detect isolated pitting**
 - » Information can be lost in data noise

$$v = v_o \times \sqrt{\frac{1}{\left[1 + \left(\frac{D_i}{t_r}\right) \times \left(\frac{K_l}{E}\right)\right]}}$$

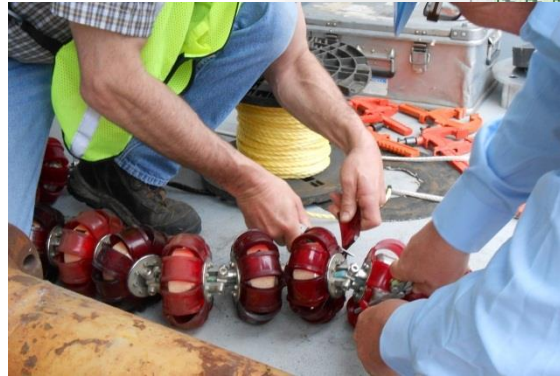
Remote-field testing (PICA SeeSnake)

- » Generates / detects electromagnetic field
- » Pros
 - High resolution detection of defects
 - Long runs possible
 - Proven over two decades
- » Cons
 - Requires outage for pipe access

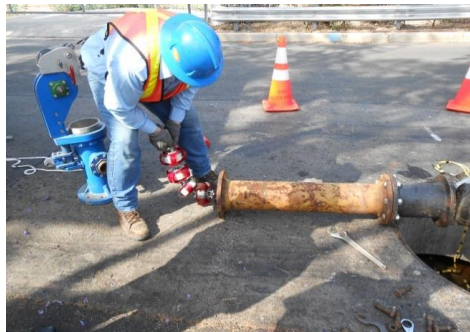
Inserting the tool into the launching port. Normally this tool is launched from a fire hydrant's vertical drop leg.

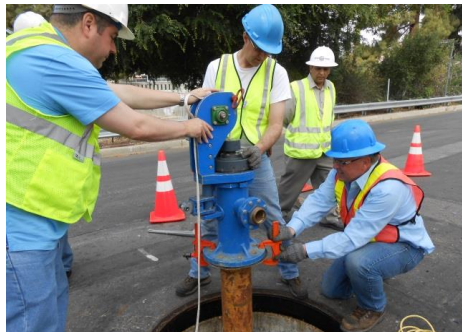
This custom hydrant guides the rope past a seal. By using clamps to hold the hydrant in place, flange patterns don't have to match.

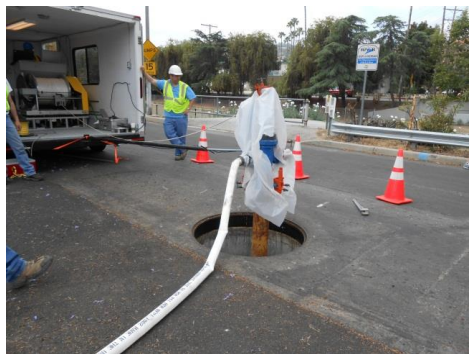
Ready to launch. The fire hose provided water to push the tool to the far end of the main. A plastic sheet contains water that leaks from the assembly. The hydrant is braced to the trailer to counteract the winching force.

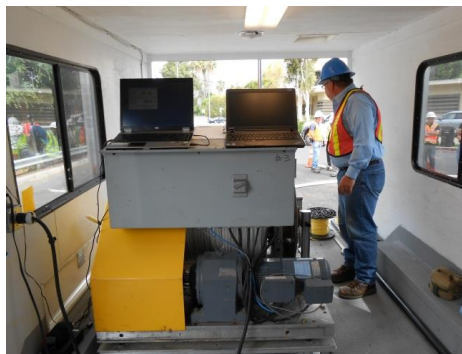
The location of the NDE tool is tracked by measuring the amount and speed of tether rope used deployment. Underneath the table is the motor used to winch back the tool. All tools and equipment were powered from a small electrical generator.

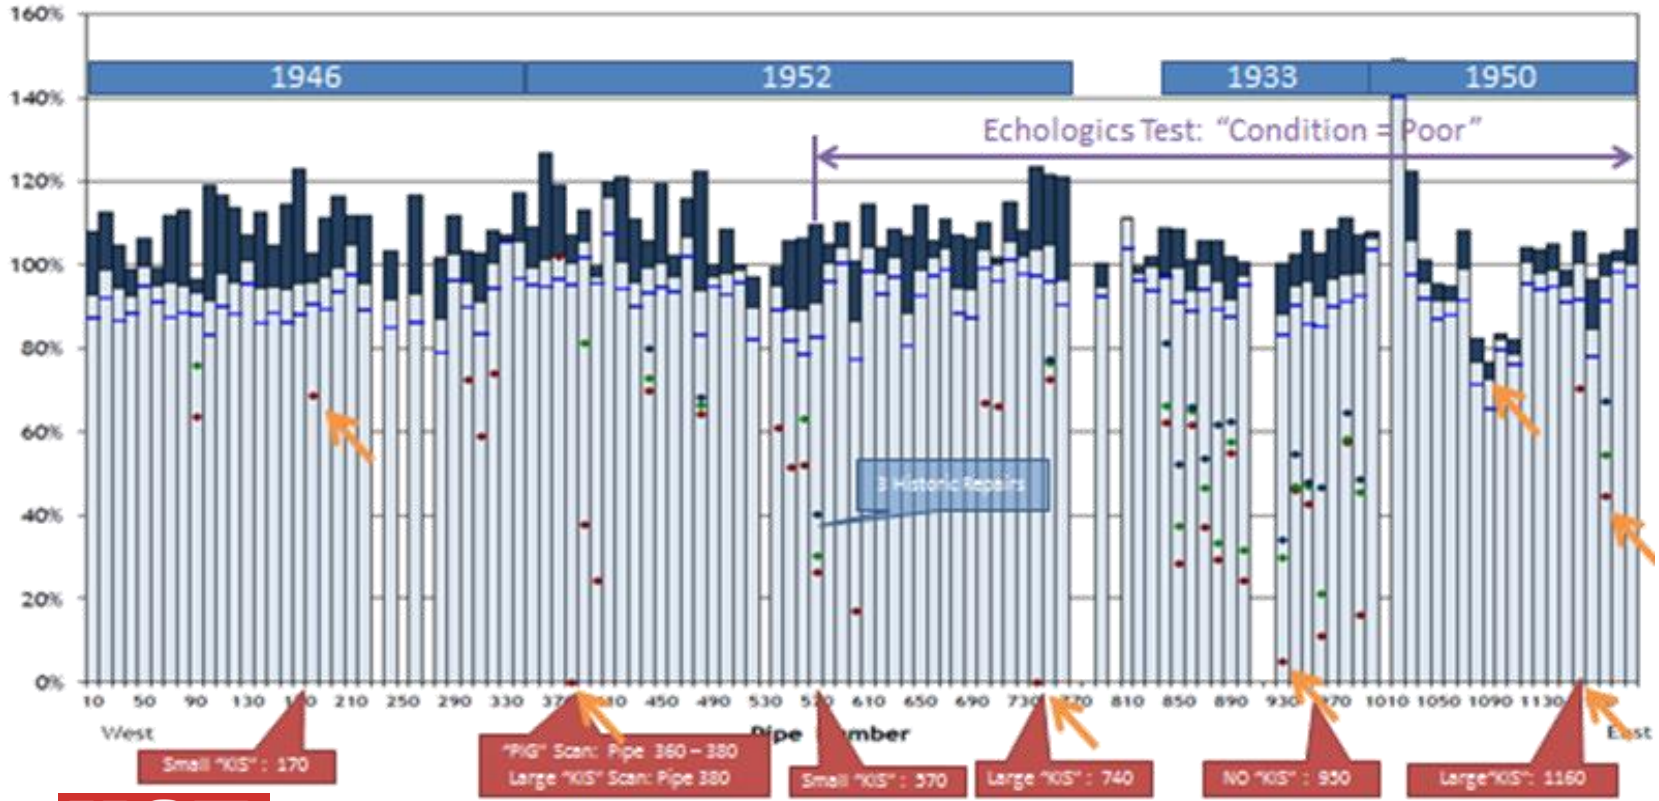
Exhumation plan with a focus on 1933 pipe

↗ = Proposed Extraction

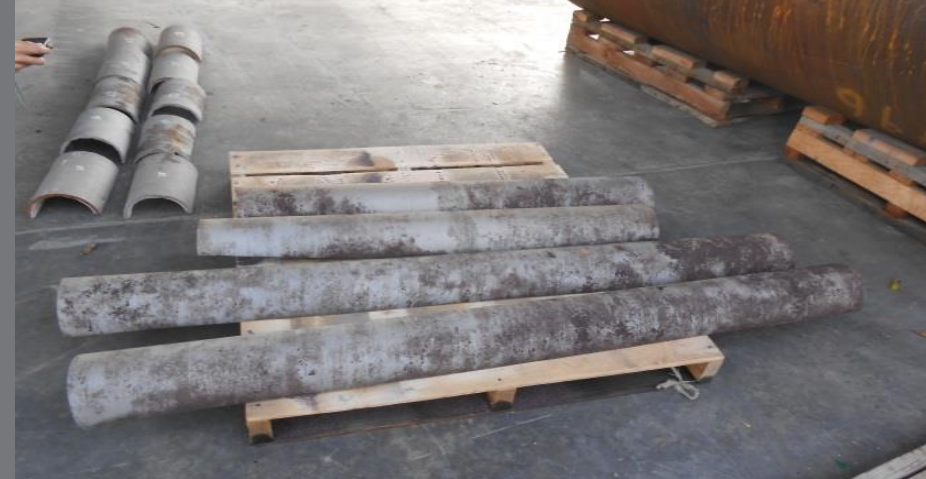
Seven pipe segments were split longitudinally into 14 pieces, then sandblasted.

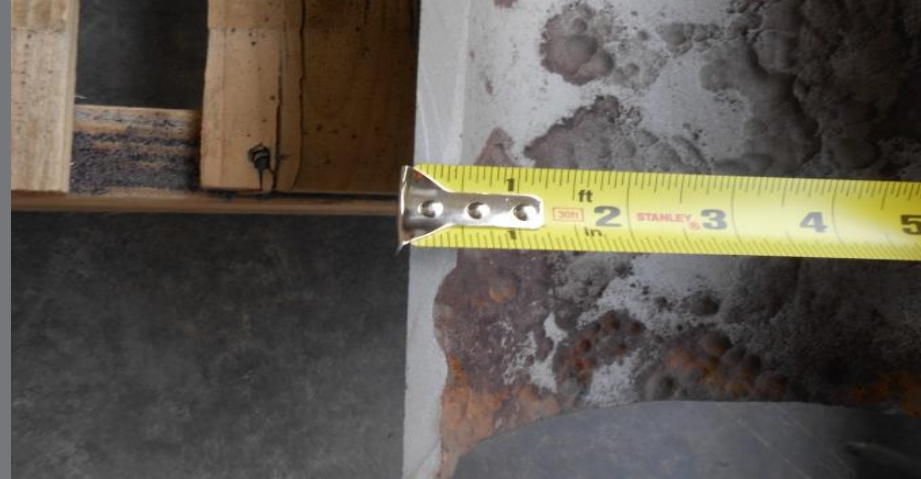
Uncorroded pipe measurements were generally 7/16-inch thickness (0.43 inch).

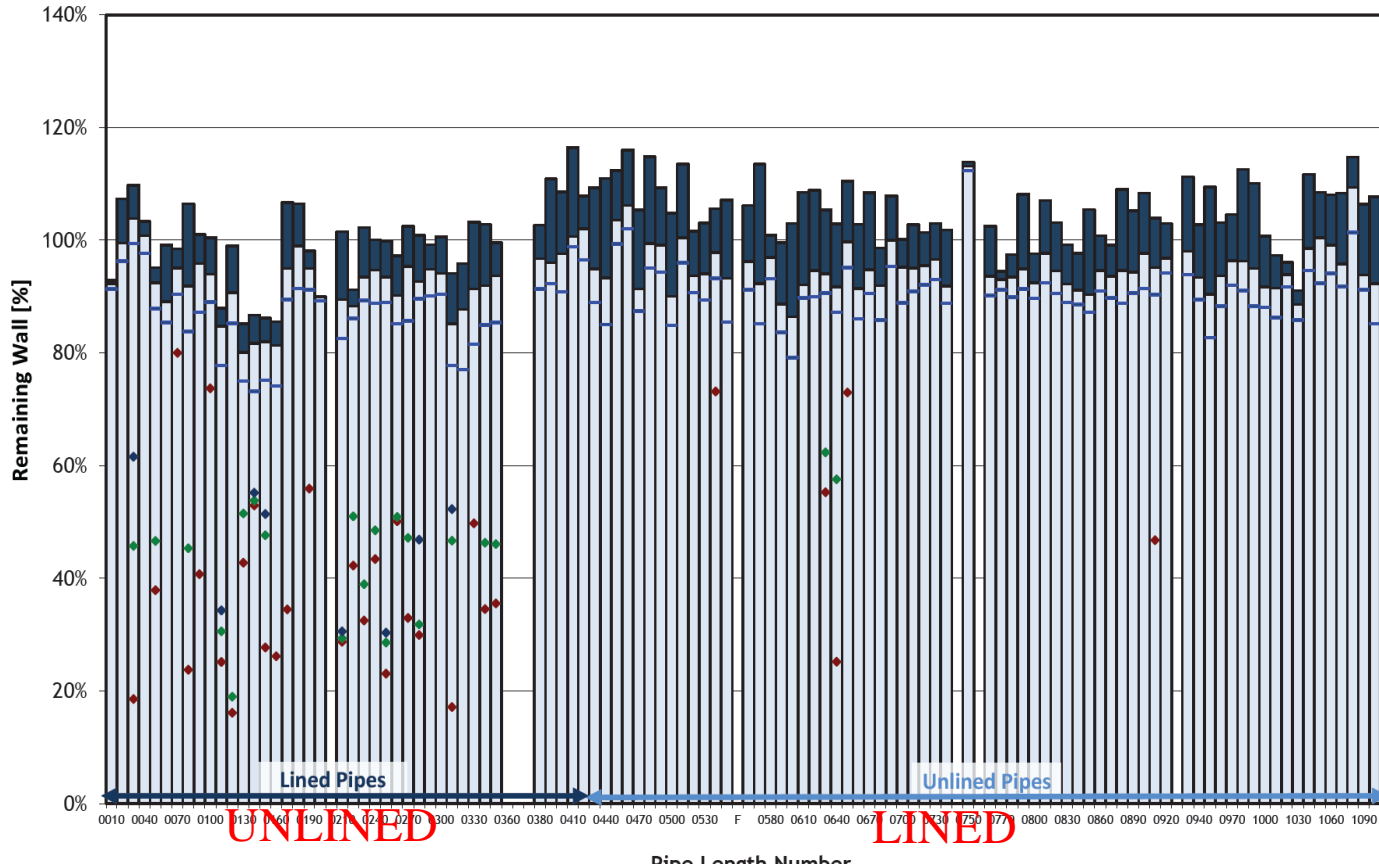
WRF Seattle-37th Ave SW 8 inch Water Main

Seattle – Mild to moderate corrosion...except unlined portion

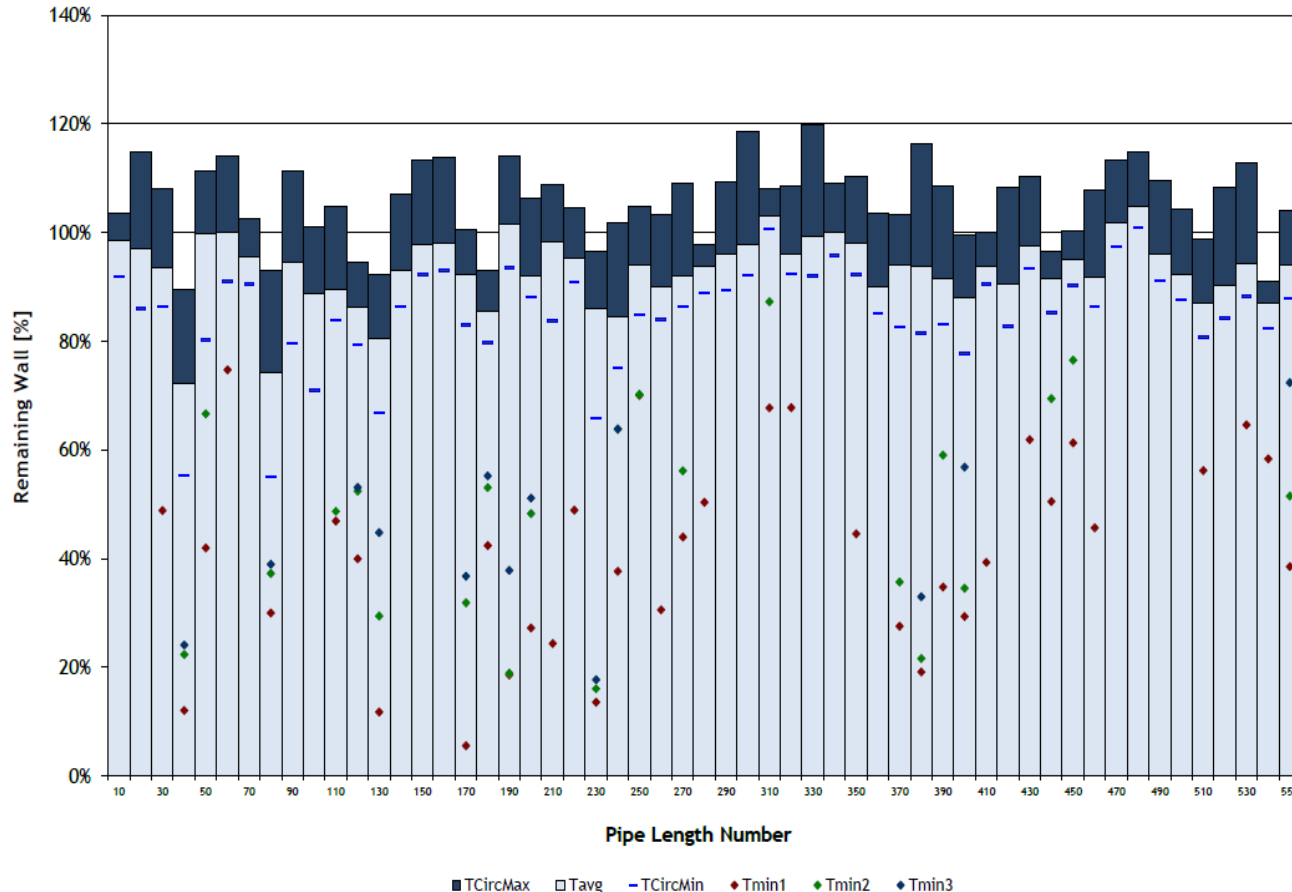
WRF Denver Water - 6in S. Camargo Rd

Denver – Sporadic, moderate to severe corrosion

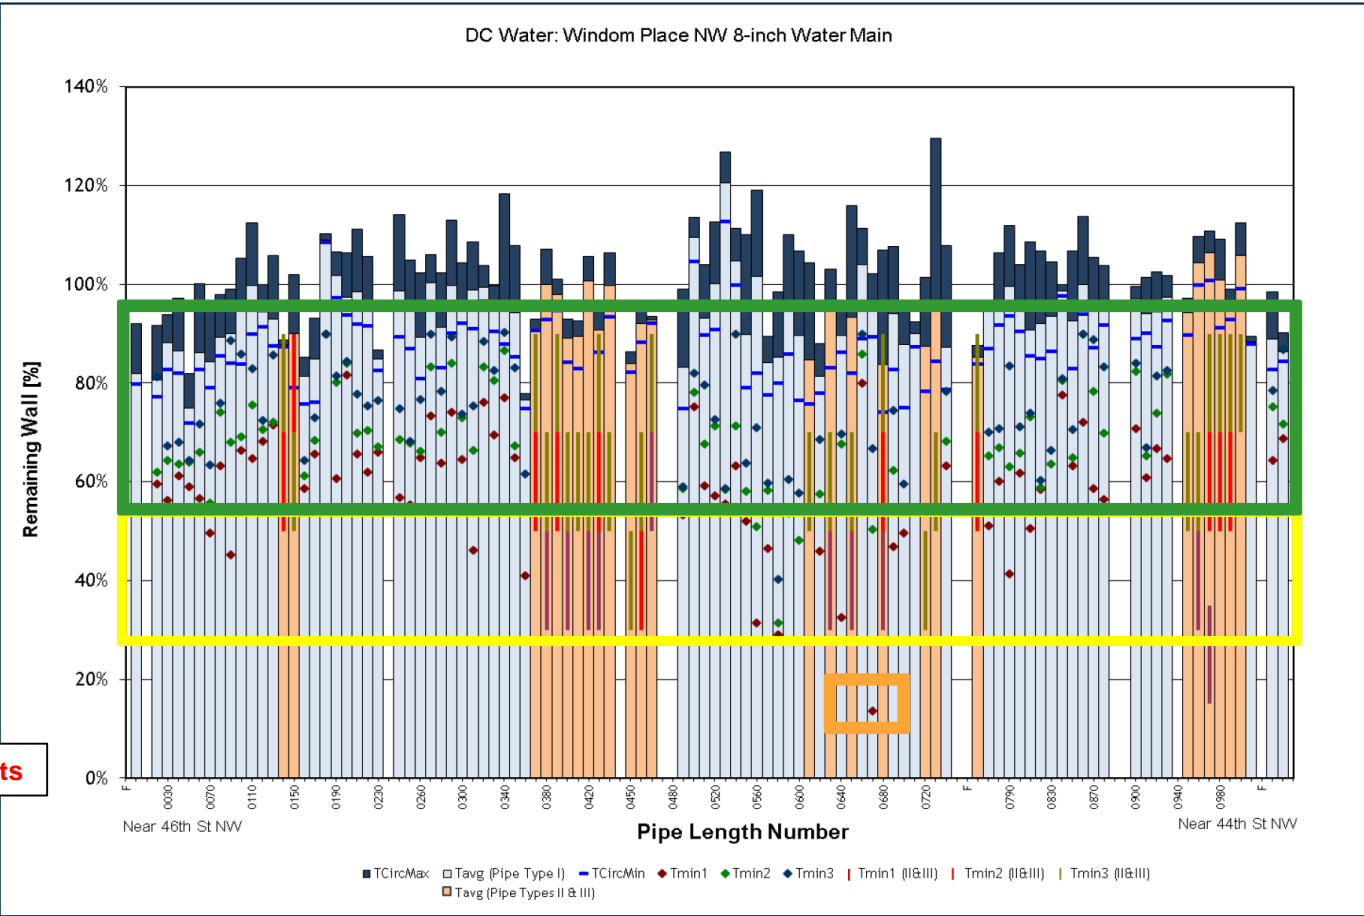
DC Water Pilot – Windom Place NW 8” Water Main

Data verifies:

- Condition = Good
- Non-structural liner is cost-effective solution

No Through Pits

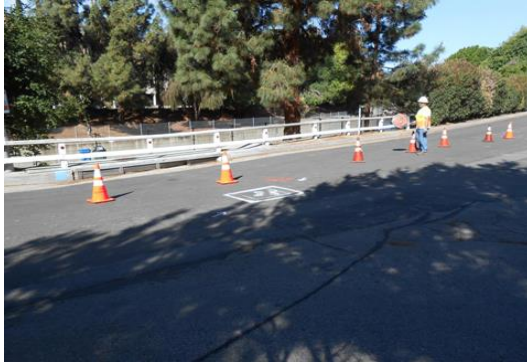
Traffic control by LADWP. The hole location was pre-marked and cleared for excavation. The location is the intersection of Valleyheart Drive and Ethel Avenue.

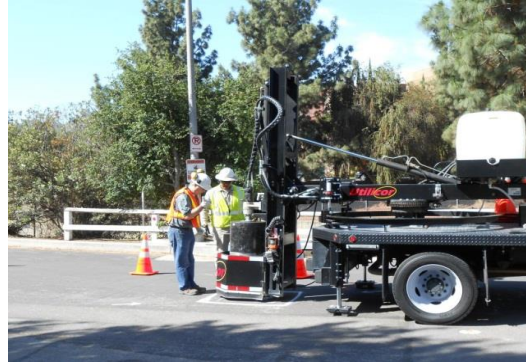
The coring rig positioned over excavation location.

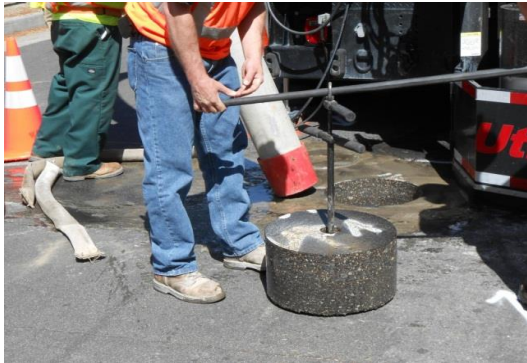
Two persons lifted the core using a special tool that grips the center pilot hole. The core was then tipped on its side and rolled out of the way.

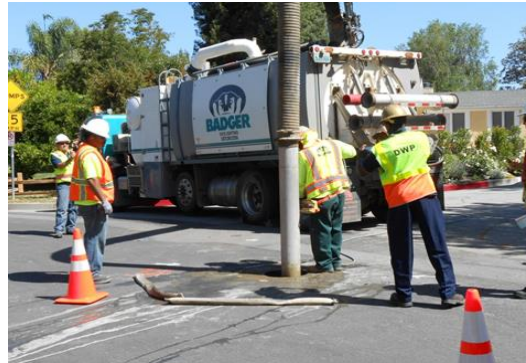
Vacuum excavator was performed using a high-volume unit equipped and water jet lances.

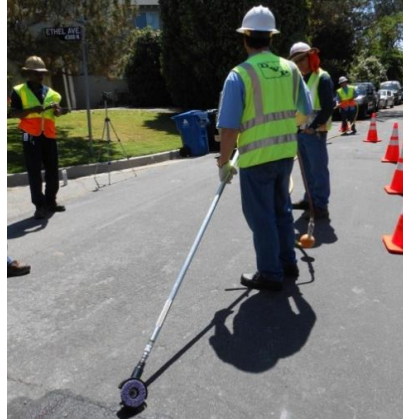
A long-handled, air-powered grinder with plastic abrasion disk was used to prepare the pipe surface for wire bonding.

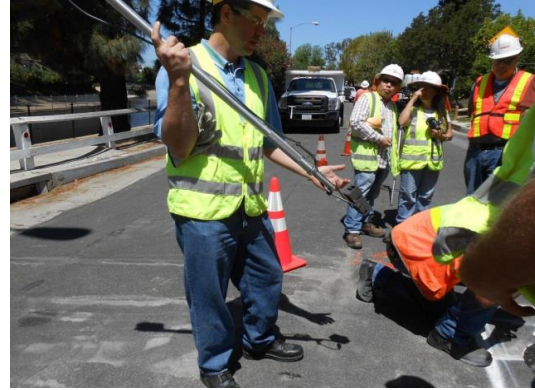
Another long-handled tool was used for exothermically welding the anode to the pipe.¹

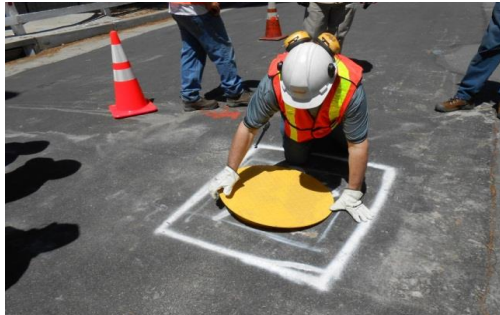
The excavations can be plated without a backhoe or other equipment. The plate has an underside ring that extends into the hole, preventing it from sliding. Plates are available that lock in place.

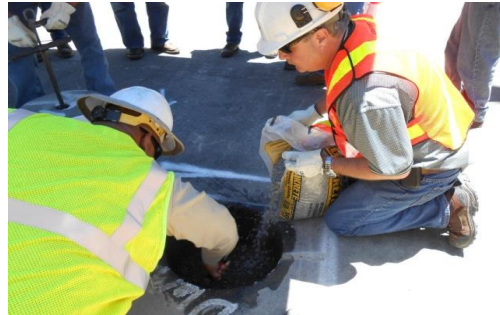
After backfilling using conventional methods, a layer of pea gravel was placed for leveling. This was followed by a dry-fit test to verify that the excavated core would be level with the adjacent pavement.

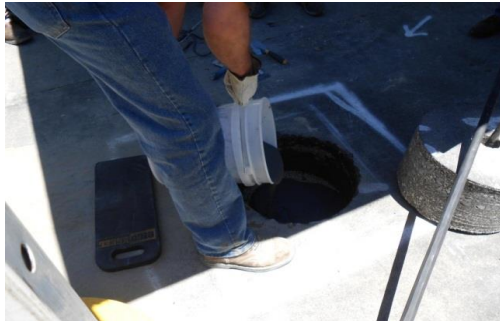
A grout-like bonding agent was pored into the hole. The extracted core, shown on the right side of this photo, is ready for placement.

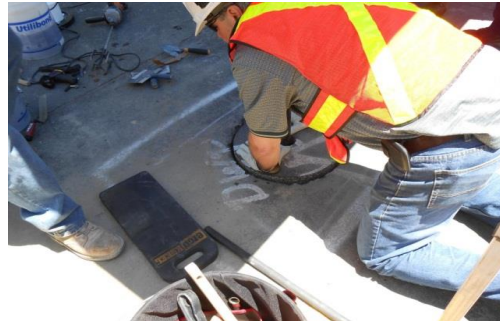
The core is placed into the hole, then wiggled back and forth, forcing the bonding agent up the sides and center of the donut-shaped core. The core is aligned with marks made before-hand.
