Debris Removal Solutions

CLEANING INFLUENT AND RETURN
CHANNELS AT CORPUS CHRISTI'S
OSO WATER RECLAMATION PLANT

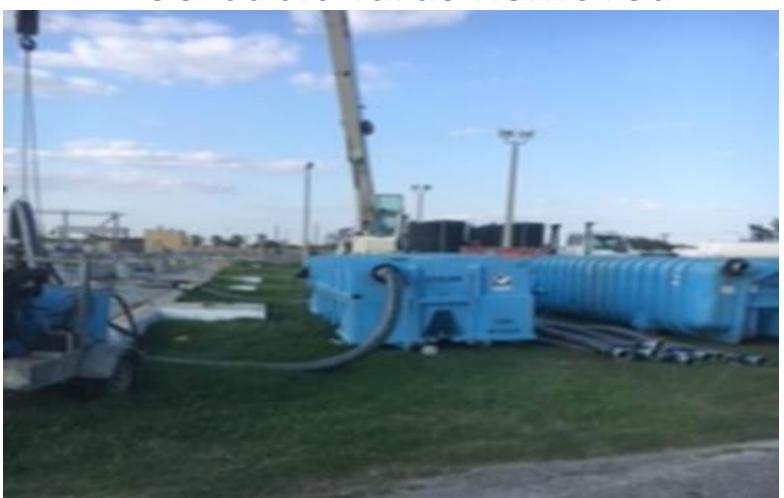
EMERGENCY CLEANING 2017 95 Cubic Yards Removed

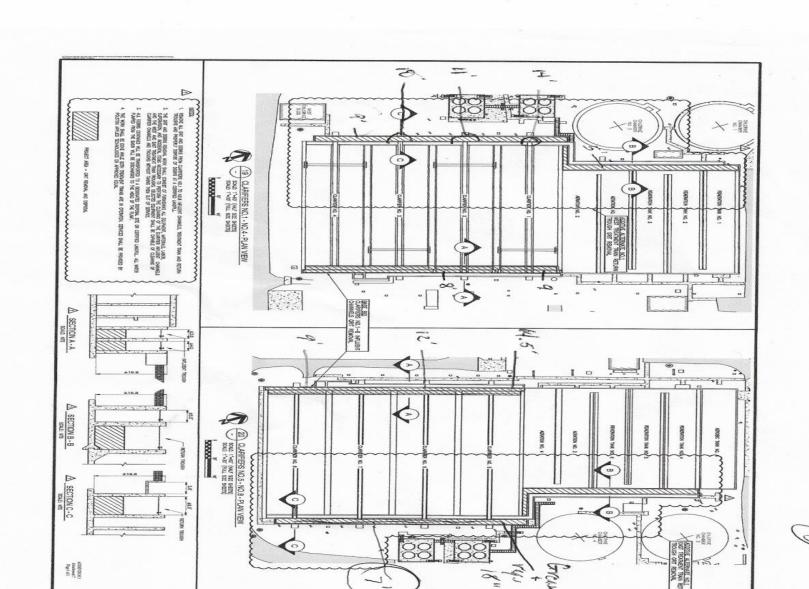
CHANNEL IS 17' DEEP

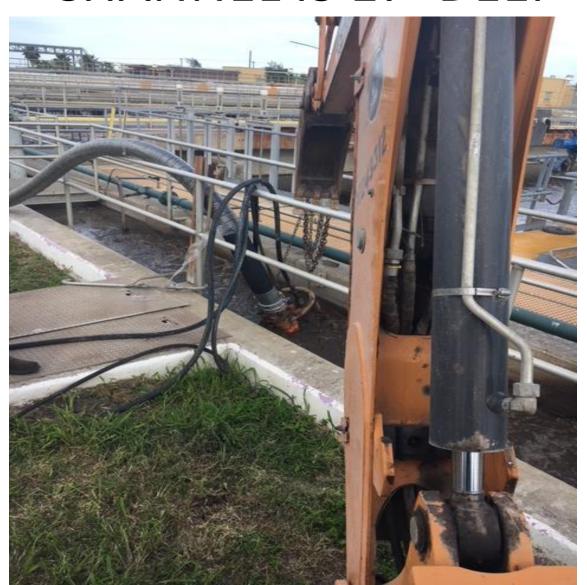
AIR GUNS BREAK UP RAGS

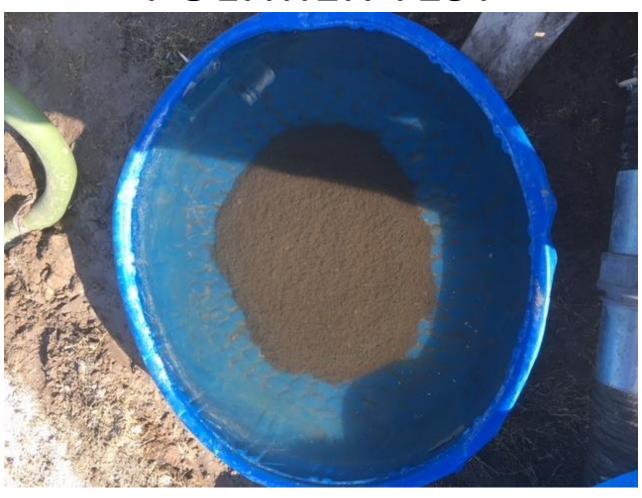
INJECTING POLYMER TO STREAM

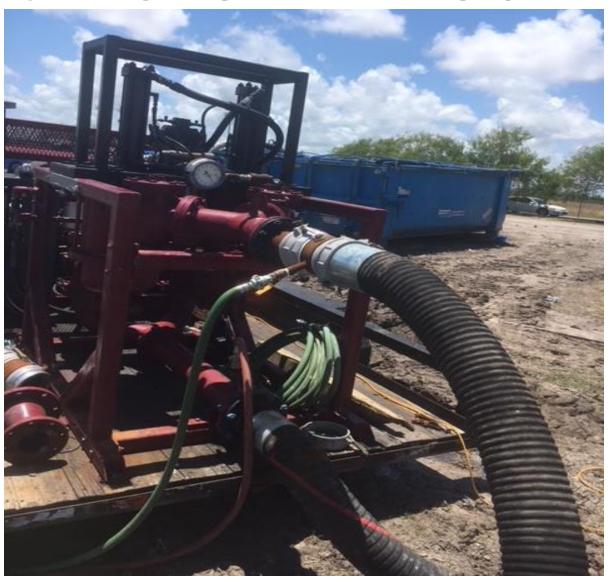
Phase Separator

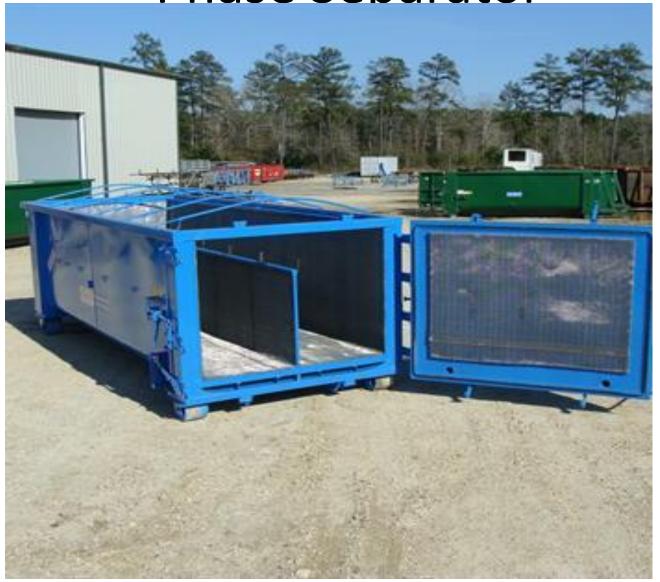
POLYMERIZED MATERIAL

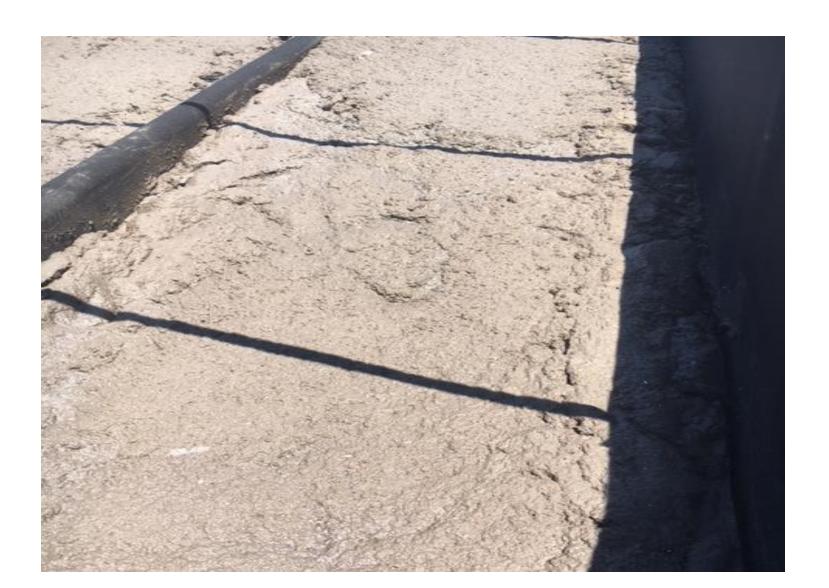
FIRST BOX HEADED TO LANDFILL 9.2 TONS

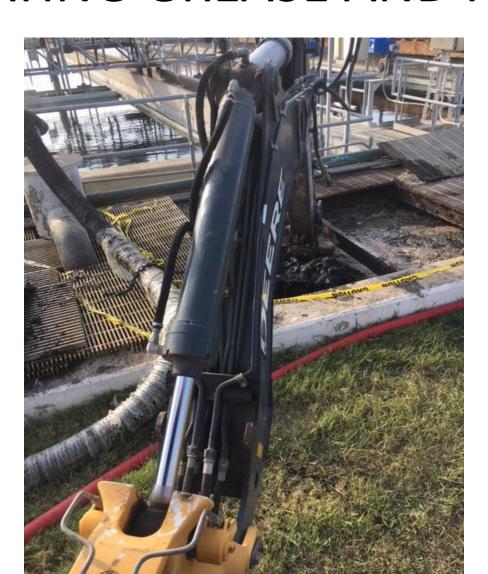
RAGS IN MANIFOLD
