What to Do With All This Corroding CMP Storm Drain Pipe?

Presented at UCT, Ft. Worth, TX – January 29, 2019

National Plant Services, Inc., a Carylton Company

Michelle Beason, PE

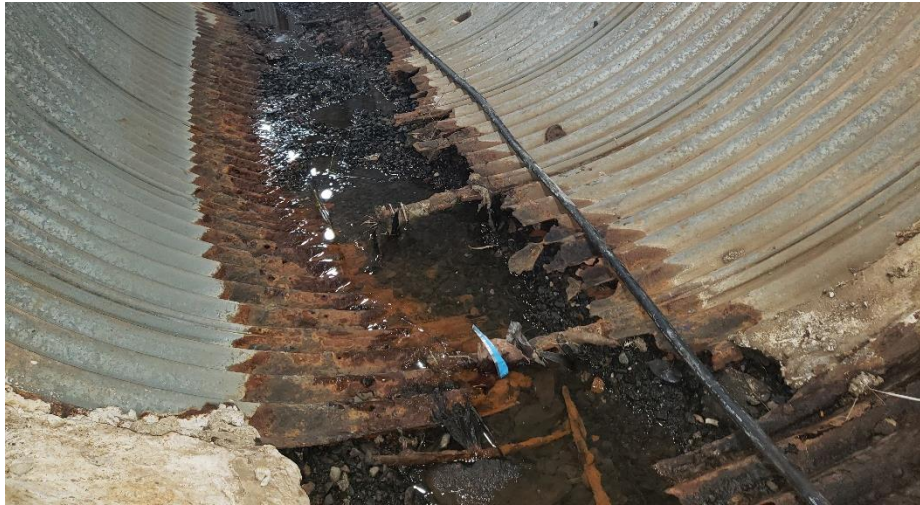
1. The invert is usually the first to go.

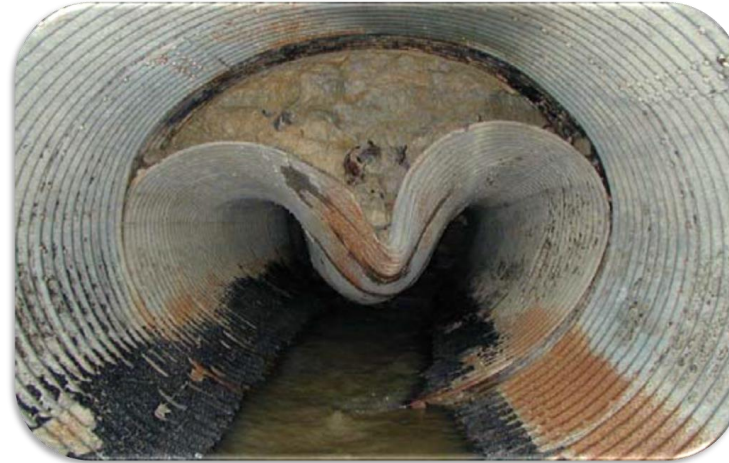
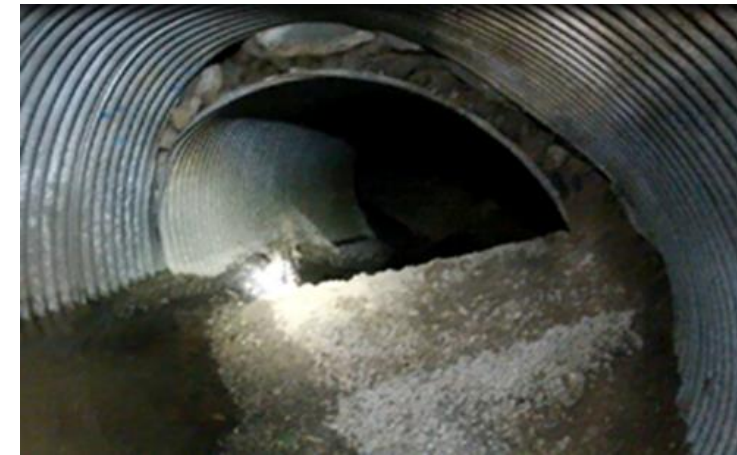
- The top of the pipe buckles downward
- The invert collapses in on itself causing the pipe sections to shrink, and a path for soil entry.

3. Then a sinkhole can develop

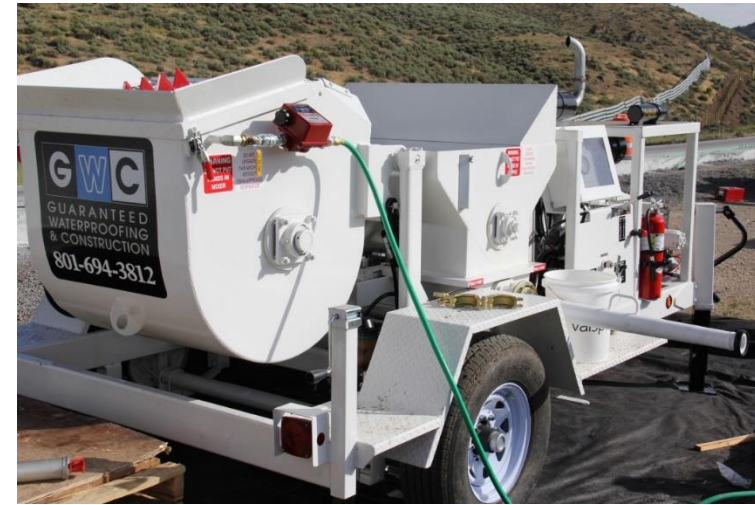
Mortar Mixer – Pump Assembly

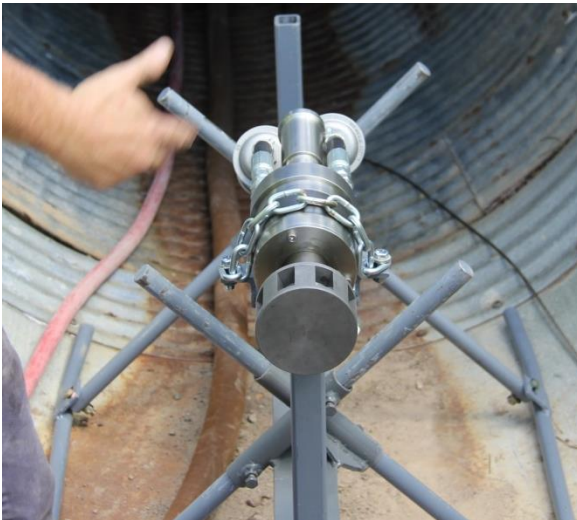
CentriPipe – Retrieval Sled

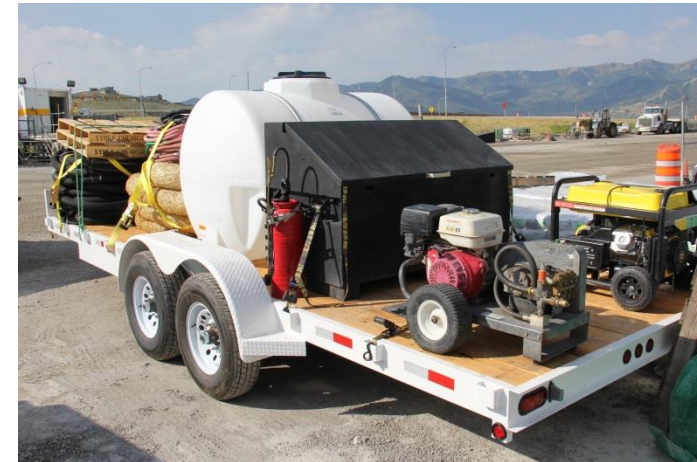
**Support Equipment
(375 CFM Compressor not Shown)**

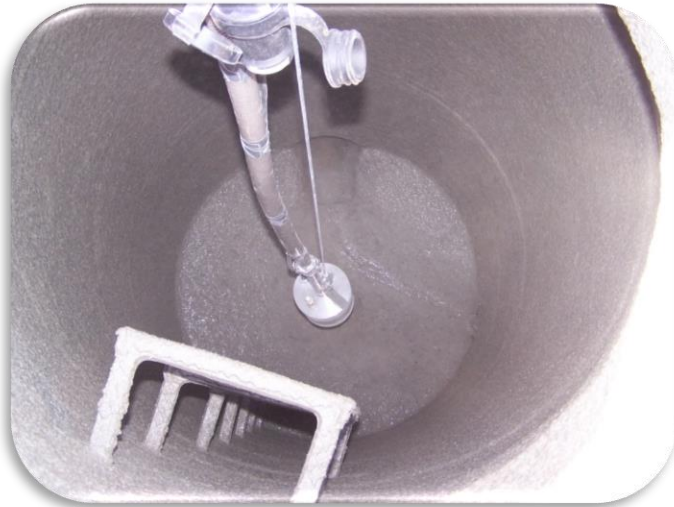
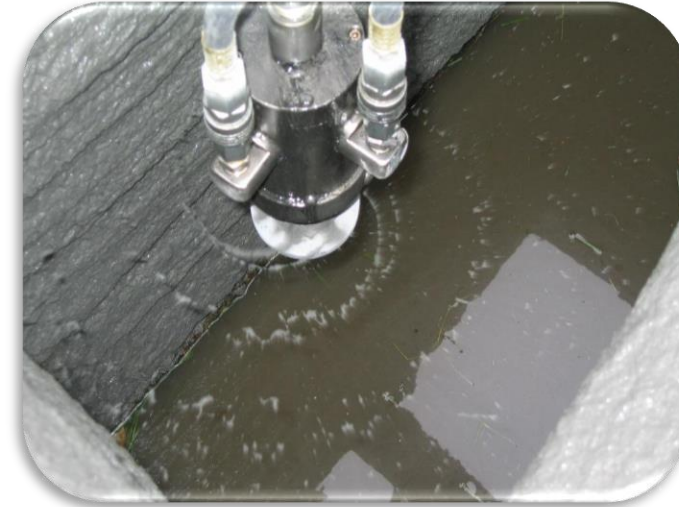
**Conforms to Host Shapes
Minimizing area Reduction**

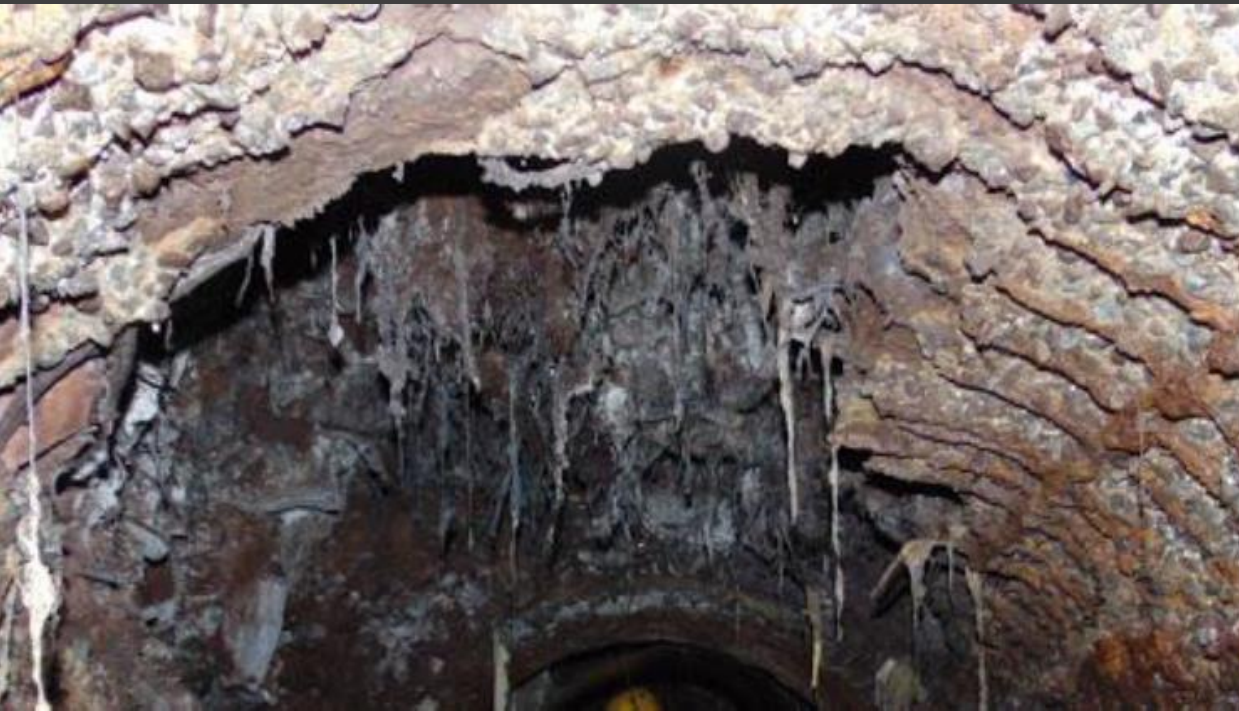
Project #1: Rockland NY Interceptor, 36", 750 feet long

- Portions of the crown were completely gone.
- Steel bands were put over the voids and secured with masonry anchors.
- Structural grout injected behind steel.
- Finished result was a new concrete pipe.

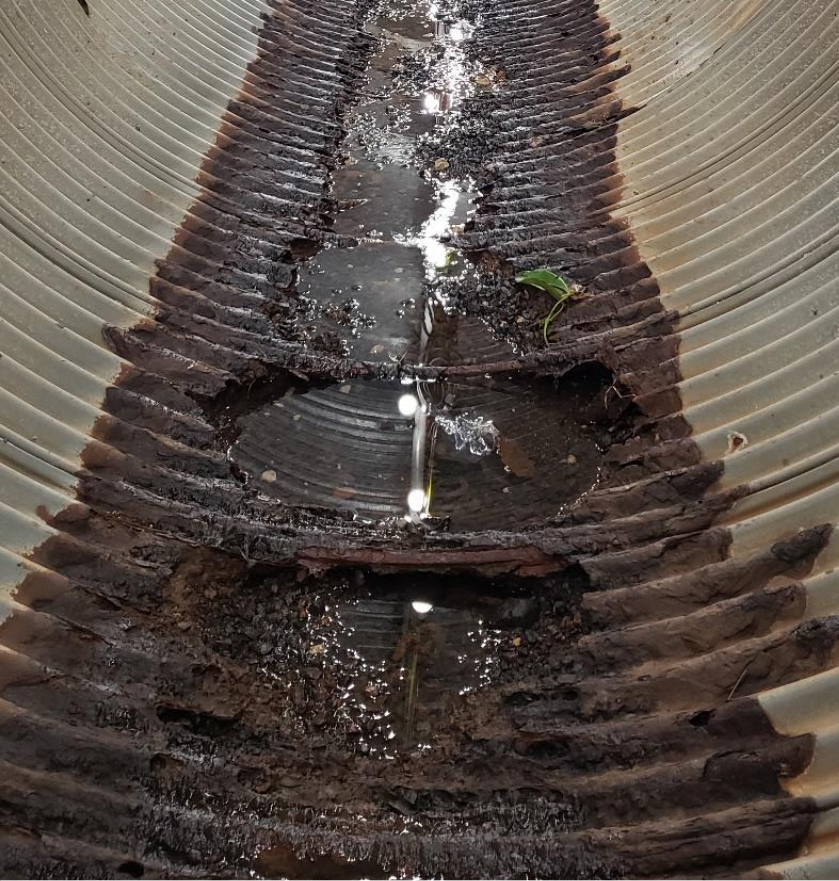
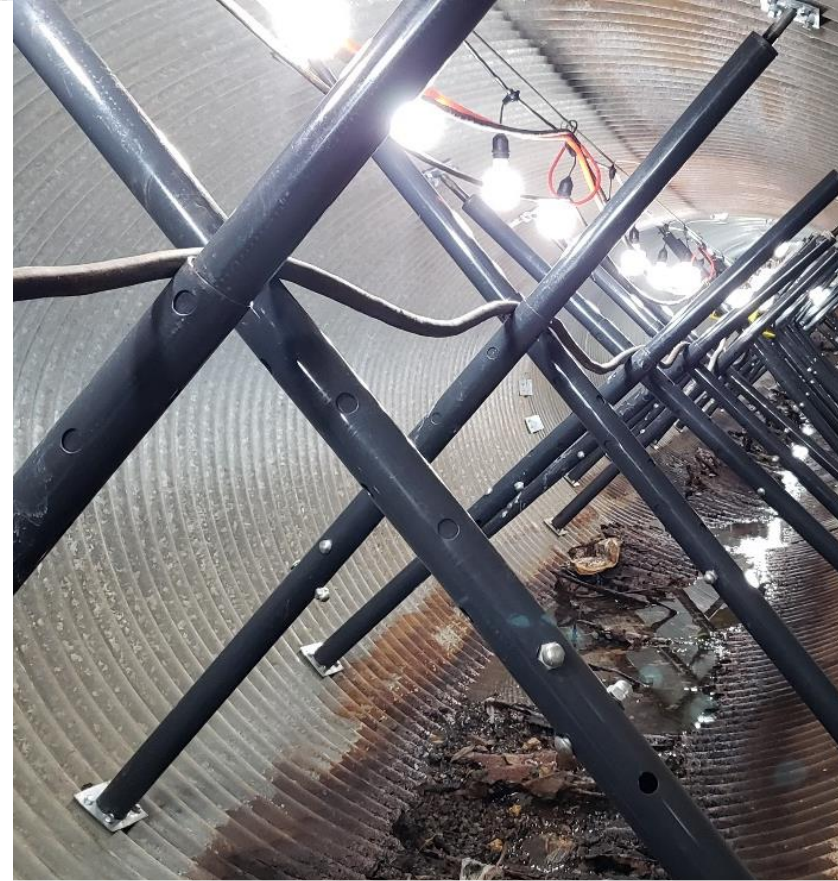
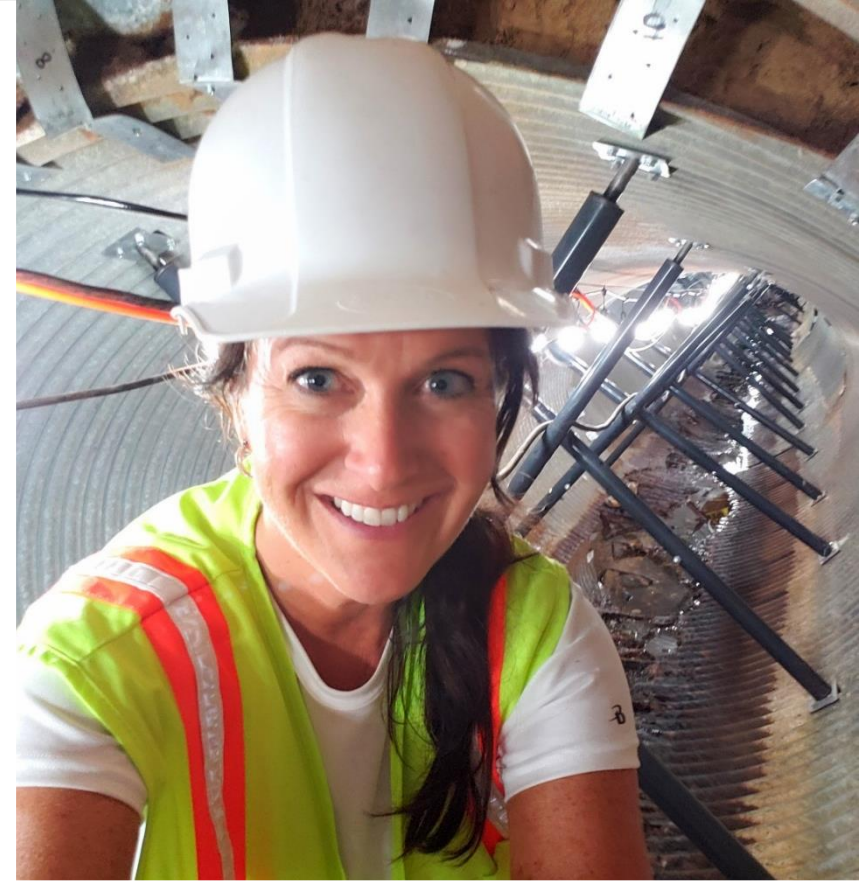
CLEAN CULVERT AND STABILIZE WORST SECTIONS

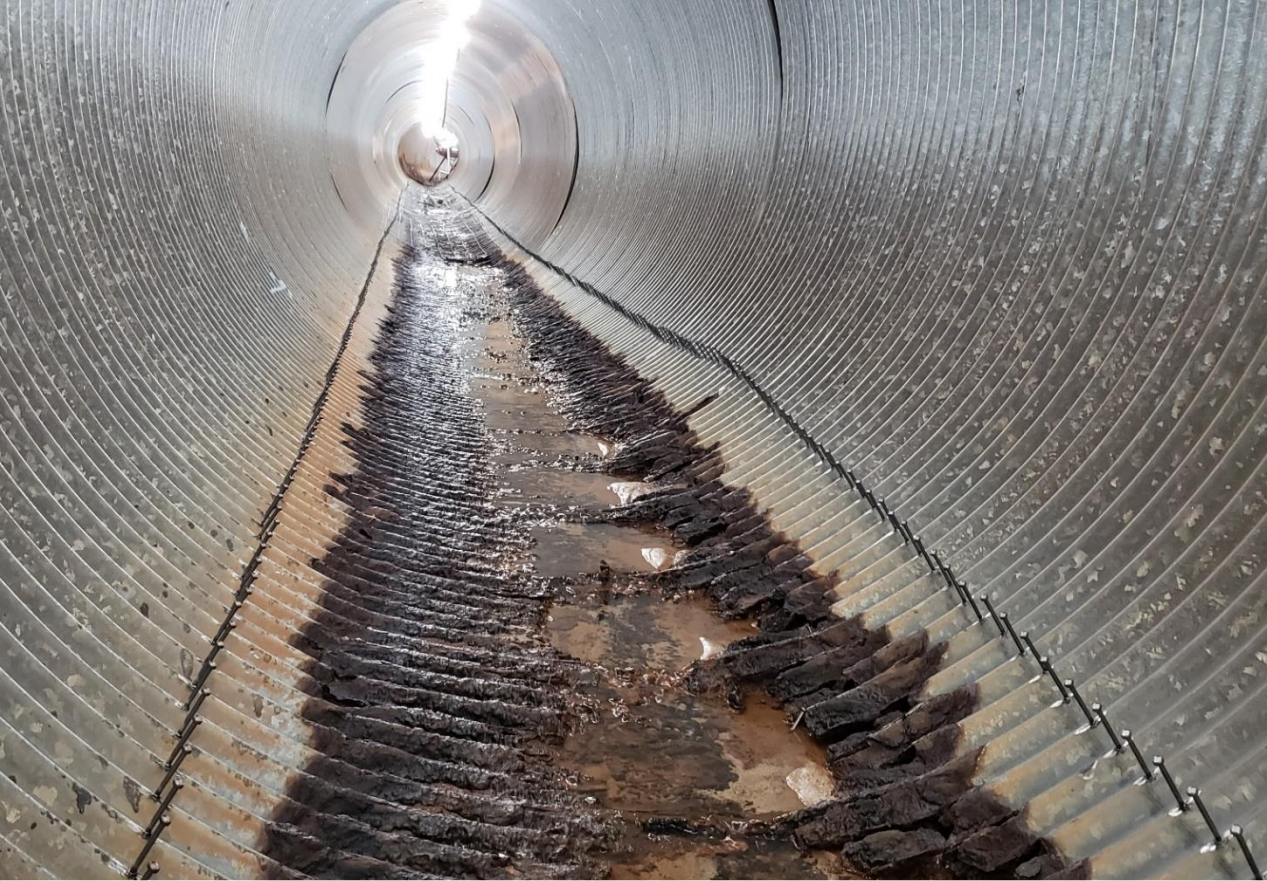
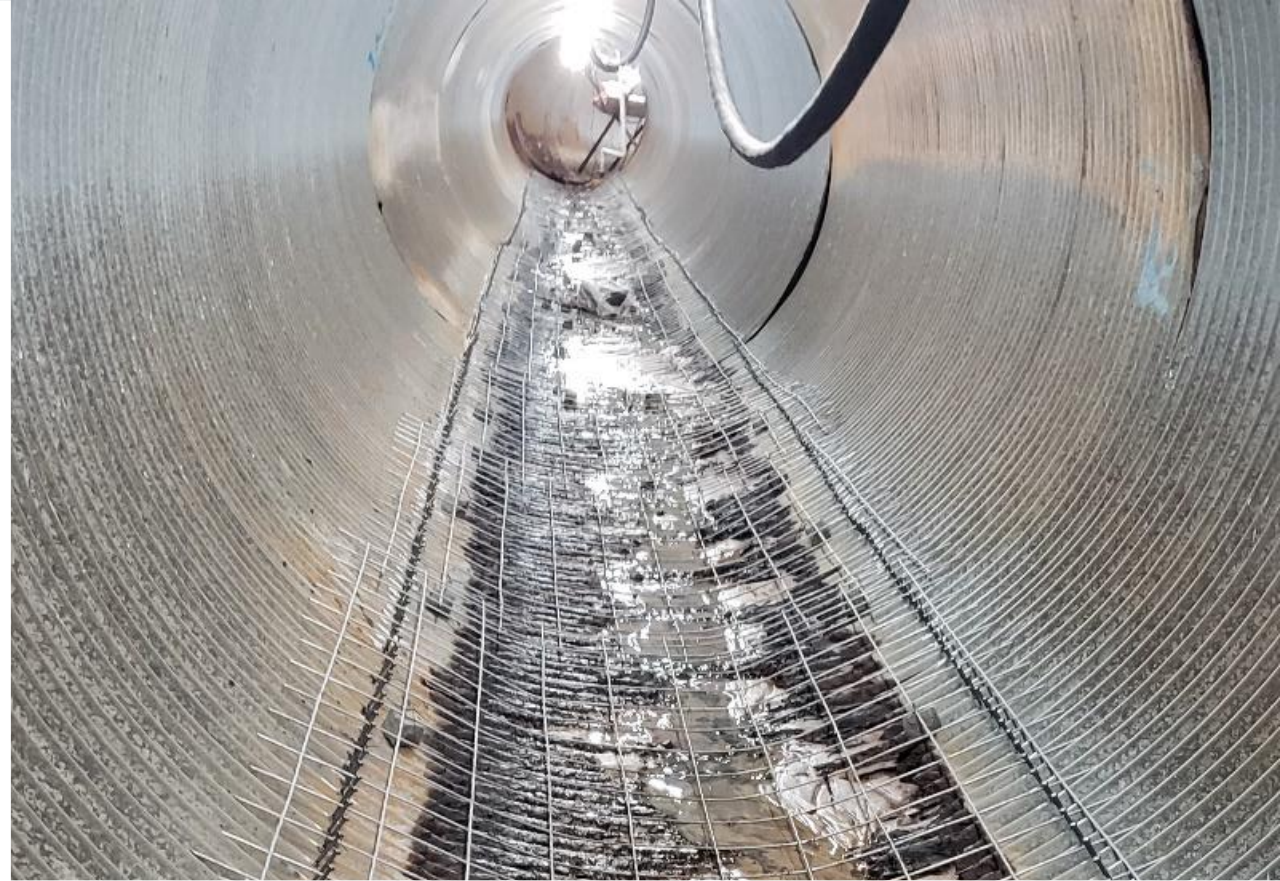
COMPLETE REINFORCEMENT IN INVERT

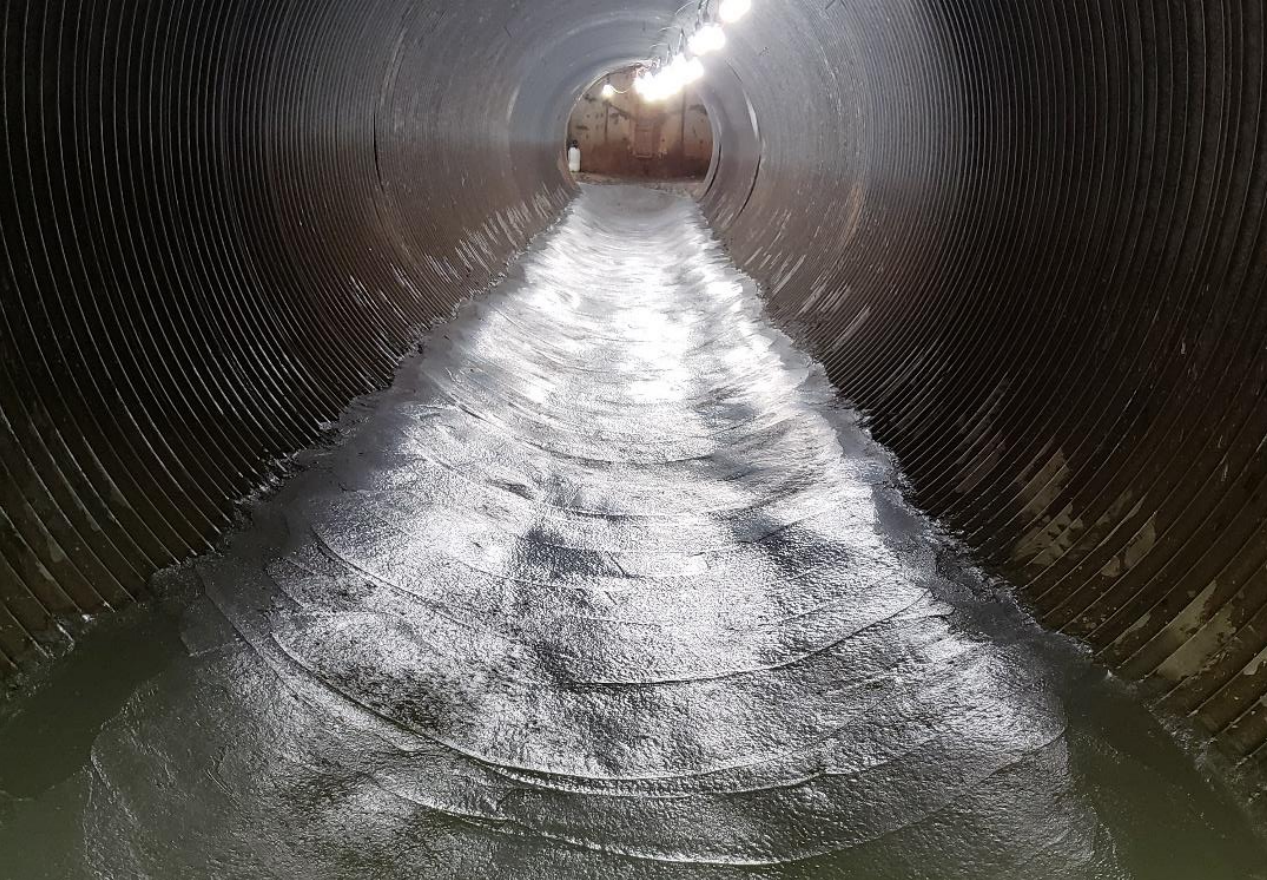
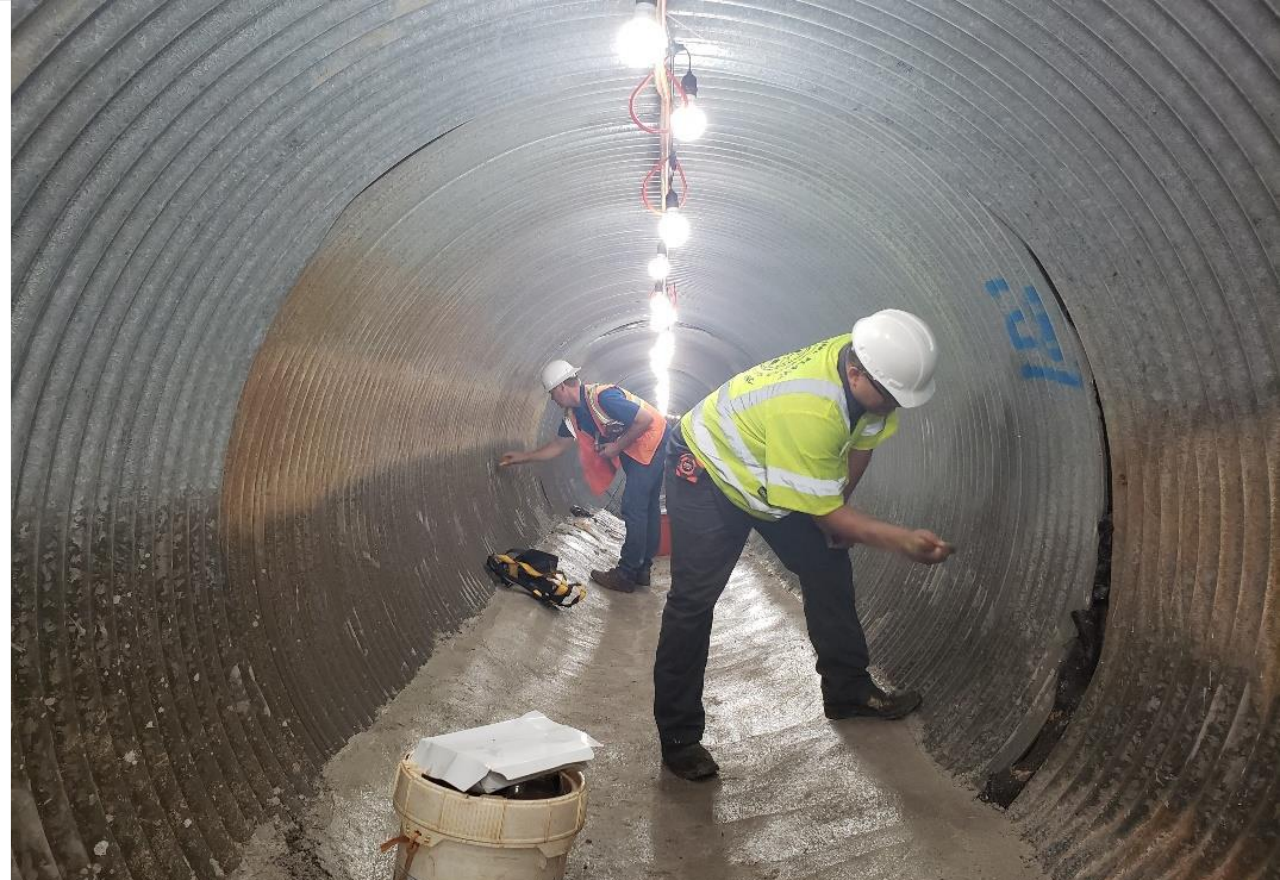
POUR NEW CONCRETE INVERT;
ONCE WE DID, WE FOUND VOIDS BEHIND PIPE
THAT HAD TO BE STABILIZED BEFORE SPINCAST.

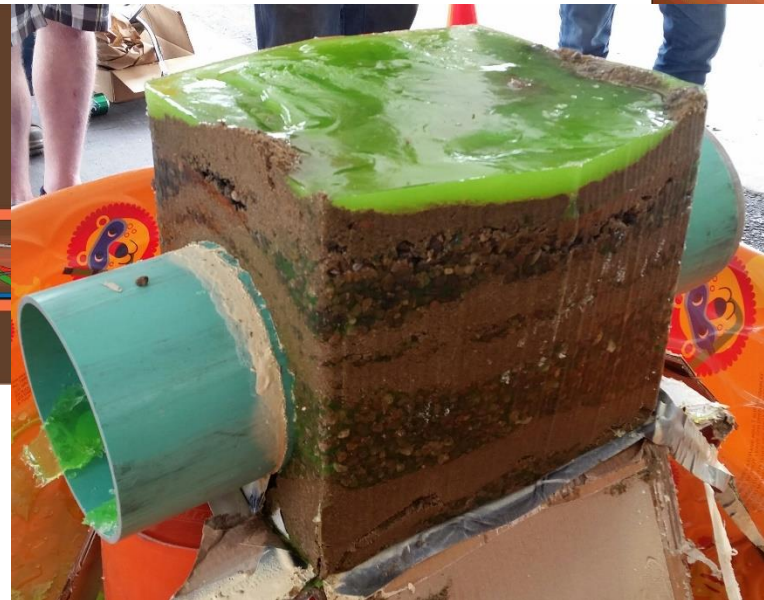
Injection Grouting

TWO TYPES OF
GROUTS WERE
REQUIRED FOR THIS
PROJECT:

Avanti AV-100
Acrylamide
Grout

Avanti AV-275
Foam Grout

GROUT FIRST TO STOP LEAKS

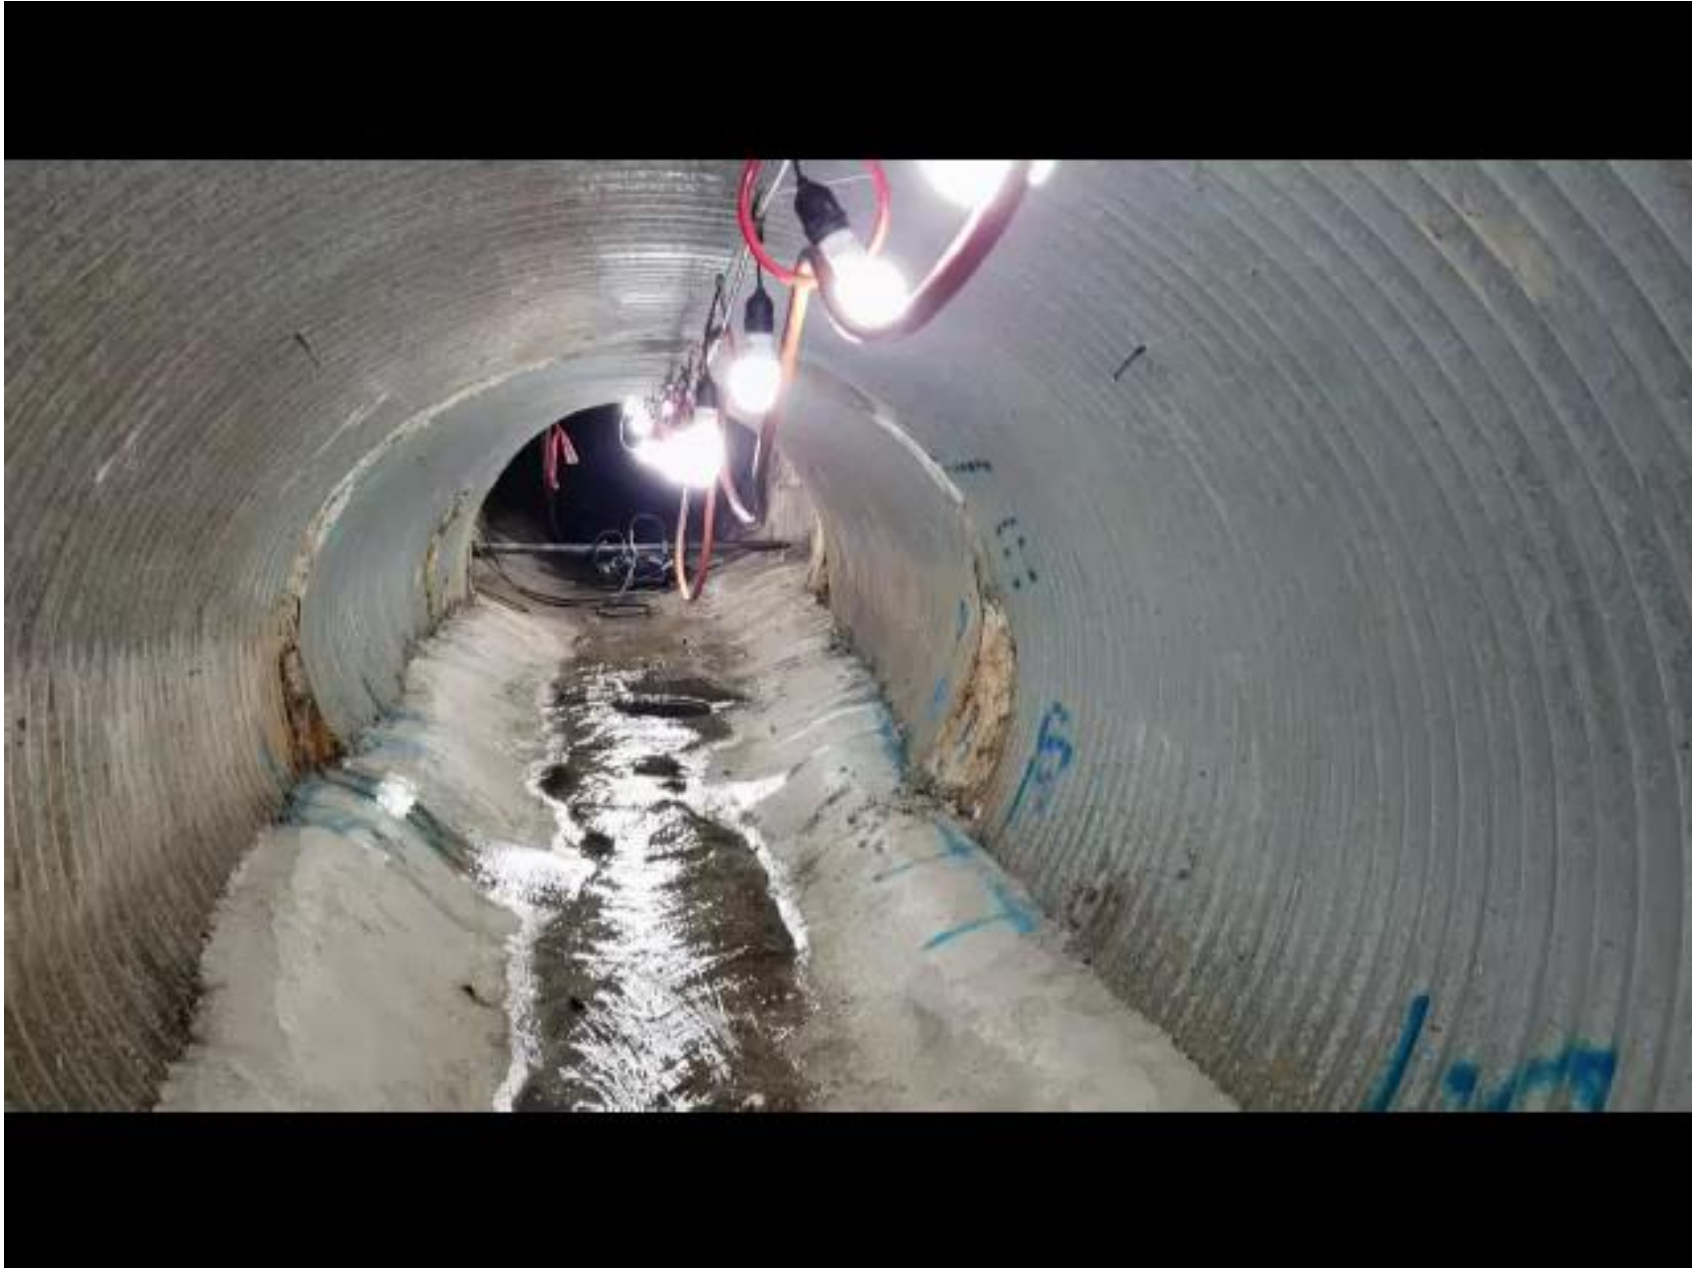
MANUAL GROUTING

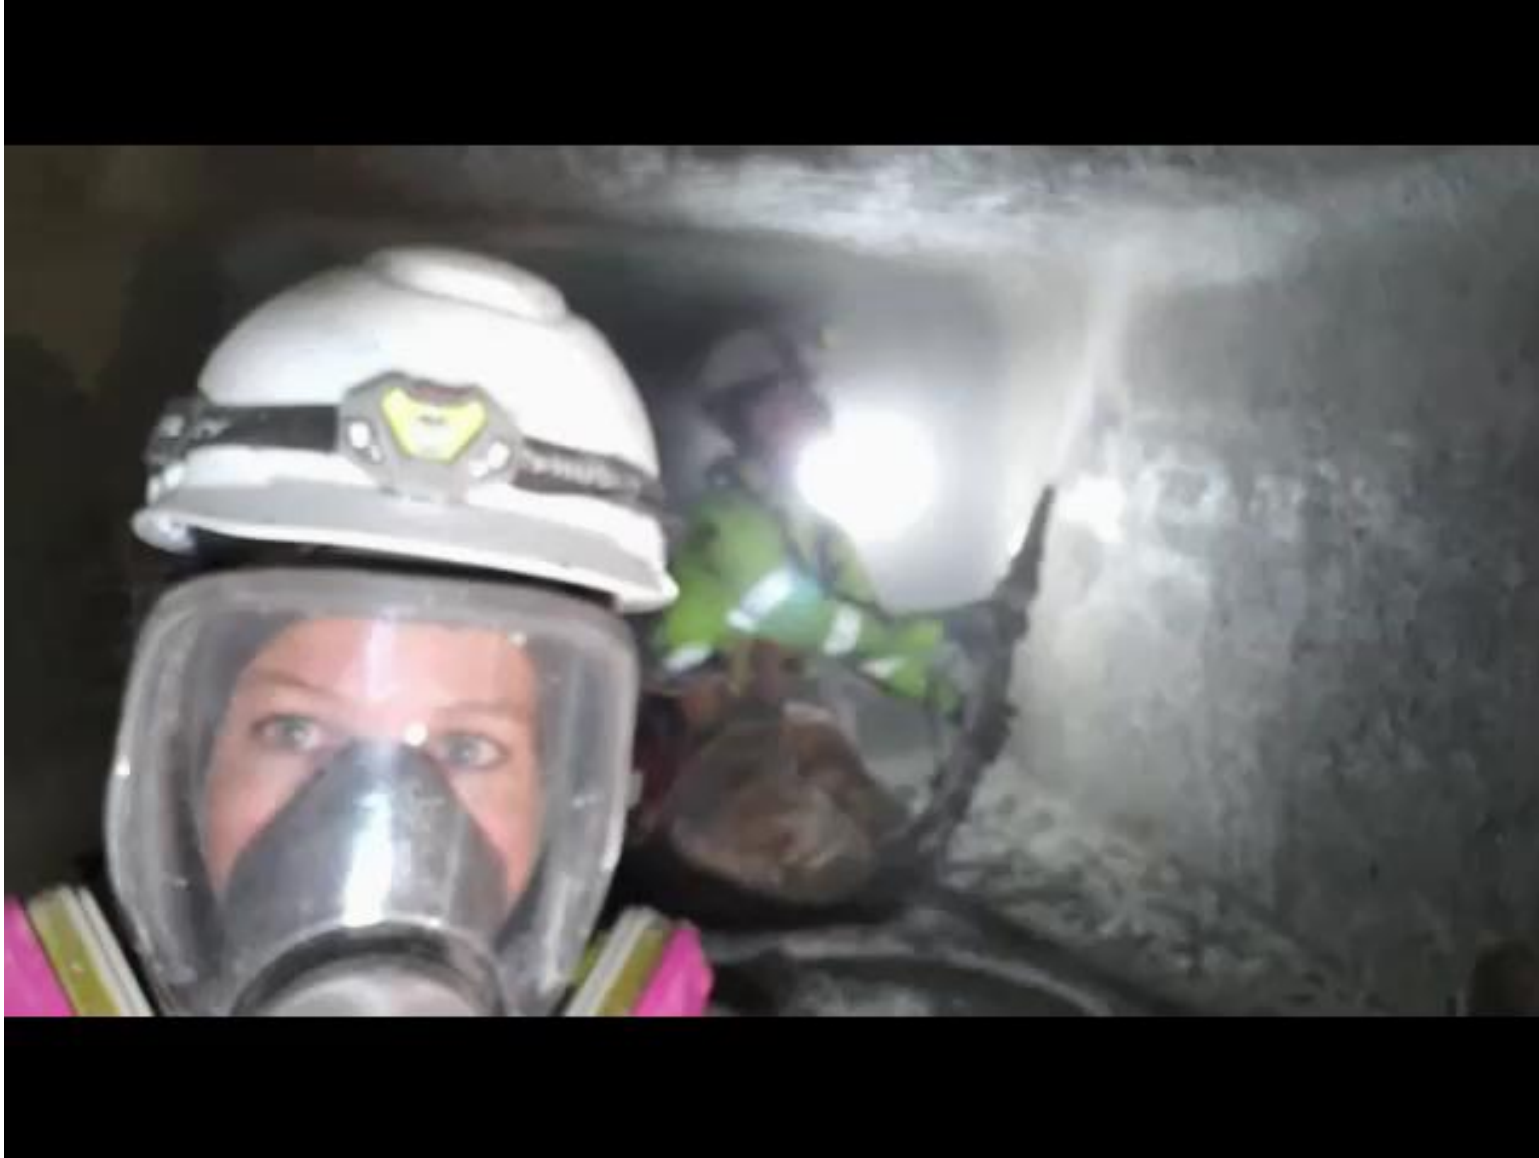
Mortar can also be hand sprayed
