# City Uses Fiberglass-Reinforced CIPP to Rehab 1,900' 16" Ductile Water Main

Track II – Waterworks  
January 28, 2020

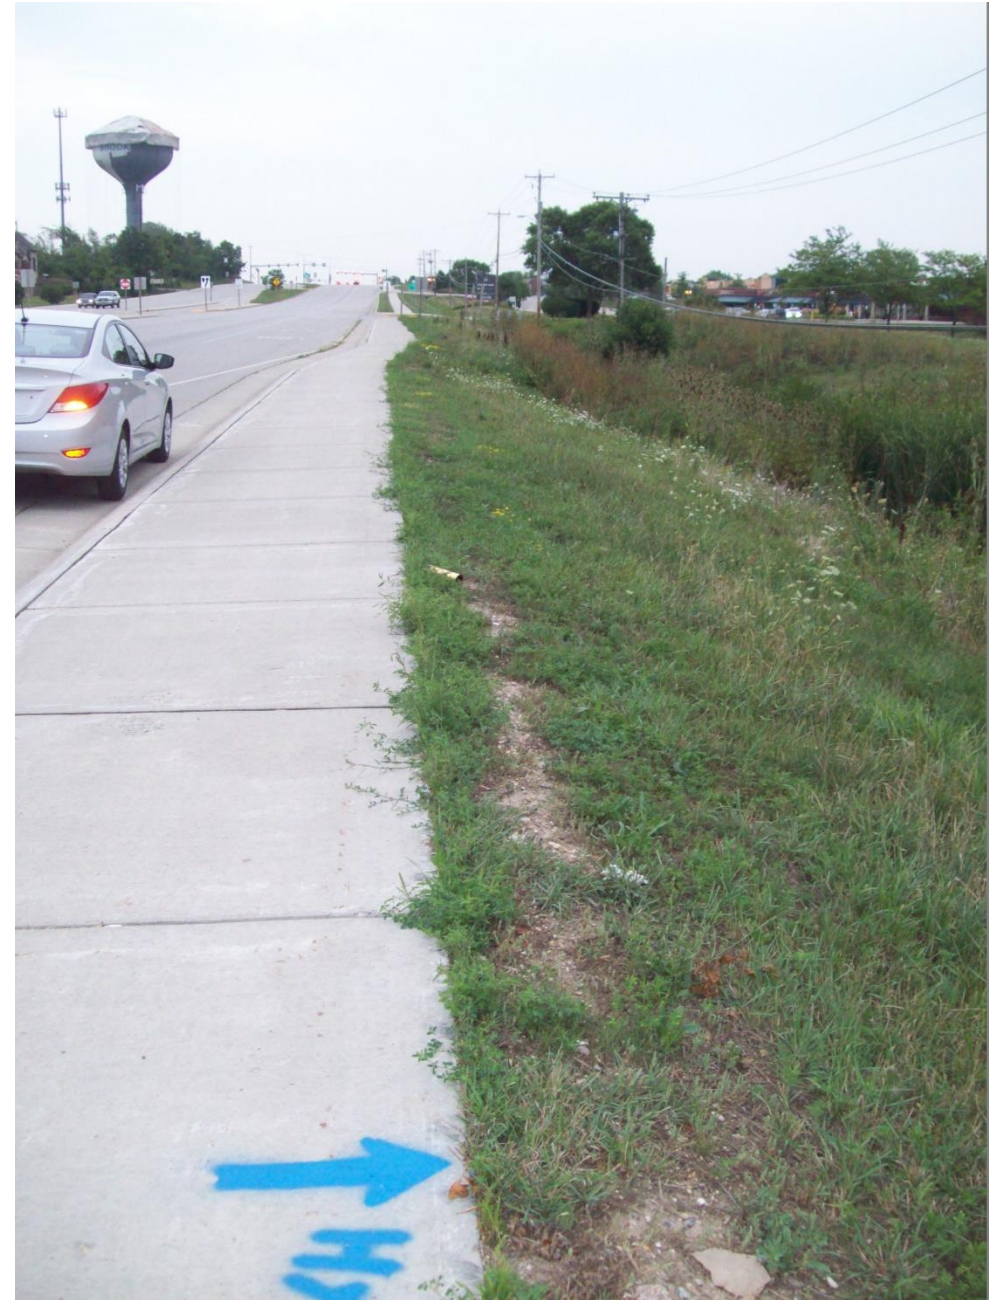
- 1987 installation
- 11 breaks since 1995, 6 breaks in last 5 years
- Wetland impacts
- Deep water main ( $\leq 14$  ft)
- Water main was located on the side slope of a deep ditch
- Power poles and transmission cables near water main alignment

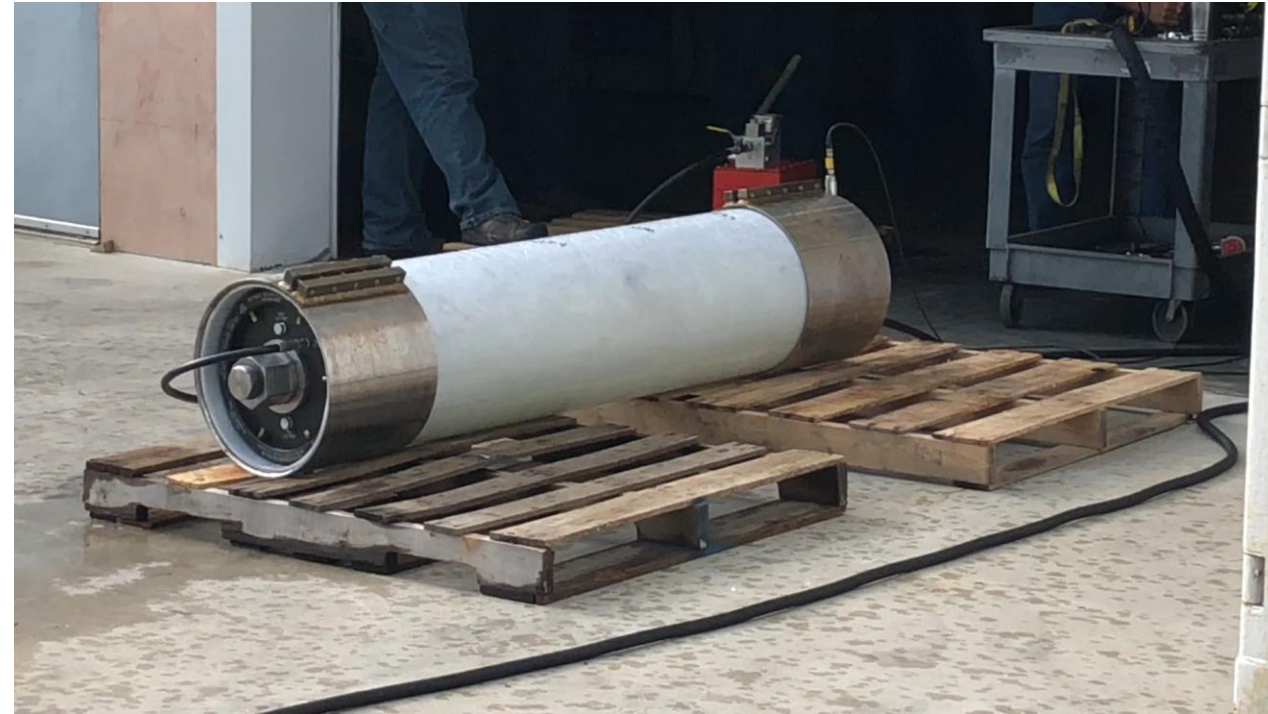
- RS BlueLine CIPP by HammerHead given conditional approval by WiDNR
- Diameter-specific short-term burst testing required to satisfy WiDNR design requirements
  - 16 in OD CIPP tested independent of the host pipe per ASTM D1599
  - $2.5 \times \text{MAOP} = 250 \text{ psi min}$

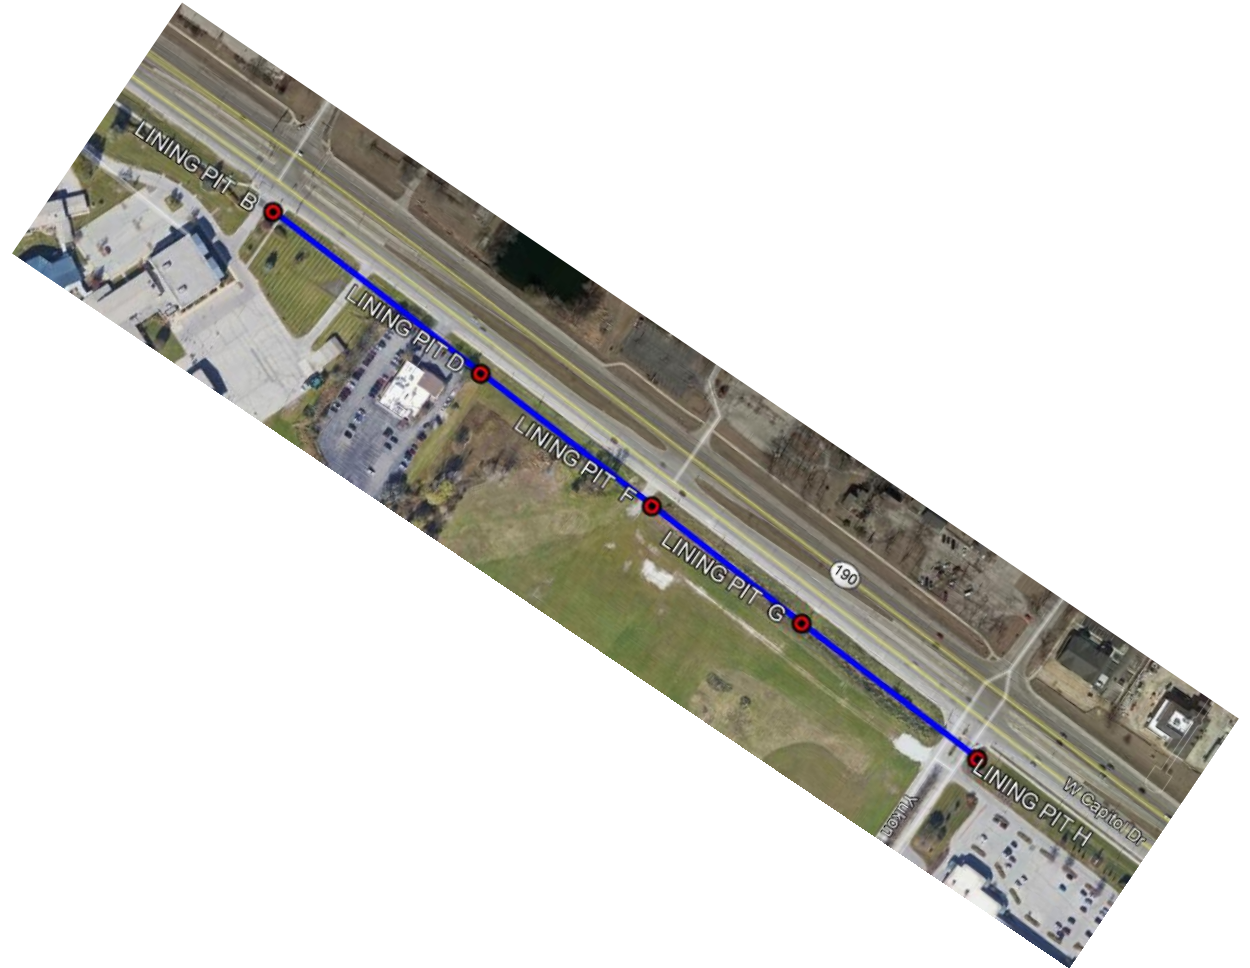
- Site walk
- Plan cleaning & lining sections
- Layout of equipment for operations
- Drag scrape pipe cleaning method used
  - Two cleaning runs – Pit to Pit of 1,029 ft and 845 ft

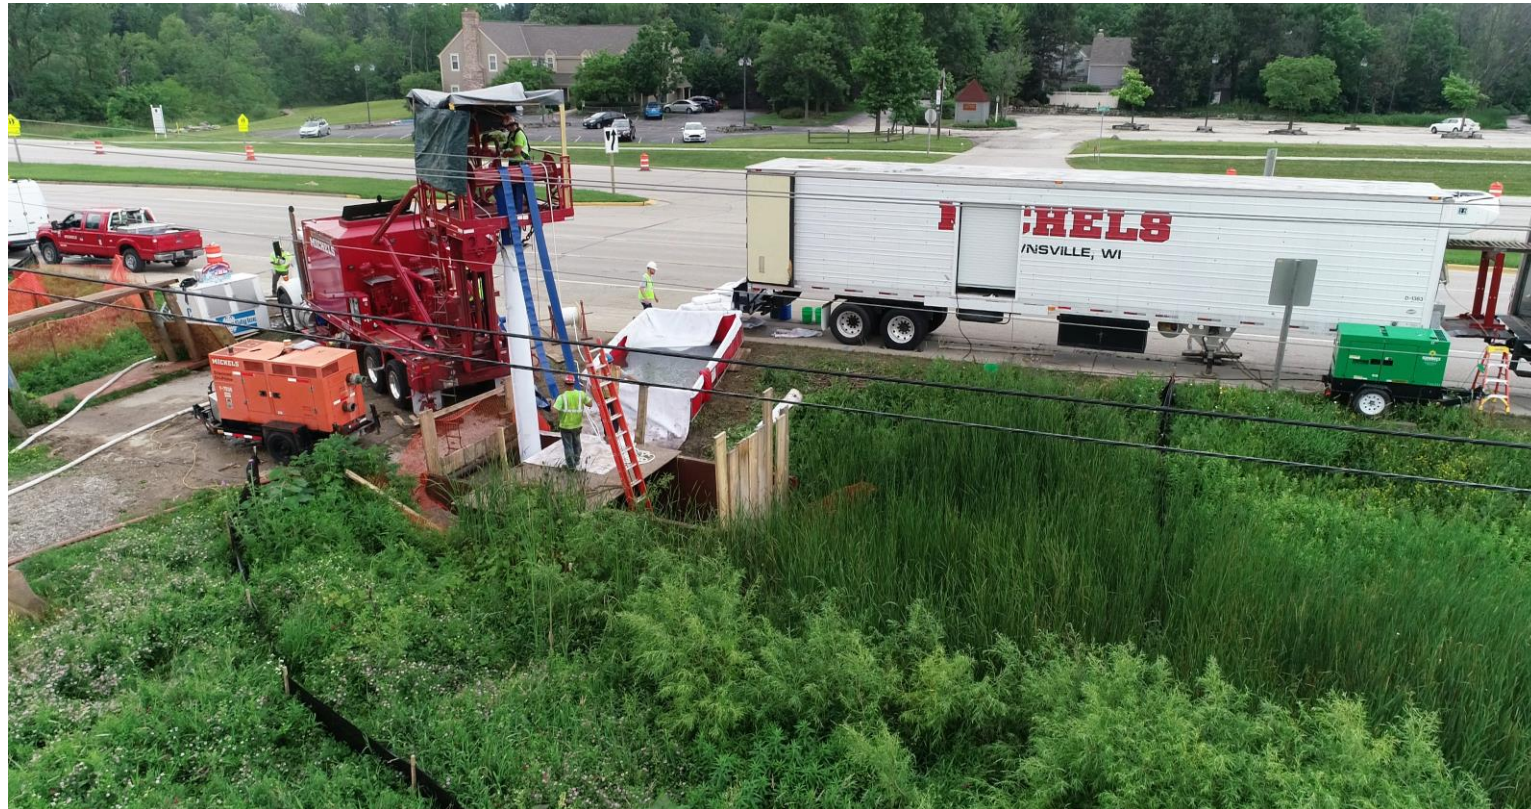
- Water inversion & cure
- Liner installation lengths
  - Pit B to D = 550'
  - Pit F to D = 438'
  - Pit F to G = 396'
  - Pit H to G = 427'
- Pressure testing at 122 psi for two (2) hours
- Mechanical seals installed at CIPP ends

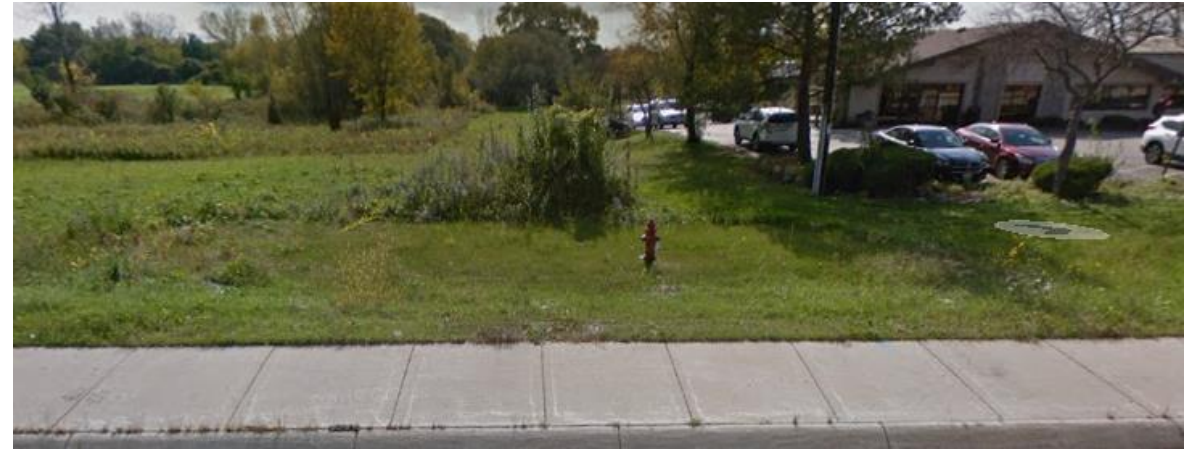
- Work area restrictions
- Overhead power lines near water main alignment
- Ground water infiltration and storm water runoff
  - Constant dewatering of pits
- Hot outside temperatures and UV light exposure during liner wet out and installation
- Active hydrant locations for water for installation and pressure testing

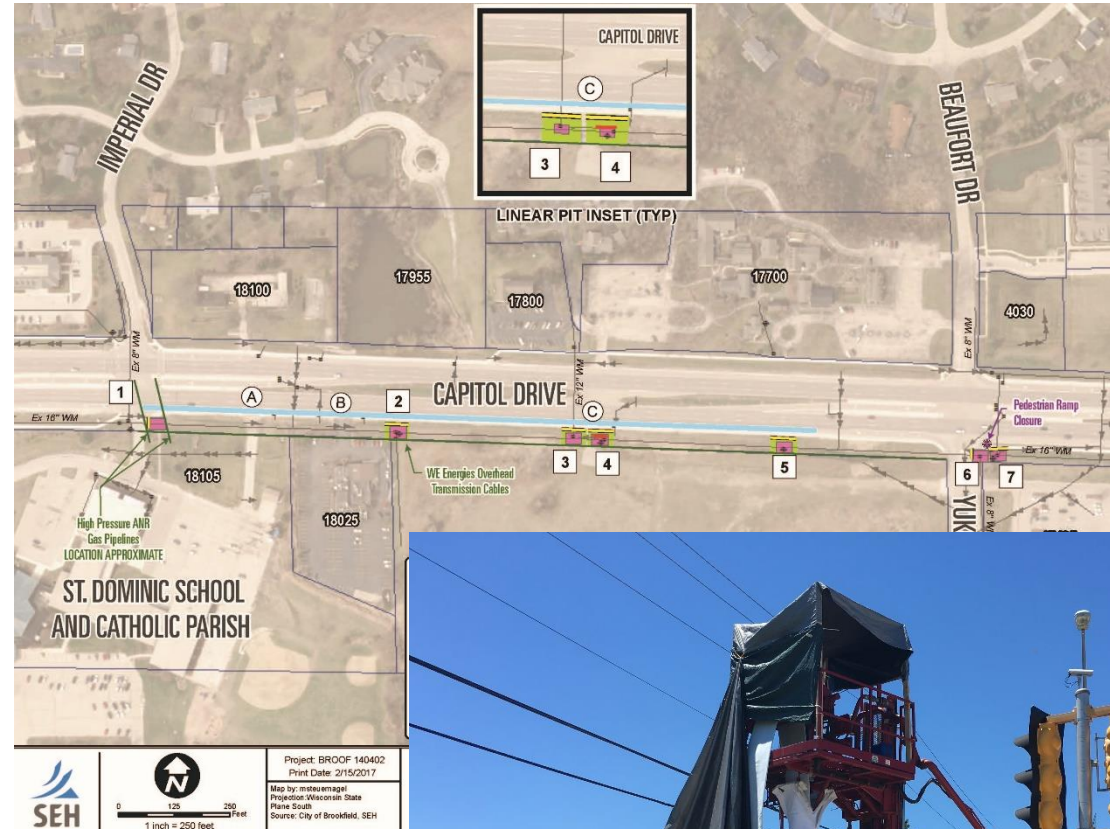
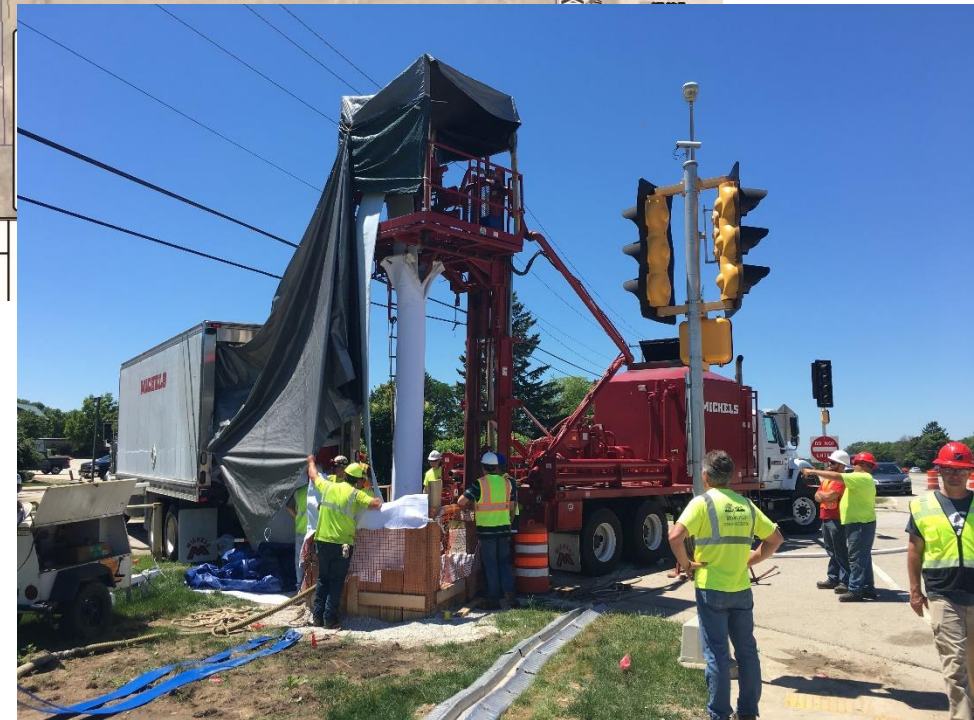
## Lessons Learned - continued

- Hymax coupling repair sleeve on 16" had bolts that protruded into pipe to keep pipe from pulling out of the coupling.
  - Cured-in-place point repair installed over bolts to protect the CIPP
- Liner defects observed during QA/QC inspection prior to lining; liner was replaced and resulted in a 1 week delay
