# SAWS SSO Reduction Program Overview

Jeff Haby, P.E.

Albert Rodriguez, P.E.

UCTA National Conference

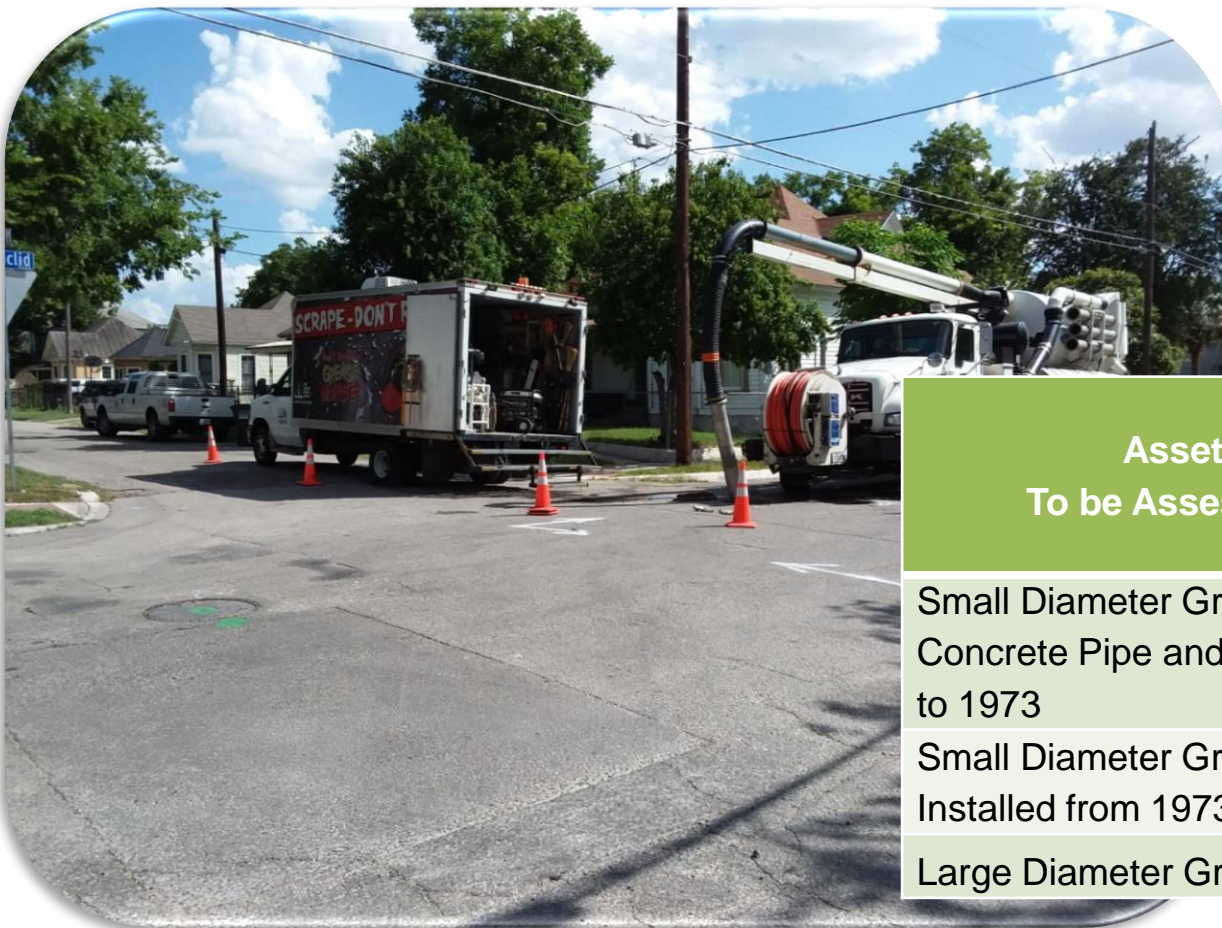
# Condition Assessment

## CCTV, Sonar or Pole Cam

Asset Description To be Assessed by July 2017	Miles of Inspections Required Under CD	Miles of Inspections Completed	% Complete
Small Diameter Gravity Sewer - EARZ, Concrete Pipe and Clay Pipe Installed Prior to 1973	1,869	1,909	102%
Small Diameter Gravity Sewer - Clay Pipe Installed from 1973 through 1982	410	411	100%
Large Diameter Gravity Sewer	364	378	104%

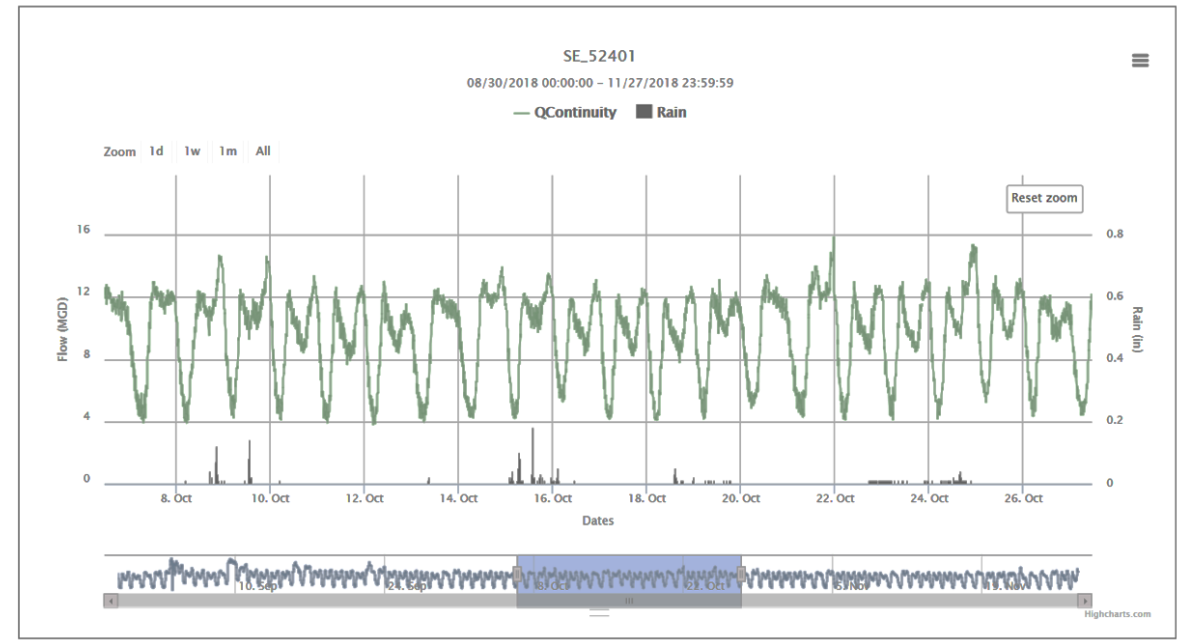
# Flow Monitoring

## Wet Weather Response – Poor Performing Area

## Wet Weather Response – Well Performing Area

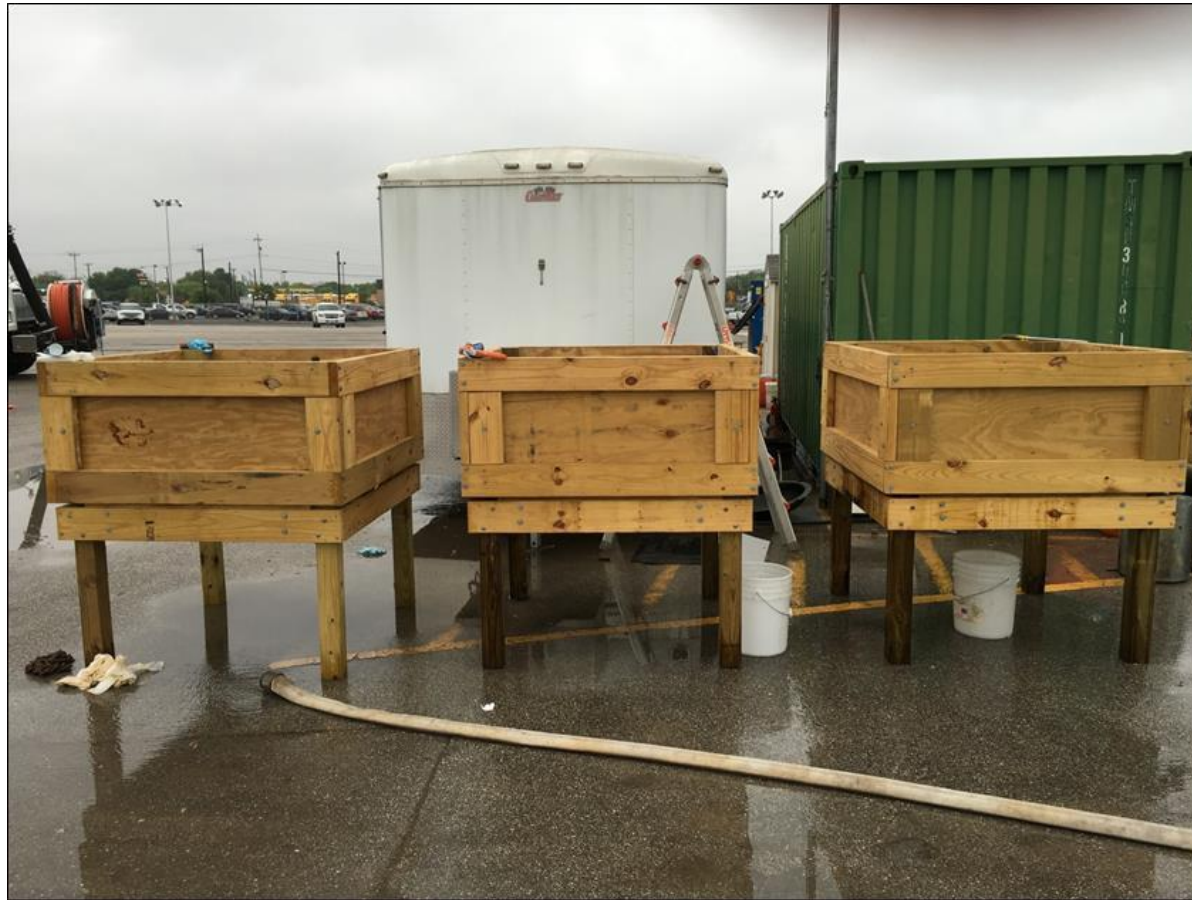
## Manhole Inflow Testing

Plan (Top) View

Section View

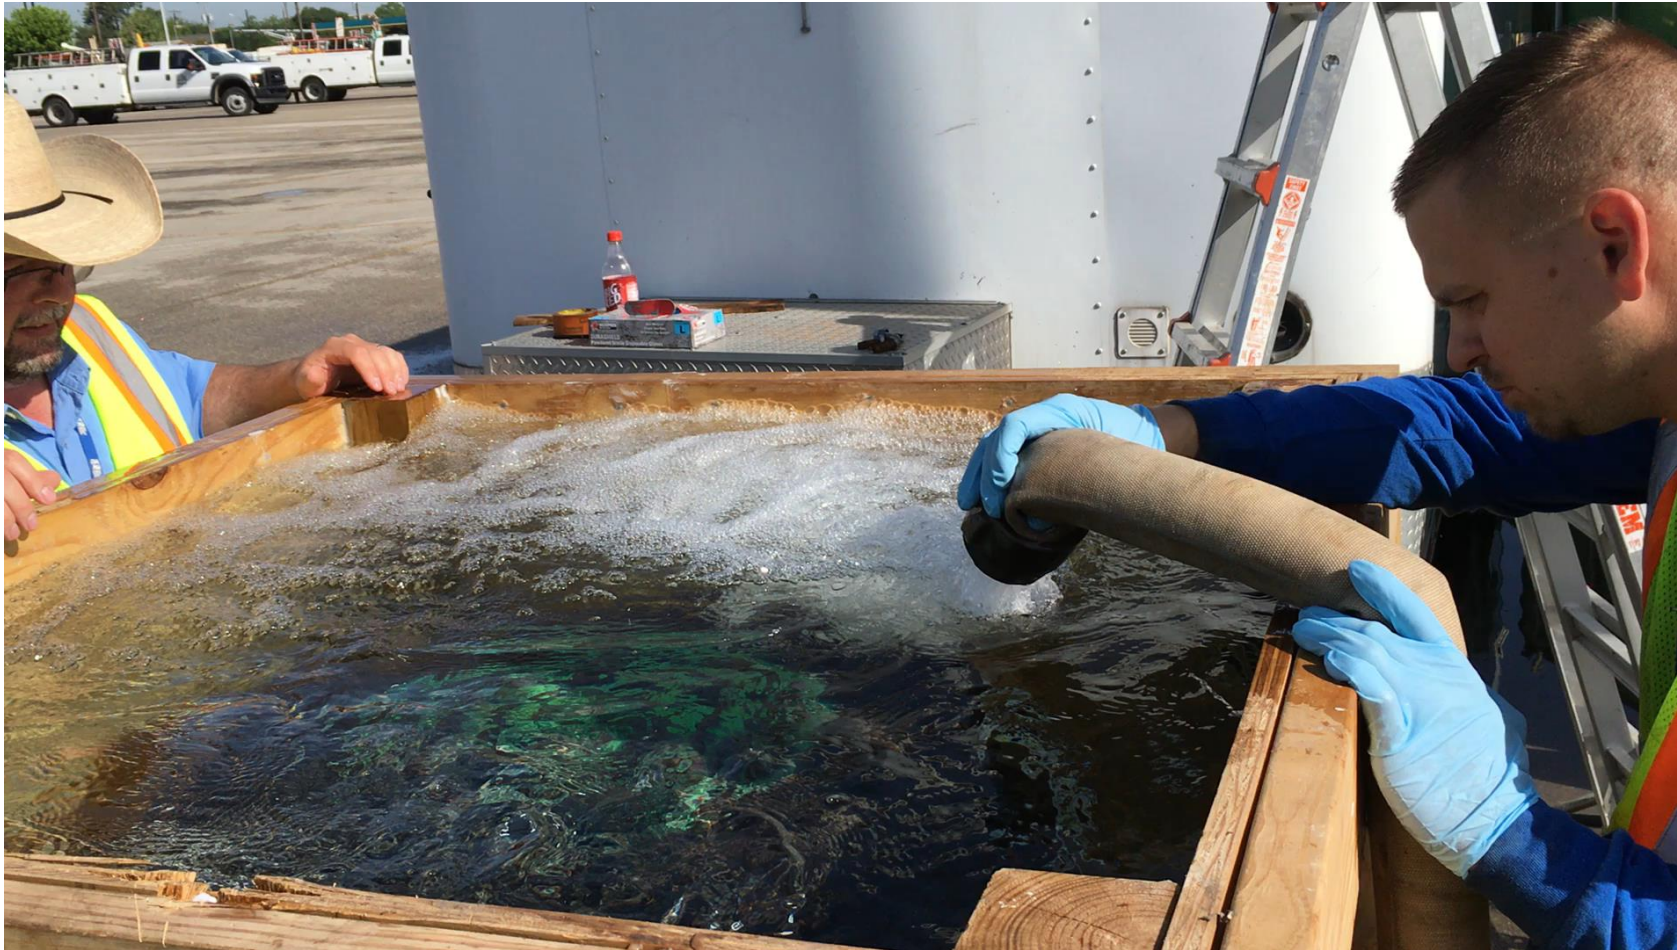
# Bad Performance | 22 GPM at 12" Submergence

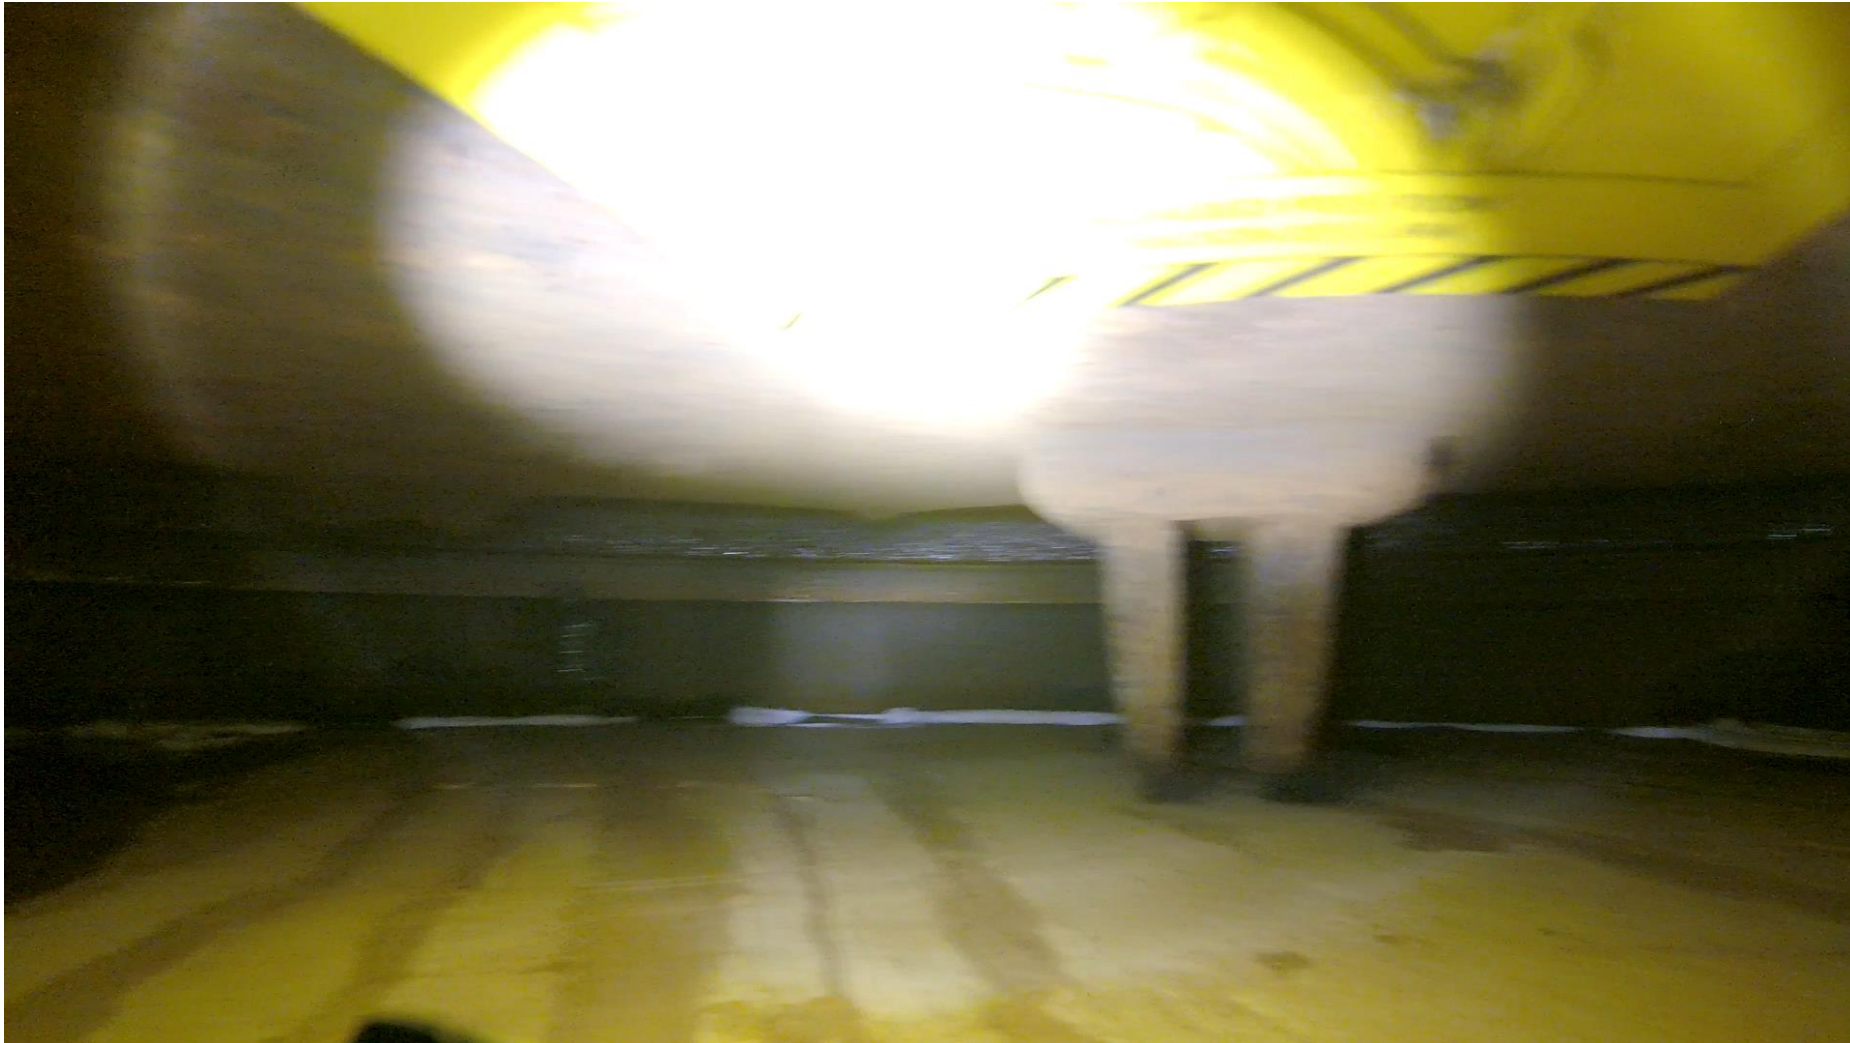
# Good Performance 0.005 GPM at 12" Submergence

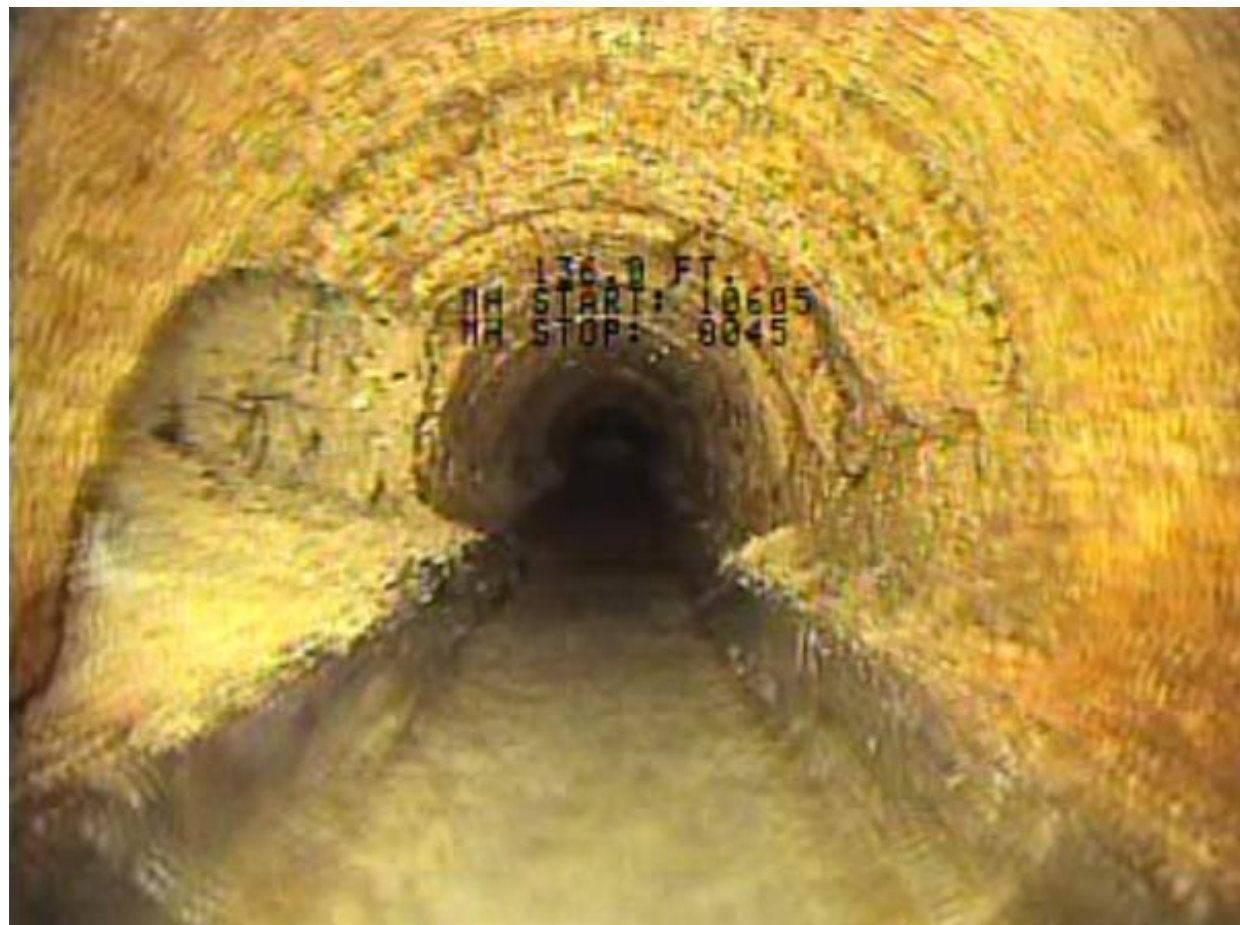
# CCTV

## PACP and SAWS Grading System

- Grading System
  - A – Very Good
  - B – Good
  - C – Fair
  - D – Poor
  - E – Very Poor
- PACP Coding
  - All CCTV is stored within a NASSCO compliant database
