# What Lies Beneath?

## Identifying and Maintaining Buried Wastewater Assets

North Texas Municipal Water District's  
Condition Assessment Program

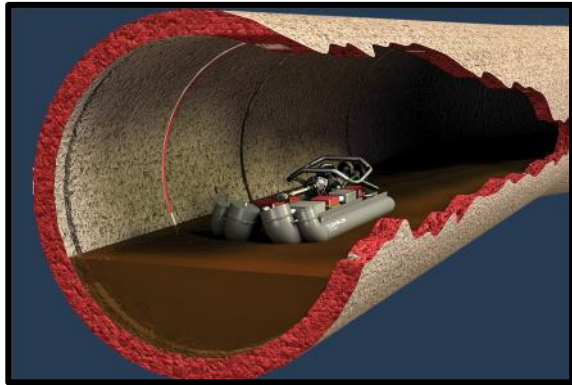
Multi Sensor Inspection (MSI)

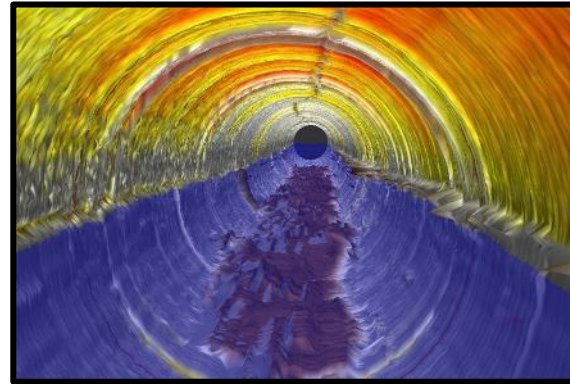
3D Laser Inspection

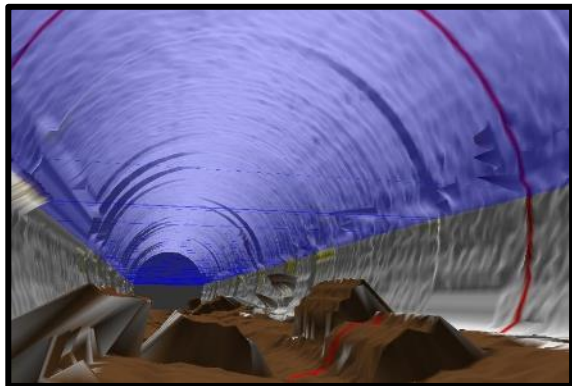
Sonar Inspection

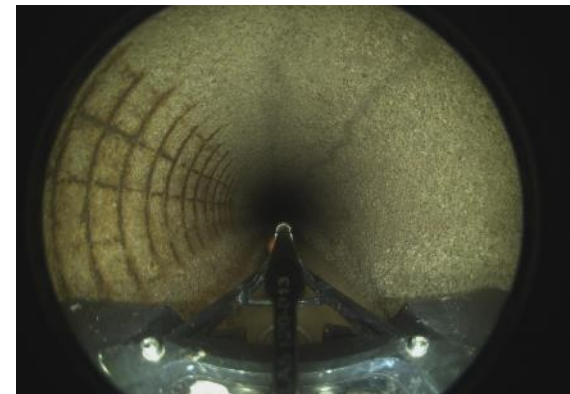
HD Video

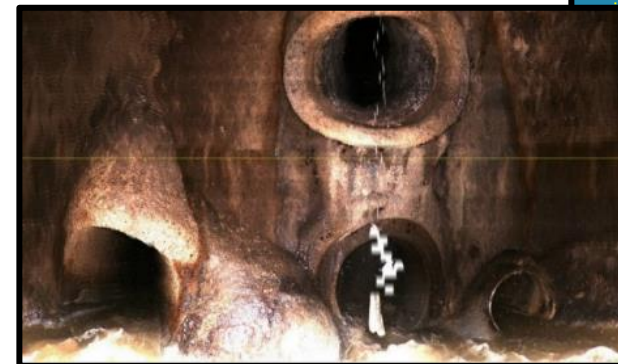
Digital Manhole Inspections

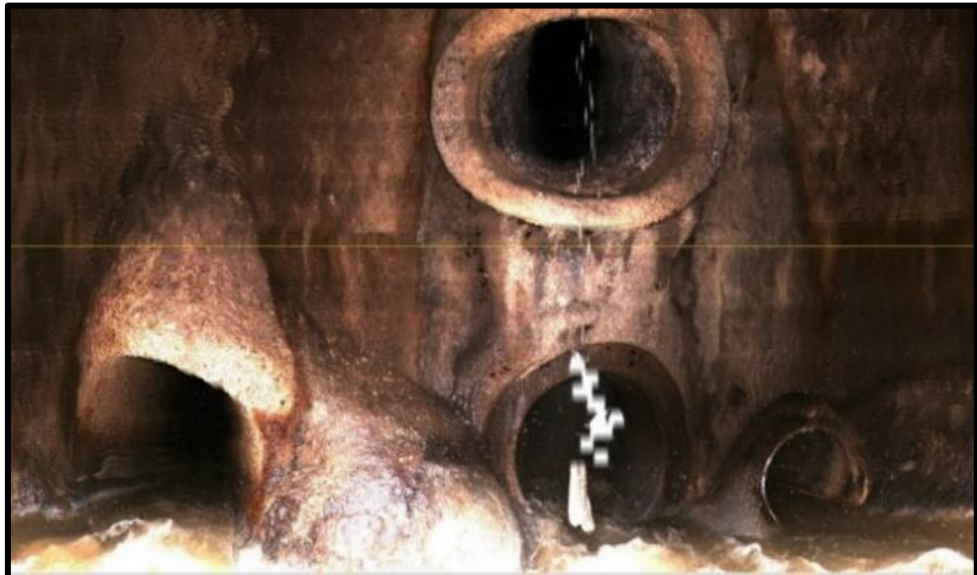
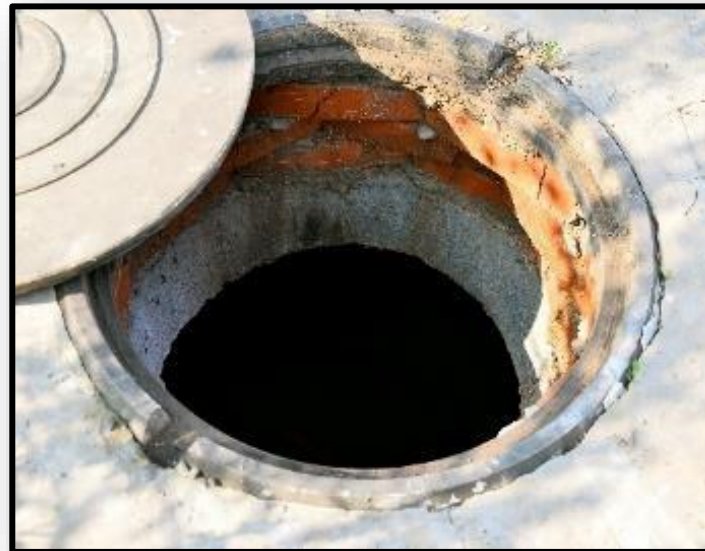
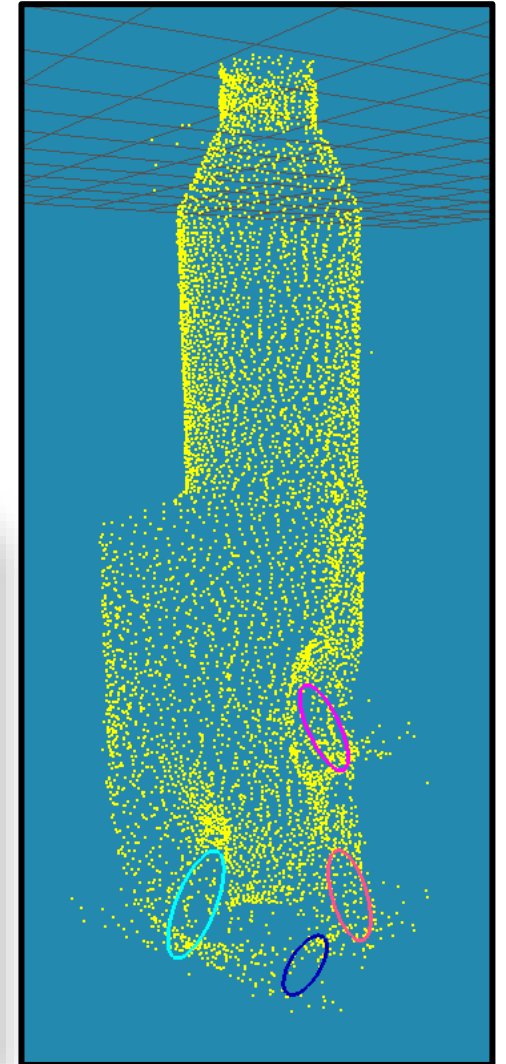
- Accurate point cloud measurements
- Identify defects, pipeline locations and inverts, manholes, and lining materials
- No manned entry required
- Integration into CCTV management software

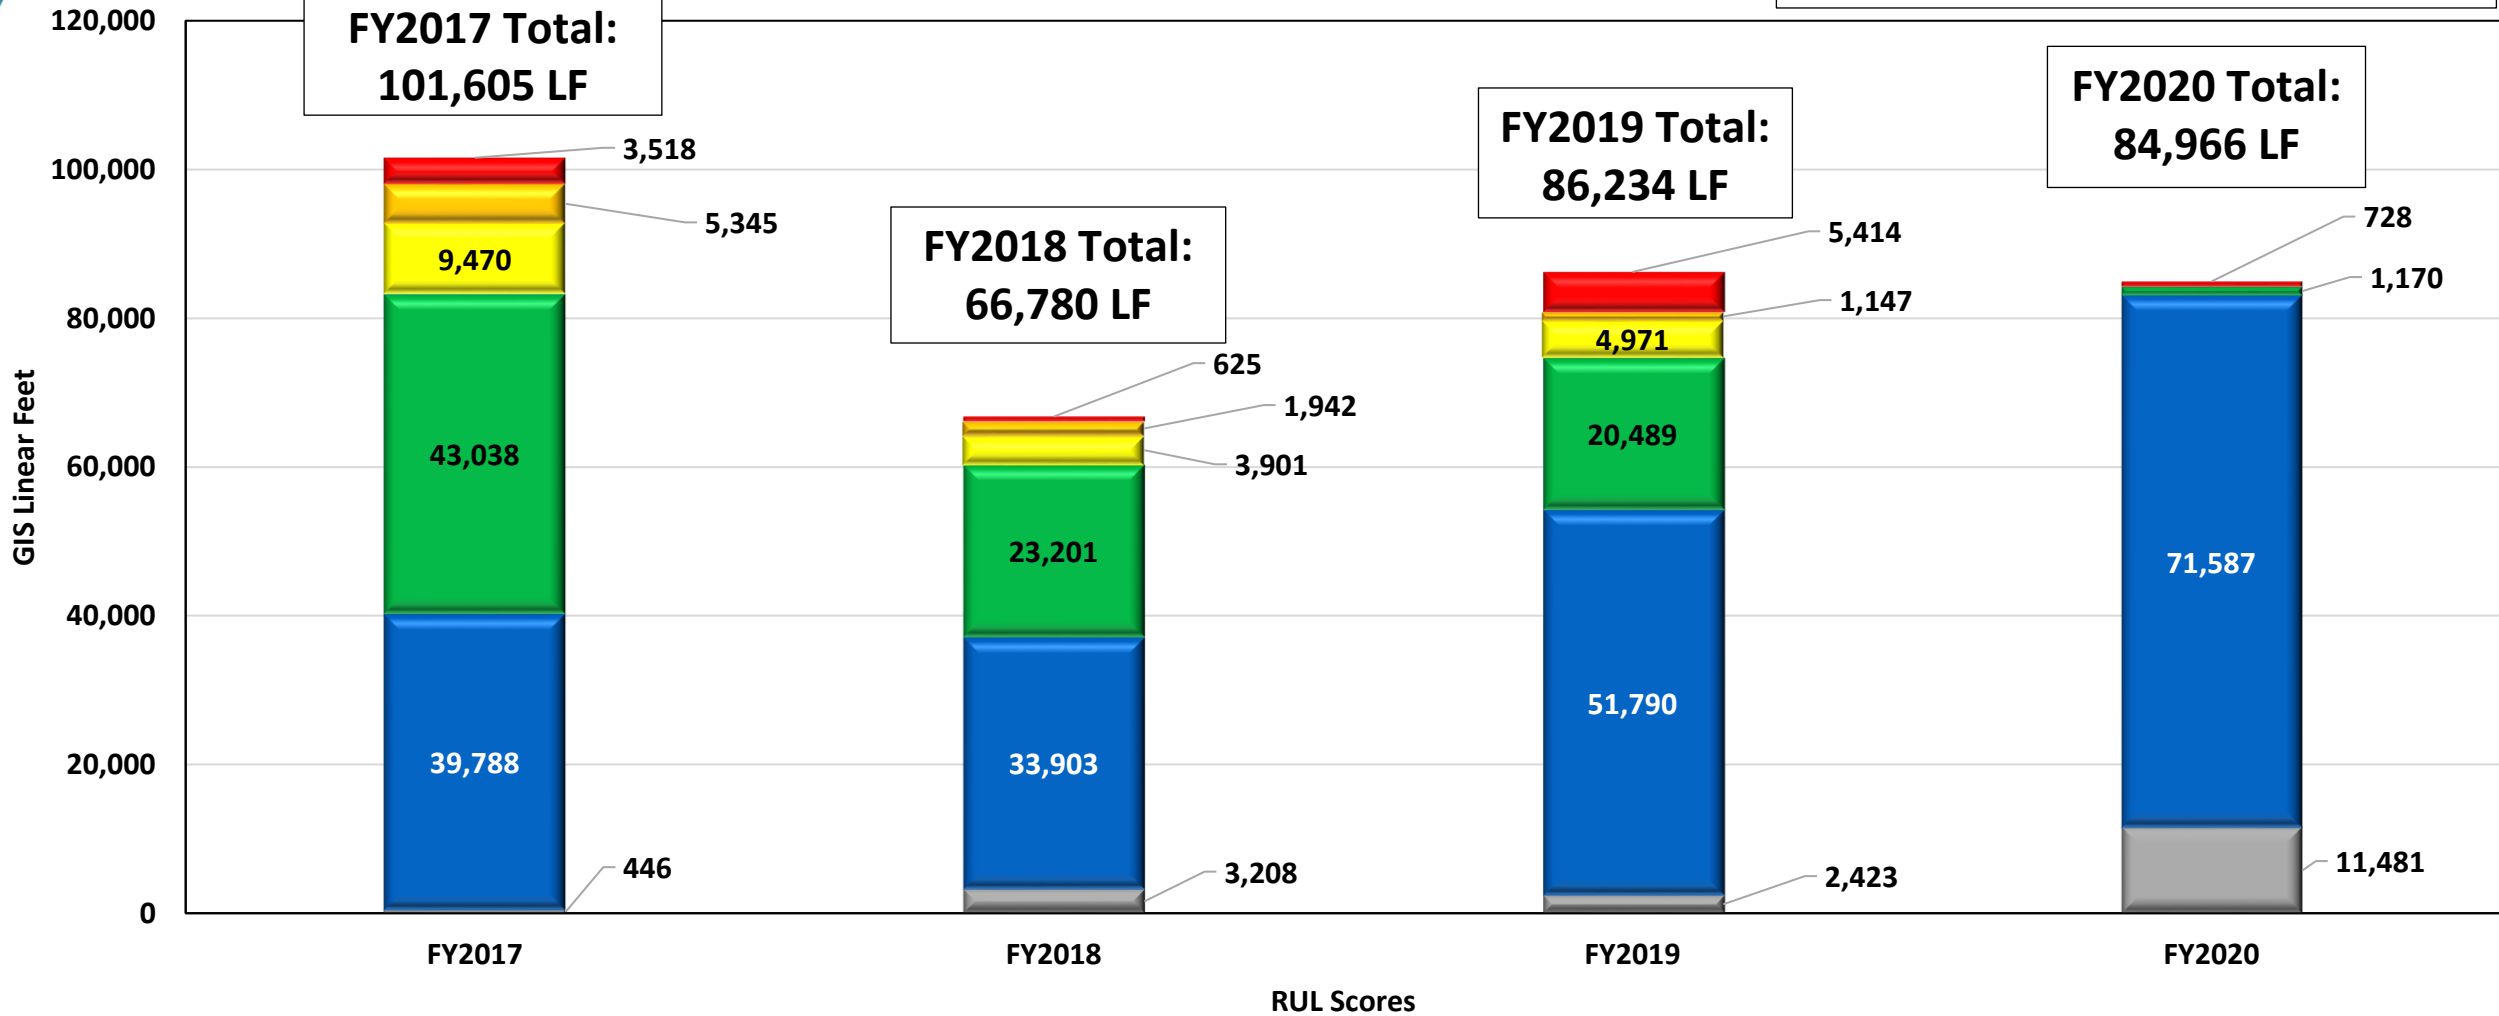
339,585 LF Inspected of 710,000 LF Total  
48% Complete

■ Sonar Only ■ 1 ■ 2 ■ 3 ■ 4 ■ 5

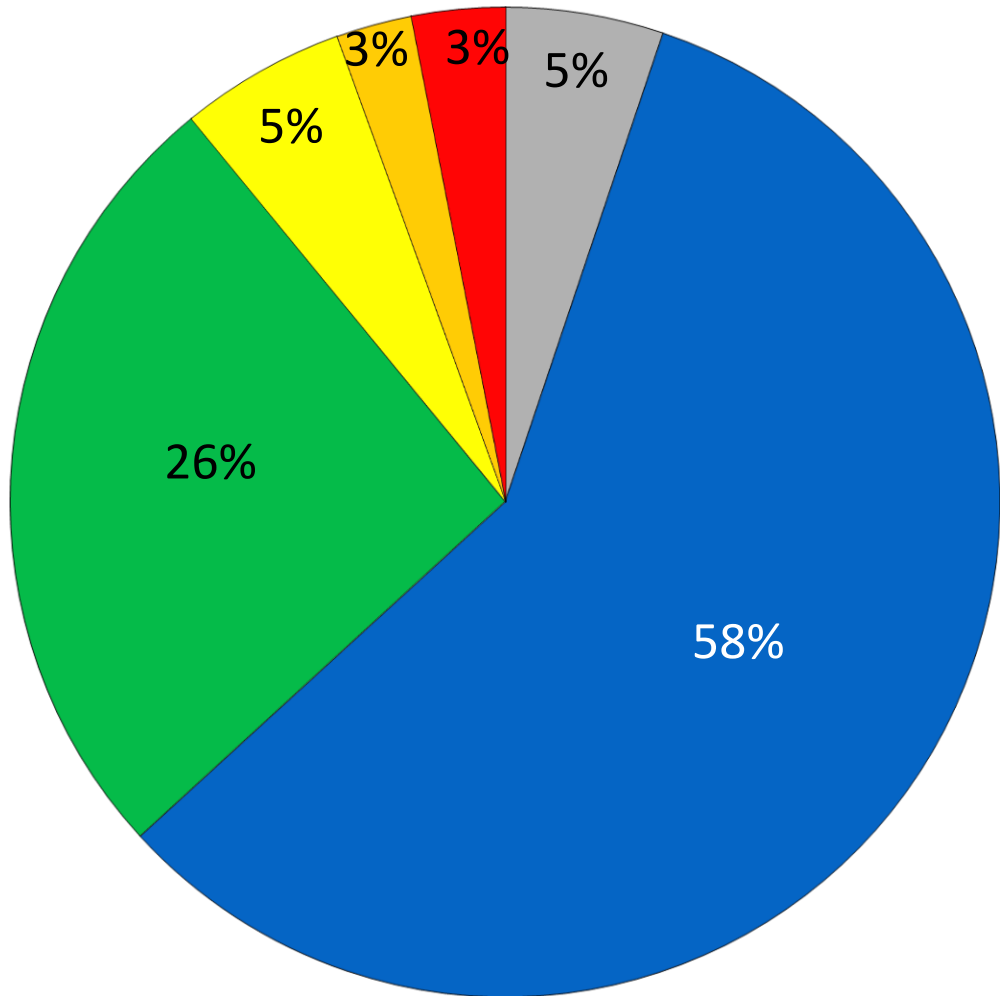
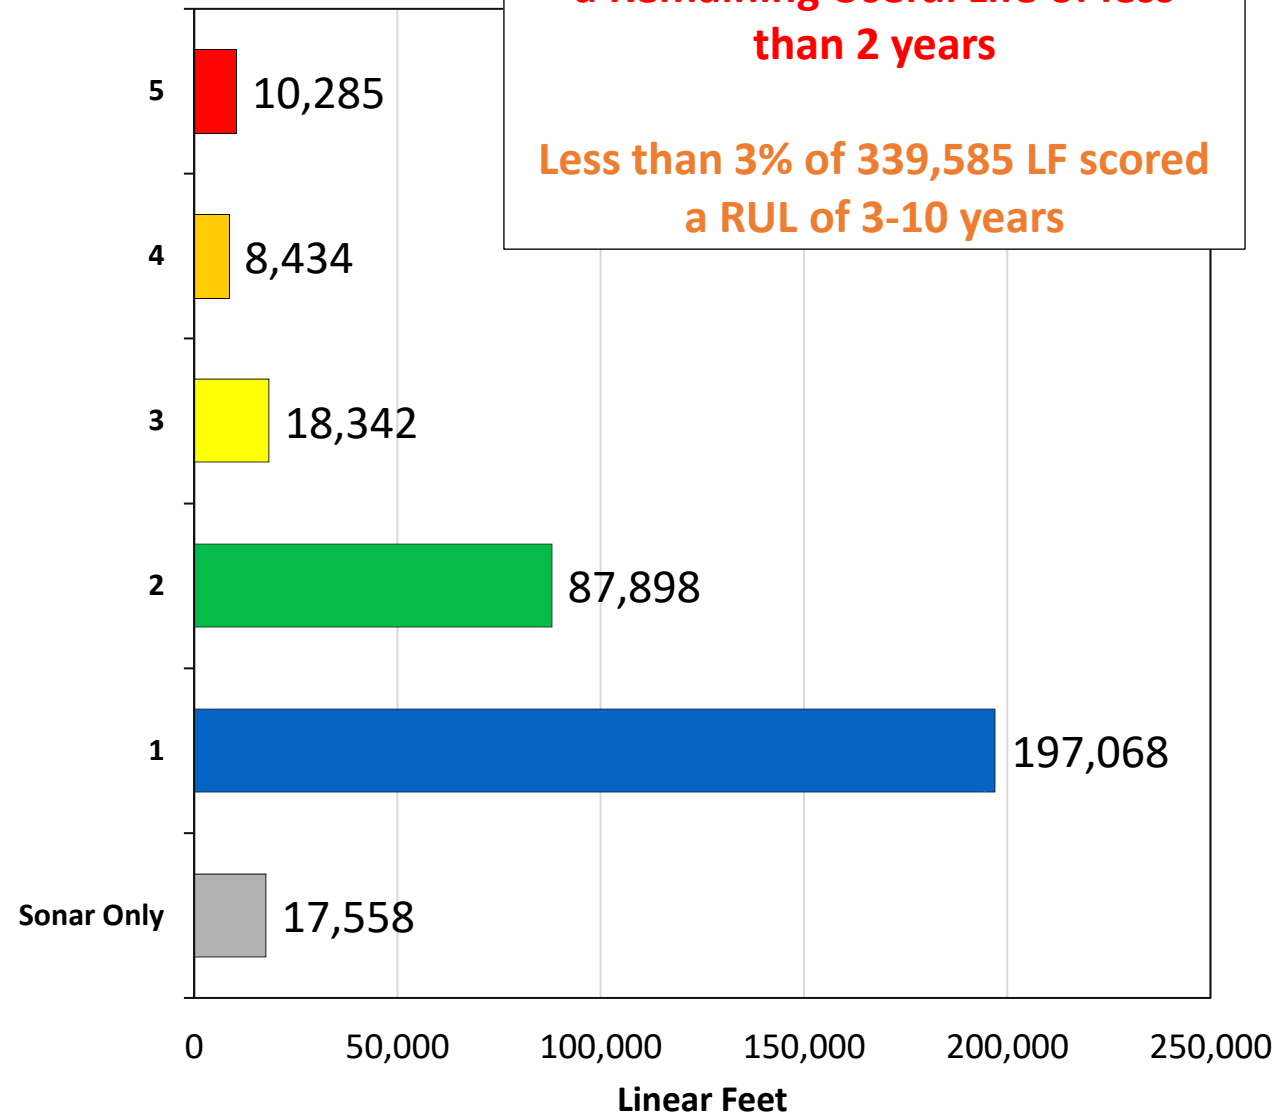
**Less than 3% of 339,585 LF scored a Remaining Useful Life of less than 2 years**

**Less than 3% of 339,585 LF scored a RUL of 3-10 years**

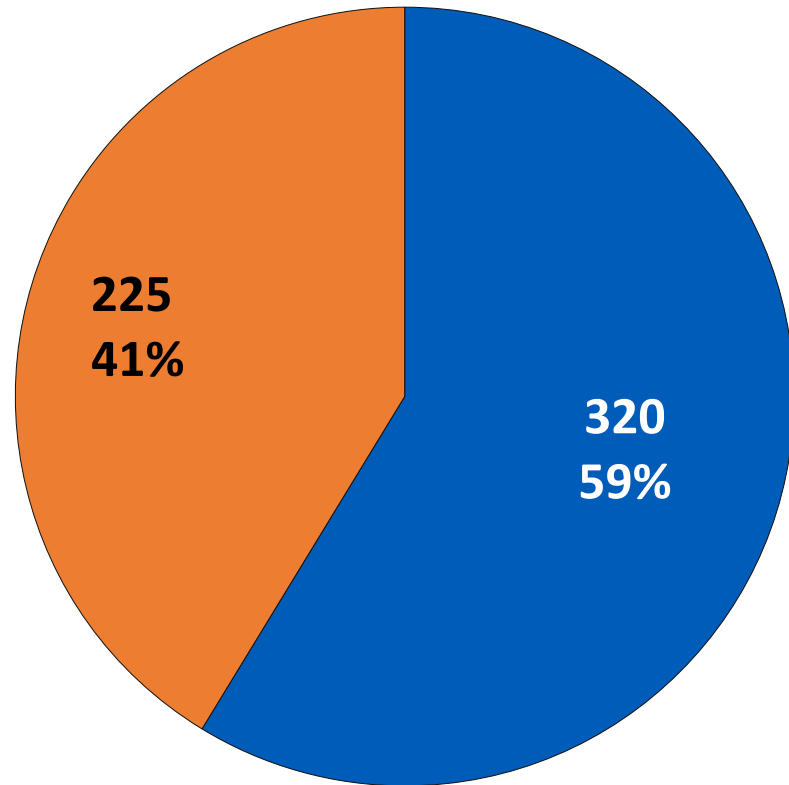
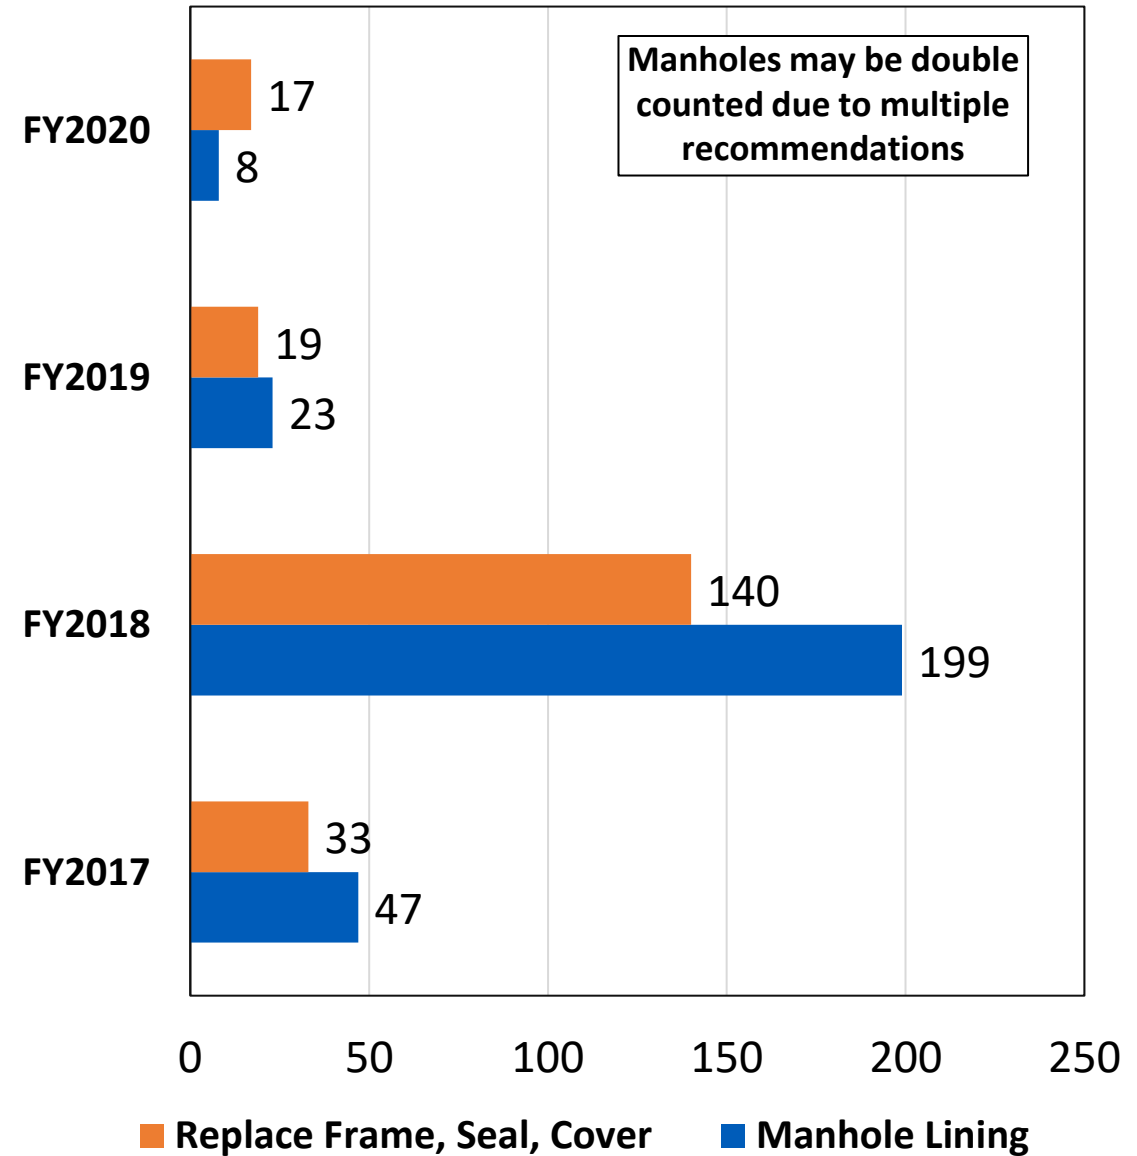
- CAP Inspections with Recommendation
- CAP Sound Inspections

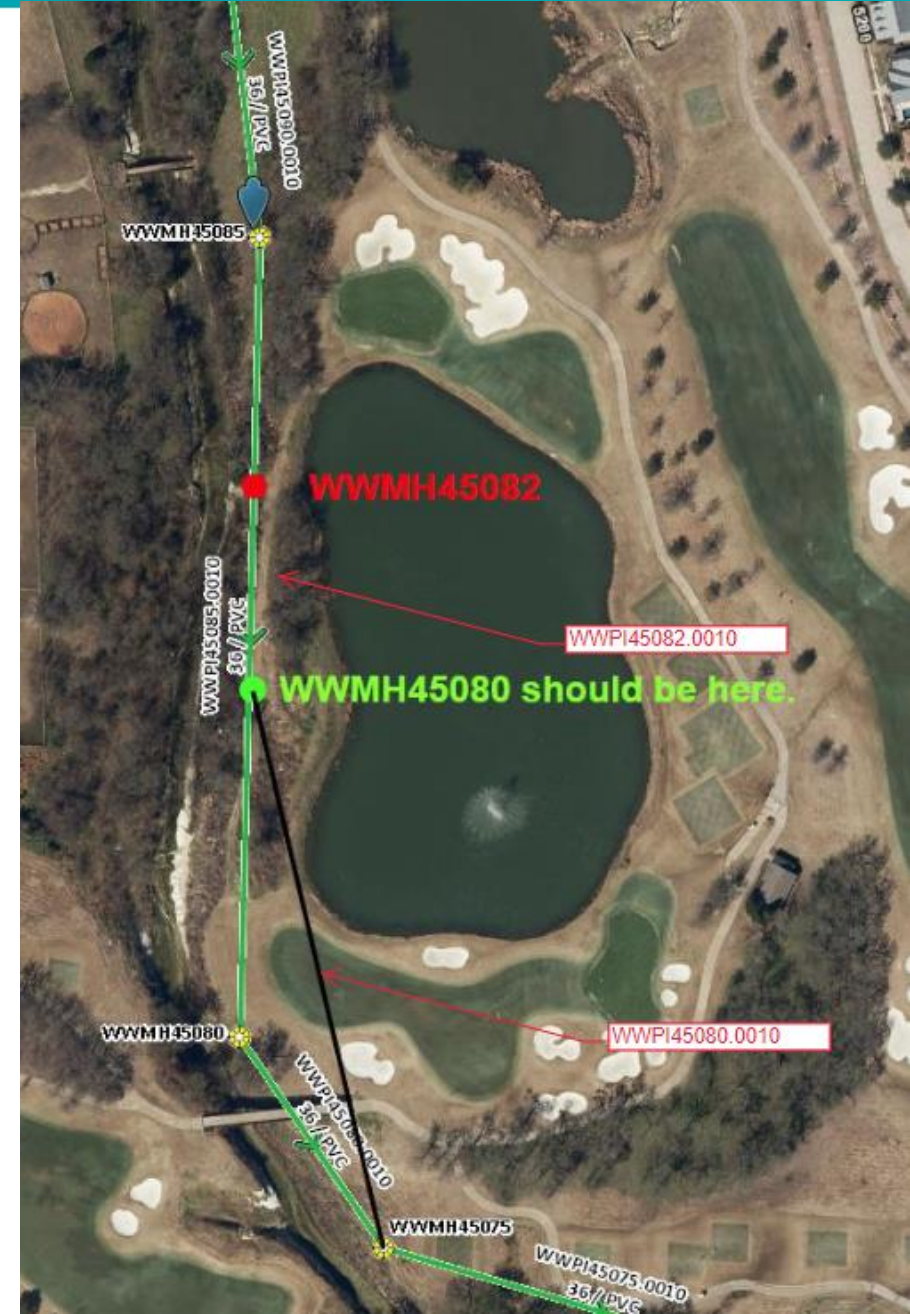
Approximately 50 manholes raised, inspected, and surveyed in FY2019 & FY2020

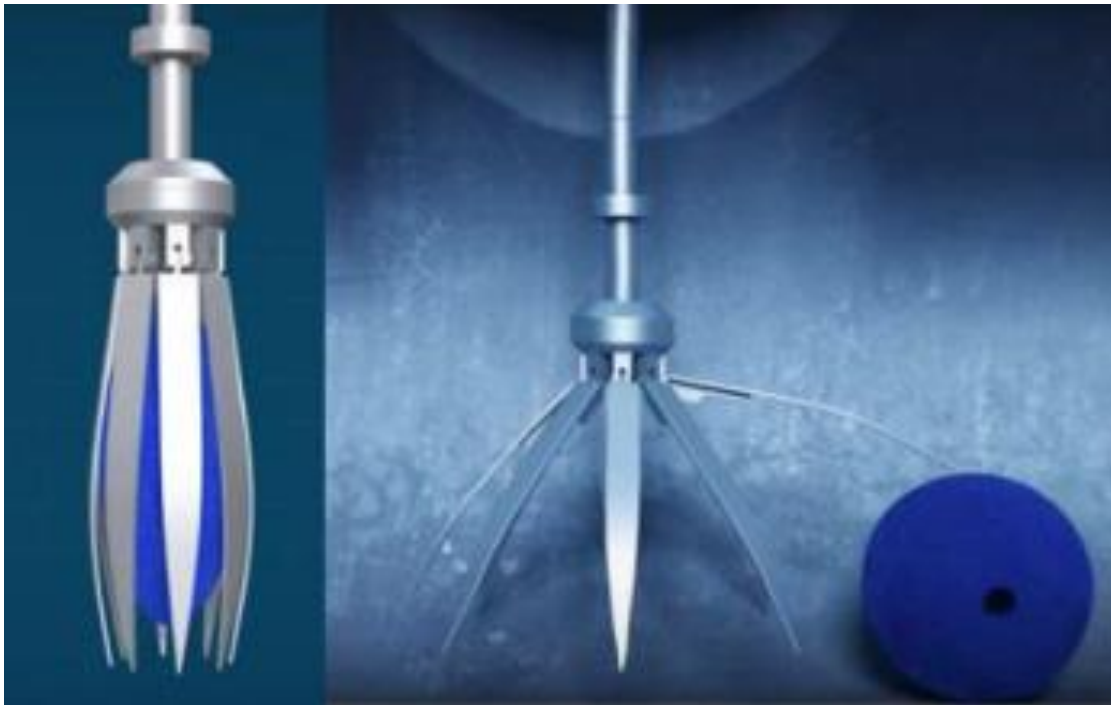
SmartBall<sup>®</sup> acoustic leak and gas pocket tool

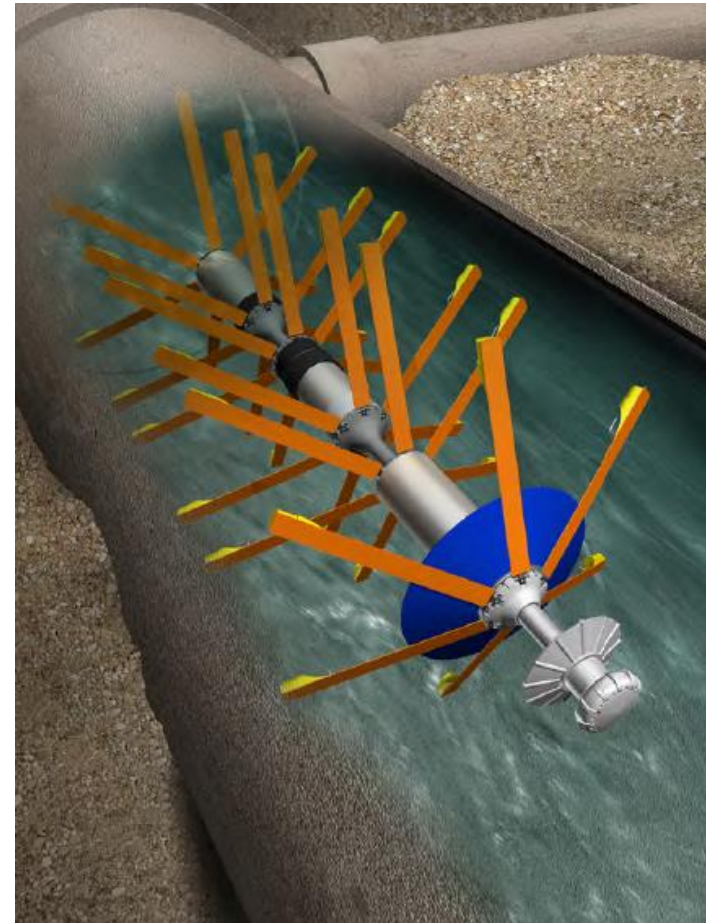
PipeDiver<sup>®</sup> electromagnetic tool

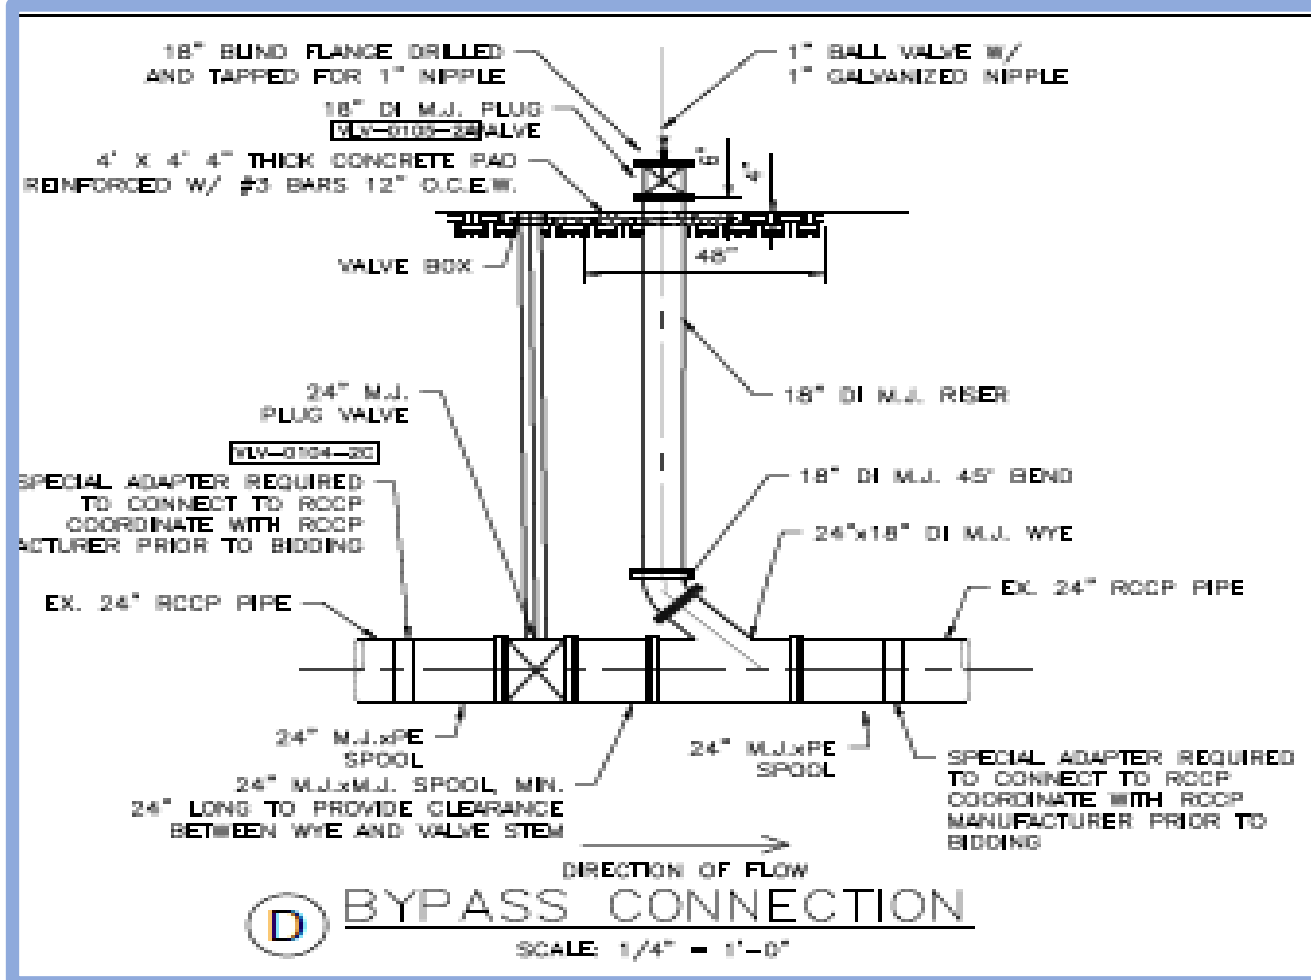
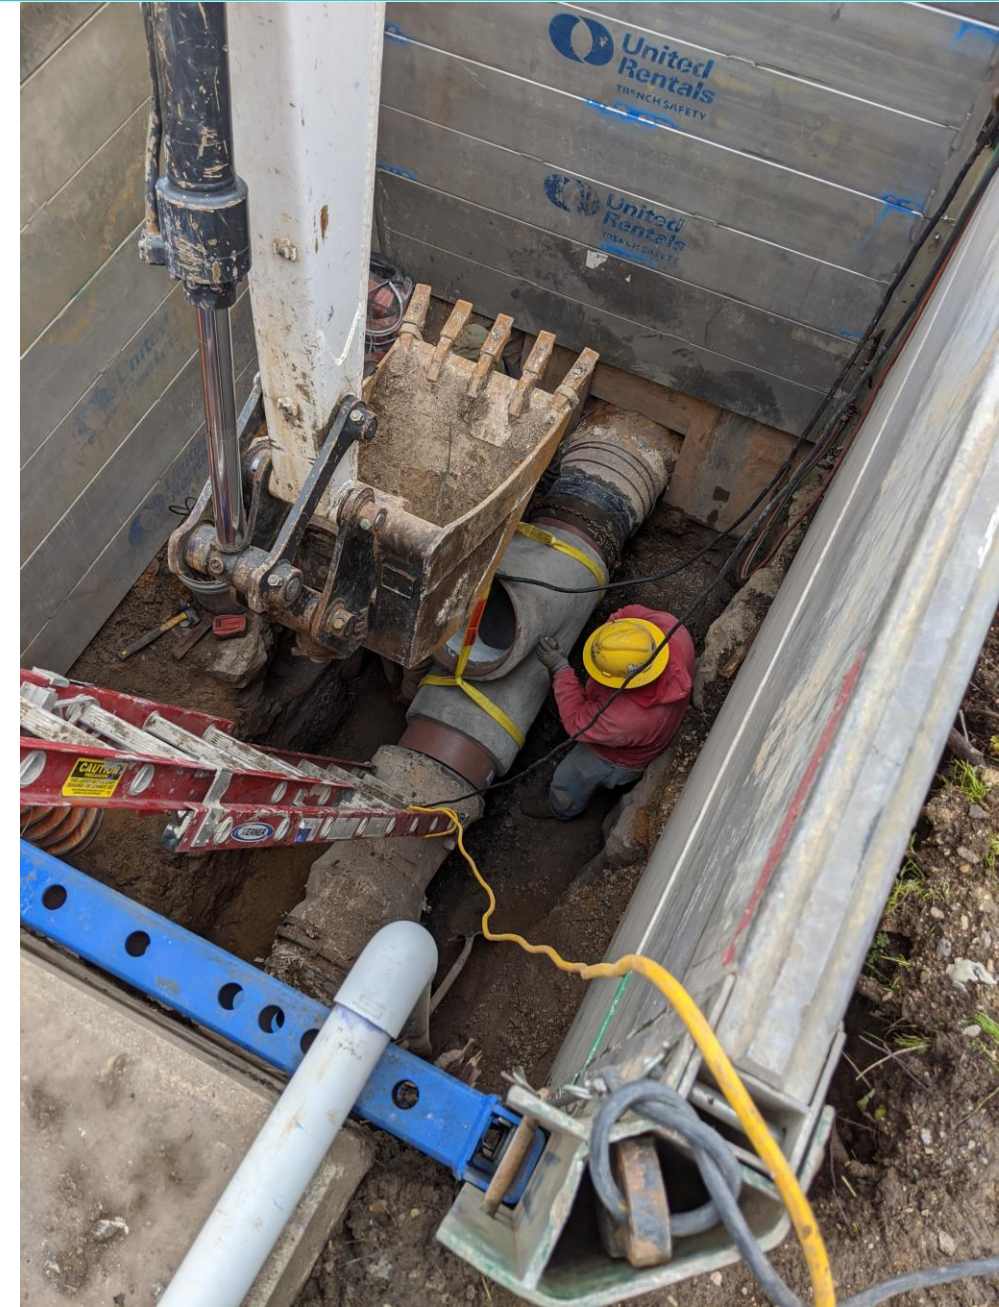
Added insertion point for PipeDiver access

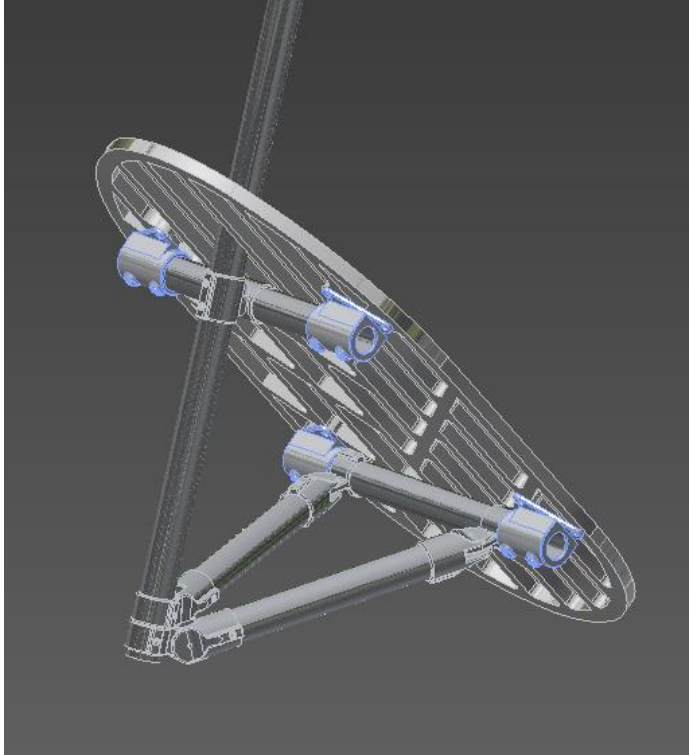
Custom fit to the discharge manhole to capture the inspection tools

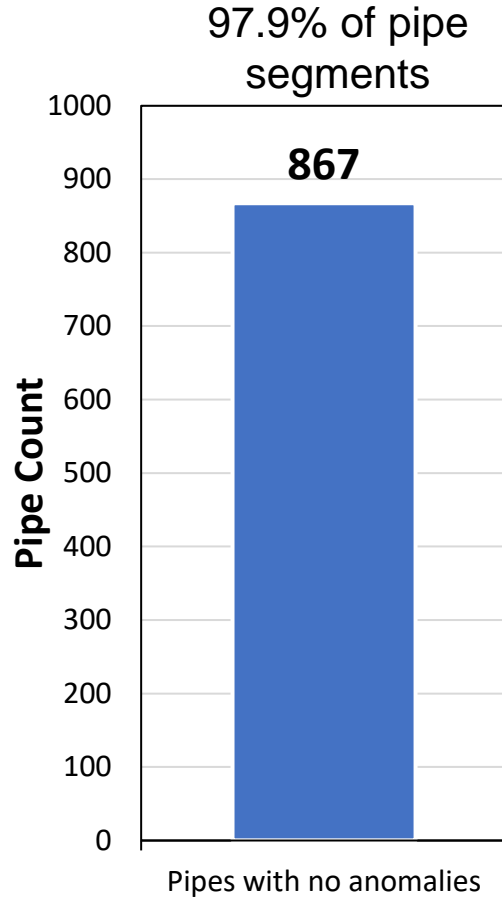
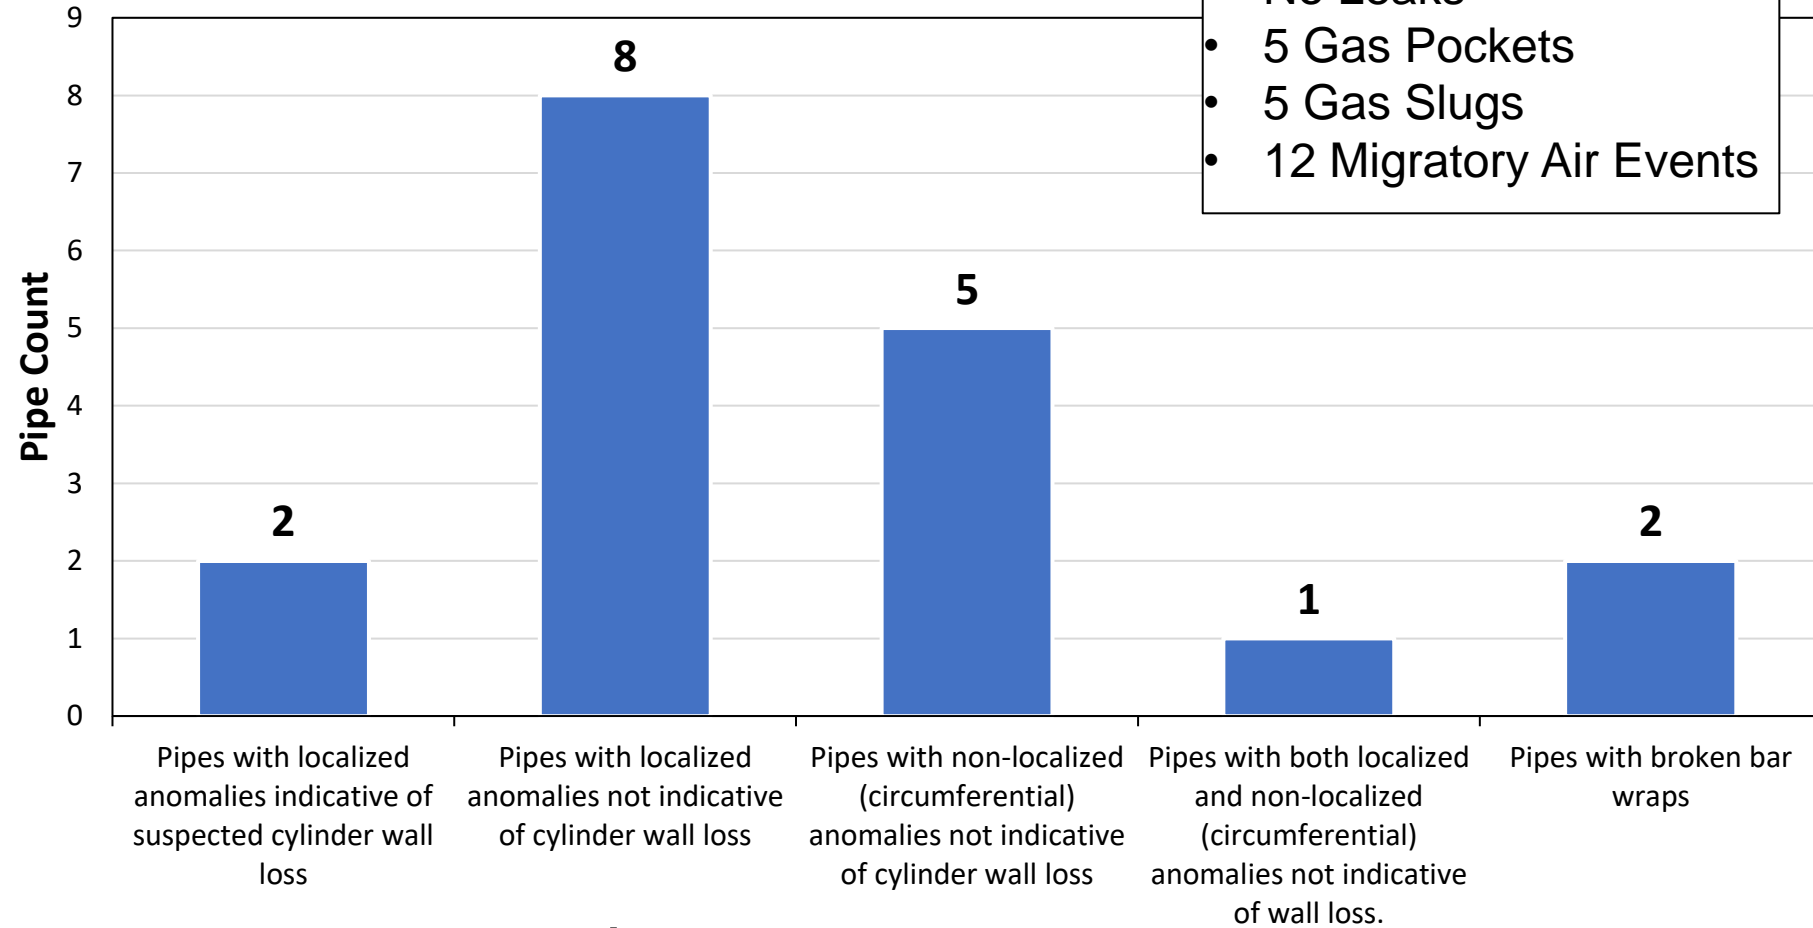
- Acoustic Results**
- No Leaks
  - 5 Gas Pockets
  - 5 Gas Slugs
  - 12 Migratory Air Events

Total number of pipe segments: 885 pipes

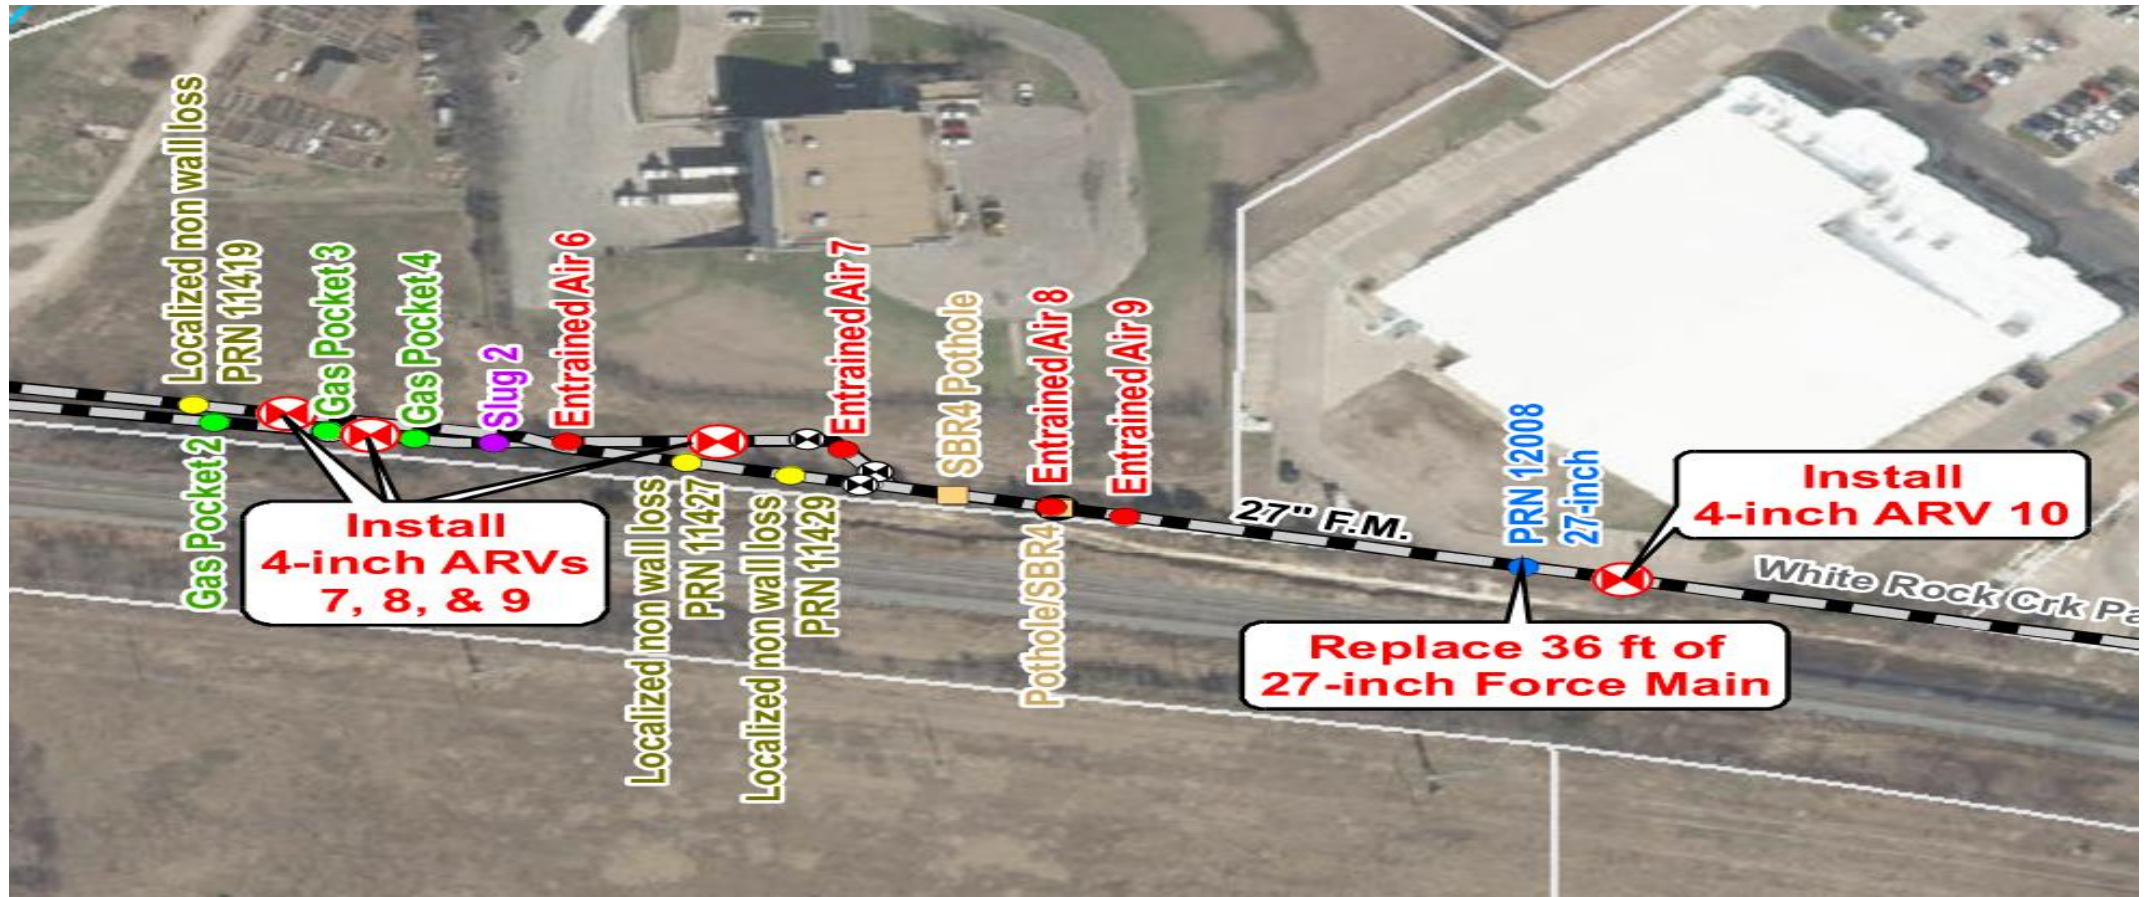
1. Identified ARV and rehab locations
2. NTMWD budgeting and planning rehab projects

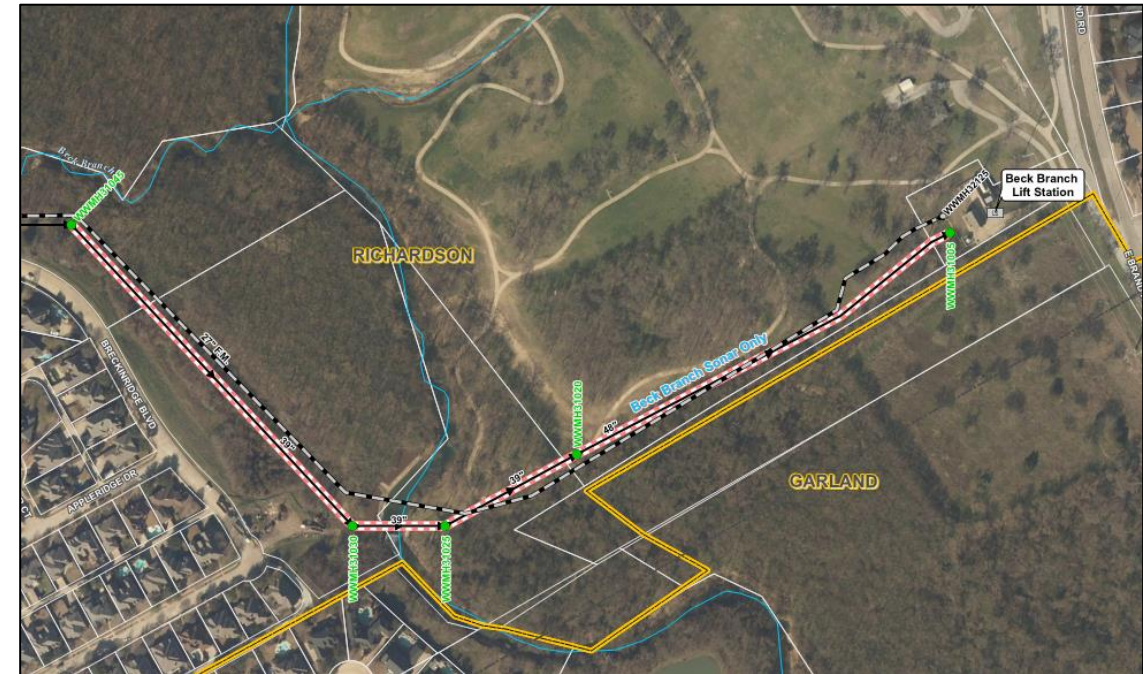
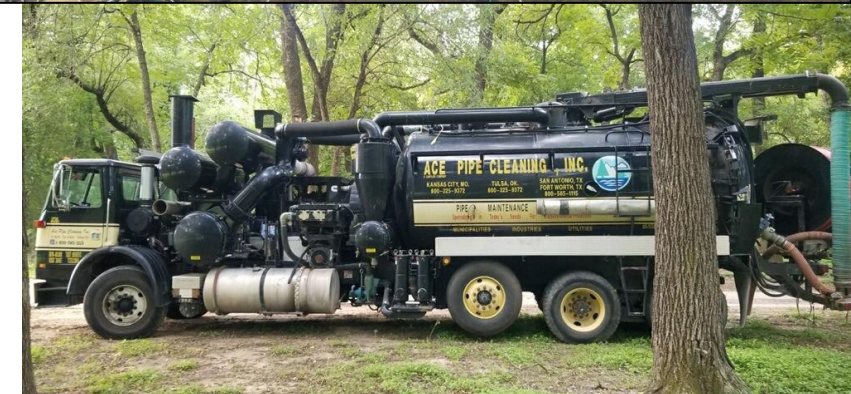
### Proactive Cleaning

- Beck Branch Interceptor
- Forest Grove Siphon
- West Rowlett Creek Siphon
