MWS PCCP Inspection Program

Metro Water Services

Critical Pipe Failure Case Study

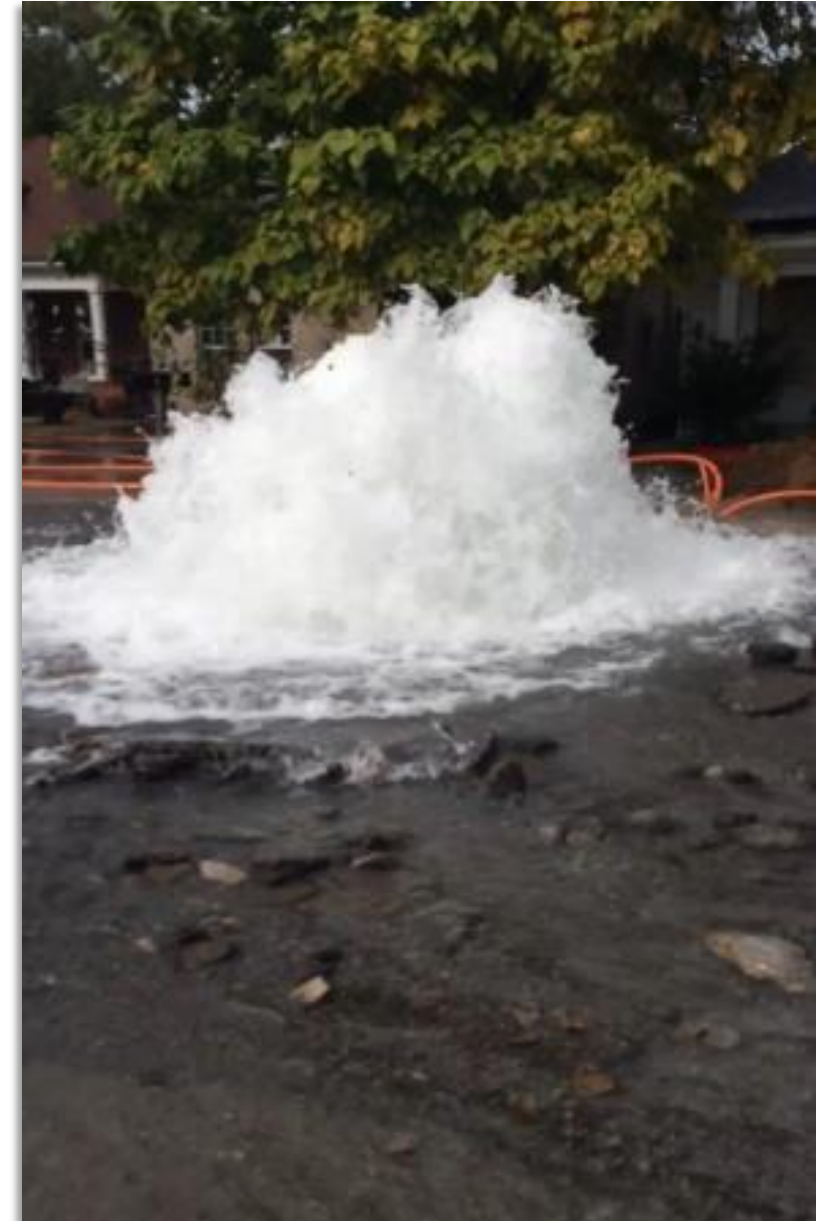
- July 30, 2014
- 30" PCCP Discharge Pipe from Thompson Ln PS
 - 1973 PCCP – Installed with Interstate 65
 - Sole feed from 3rd largest PS in system (16 MGD capacity)
- 15,000 Customers Affected
 - Less than 100 out of water completely
- 5 Day Outage

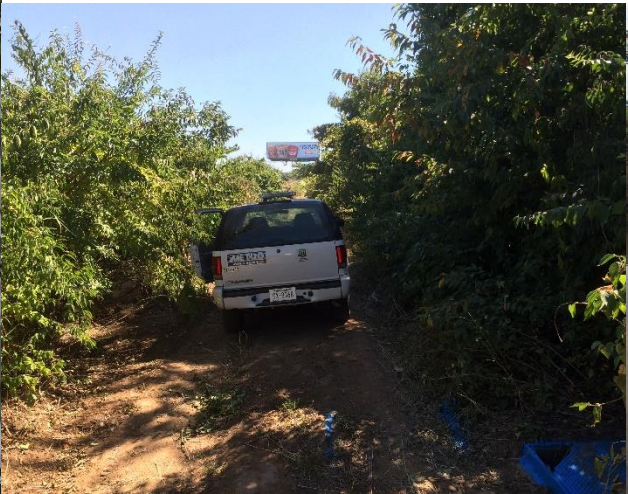
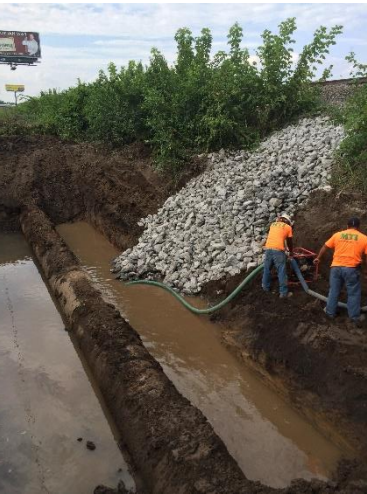
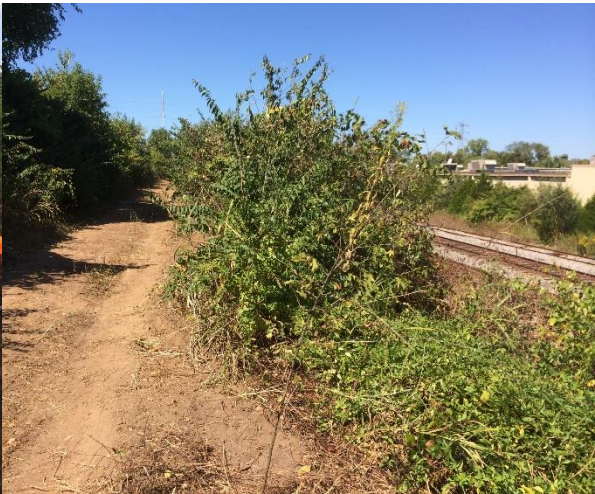
Critical Pipe Failure Case Study

- Criticality of Pipe
 - Primary feed to 15,000 customers
 - PCCP – longer repair times
 - Cross-country main located between I-65 and CSX railroad
 - Difficult to access in woods

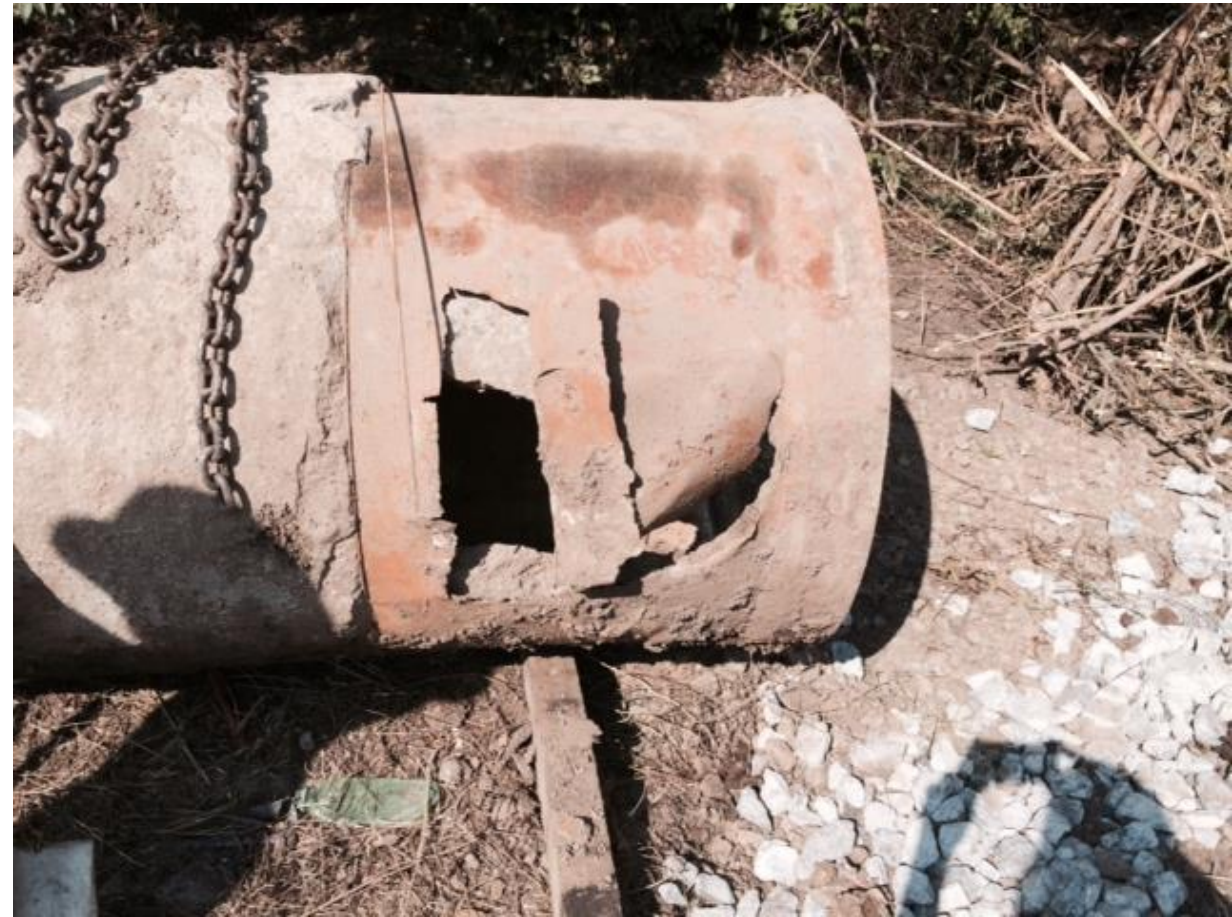
Critical Pipe Failure Case Study

- Break Location
 - Between Interstate and Railroad Tracks
- Pipe Segment Installed on Improper Bedding
 - Years of railroad vibration on rock

- Lessons Learned
 - Redundancy needed
 - Detailed installation and inspection of new mains is paramount – proper bedding is key
 - Inspection of critical mains once in service is necessary

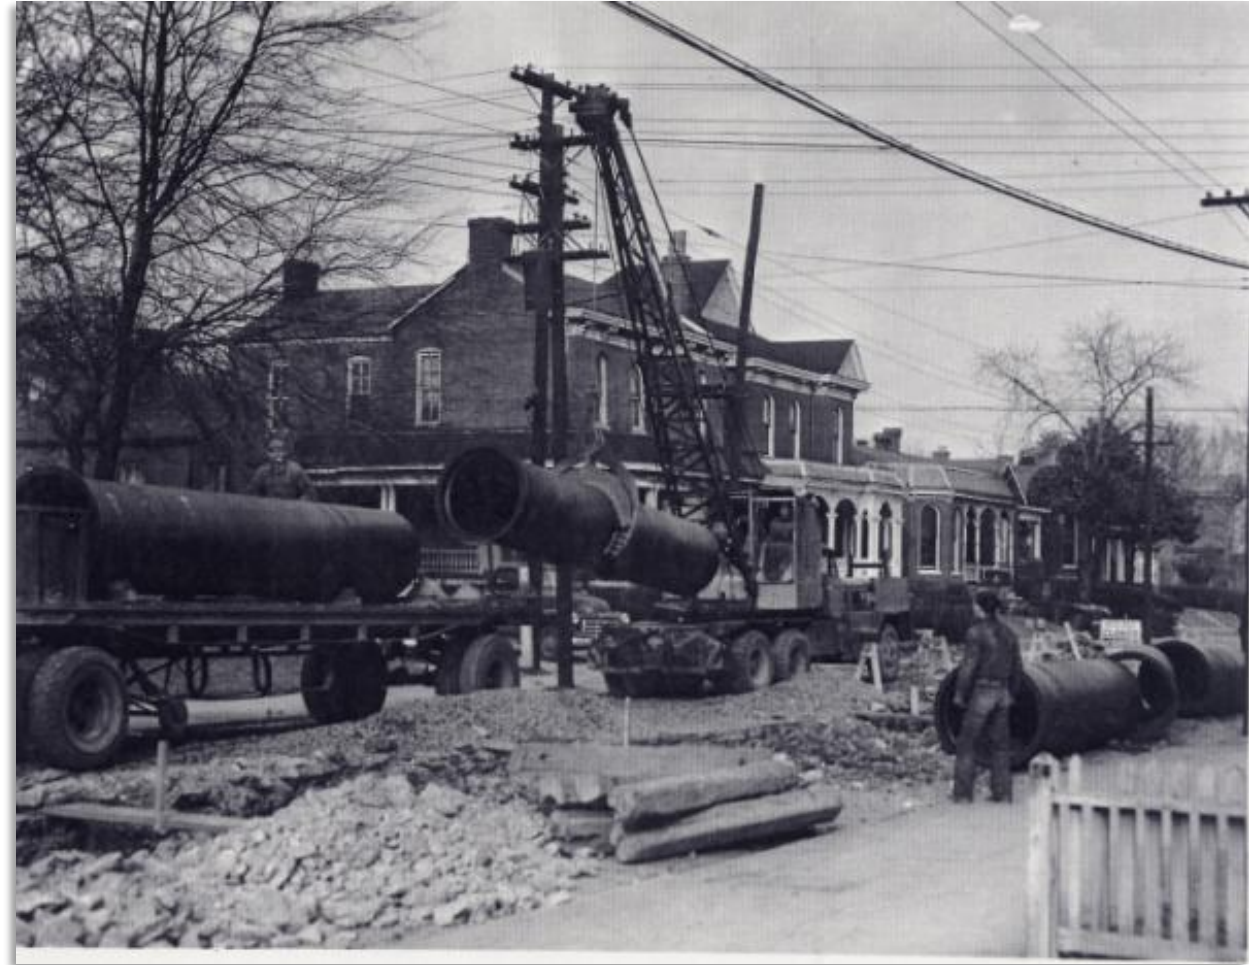
PureTech Condition Assessment

- Pressure Transient Monitoring
- SmartBall
 - Leak and Gas Pocket Detection
 - Massman 42" – 32,500 feet
 - Airport 30" – 10,400 feet
- PipeDiver
 - Electromagnetic Inspection
 - Structural Analysis
 - KR 60" – 19,200 feet
 - Thompson 30" – 5,000 feet

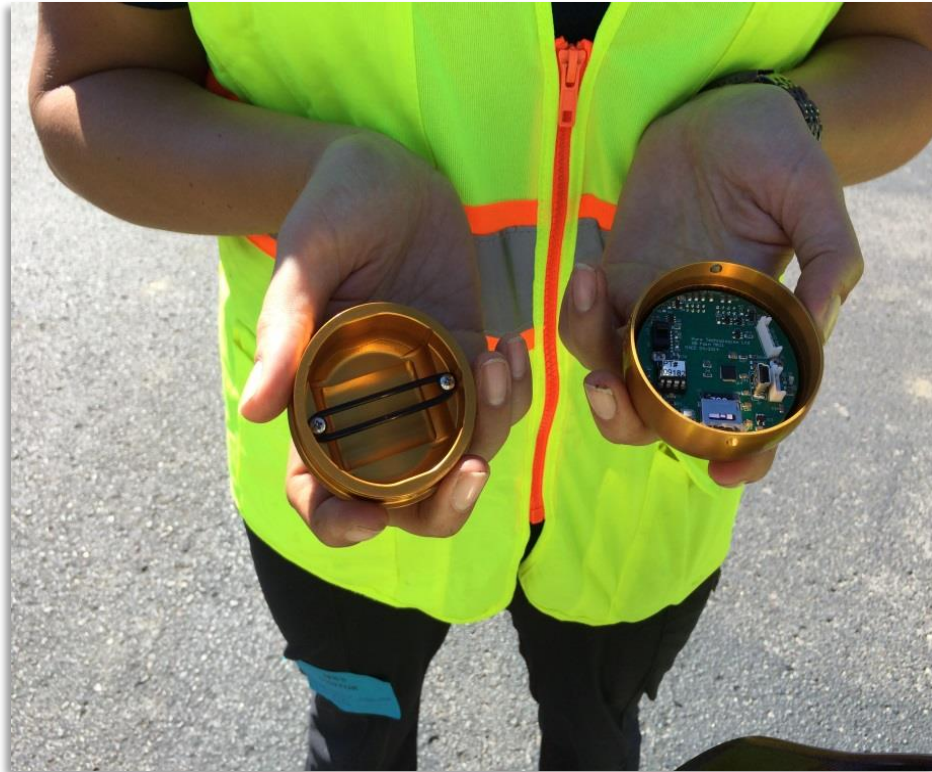
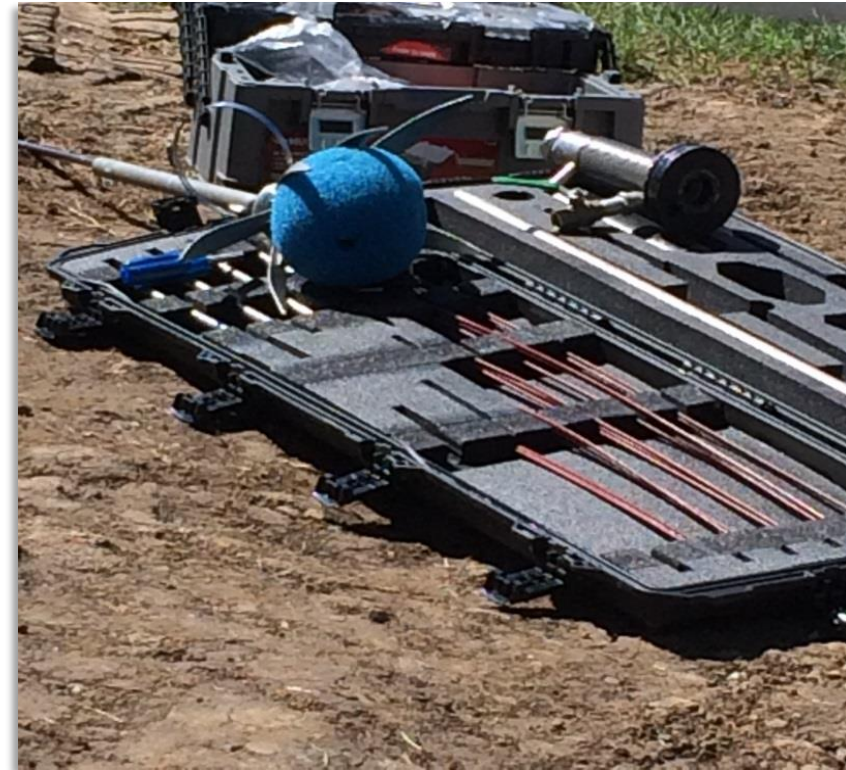
SmartBall® Leak and Gas Pocket Detection

- All pipe materials 8" and greater
- Inserted and extracted while pipe is pressurized

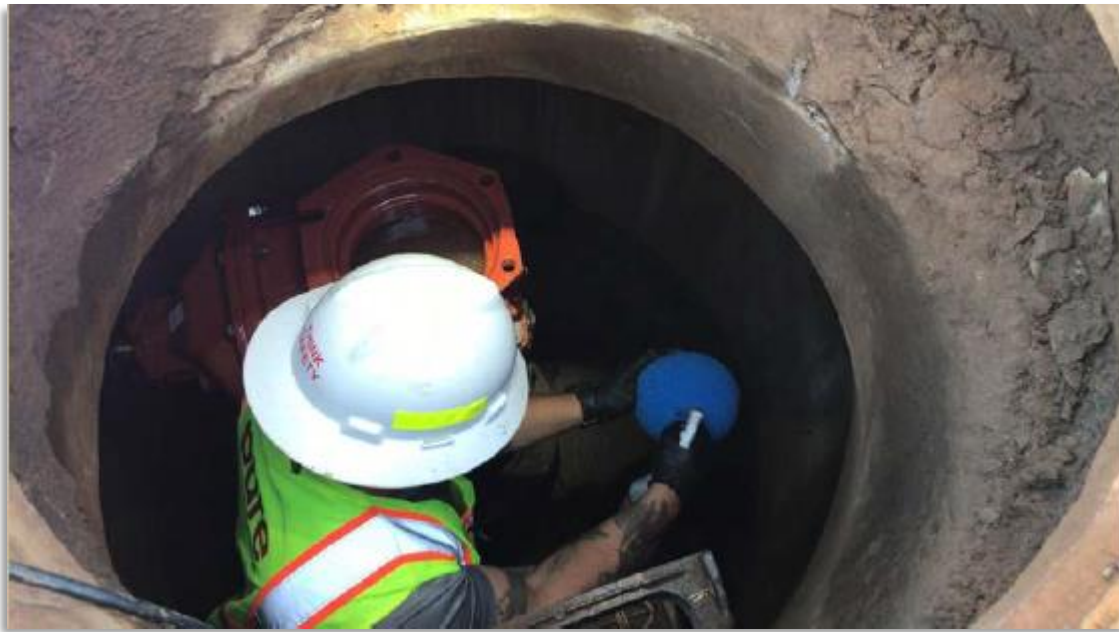
- Massman 42" – 32,500 feet

SmartBall Insertion – Massman and Airport

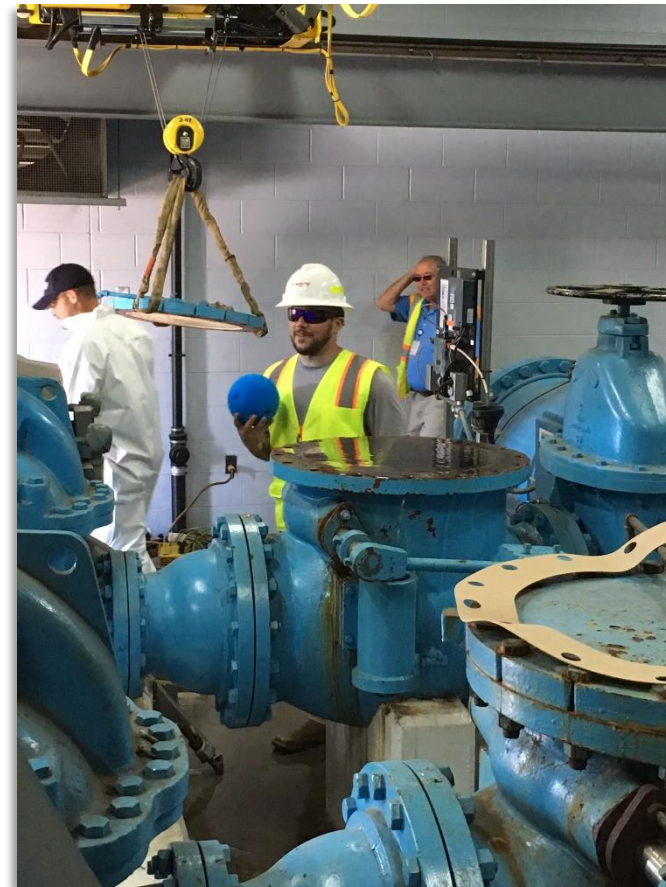
Airport 30" –
10,400 ft

Inserted at Pump
Station

- Isolated check valve and removed top flange

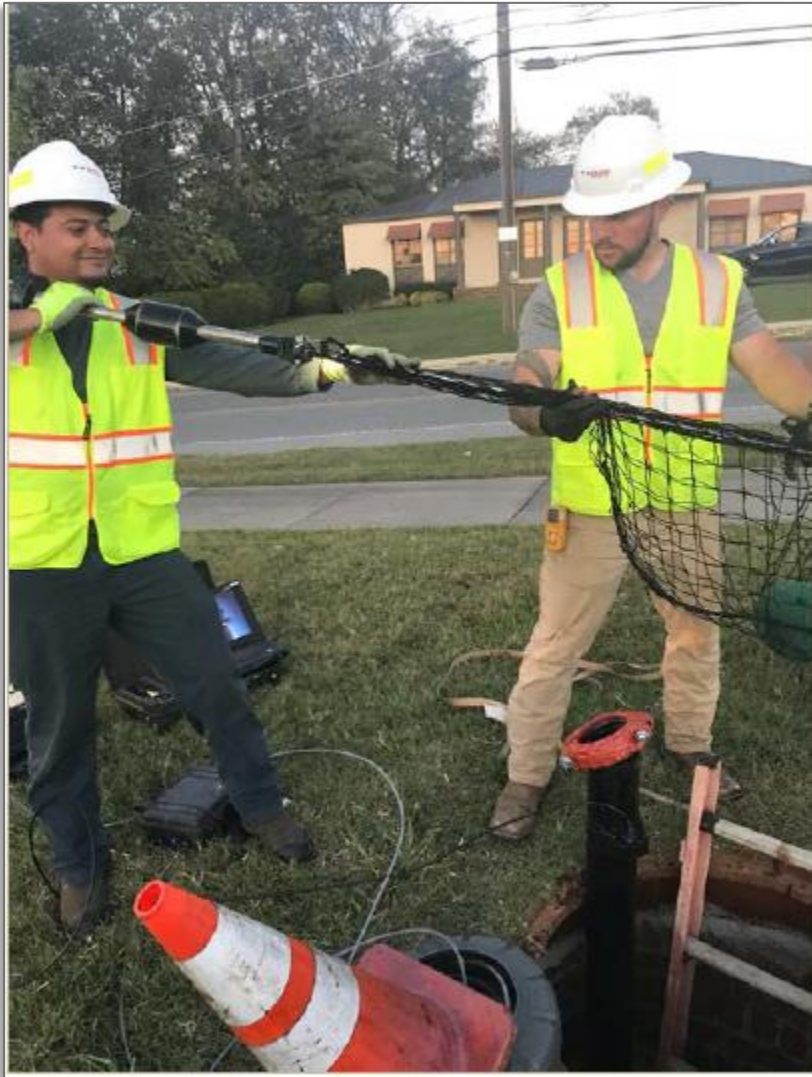
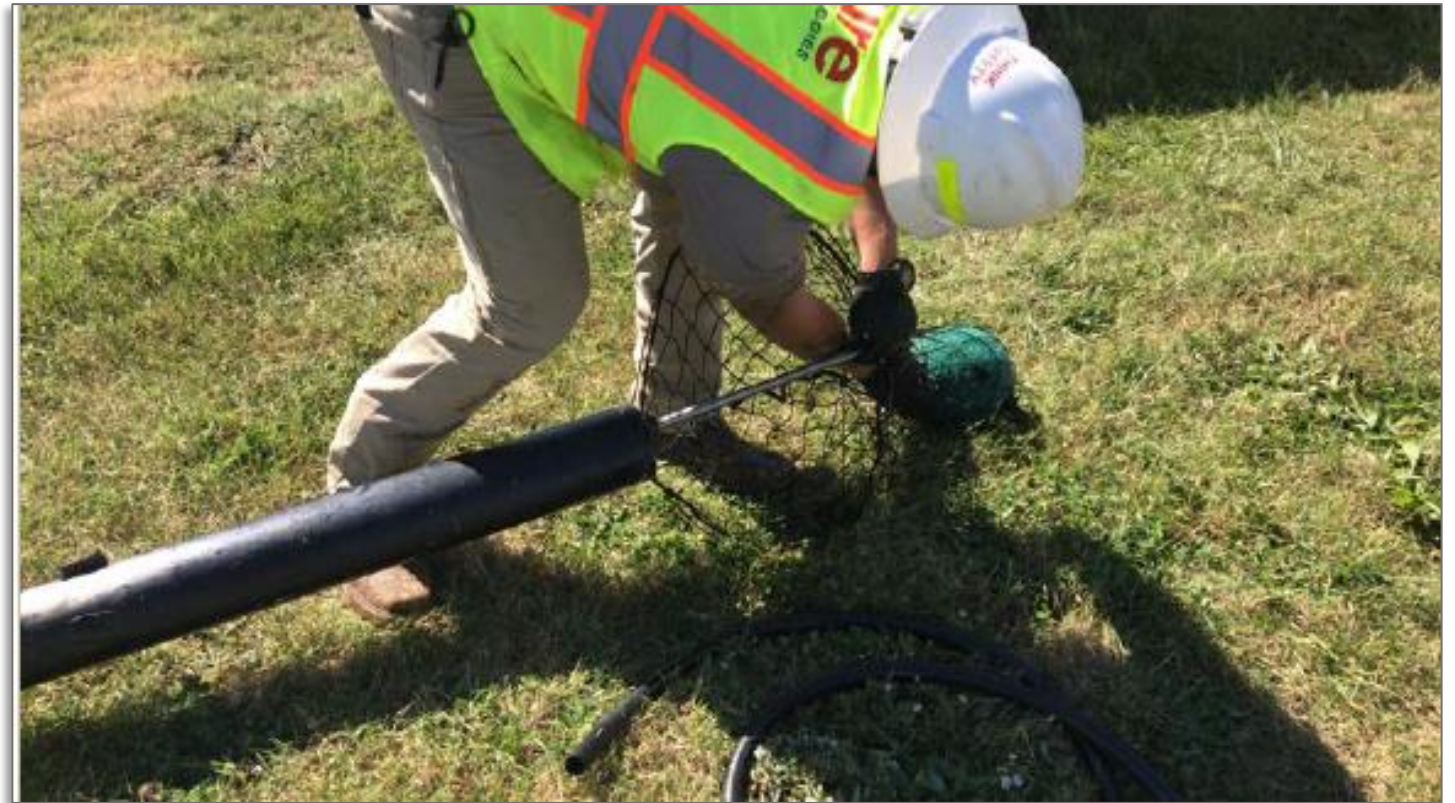
PipeDiver[®] Electromagnetic Inspection and Structural Analysis

- 16" – 120" diameter
- Designed for use on PCCP mains
- Can be used on all metallic pipes
- Can utilize CCTV to video inside pipe during inspection

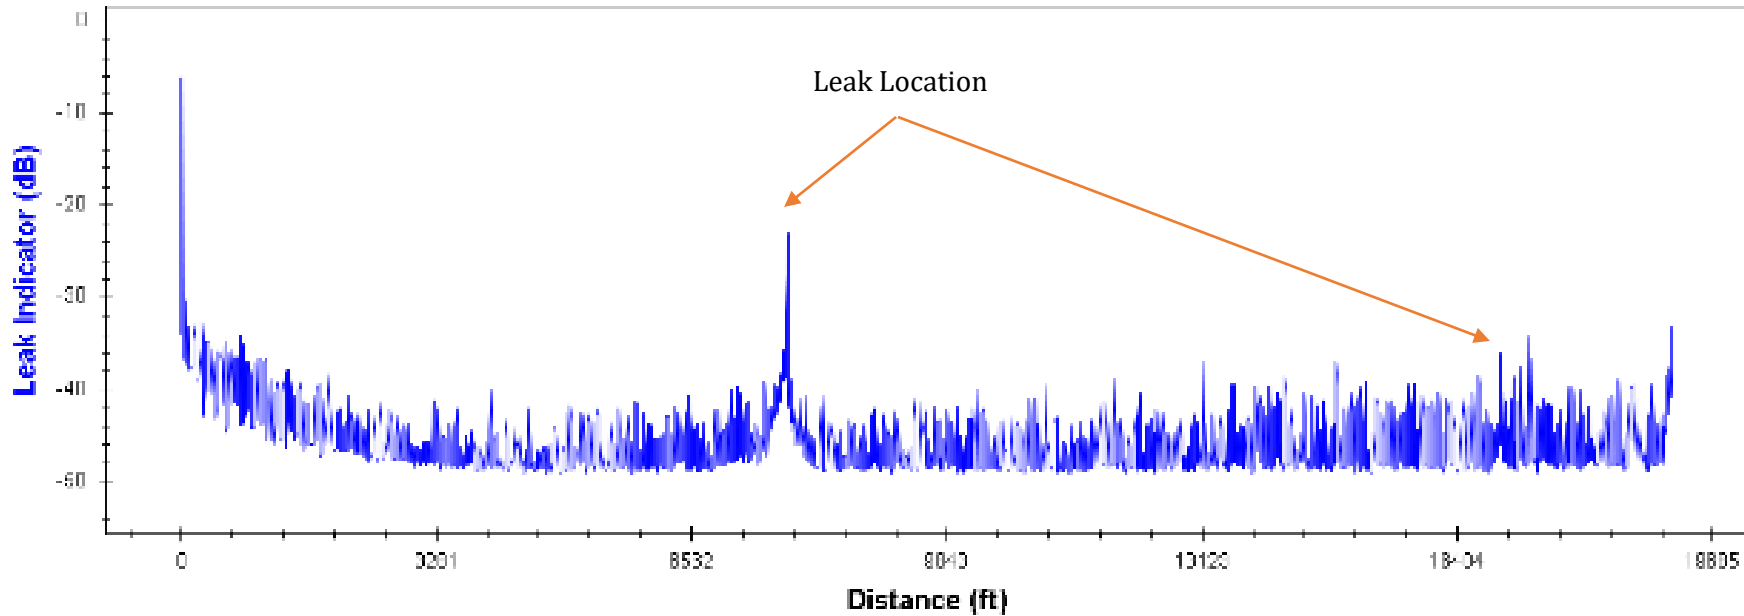
SmartBall Results

- 2 Leaks Detected
- No Air Pockets Detected

- Pressure transient events occur during normal operating procedures, but amplitude of event remains within design pressure.
- Two (2) leaks to be repaired.
- 143 pipes (12%) exhibit distress
 - Four (4) pipes require immediate repair
 - Remaining pipes are in serviceable condition and should be re-inspected to identify any increased deterioration within 5 years

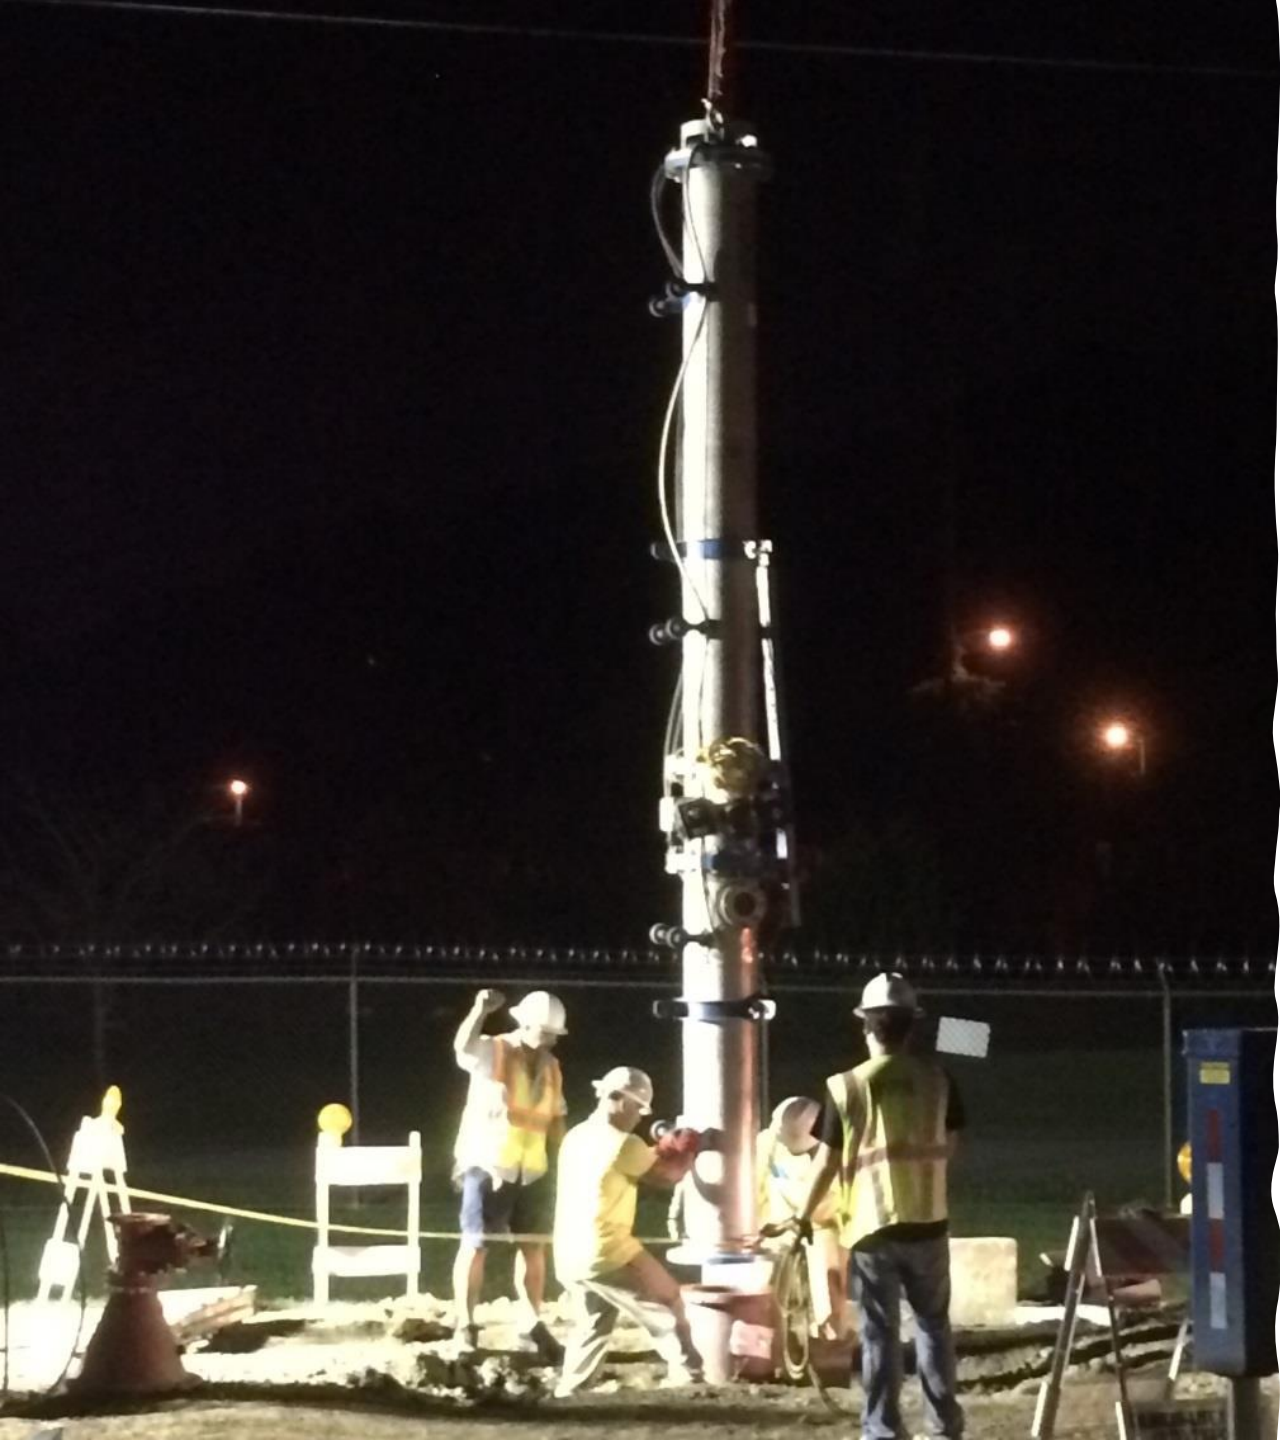
PipeDiver[®] Electromagnetic Inspection

Summary of Inspected Pipes							
Pipeline	Number of Inspected Pipes	Pipes with Distress		Anomalous Pipes		Thicker Cylinder Pipes	
		No.	Percent	No.	Percent	No.	Percent
McGavock Pike Transmission Main	1,202	143	11.9	3	0.25	122	9.98
