Environmentally Friendly Epoxy Coating System Offers Big Benefits to Hydroelectric Station

Presented By:
Hunter Sansone, Project Engineer

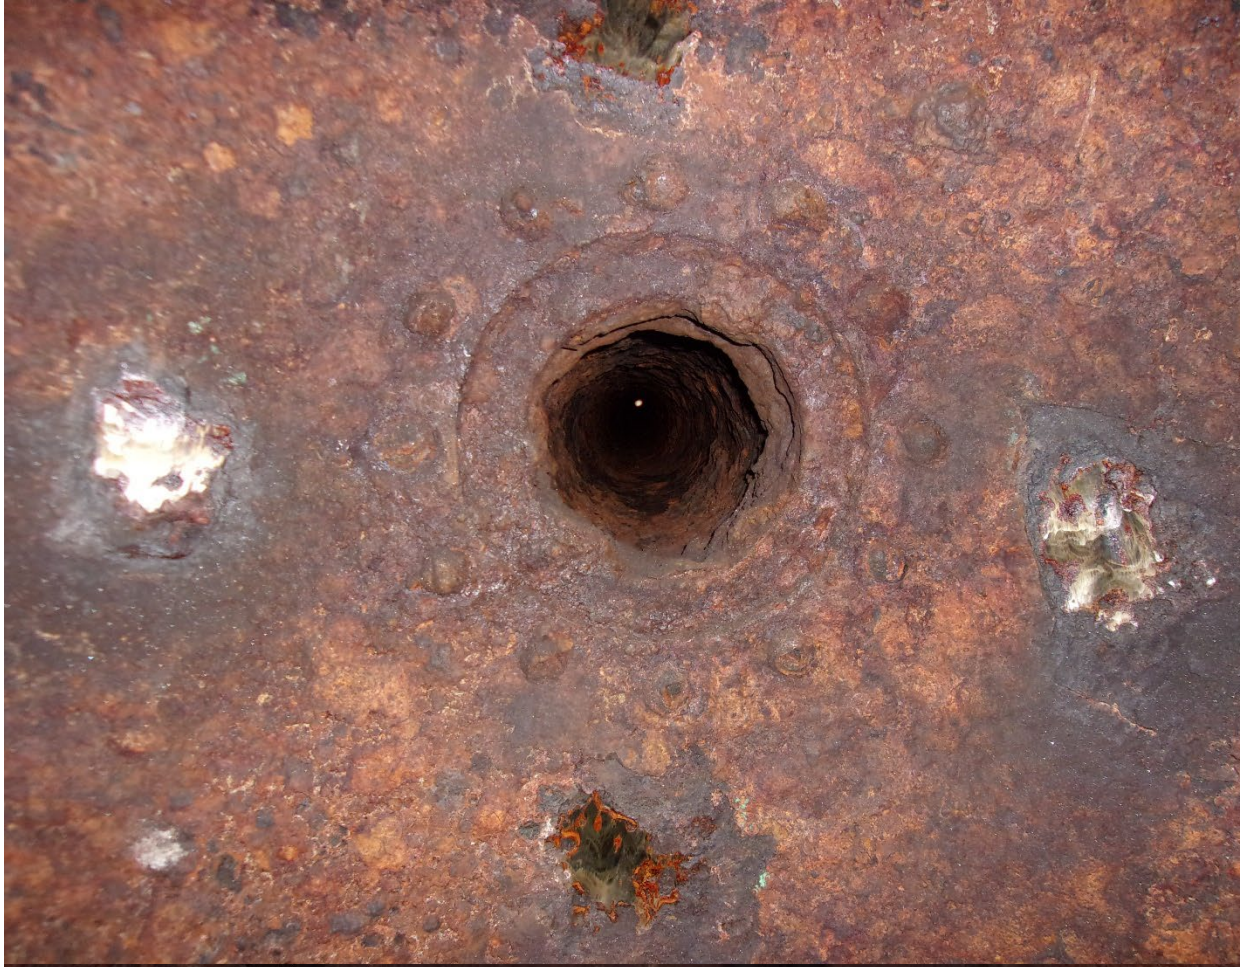
Fish Passage

- » A downstream passage was installed using two existing 48-inch steel penstock headwall pipes.
- » Pipes required rehabilitation including structural repair.

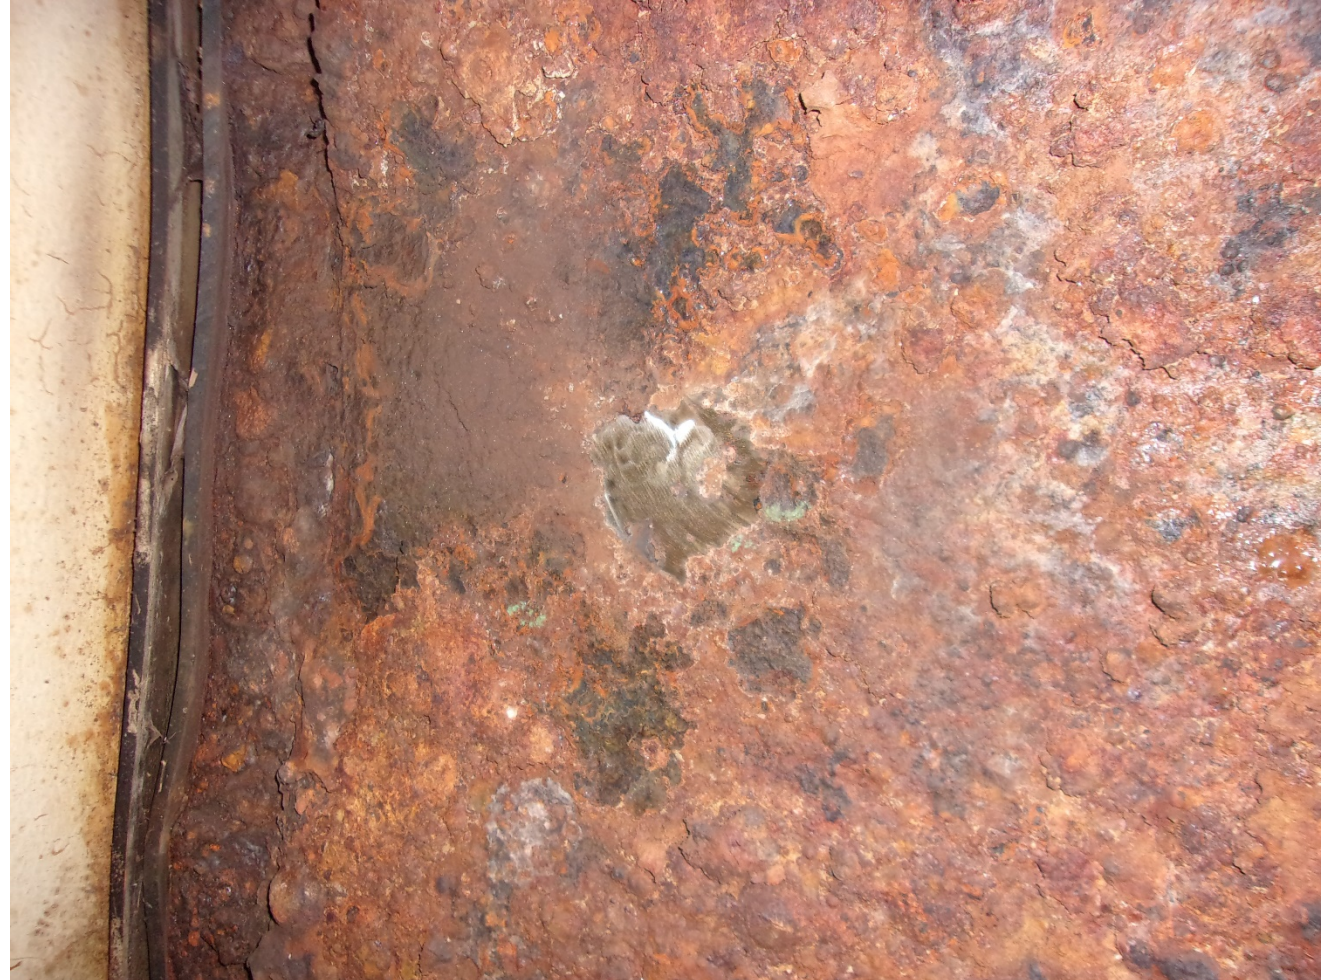
The deteriorated wall thickness of the steel led to concerns of groundwater infiltration and continued corrosion of the penstocks, which could lead to eventual failure.

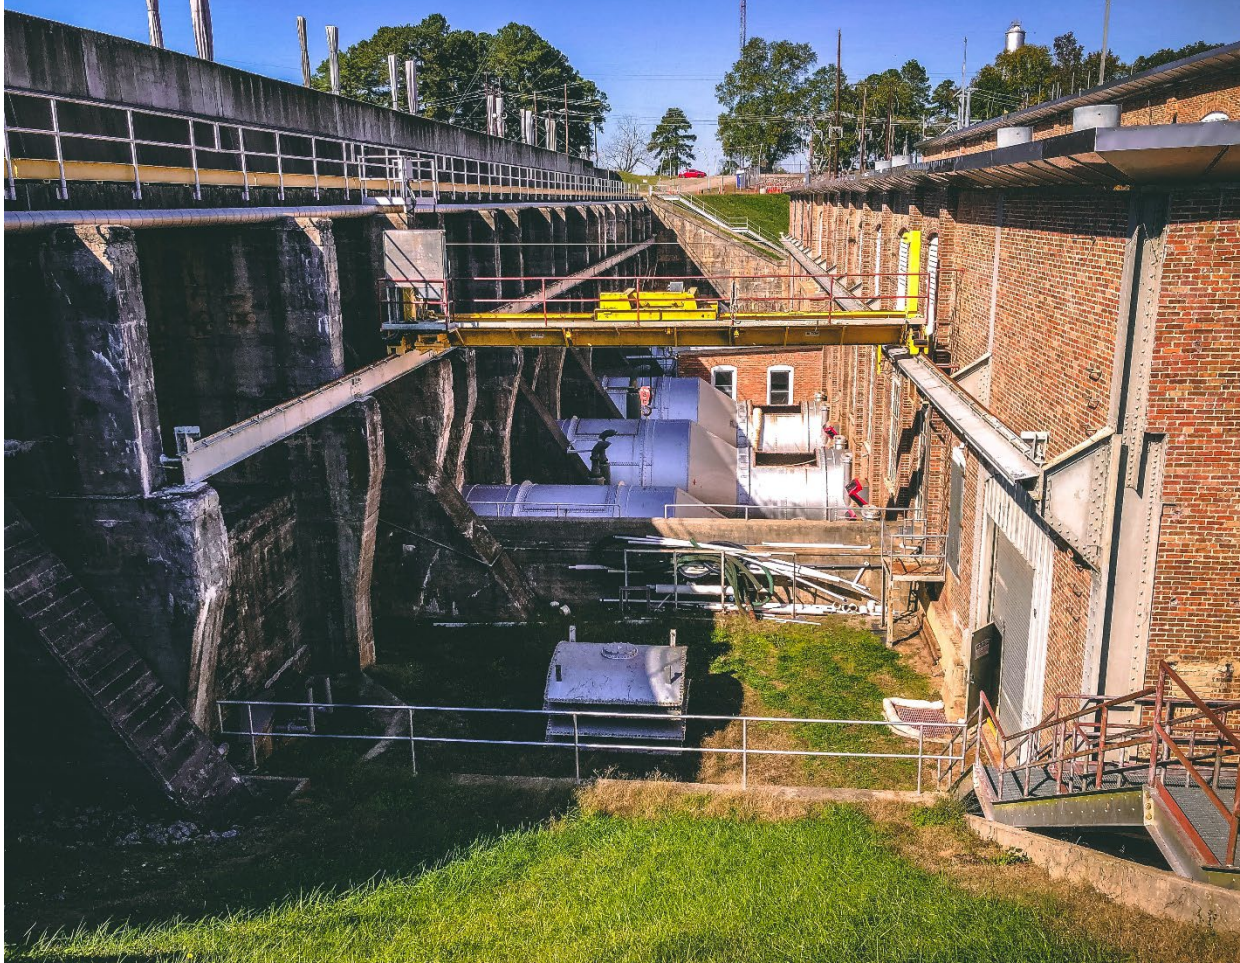
Project Challenges

On April 28th, 2020, a progress meeting determined that the headwall pipe rehabilitation restricted the General Contractor's main scope, moving our scope into the critical path.

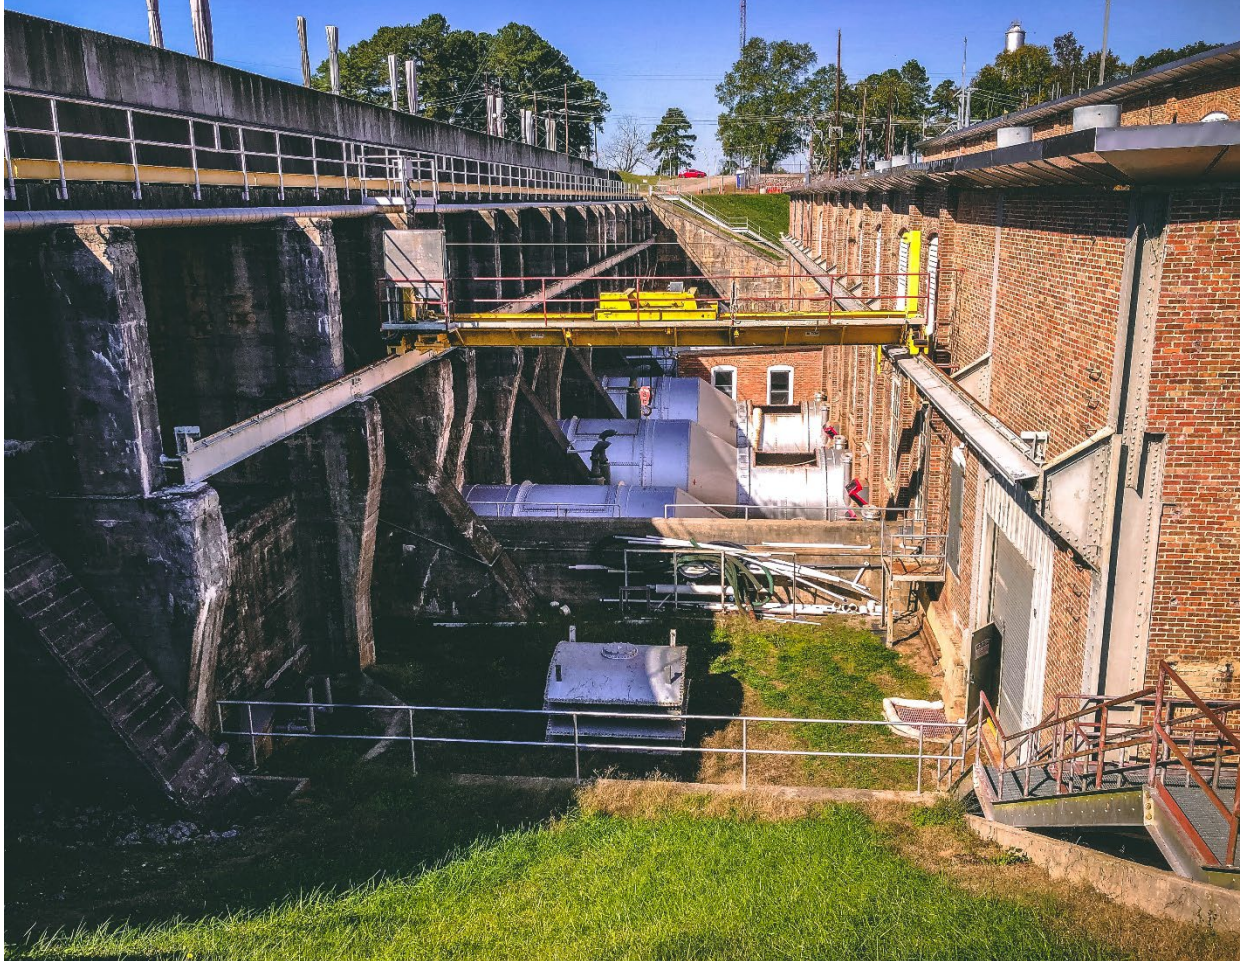
Project Challenges Cont.

We completed our scope by May 9, 2020, just 10 days after the April 28 progress meeting, **keeping the project on schedule and minimizing disruptions.**

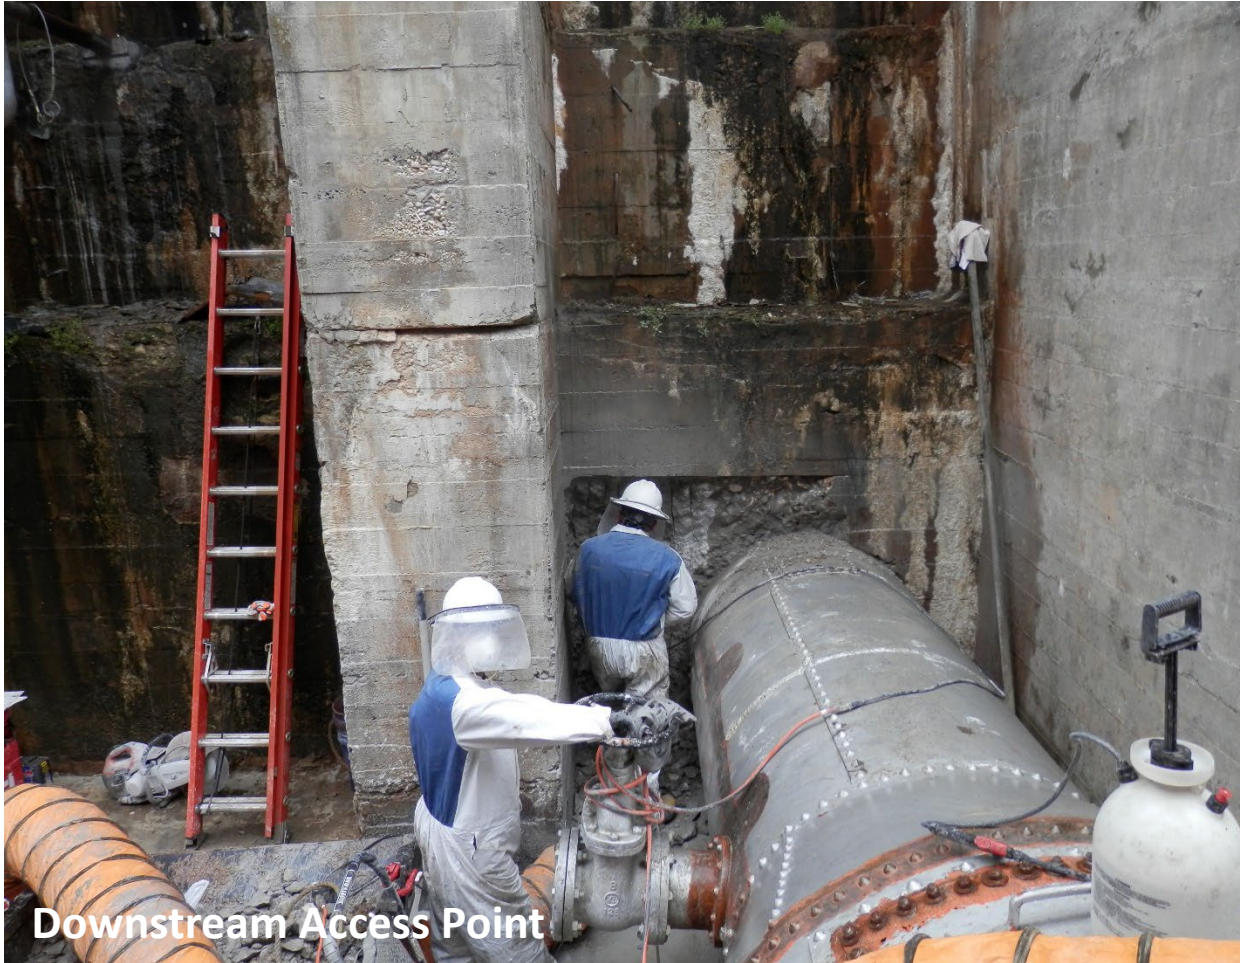
Downstream Access Point

Due to the pipe's location, access was severely limited. On the upstream side, a coffer-dam provided the access point, which offered the simplest access.

Due to a rain event and rising river levels, A&W had to use the downstream side access point.

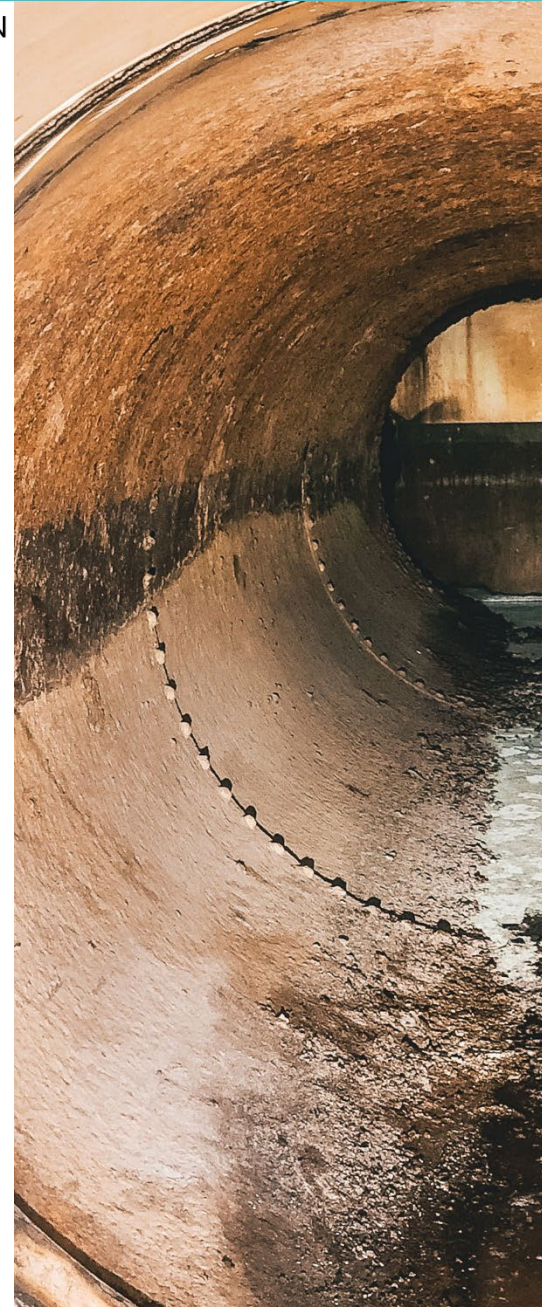
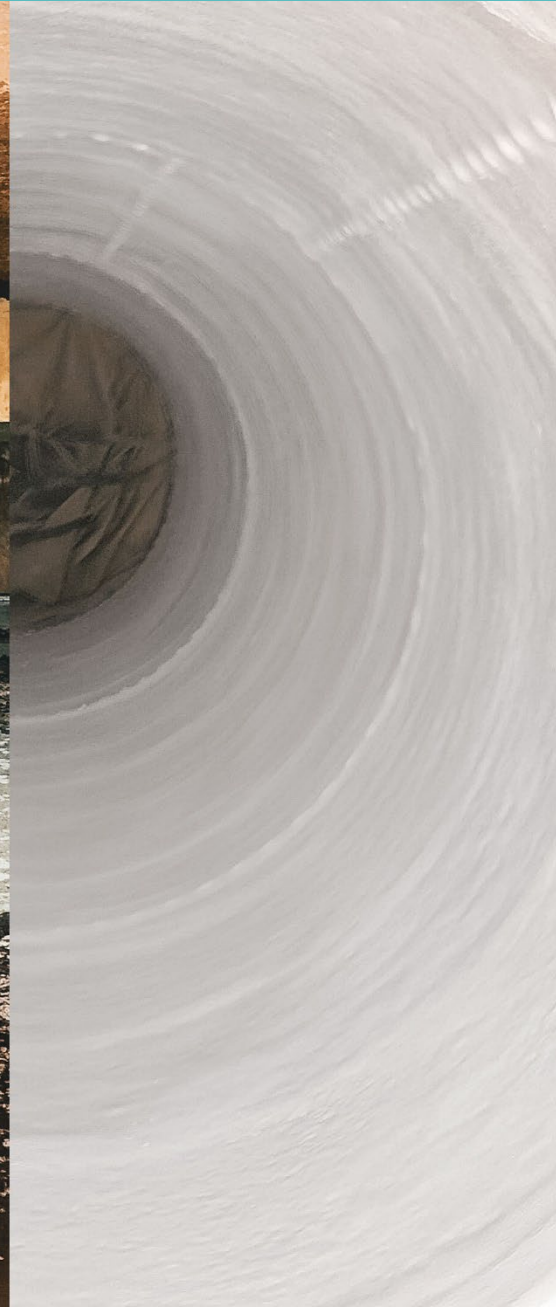
- » Nearly failing assets were structurally repaired and given years of additional service life.
- » The fish passage will remain safe to all aquatic life, including the American shad and blueback herring.
