EL PASO WATER'S USE OF MULTIPLE TRENCHLESS METHODS

**Providing Cost & Time Savings to the Canutillo
Bosque Road Lift Station and Force Main Project**

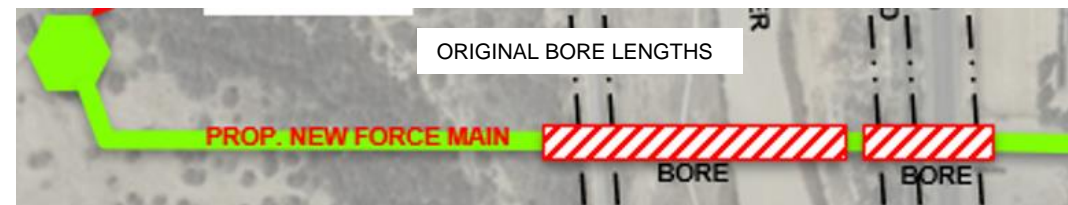
- Design team revisited project approach to simplify scope of work
- Outreach to identify key risk areas
 - Length of bores across river & RR
 - Extensive dewatering
- Installation variance was requested and approved by IBWC
 - Open cut in lieu of boring across river
 - 140 LF bore vs. 700 LF

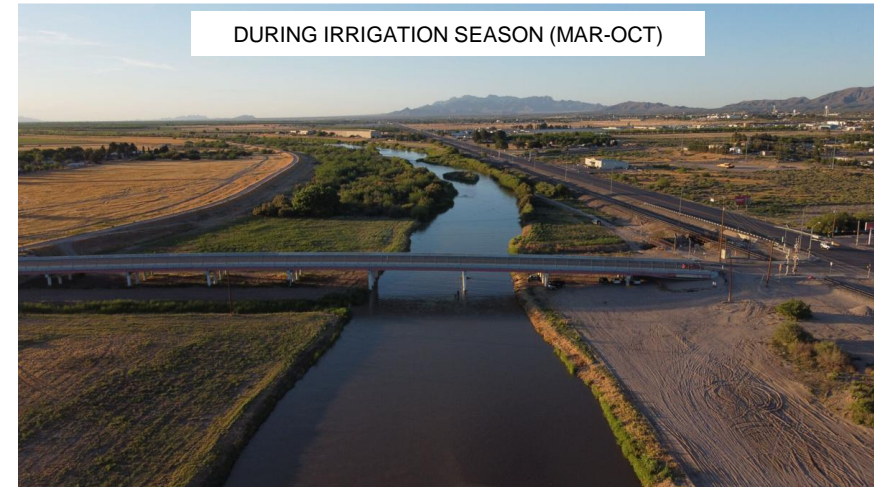
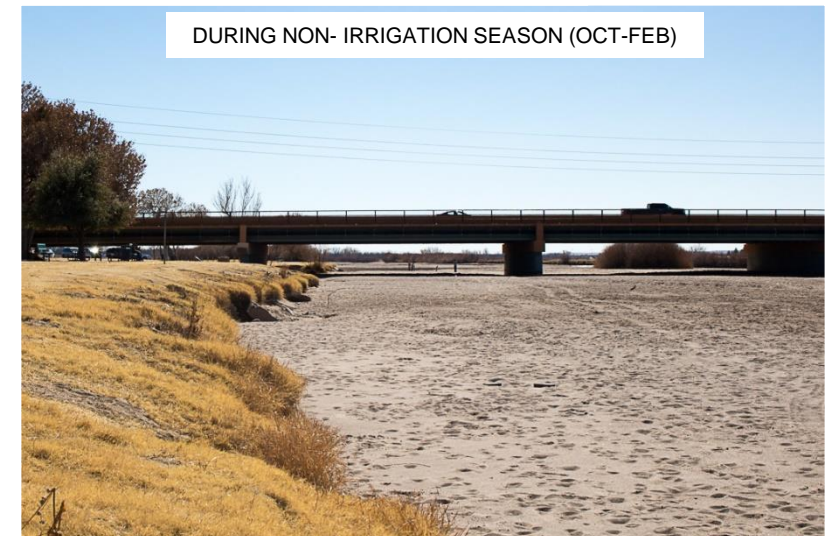
- Seasonal River translates to fluctuating groundwater table elevation
- Water supply in river available during irrigation season (March to October)
- Sequencing of work (e.g., river crossing) during non-irrigation season
 - Reduced amount of dewatering necessary
 - Discharge of dewatering directly into river (less risk for aquatic life)
 - Use of auger-boring trenchless install

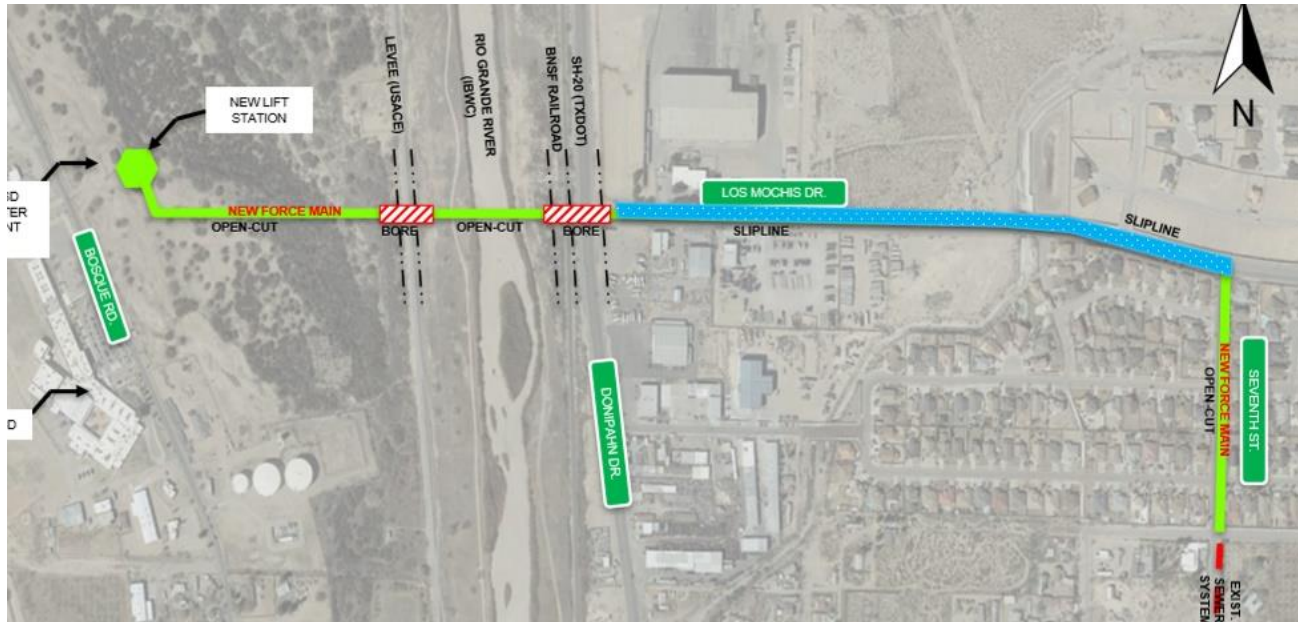
6" DR 18 FPVC® & 16" DR 18 FPVC®
Inside 30" Steel Casing with Spacers

- Specified fusible PVC as required FM material; “Piggy-Back” install
- Identified abandoned, dry 12” PVC line

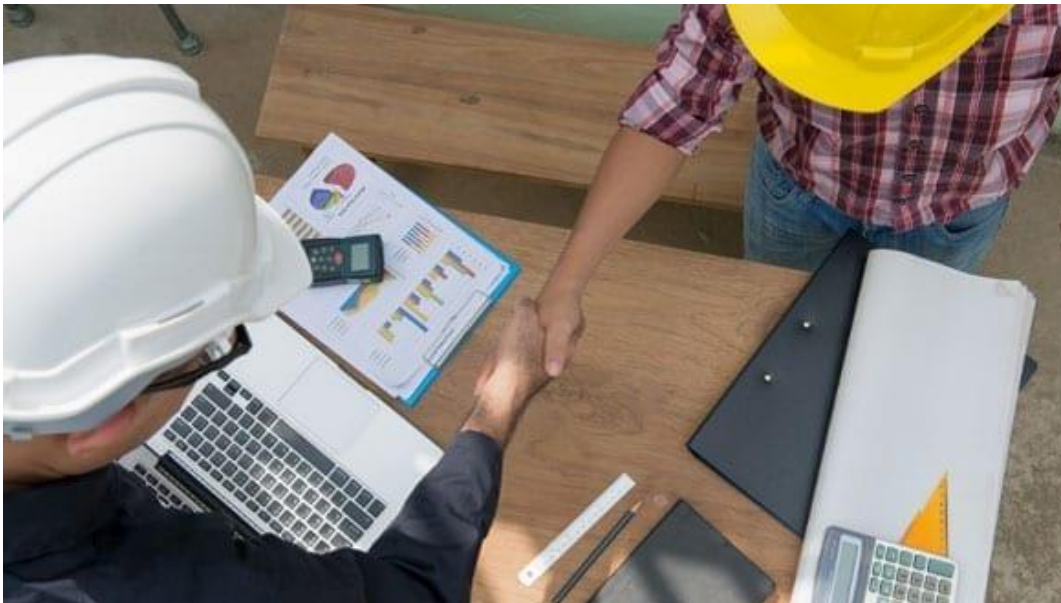
- Design revisions attracted more competitive bids
- Winning bid was 13% lower than engineers estimate

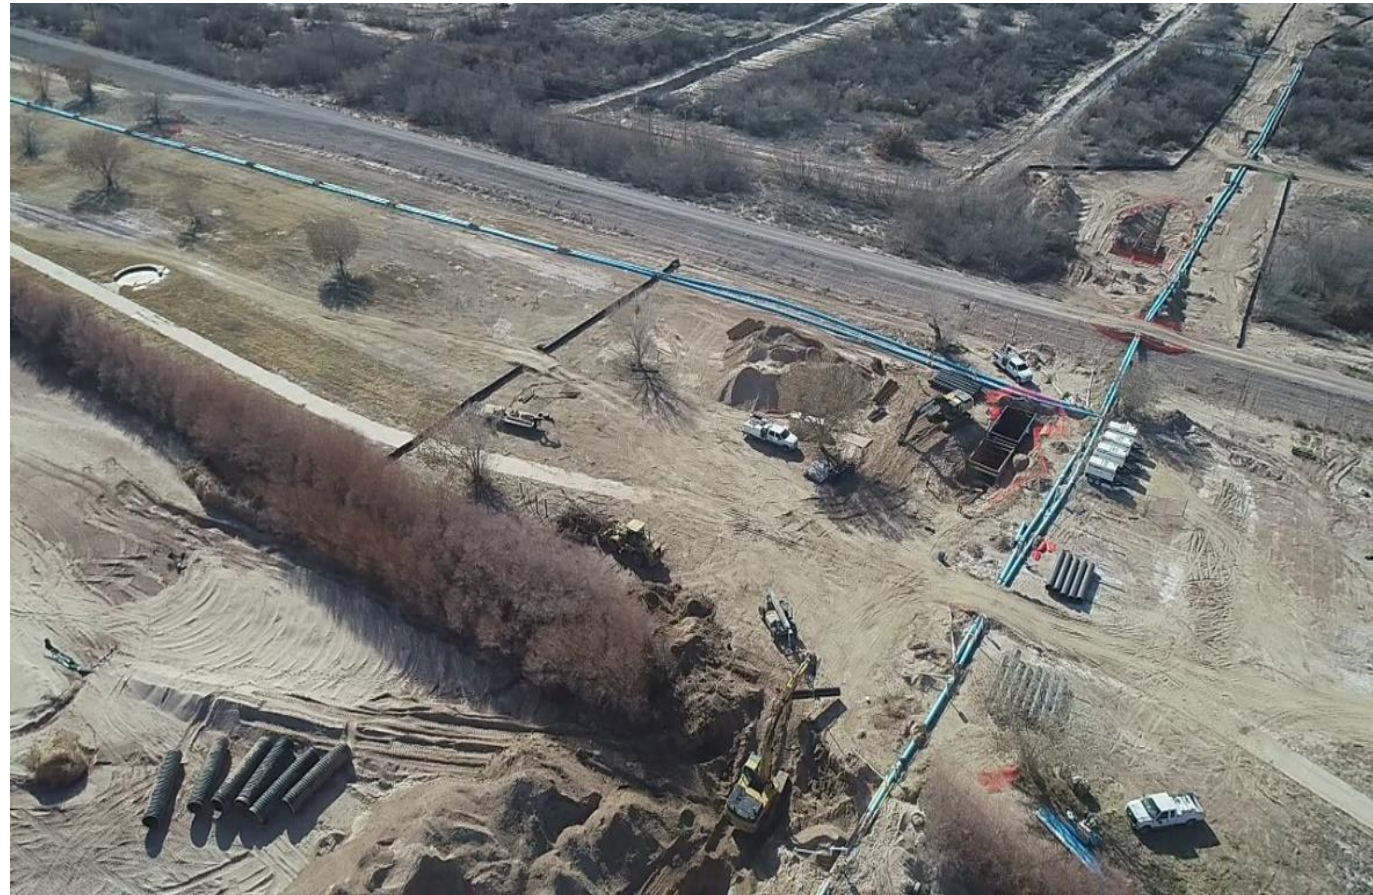
Dewatering

- System set up to discharge downstream of the river crossing
- Water samples obtained and tested to ensure quality was within TCEQ parameters
- Drawdown of the groundwater table was less complicated with no river water present

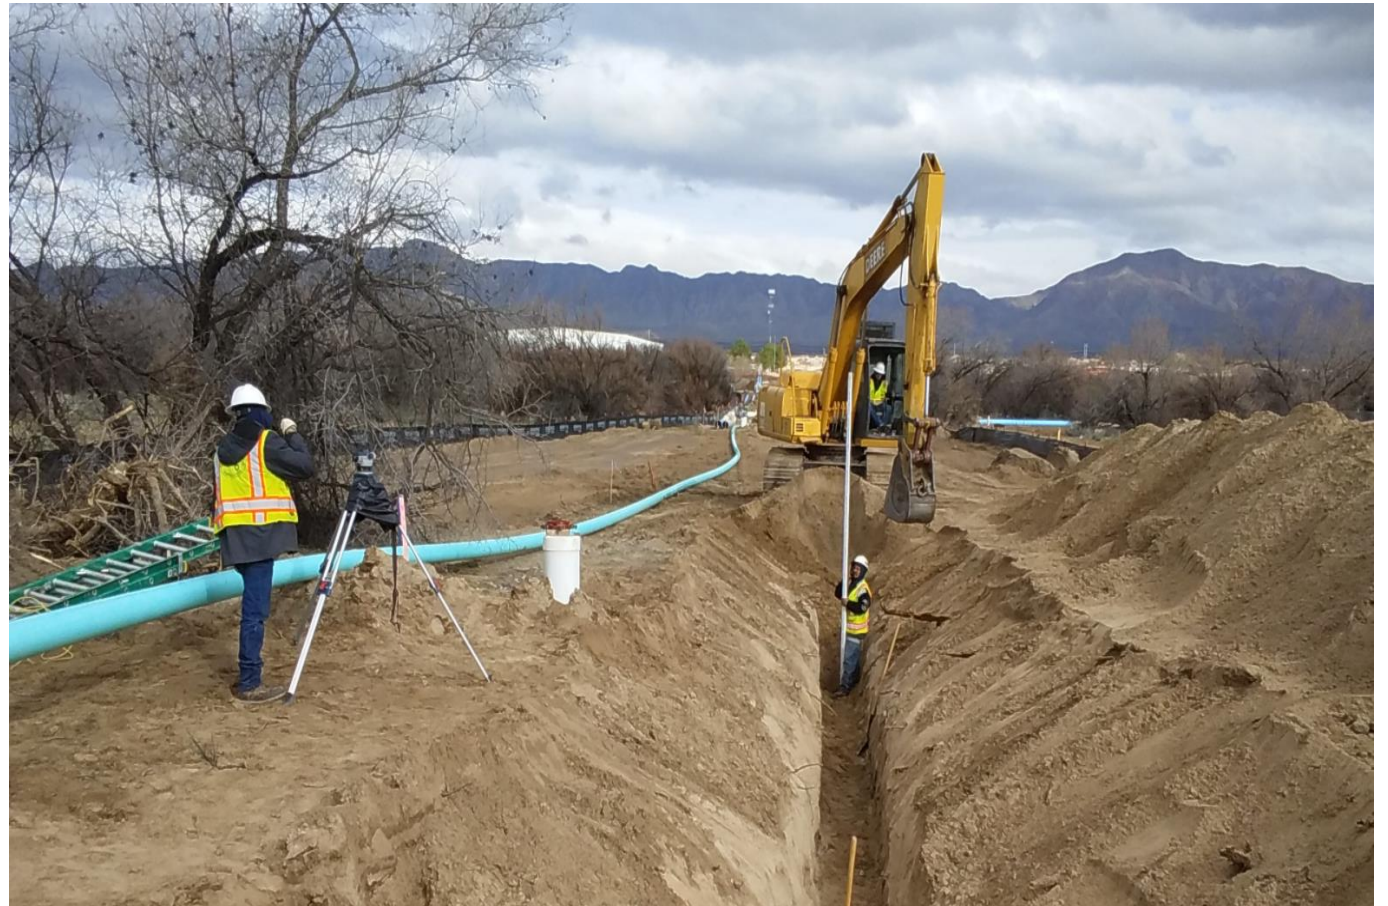
Forcemain Install

- Fusible PVC was used
- Accelerated installation process

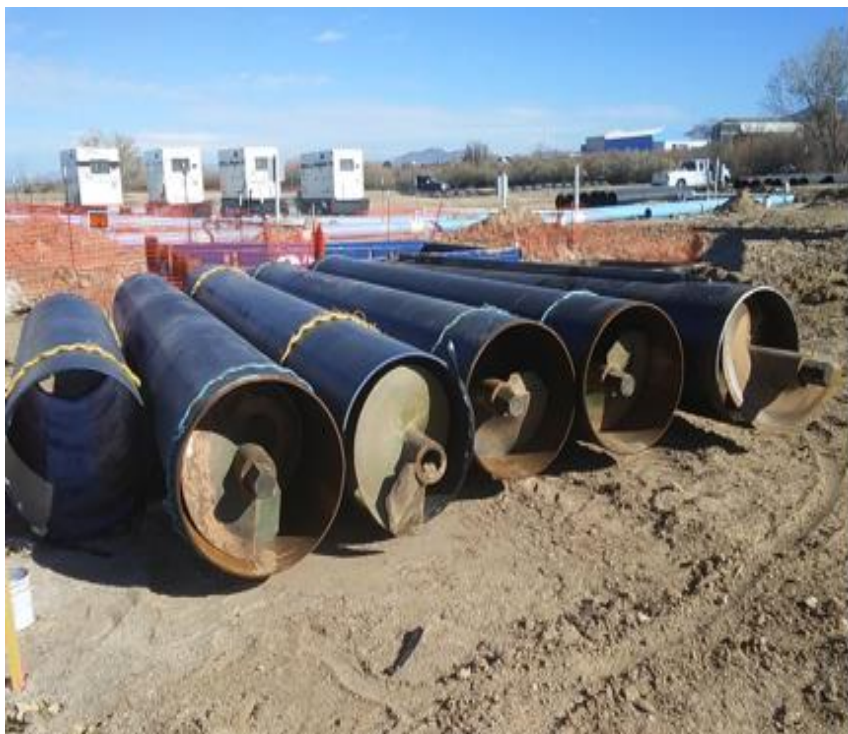
6" DR 18 FPVC® & 16" DR 18 FPVC®
Inside 30" Steel Casing with Spacers

Bores

- 2 bores (140 LF & 200 LF)
- 30" steel casing with 16" and 6" FPVC carrier pipes

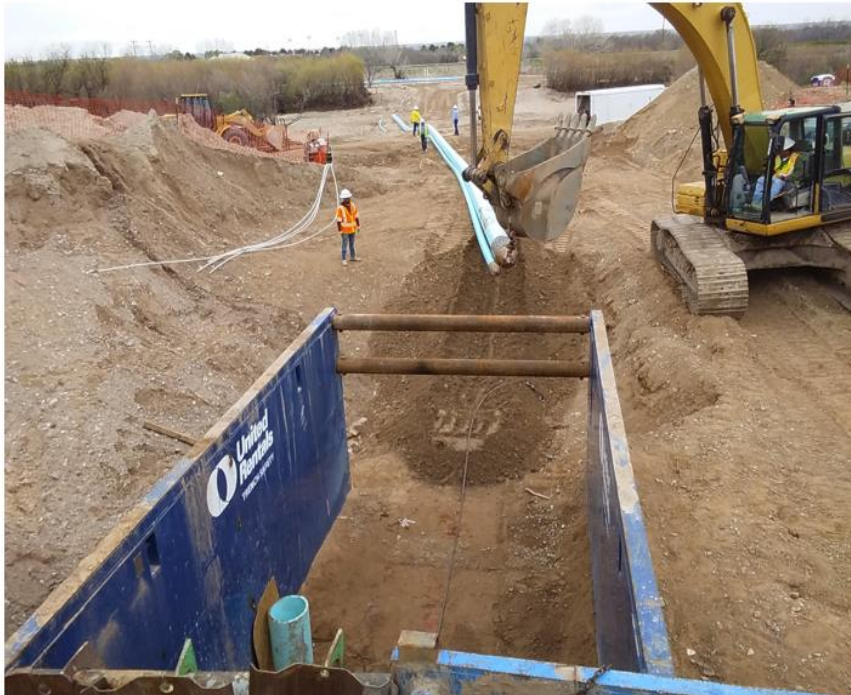
6" DR 18 FPVC® & 16" DR 18 FPVC®
Inside 30" Steel Casing with Spacers

Bores

- 2 Bores (140 LF & 200 LF)
- 30" steel casing with 16" and 6" FPVC carrier pipes

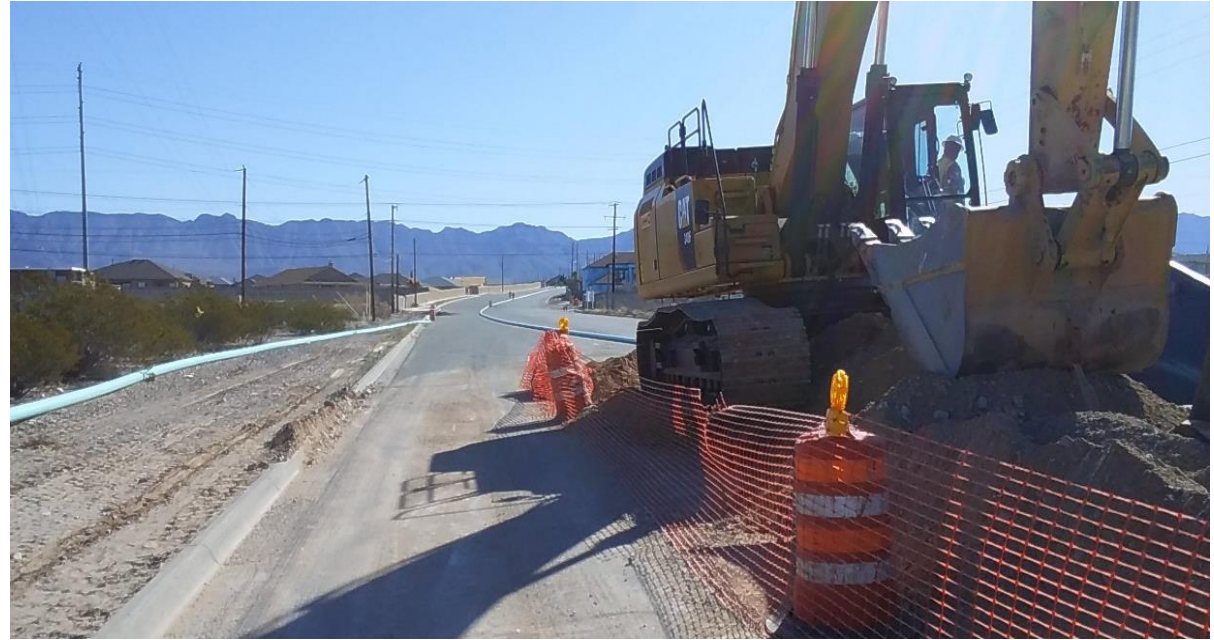
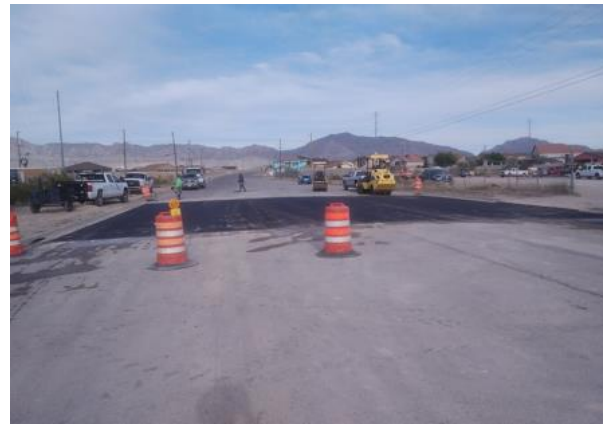
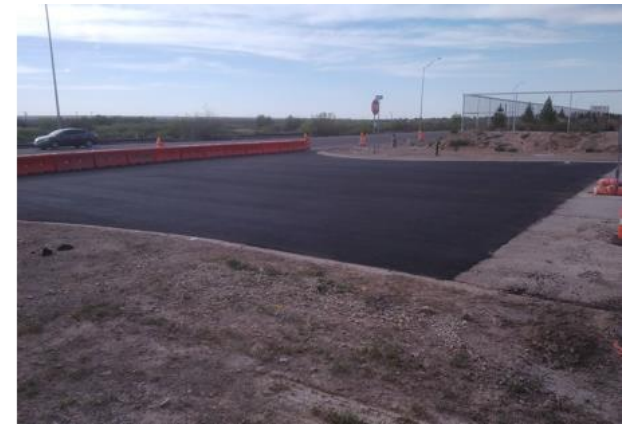
Slipline

- Less traffic control and trenching
- Repaved insertion and receiving pits only, not entire street

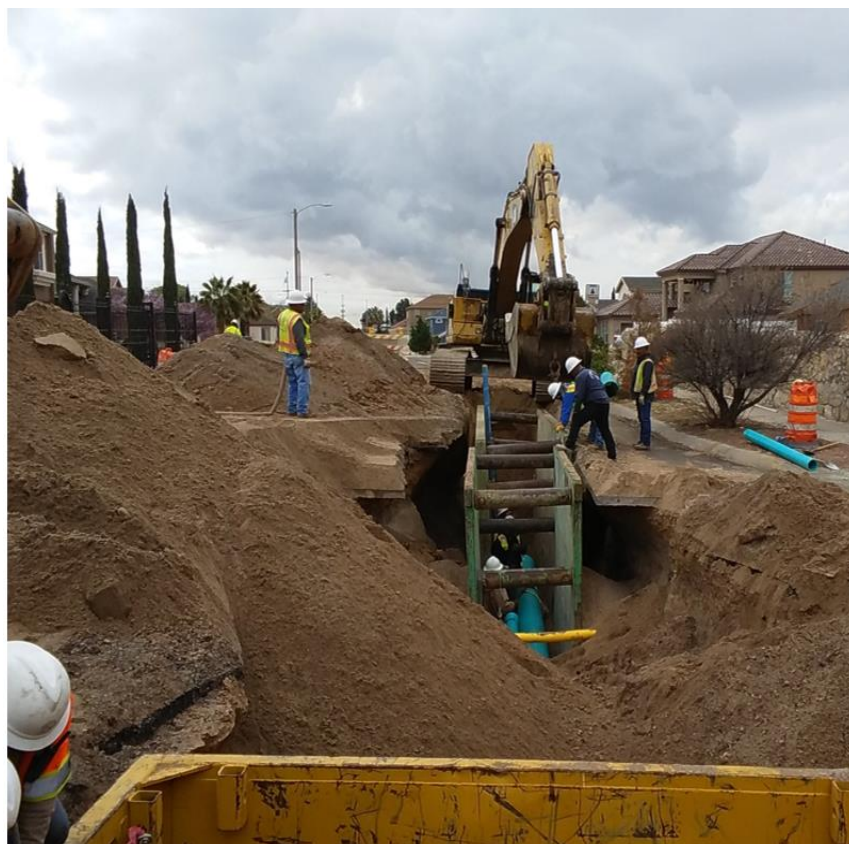
Open Cut:

- Traditional method
- Experienced trench wall failures undermining existing roadway
- Extensive traffic control needed, more inconvenience to community.
