SCA SUBSURFACE CONDITION ASSESSMENTS

QLB: Qualitative Approach

04/13/2022

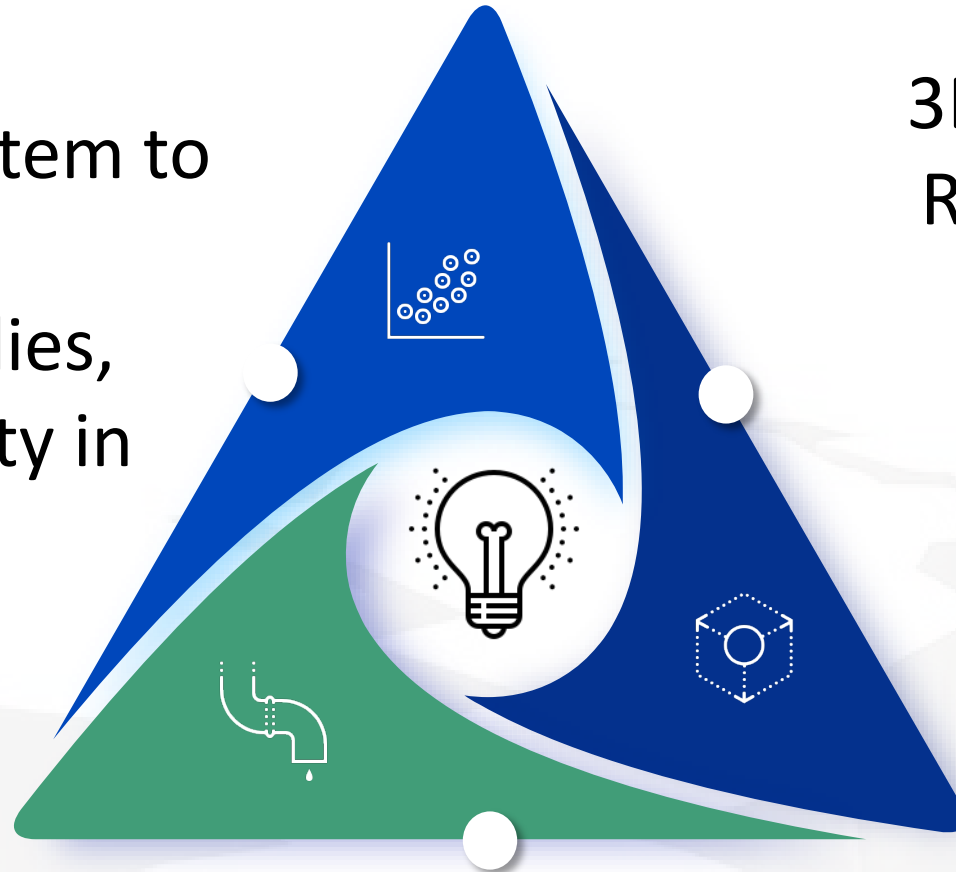
Joint Geophysical system to find and locate underground anomalies, defects or abnormality in the ground

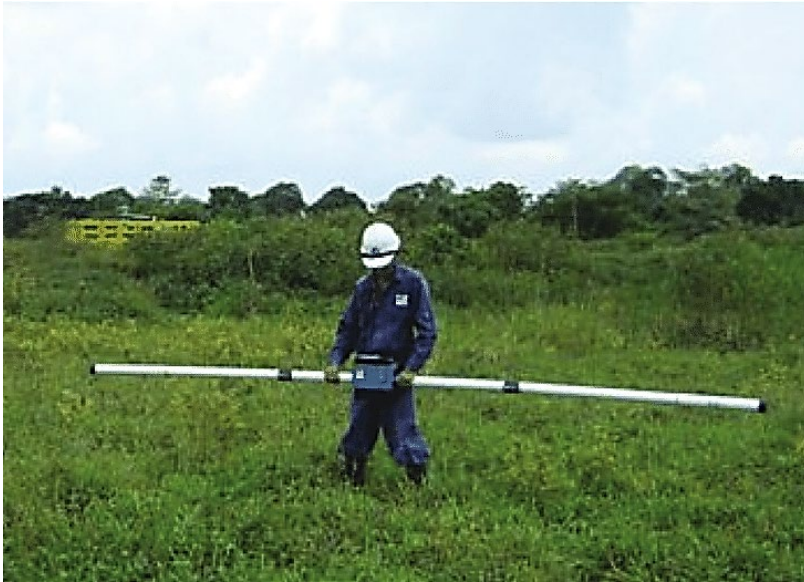
EM31-MK2 Ground Conductivity meter

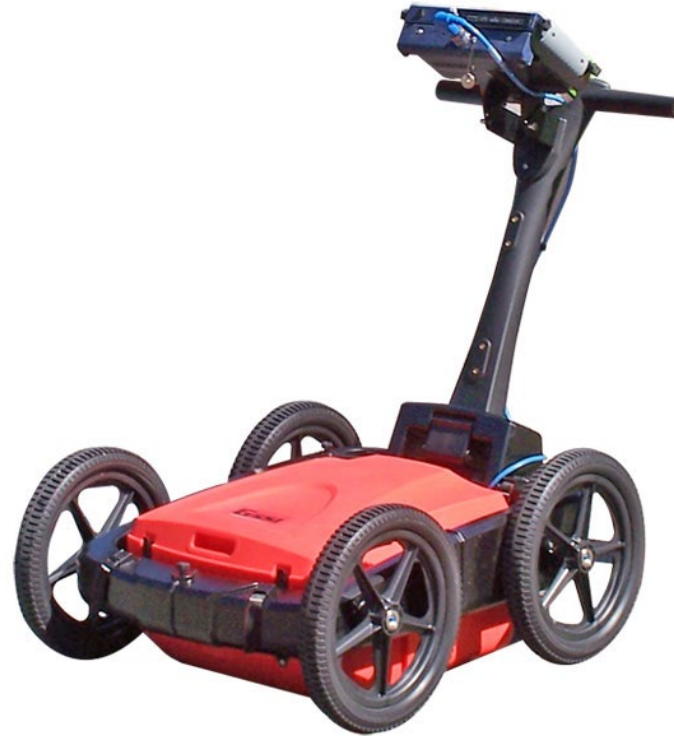
Hyper Stacking GPR Survey Unit

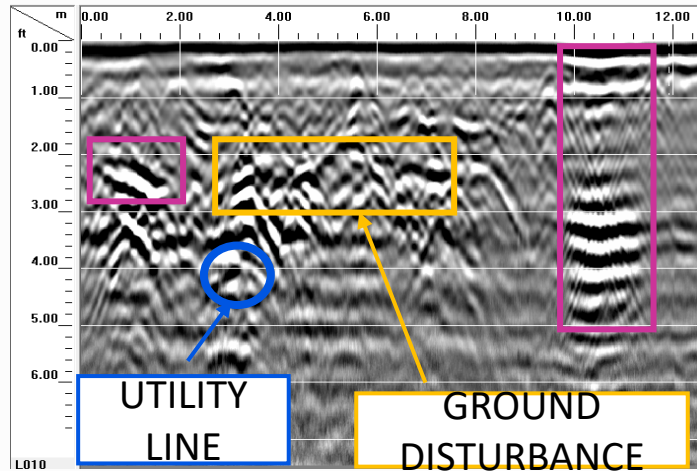
Cross section

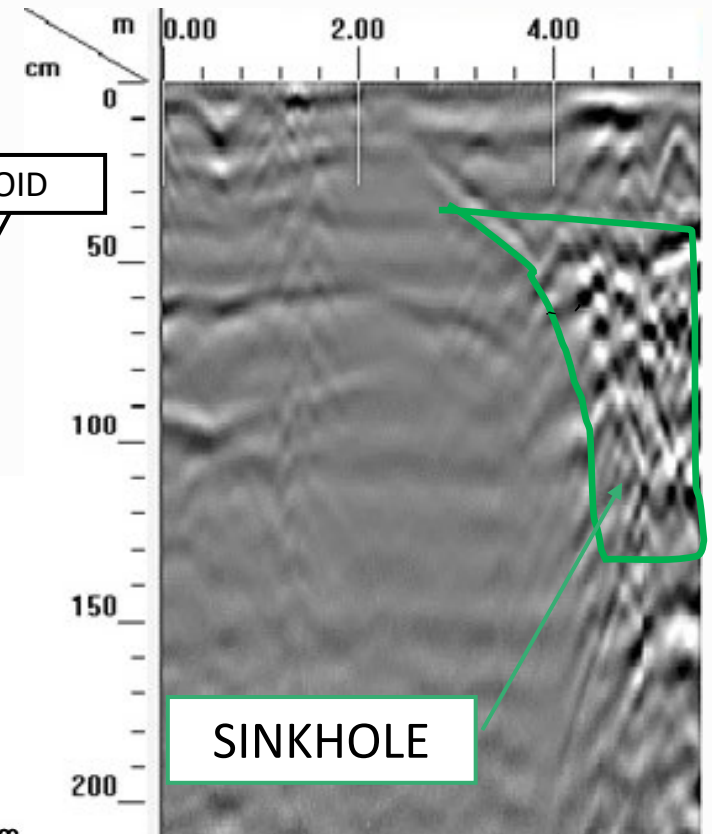
Cross section

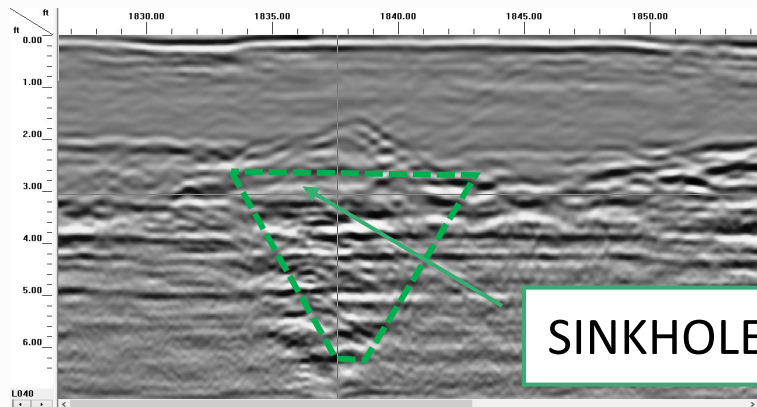
Cross section

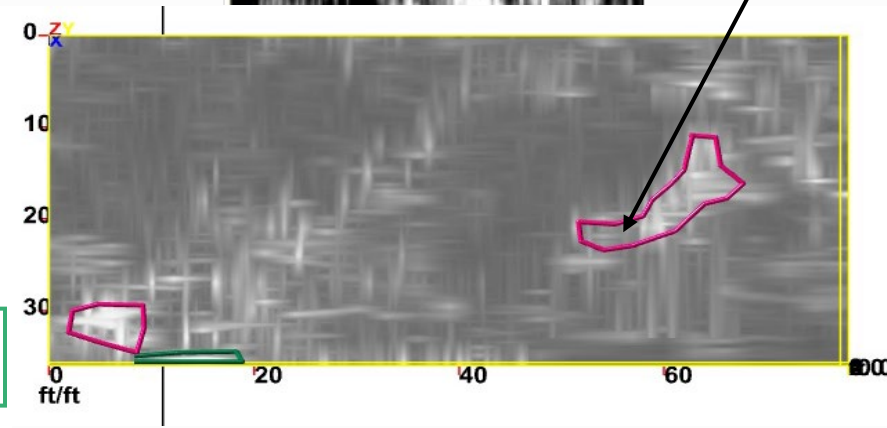
Plan view image

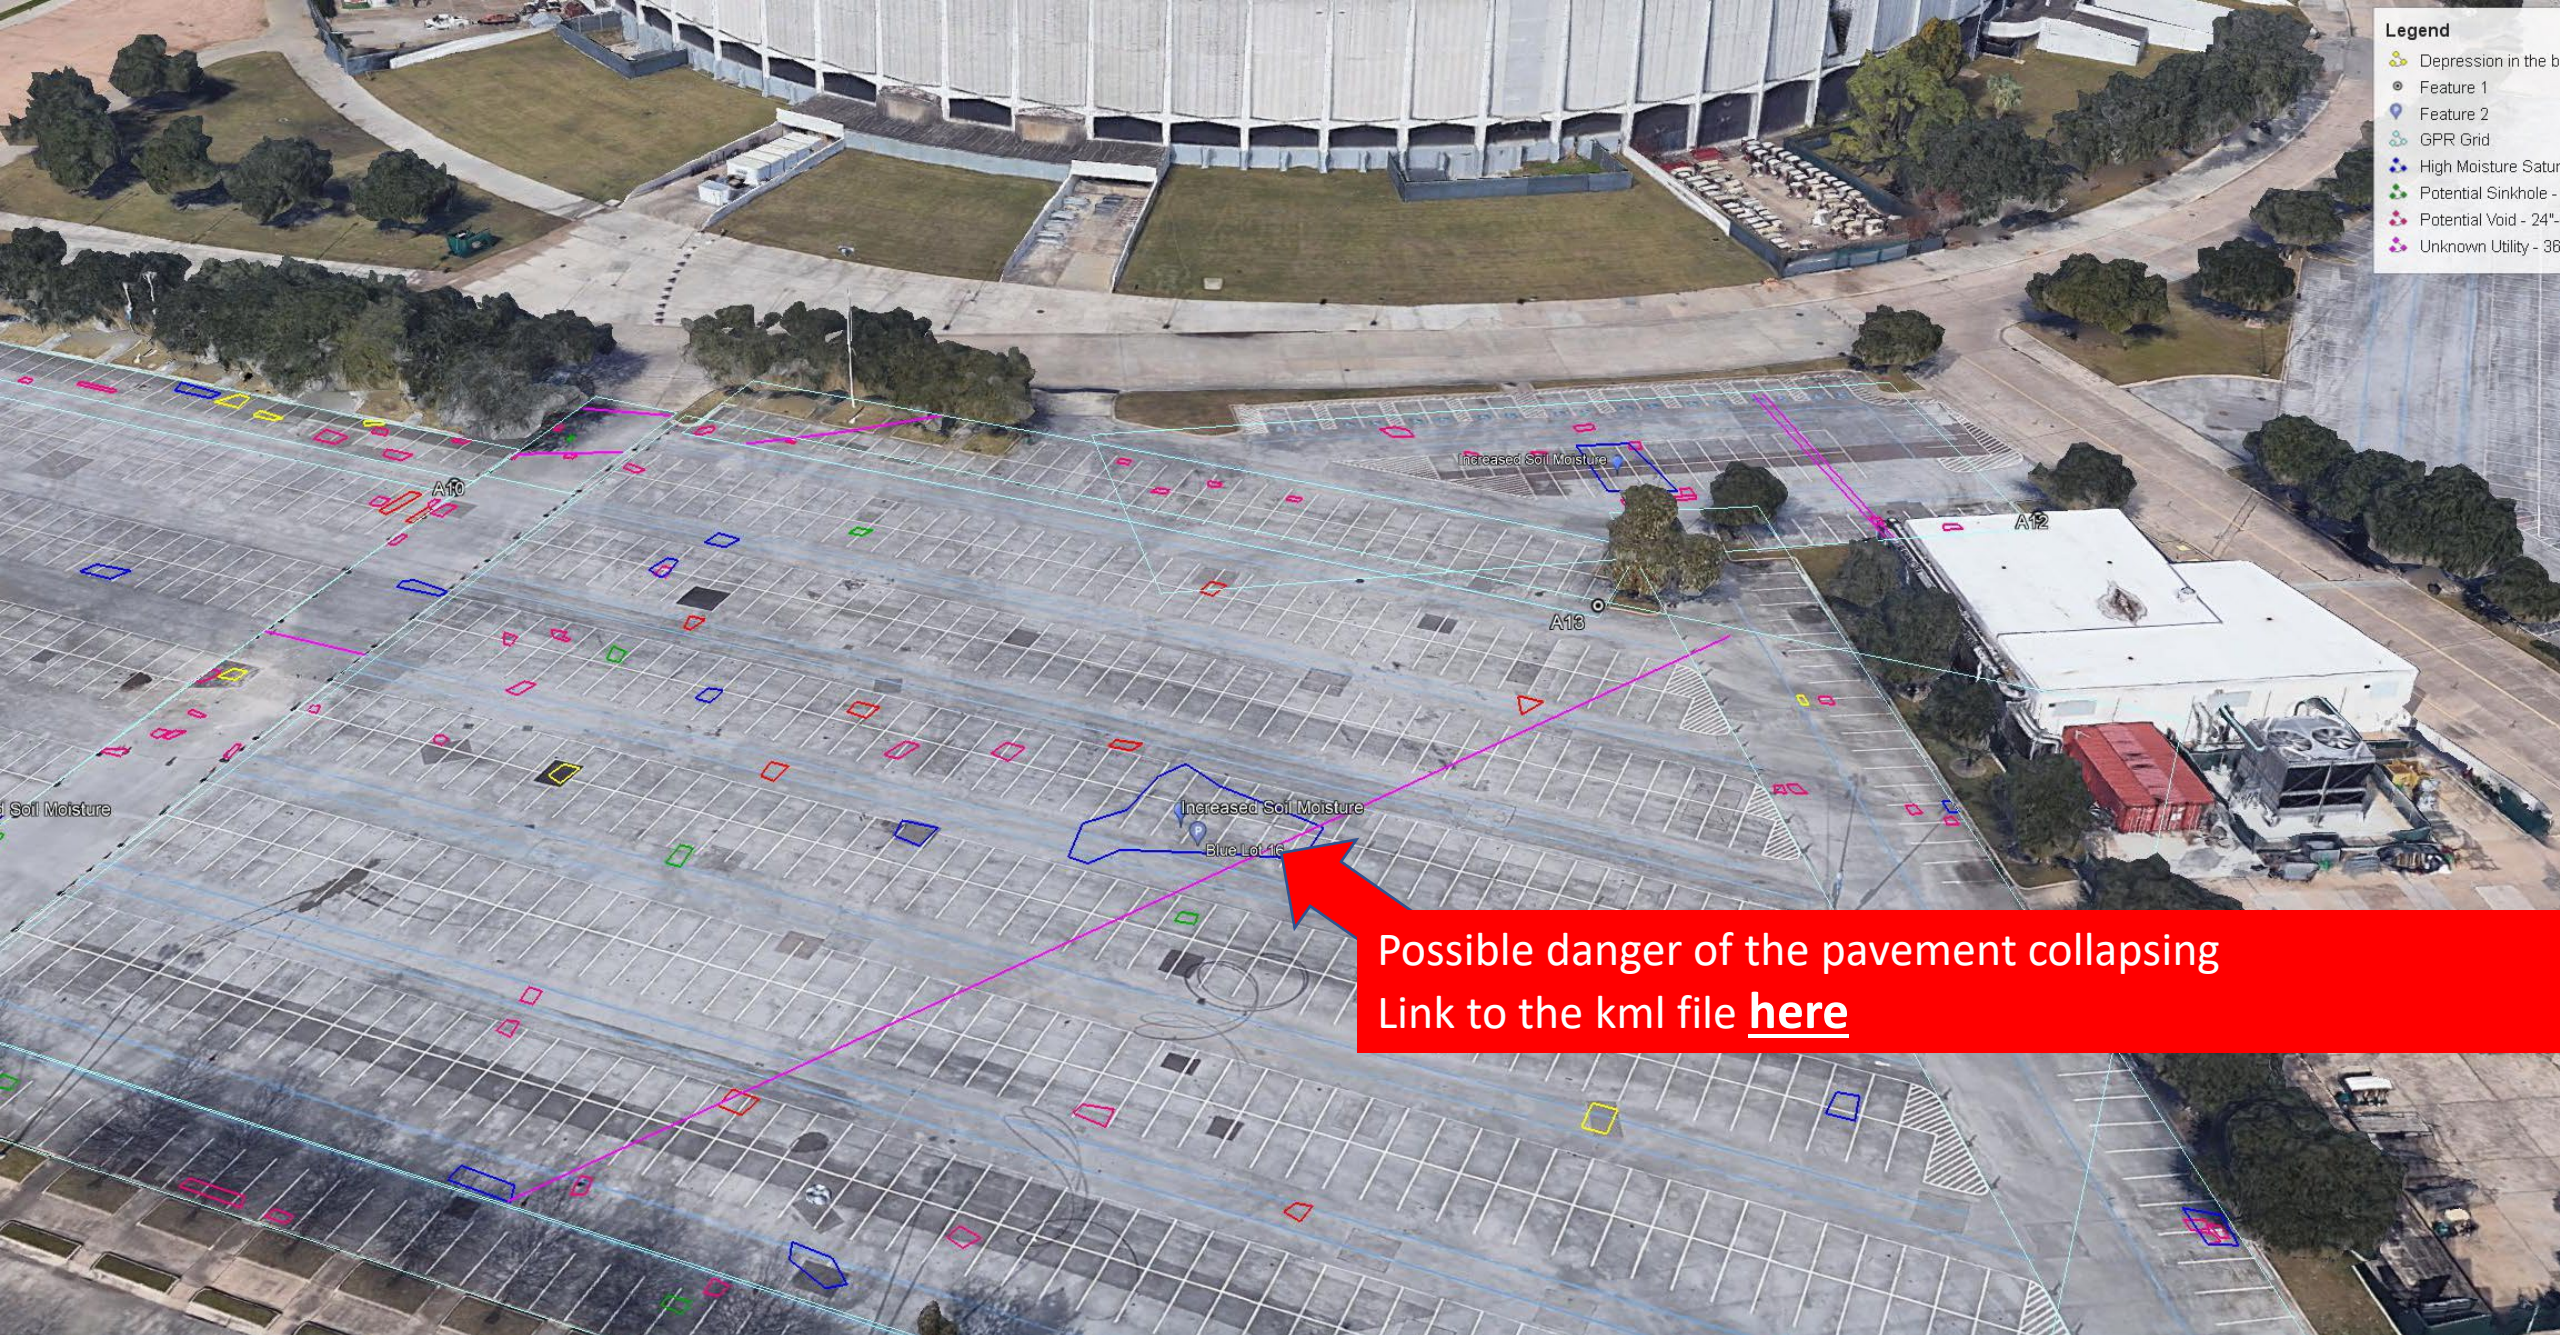
gpr	gpr scan are grid - 74x92 ft
	possible void location - 1.5-3ft
	increased moisture saturation - 3-5ft
?	unknown line - 4-6ft
?	unknown line - 2-4ft
?	unknown line - 1-1.5ft
	manhole
	utility pole
	bollard
	fire hydrant
