A NASSCO EDUCATIONAL EVENT

UNDERGROUND CONSTRUCTION TECHNOLOGY
THE UNDERGROUND UTILITIES EVENT | February 7-9, 2023 | Orlando, FL

Grouting Practice, Research and Safety

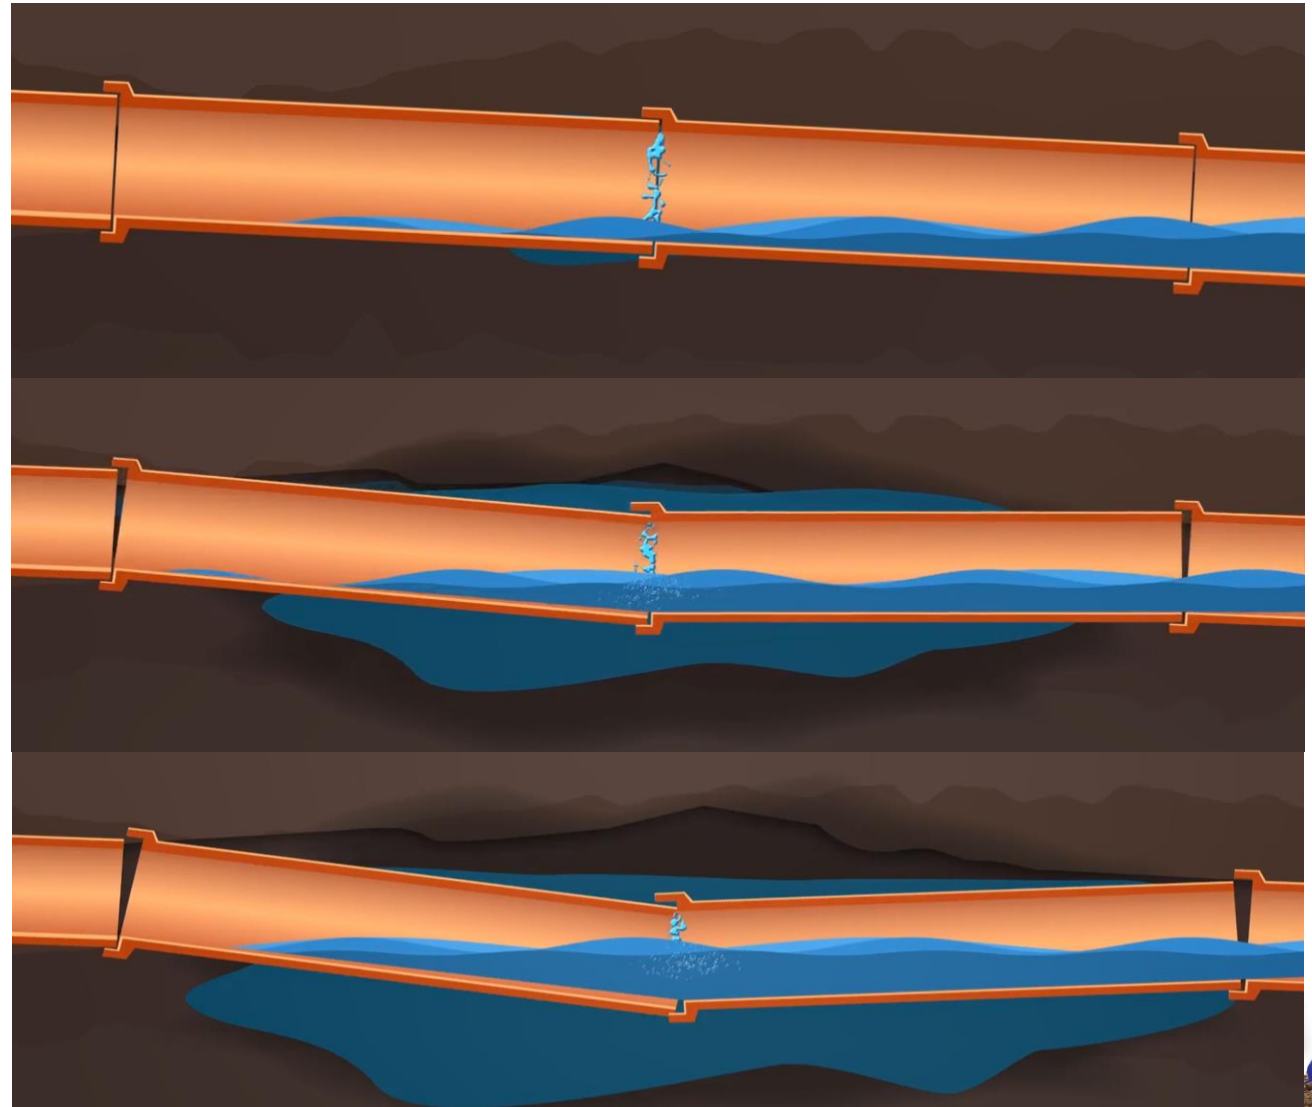
Three Stages Of Pipe Failure Due to Loss of Ground

- Stage 1:
 - Failing Joint Compounds Allow for Infiltration
- Stage 2:
 - Voids Formed Around Pipe Allow for Movement
- Stage 3:
 - Pipe Failure Due to Loss of Ground

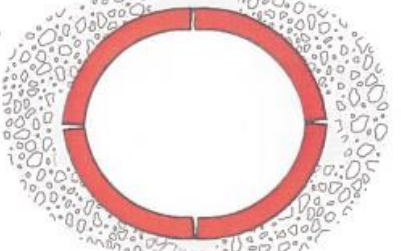
STAGE 1

Pipe cracking is caused by bad laying or subsequent overloading or disturbance. The sewer remains supported and held in position by the surrounding soil.

Visible defects: Cracks at soffit, invert and springing. Infiltration may also be visible.

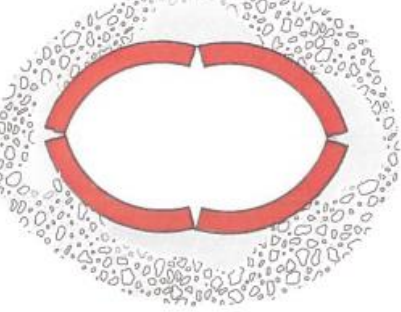
STAGE 2

Infiltration of groundwater or infiltration / exfiltration caused by surcharging of the sewer washes in soil particles. Side support is lost allowing further deformation so that cracks develop into fractures.

Side support may also be insufficient to prevent deformation if the original backfill was either poorly compacted or of an unsuitable material.

Visible defects: Fractures, slight deformation. Infiltration may or may not be visible.

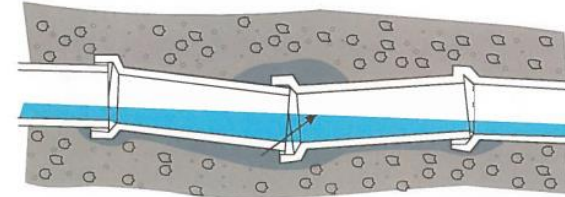
STAGE 1:

Gap in sewer at joint or a poor lateral connection.

Visible defects: Offset joint, badly made connection. Infiltration.

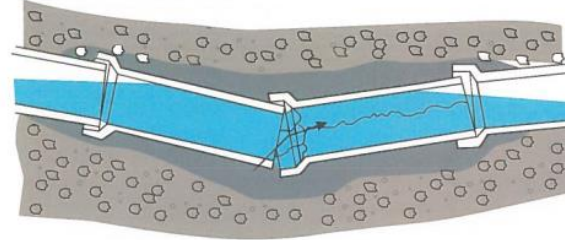
STAGE 2:

Infiltration of groundwater or infiltration / exfiltration caused by surcharging of the sewer washes in soil particles. Loss of soil support around the sewer allows pipe to move, opening joints and increasing the in wash of soil.

Visible defects: Open and displaced joints, loss of line and level. Infiltration. NOTE: Care must be exercised when viewing video tape recordings as displaced or slightly displaced joints can be overcompensated by the camera's lighting system.

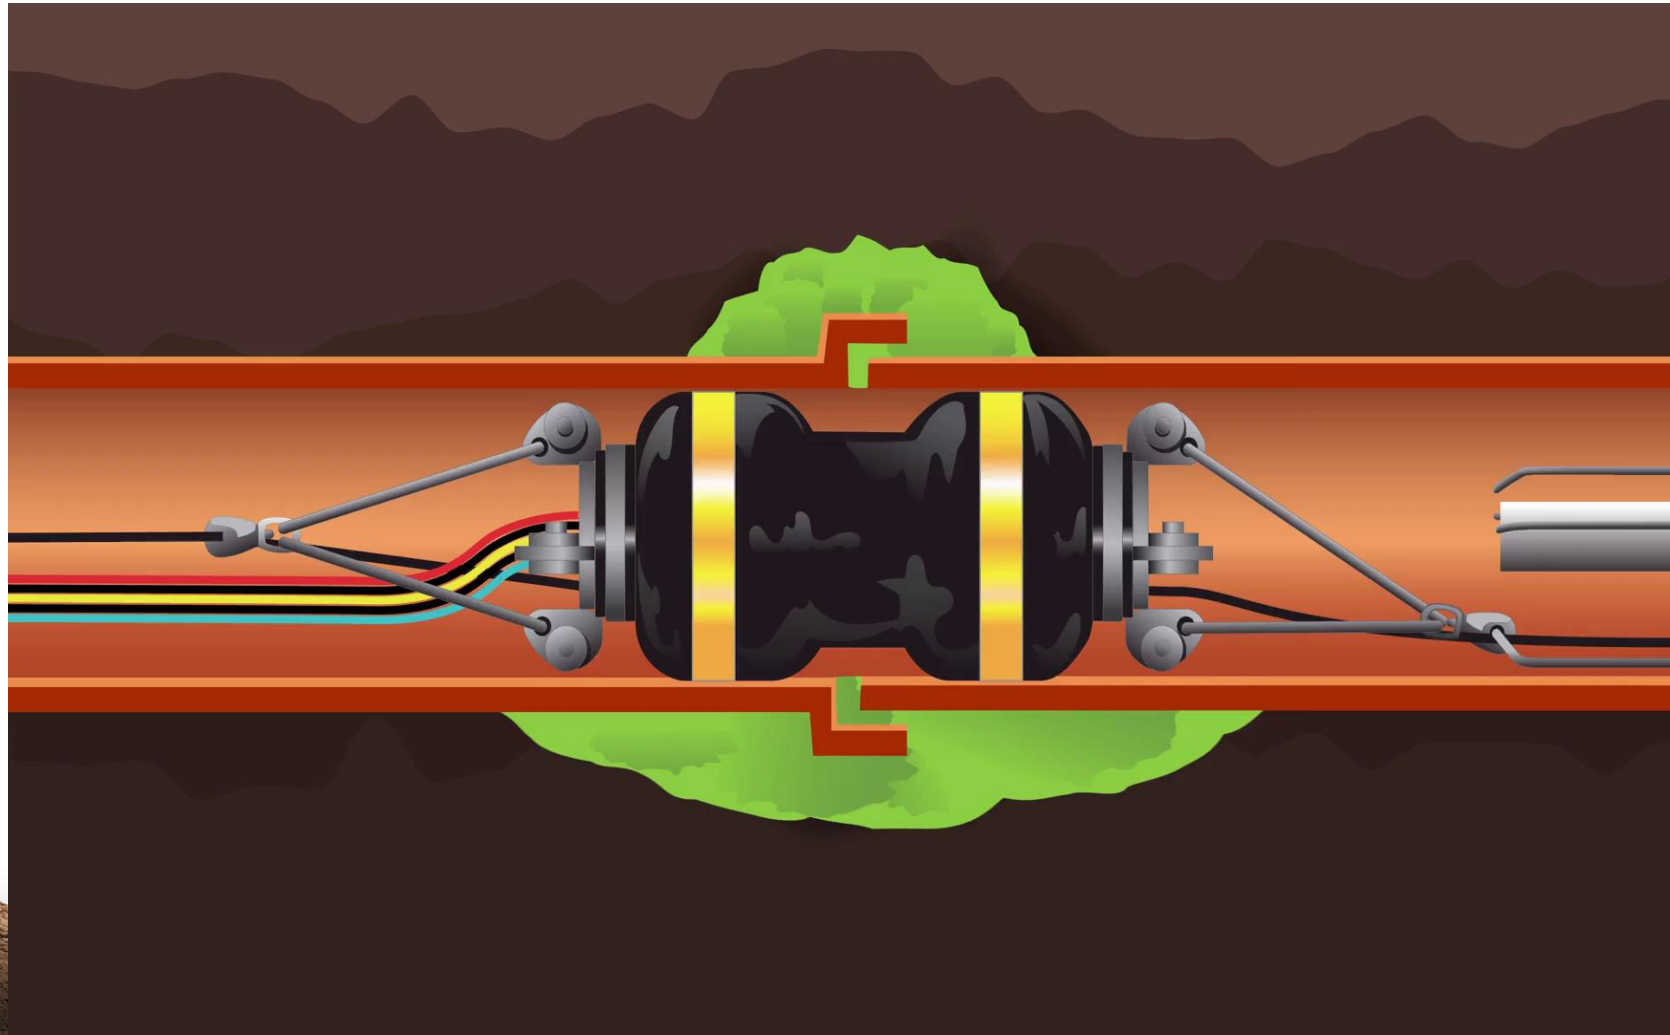
The Process of Sewer Packer Grouting

- Center Packer Upon Joint
- Perform Air Test
- Predominately Injection of Acrylamide Grout to Exterior of Pipe
- Re-test Joint

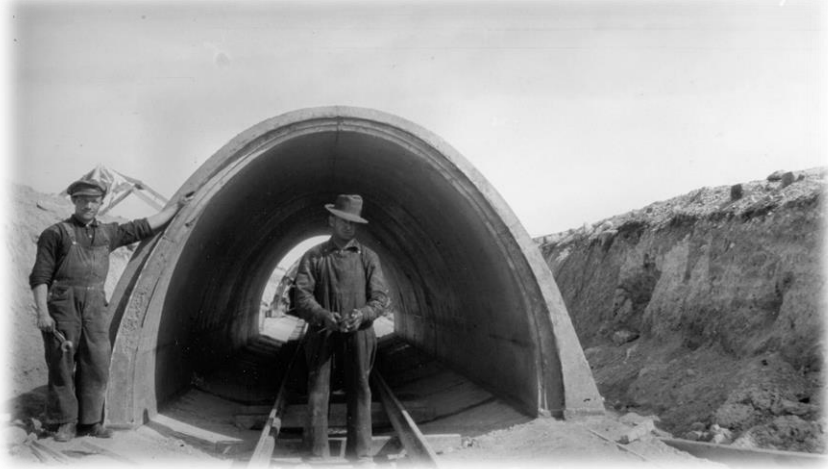
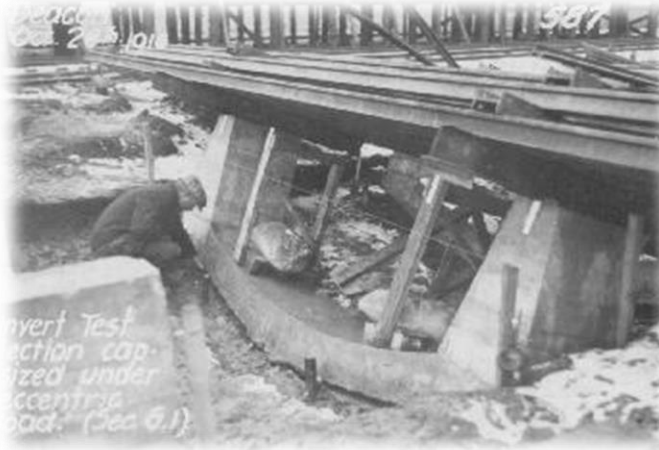
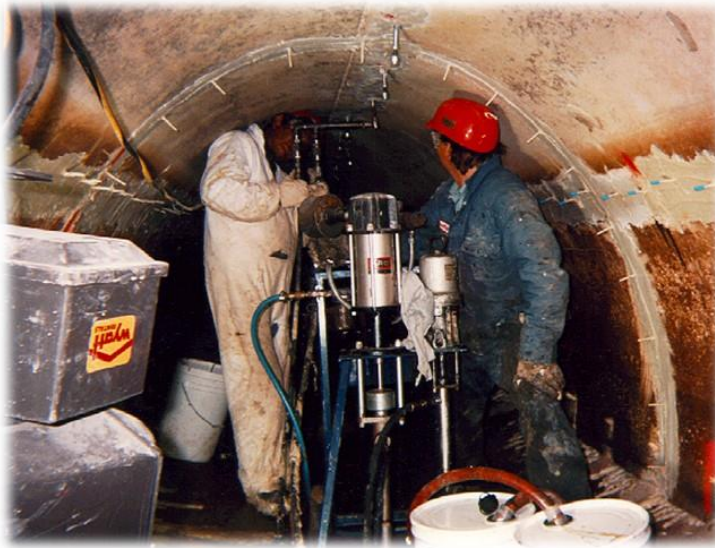
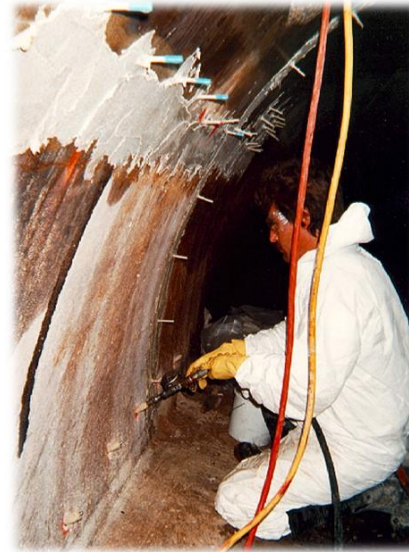
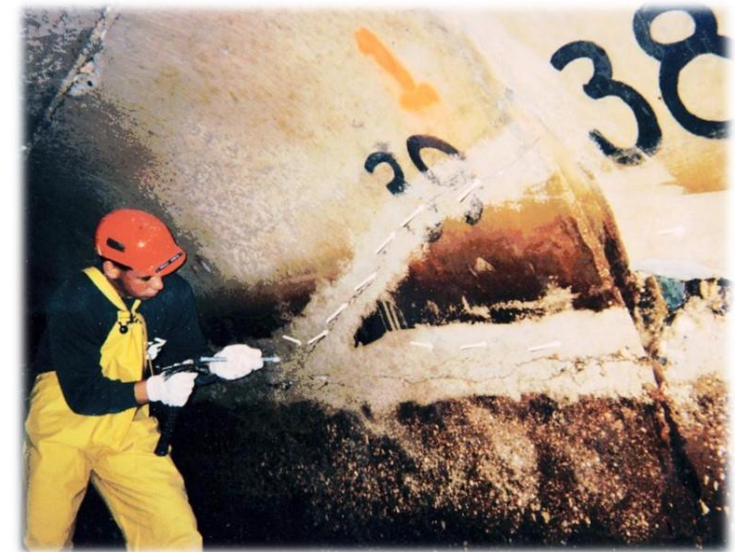
Emergency Repairs – Toronto, ON

Stabilization Grouting – Goes beyond pipe joints alone, and grout mixtures can be very innovatively matched to the application

1. External grouting for stabilization on a 48" Interceptor
 - a. Could not stop infiltration by conventional internal grouting
 - b. Soft soils and active loss of ground was creating a large sinkhole; 10-12 pipes involved and over 2 feet of settlement
 - c. Stabilized externally with cementitious grouts to strengthen soil and allow prep for a CIPP liner

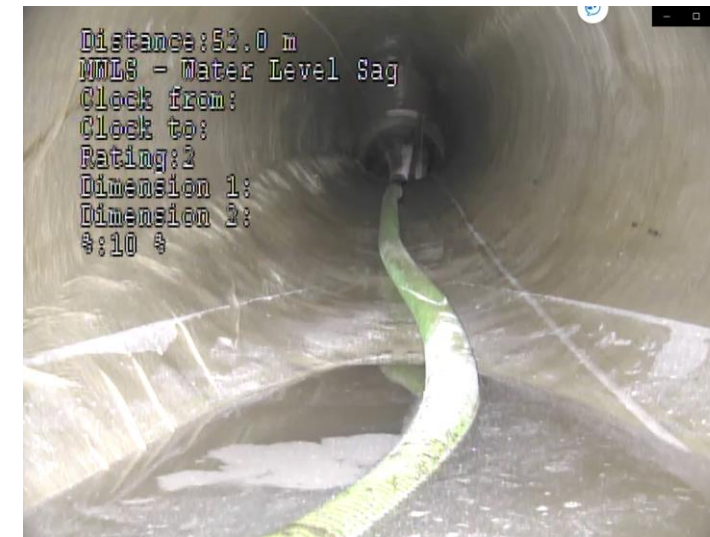
Another Emergency Repair – Toronto, ON

- Surficial depression appeared in June 2021
- MH Sunk ~ 1-2 feet and took 42" diameter pipe with it
- Engaged a slope failure that was going to take out a bridge

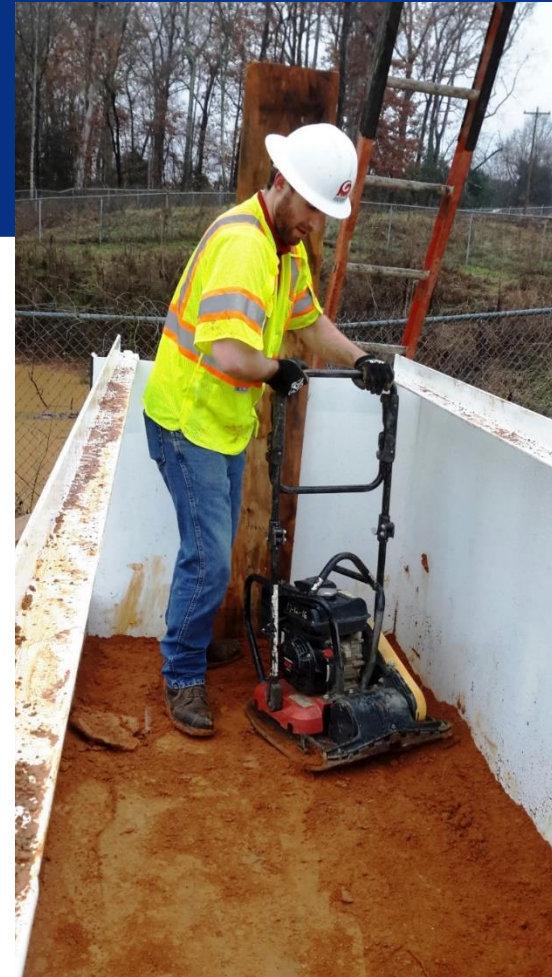
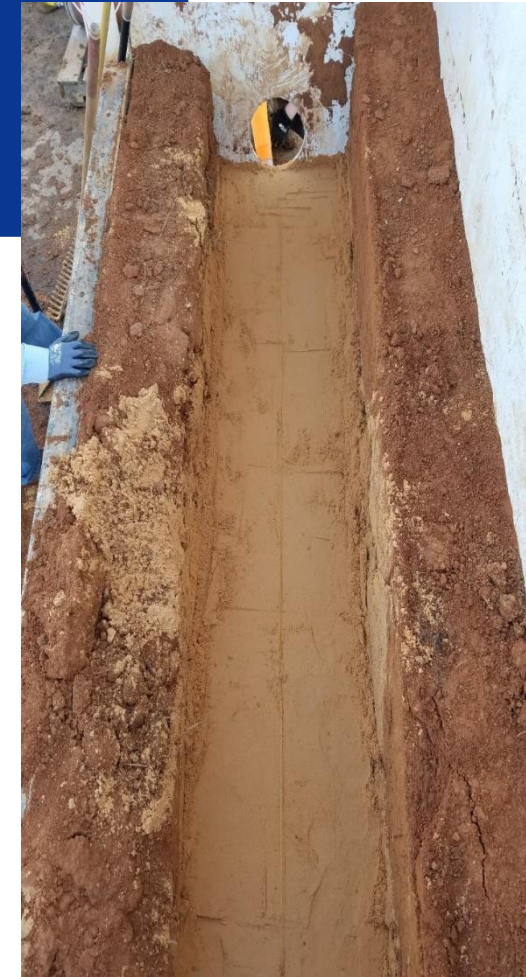
- 2016 Development of Technical Specifications
- Need to document and understand the formation of gel masses within trench during packer injection grouting
- Various smaller tests were performed
- Decision reached to construct a full-scale model of an 8" pipe installation with defects which allowed for trench reconstruction and various bedding materials

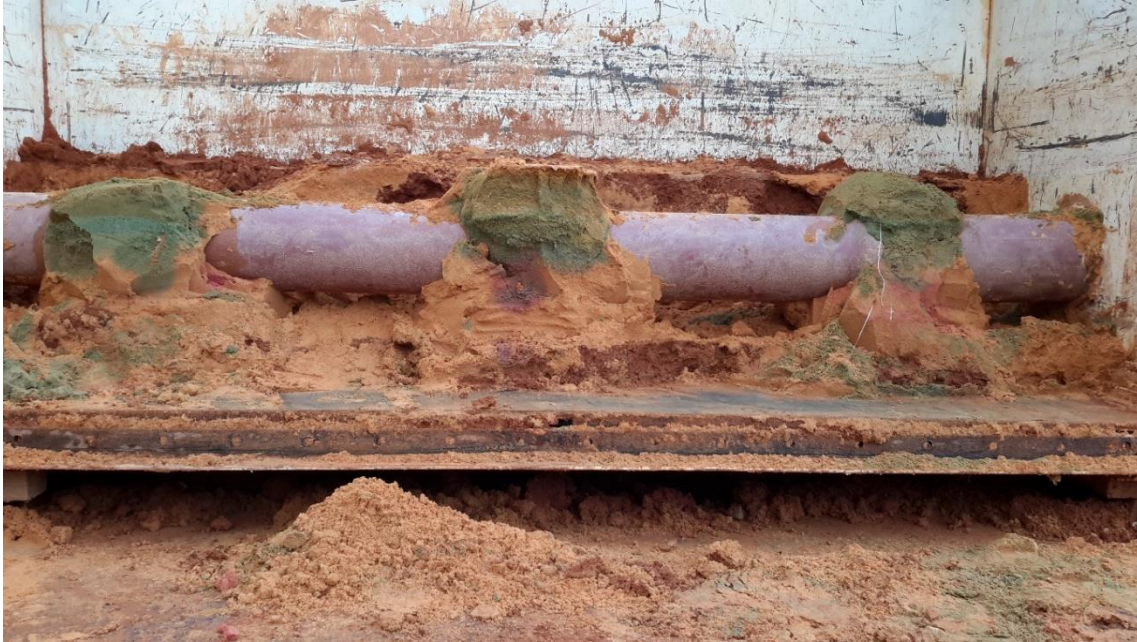
Gel Injection Trials

Vary:

- Native and embedment soils
- Grouting formulations
- Grouting gel times

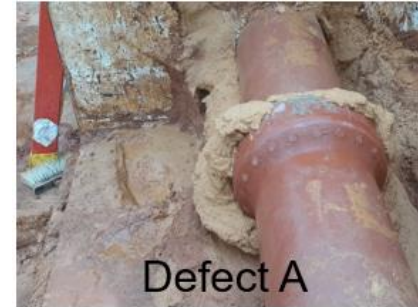
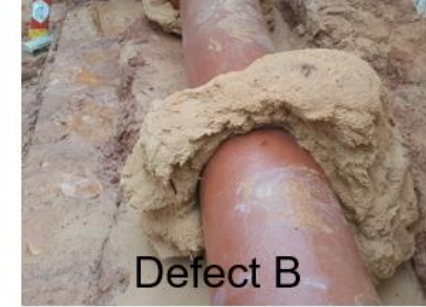
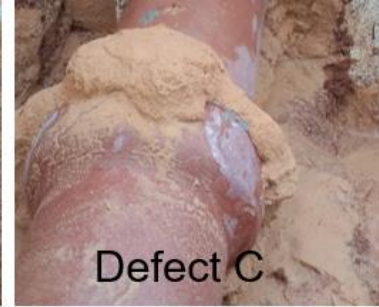
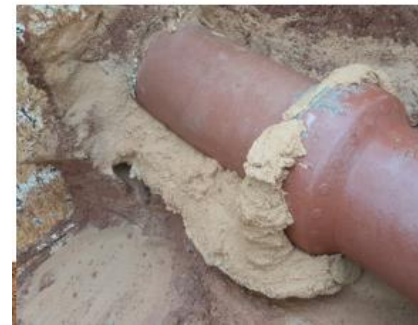
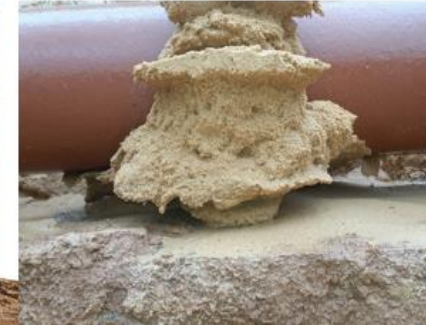
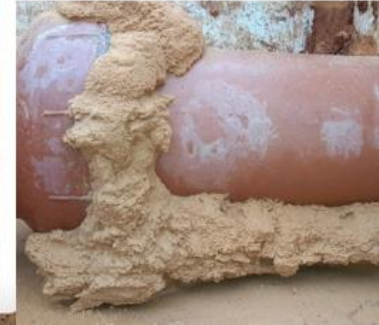
Formations Observed

Observe:

- Effect on different defect types
- Grout path relative to voids in various soil types
- Nature and effectiveness of stabilization

- Grout Descends Below the Structure Providing a Stabilizing Cradle in Haunch Area
- Defects are Sealed with Neat Grout
- Longer Gel Times Allow for Larger Gel / Soil Matrix
- Voided Areas in Pipe Trench are Filled with Neat Grout
- Trench Dams are Created to Mitigate the Free Flow of Groundwater
