# Vertical Spray In Place Pipe (SIPP) 24" ID x 25ft Access Through 18" x 24" Adapter Flange

Project Owner/Speaker: Vortex – Sean Fuller

Applicator/Speaker: Elite Pipeline Services – Scott Dishon

# Introduction

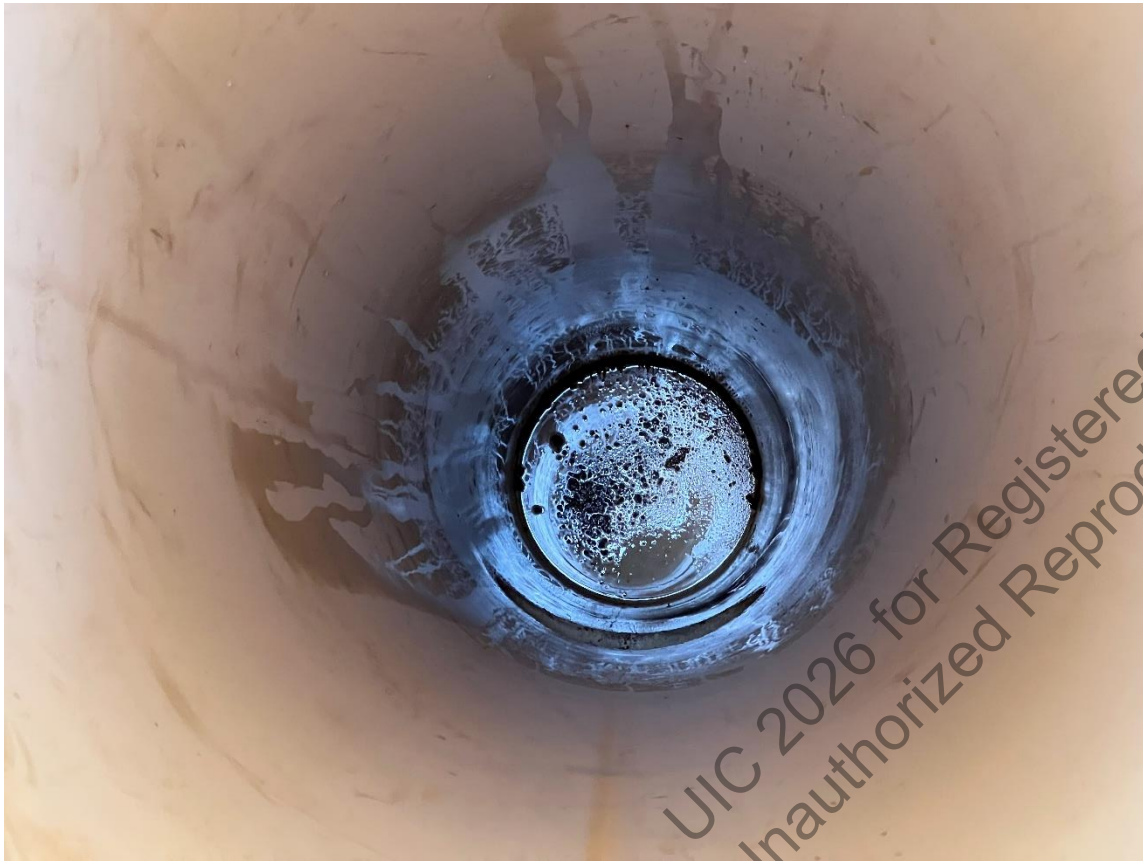
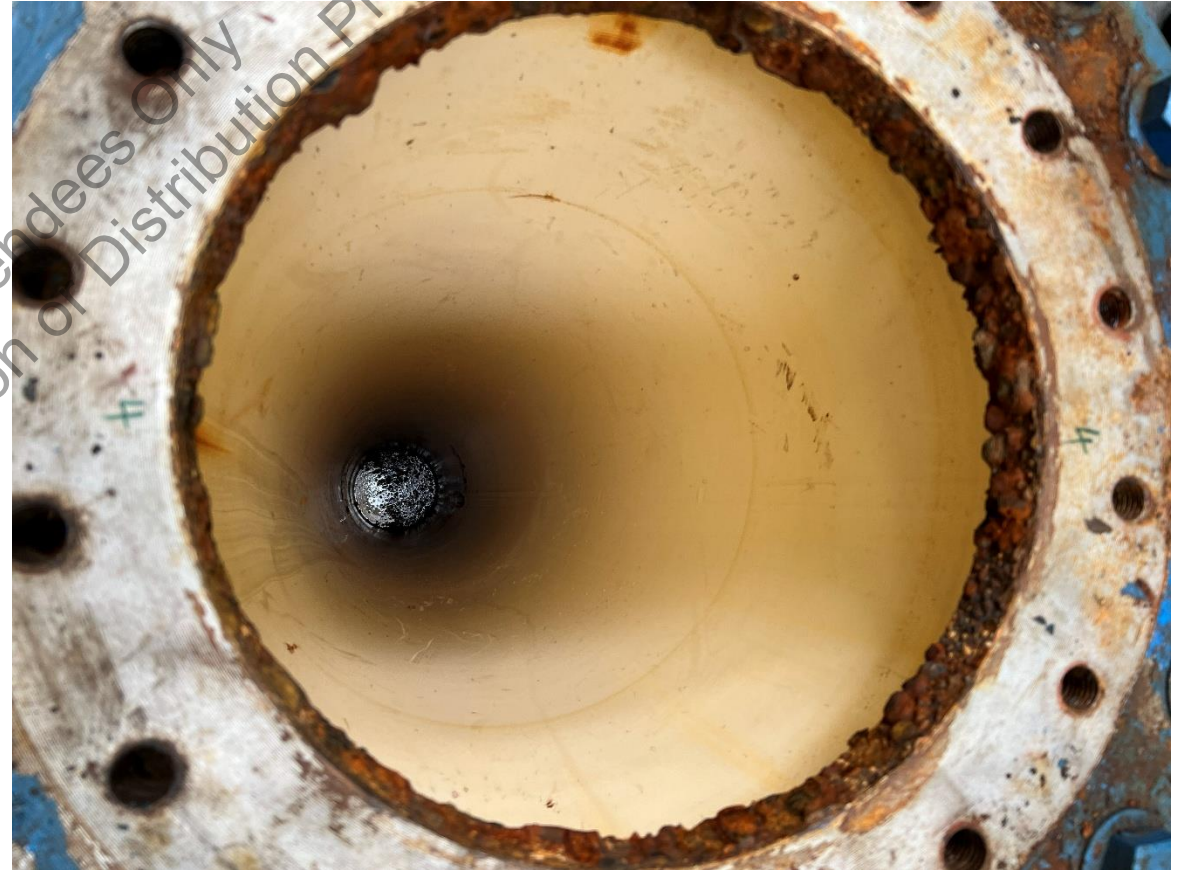
# Initial Inspection After Dewatering

12mil – 15mil Existing Coating Looks Pretty Good (20 yrs) Top Side

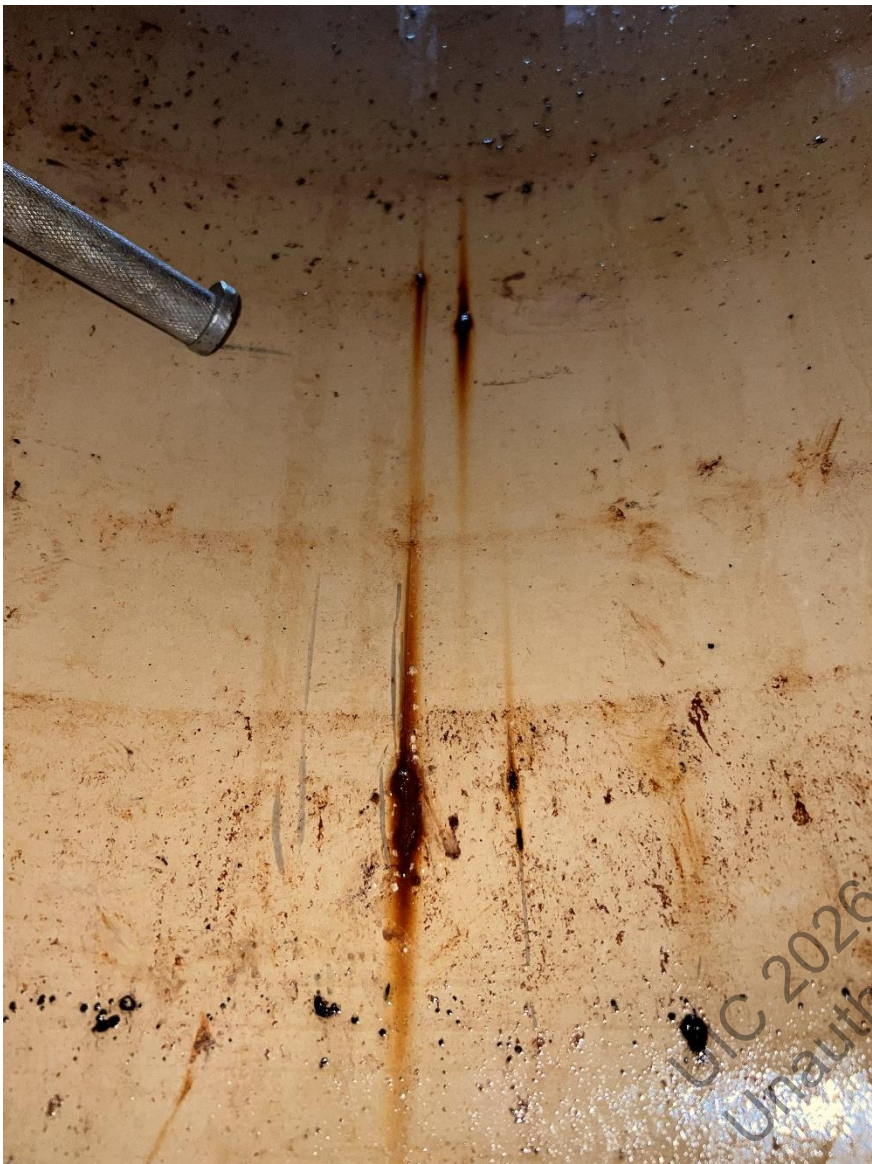
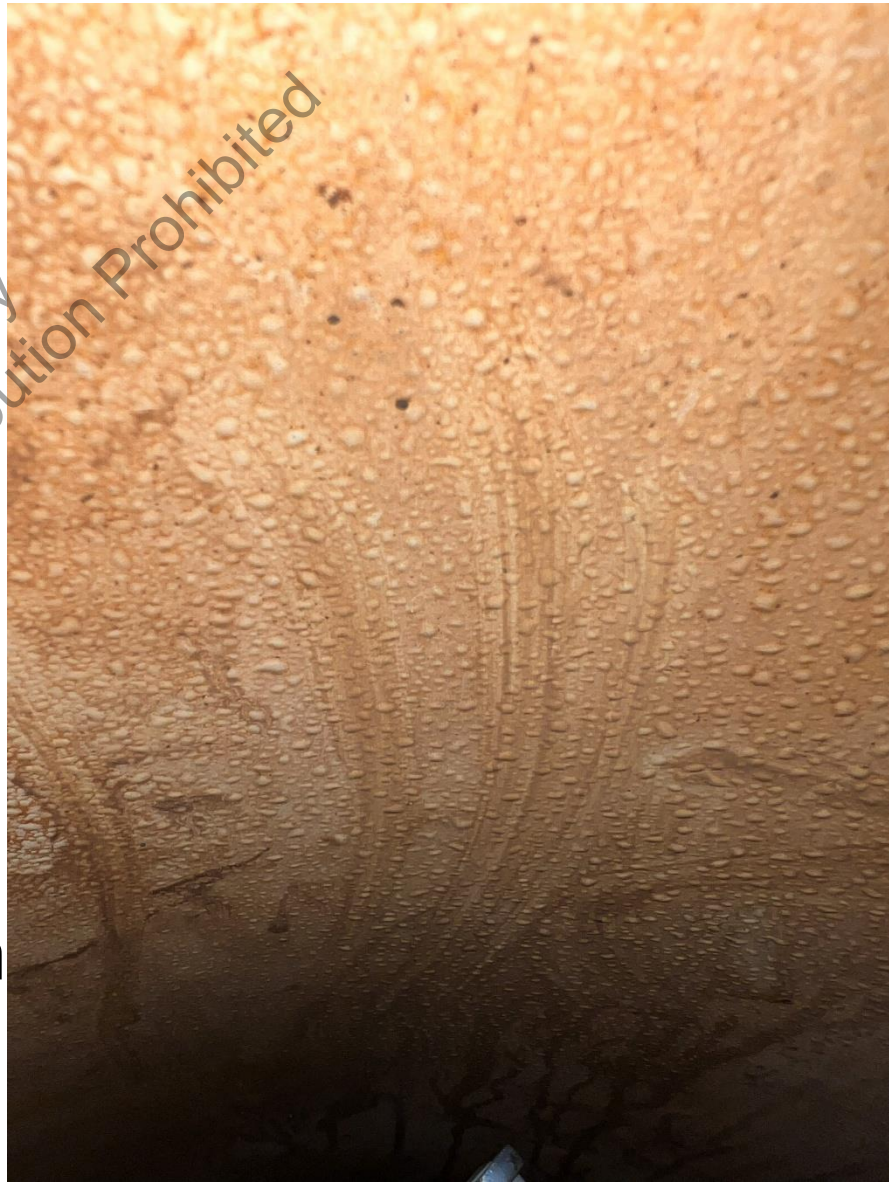
Through Walls

Coating Blistering

75% of Coating in  
Good Condition

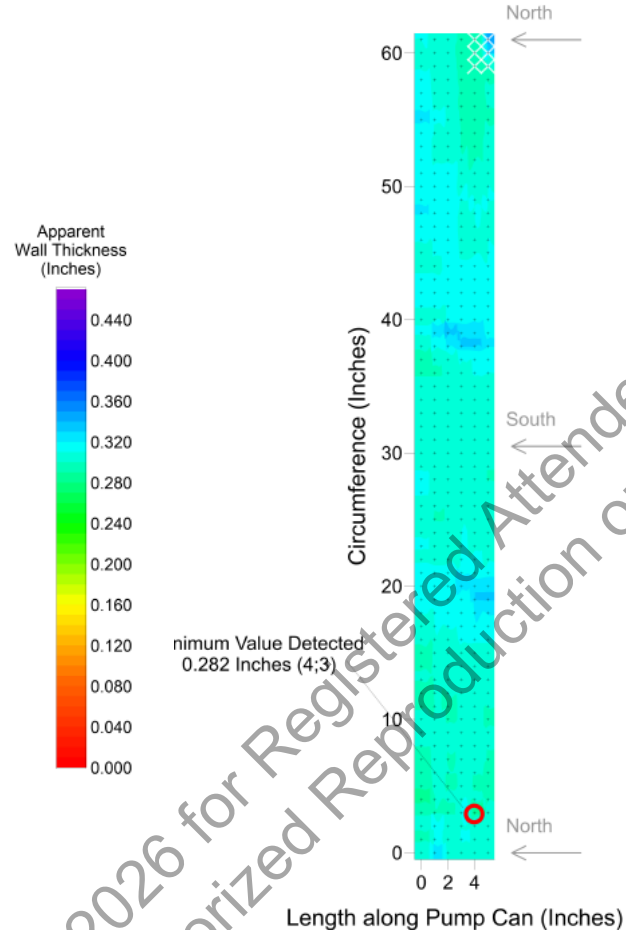
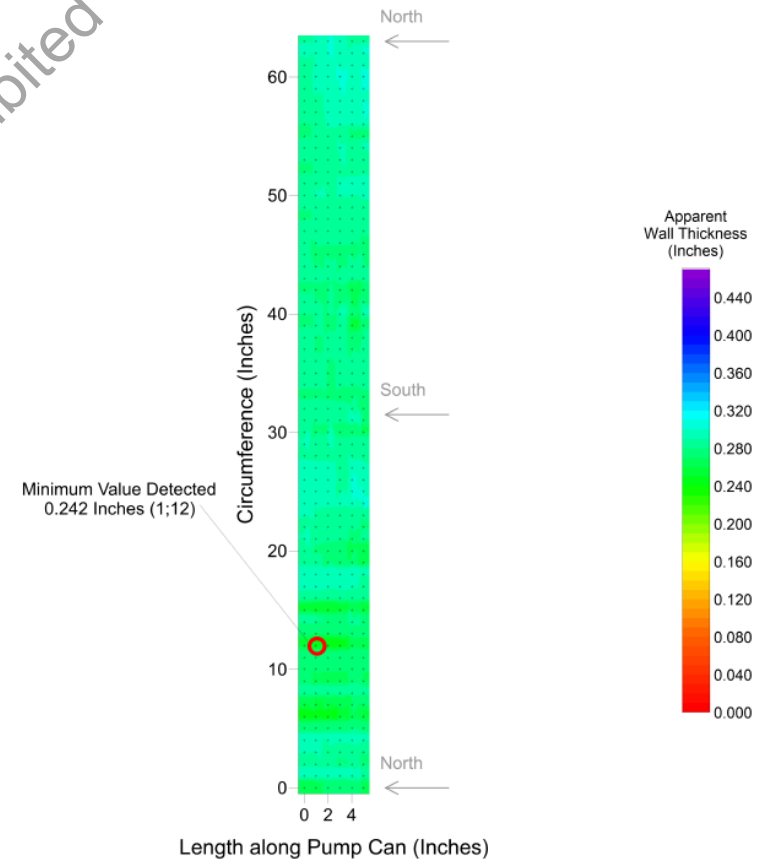
Original Wall Thickness of Cans 0.375  
 Scanning Ave – 0.247 – Confidence in Hydro Lazing Step

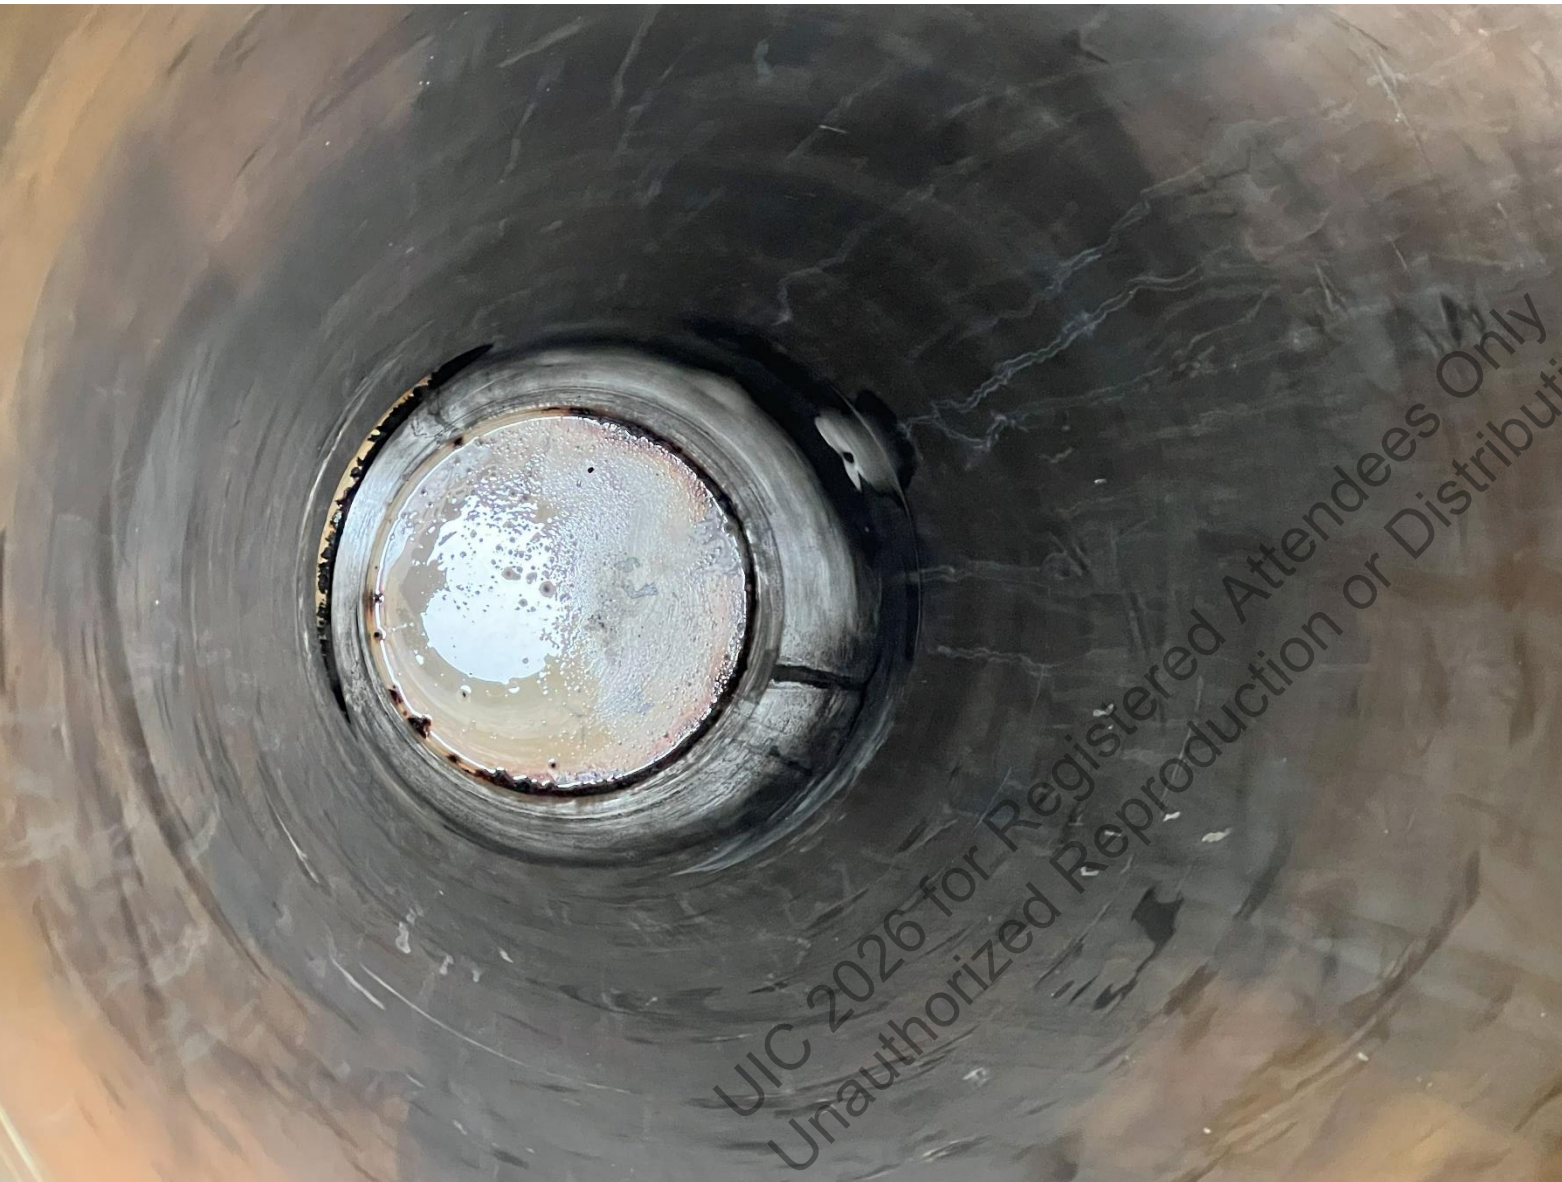
Approximately 32,000 psi  
Required to remove coating

Vac truck onsite to remove  
debris

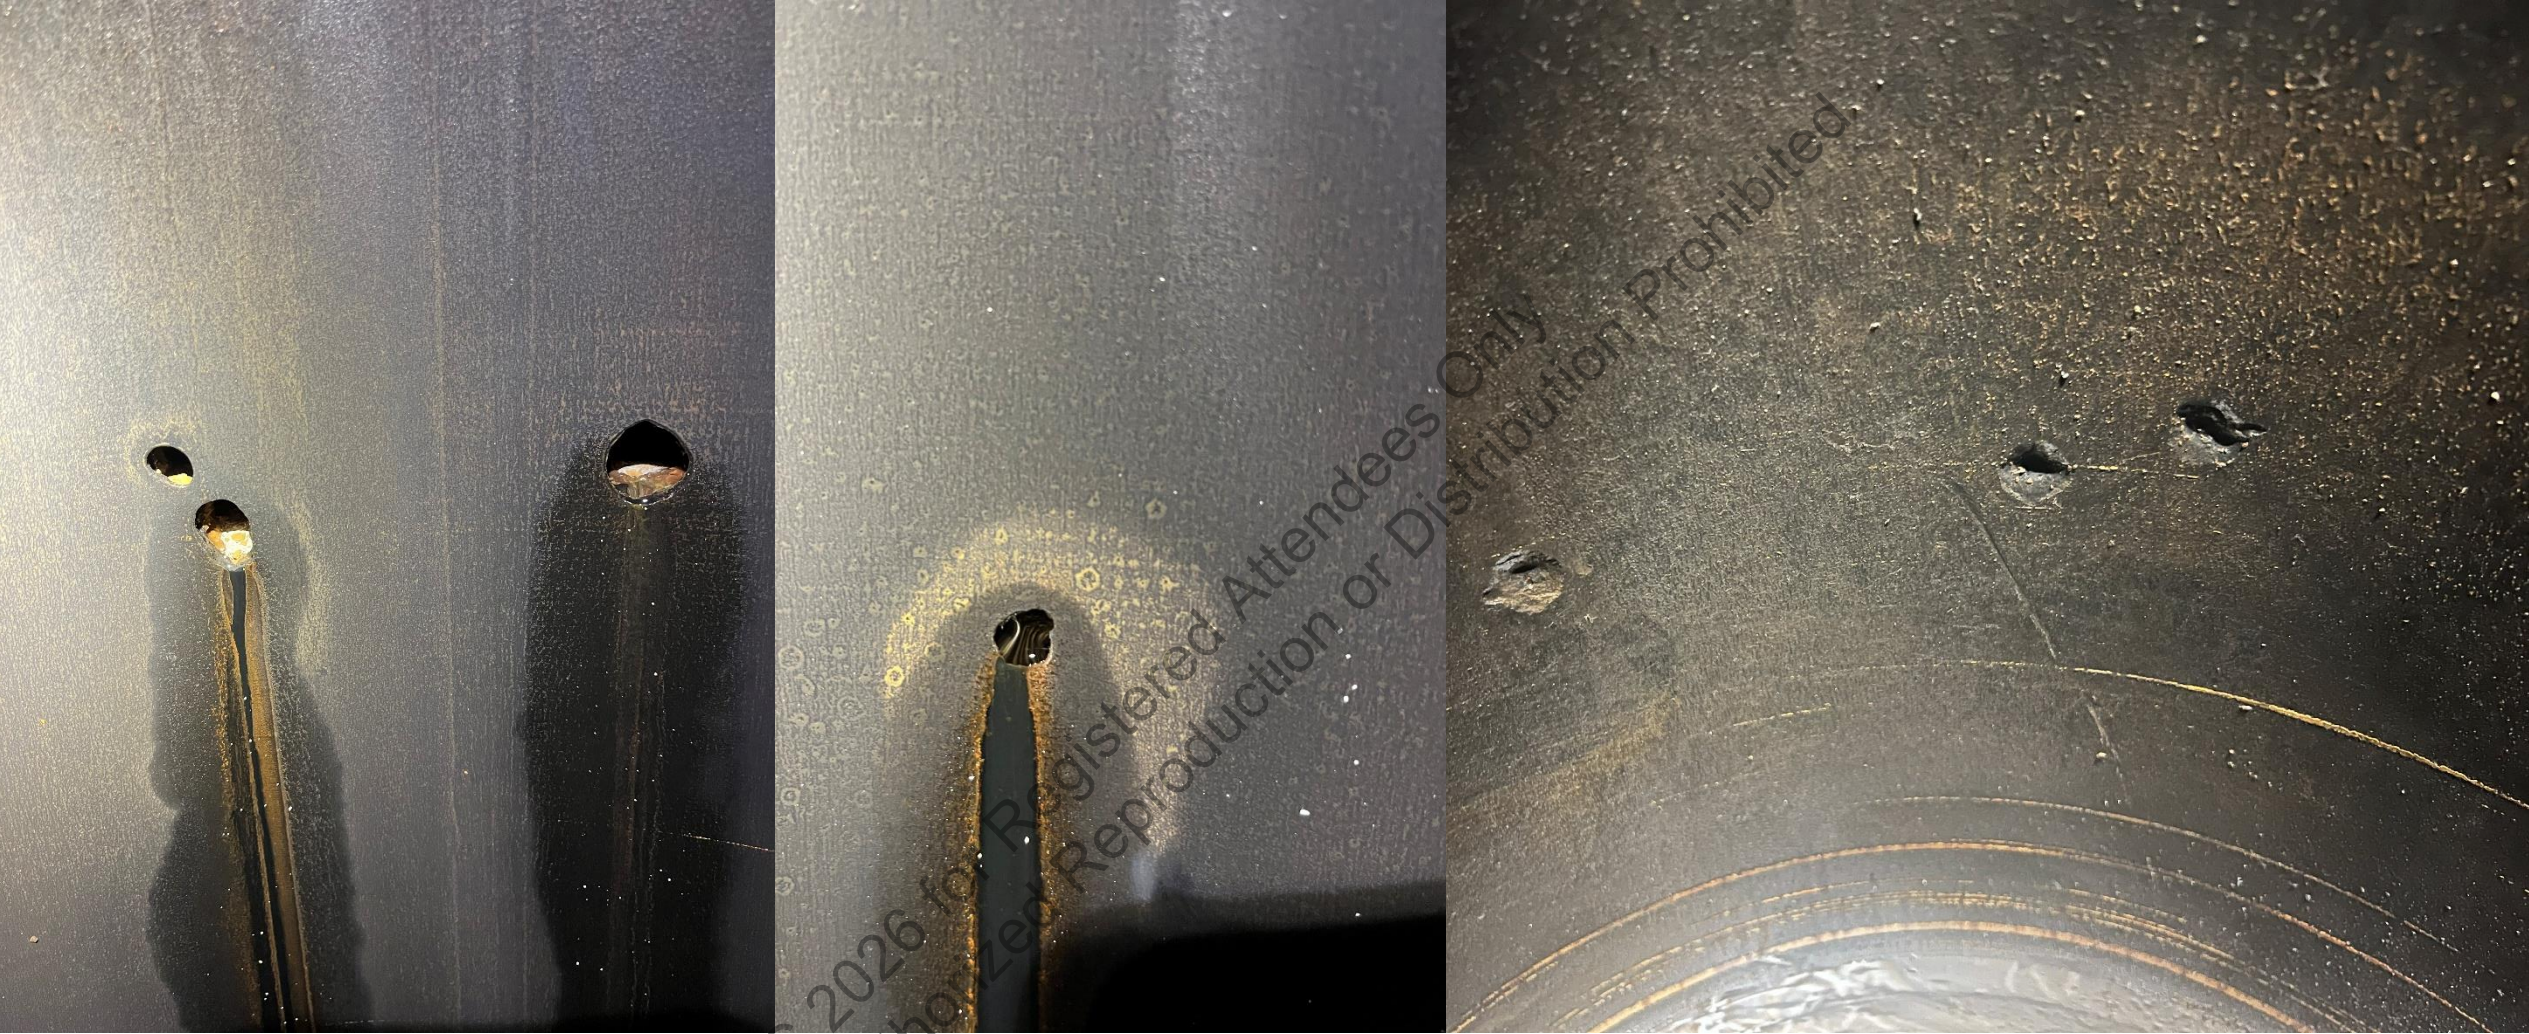
Approximately 5 Through Walls Total

75% Wall Loss Pitting

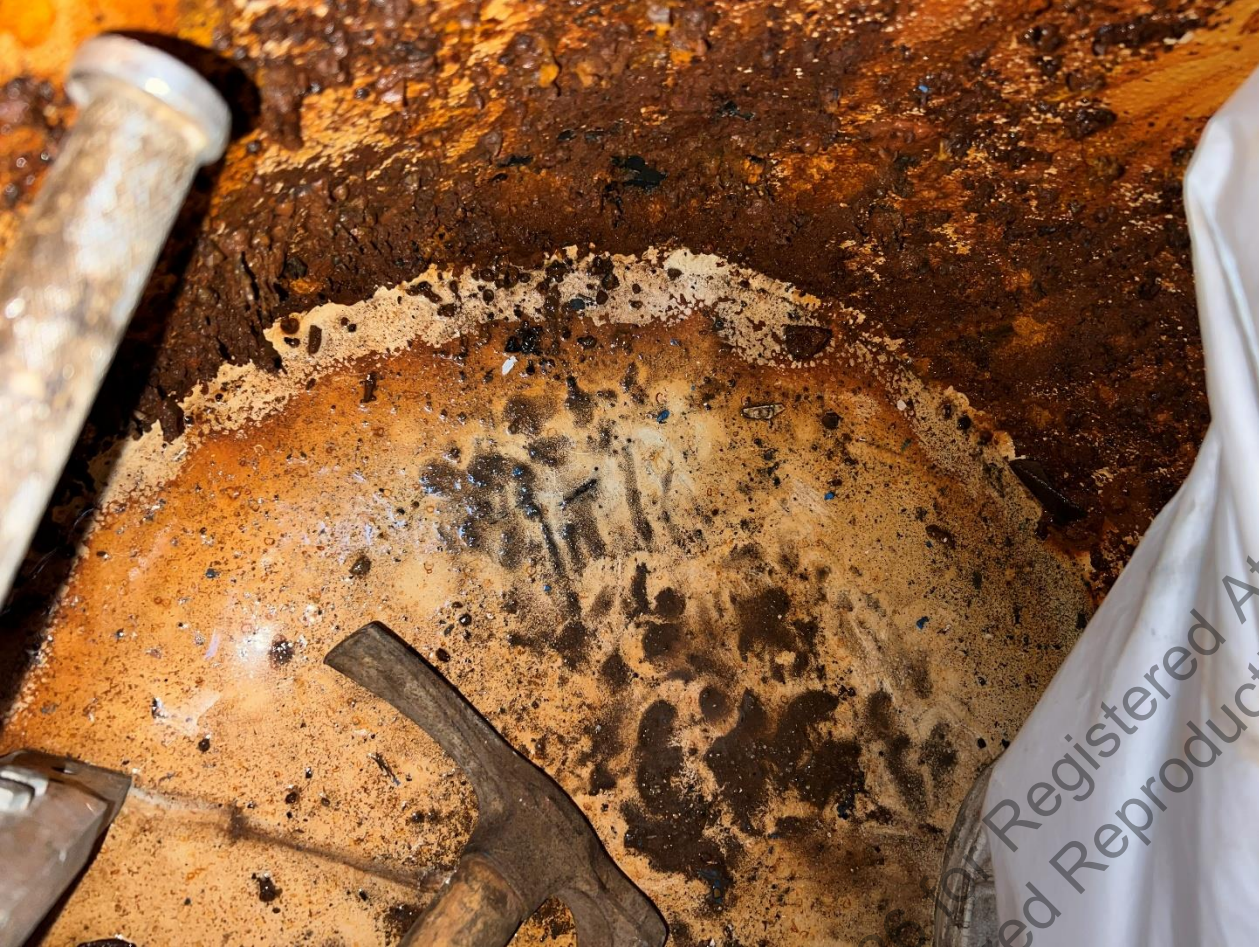
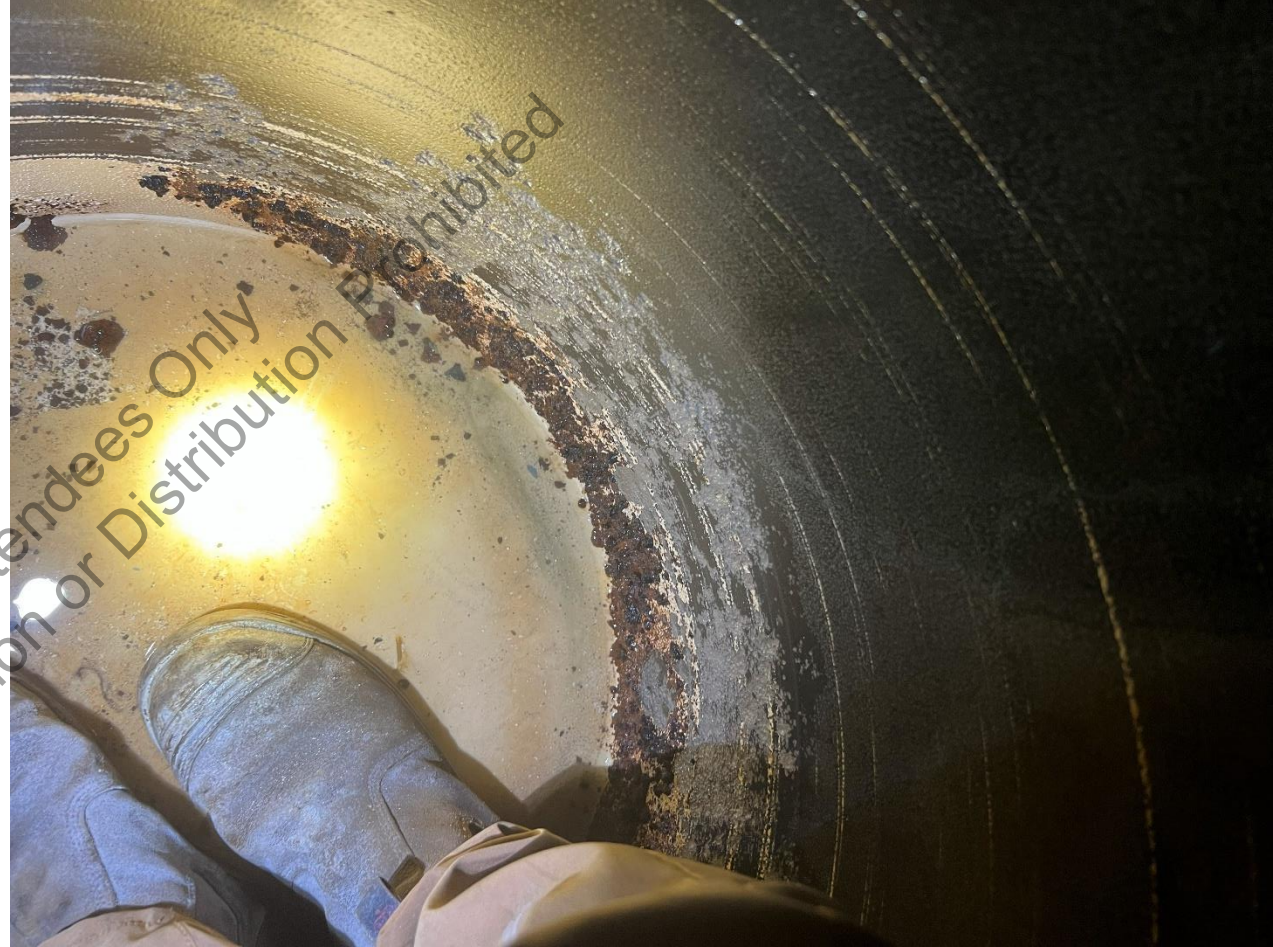
- End cap was in good condition
- Heavily corroded from welds up
- Hand Prepped
- Enecon Metal Clad Filled and Smoothed Out
- Hand Sprayed up 1ft
- SIPP Over the Top

## Filled In and Sanded Back

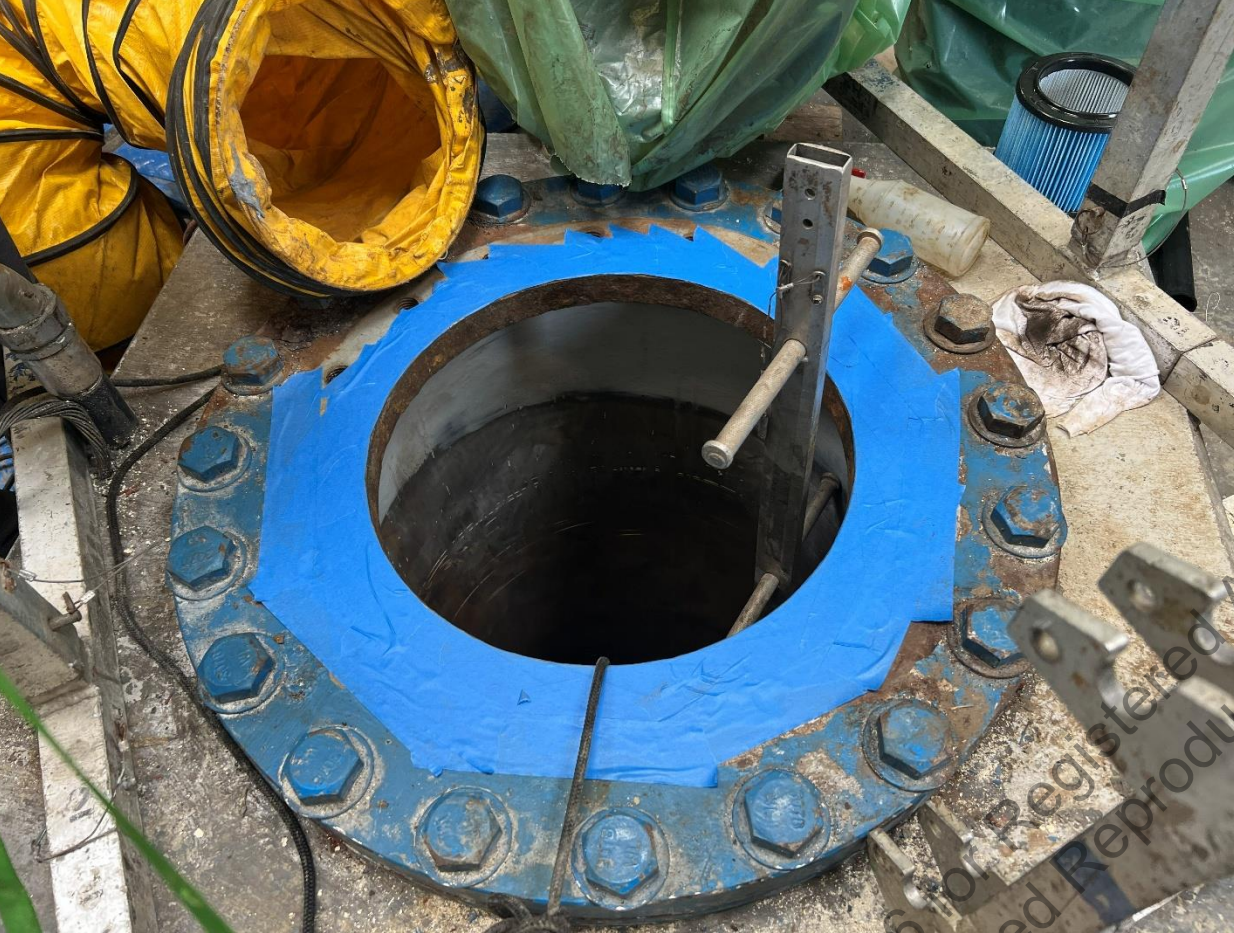
Hand Coated 1<sup>st</sup> Ft. (Welds)

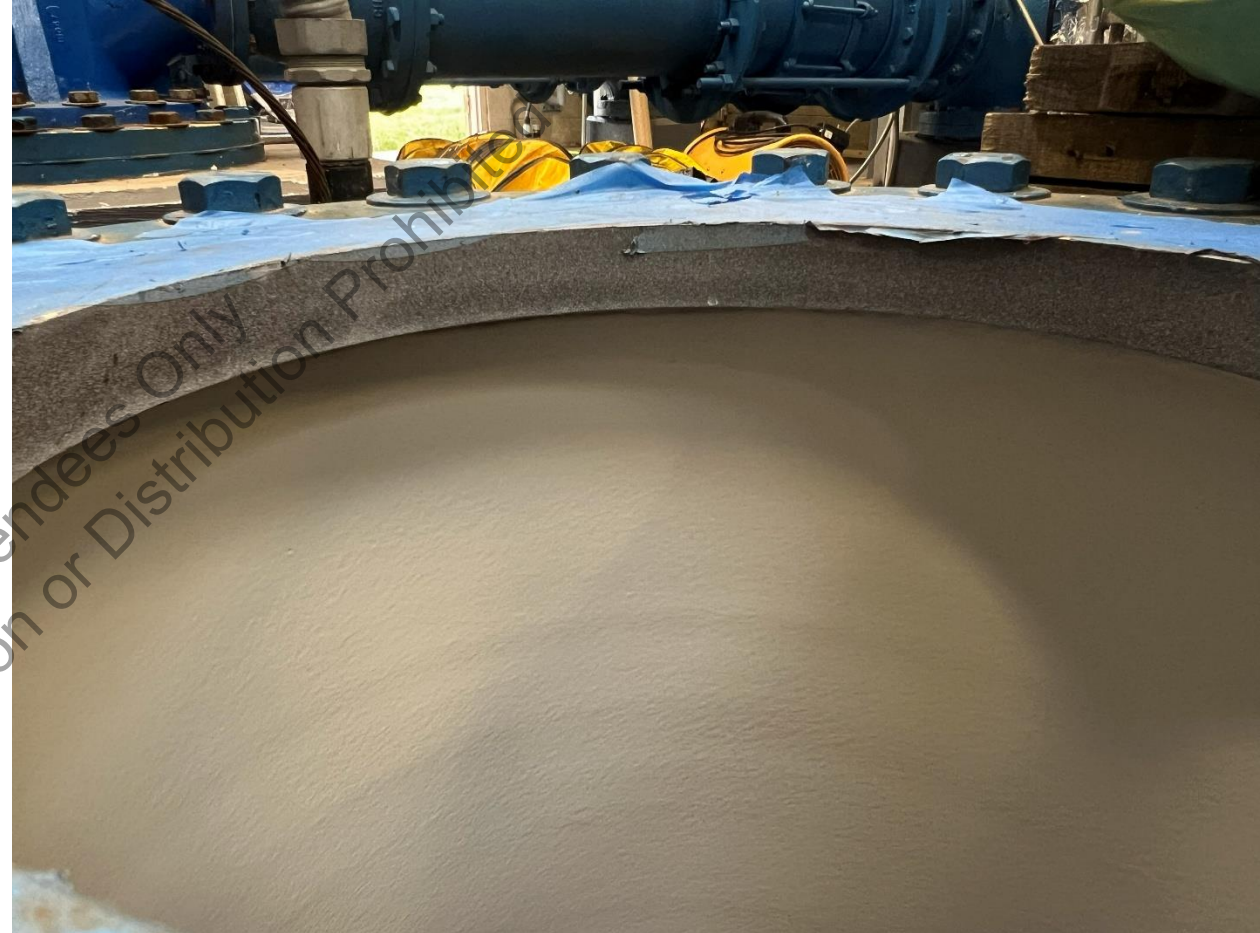
SIPP Coated Over The Top

- After repairs pump cans completely dry
- Not possible for weld repairs in certain areas (cap)
- Existing coating was 12-15mil Ave, new coating 60mil Ave
- Zero holidays after sweep
- With our SIPP Services we like to pre hand coat welds, joints, flanges to avoid possible holiday exposure
