From Full Replacement to Targeted Rehab: How Acquaint's Tech Transformed a Force Main Plant

Edzer Kooistra

January 27 – 28, 2026

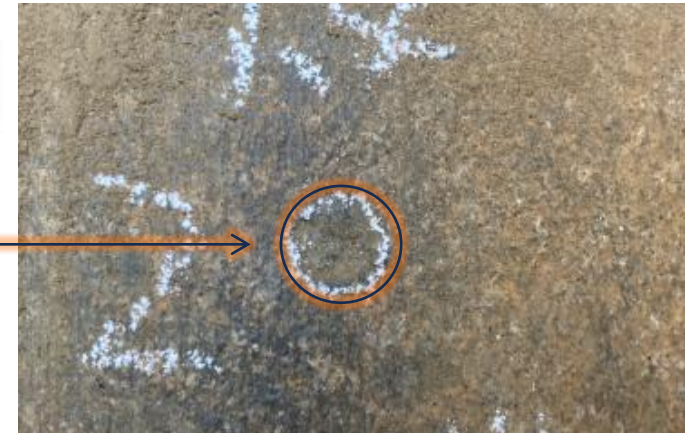
EM vs UT IN CEMENT LINED DUCTILE IRON

Figure 25: Remaining wall thickness around damaged outside wall

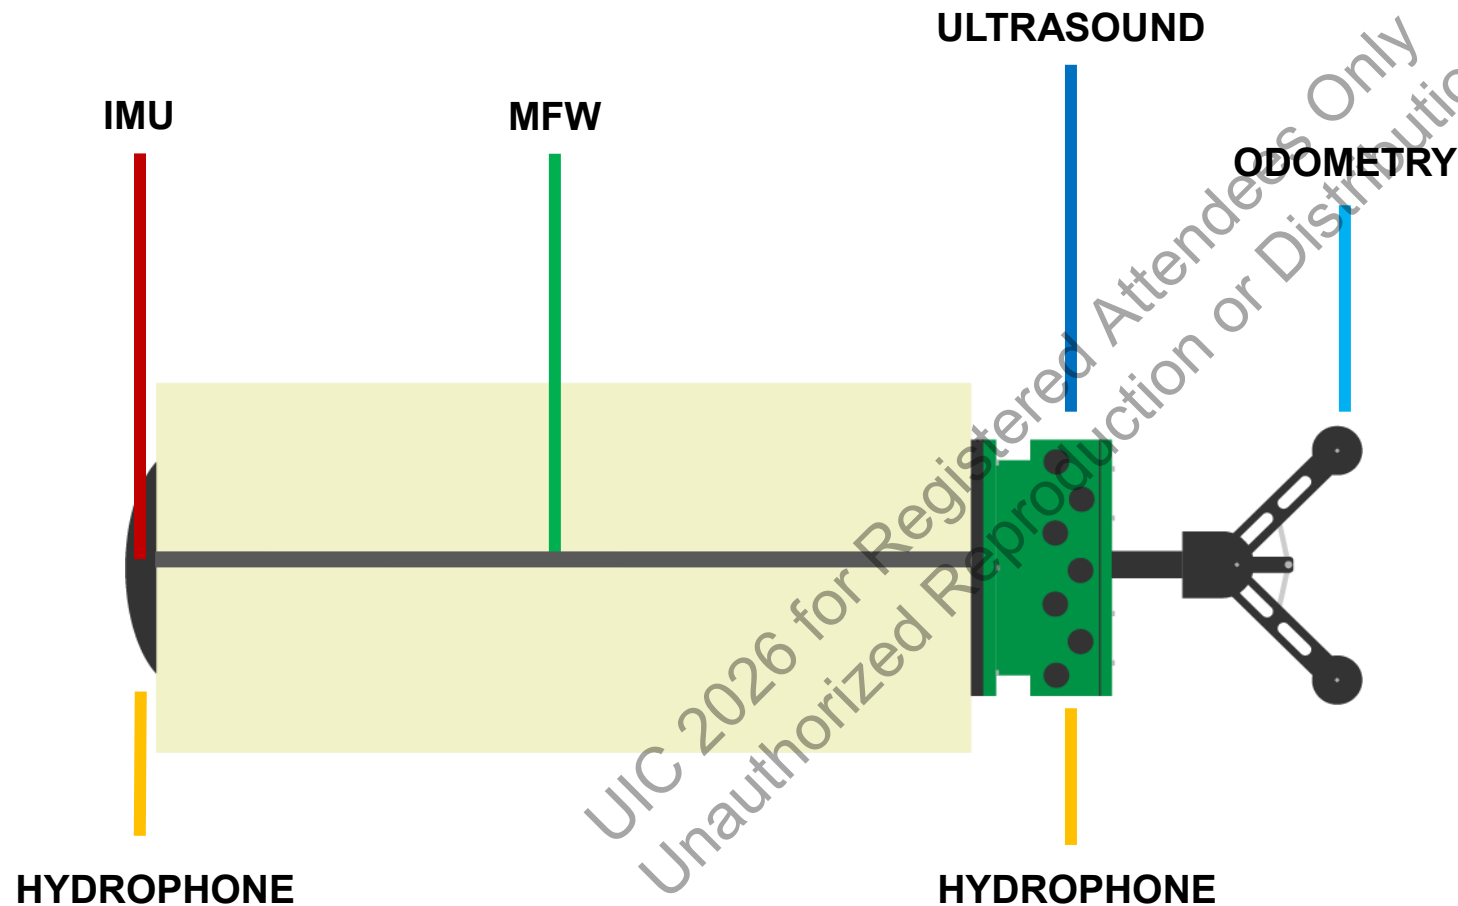
SPECS ACQUARIUS

- Many miles in a single run
- Drinking water and sewage
- Non-destructive
- Diameter > 10"
- Diameter reductions & 90° bends
- Proven technology in more than **210** projects worldwide

Measurements Acquarius	Steel/DI/Ci	Concrete	AG	Plastics (PE/PVC/GRP)
XYZ Mapping (1.6 ft)	✓	✓	✓	✓
Wall Thickness (0.019 inch)	✓ (corrosion)	✓	✓ (leaching)	✓ (delamination)
Joint Angular displacement (0,25°)	✓	✓	✓	✓
Joint Gap Width (0.16 inch)	x (or condition welds)	✓	✓	✓
Ovality (0,5%-point)	✓	✓	✓	✓
Axial Deformation (7.8 inch)	✓	✓	✓	✓
Leaks (>13.0 dB)	✓	✓	✓	✓
Air pockets	✓	✓	✓	✓
Debris	✓	✓	✓	✓
Wire break		✓ (C301/303)

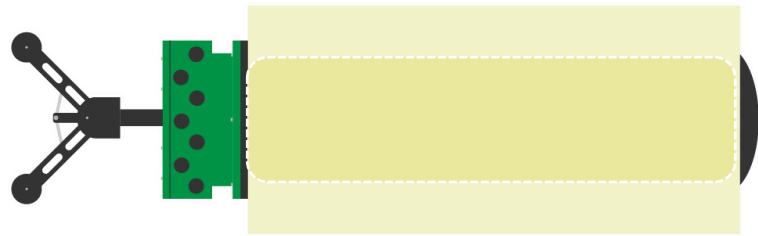
3: INSPECTION RUNS

Collection of pipe integrity and XYZ-data.

A clean pipeline and steady flow ensure the highest quality sensor data.

- ✓ Medium density foam PIG
- ✓ Acquarius sensors
- ✓ 1.3 ft/s
- ✓ Trackable
- ✓ Pressure monitoring at launch site

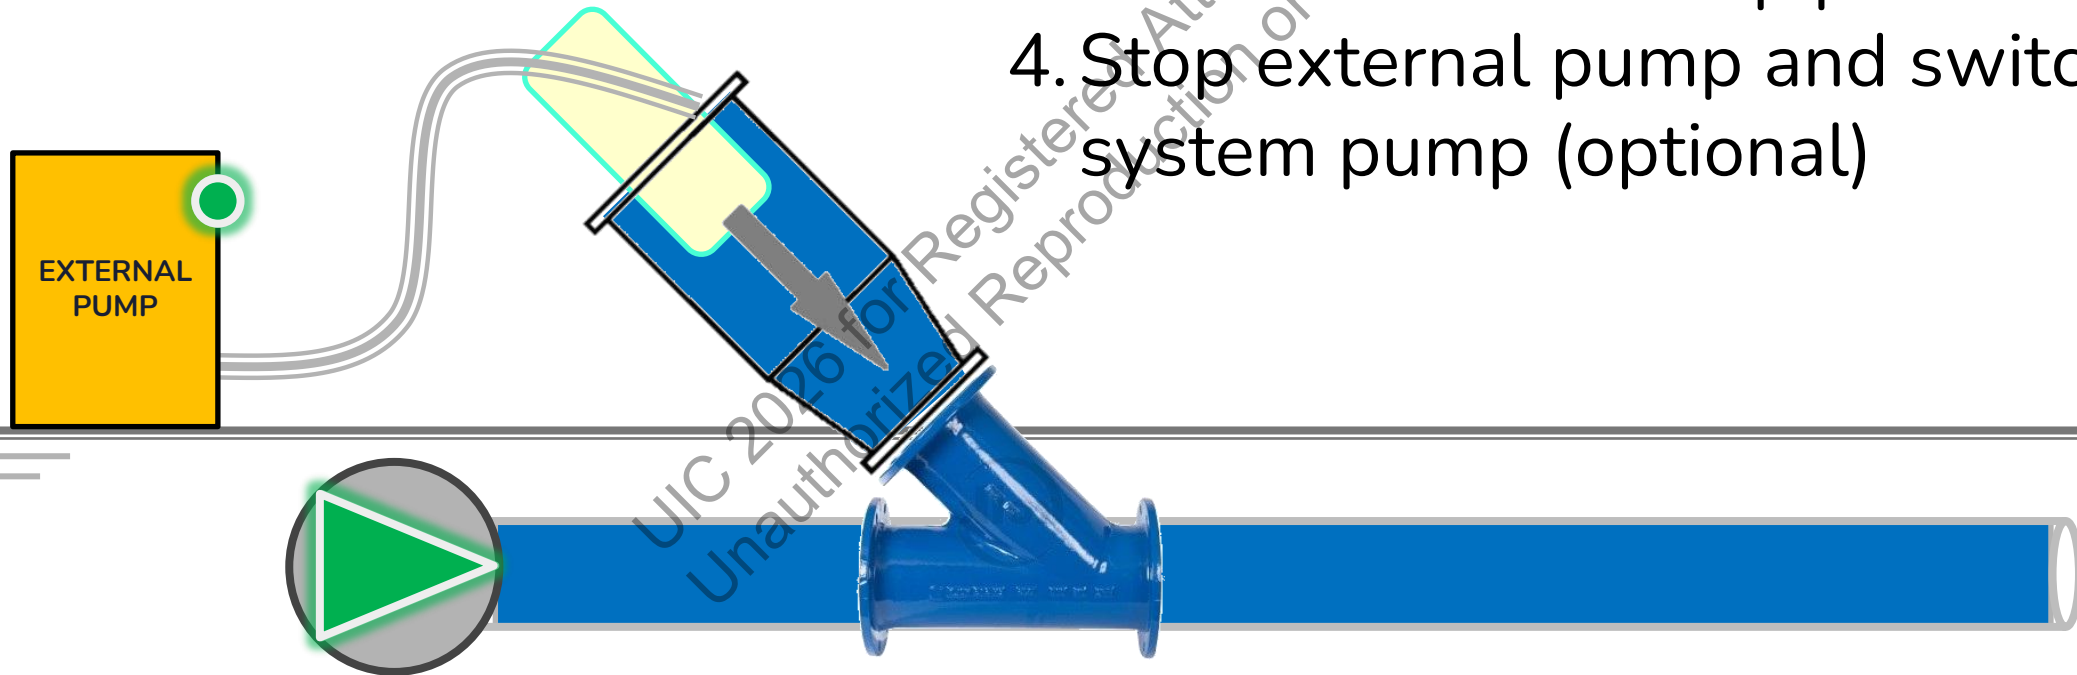
LAUNCHING ILI INSPECTION TOOL

1. Place PIG in launch tower, push to tight fit
2. Close lid and start external pump
3. Force PIG into main pipeline
4. Stop external pump and switch to system pump (optional)

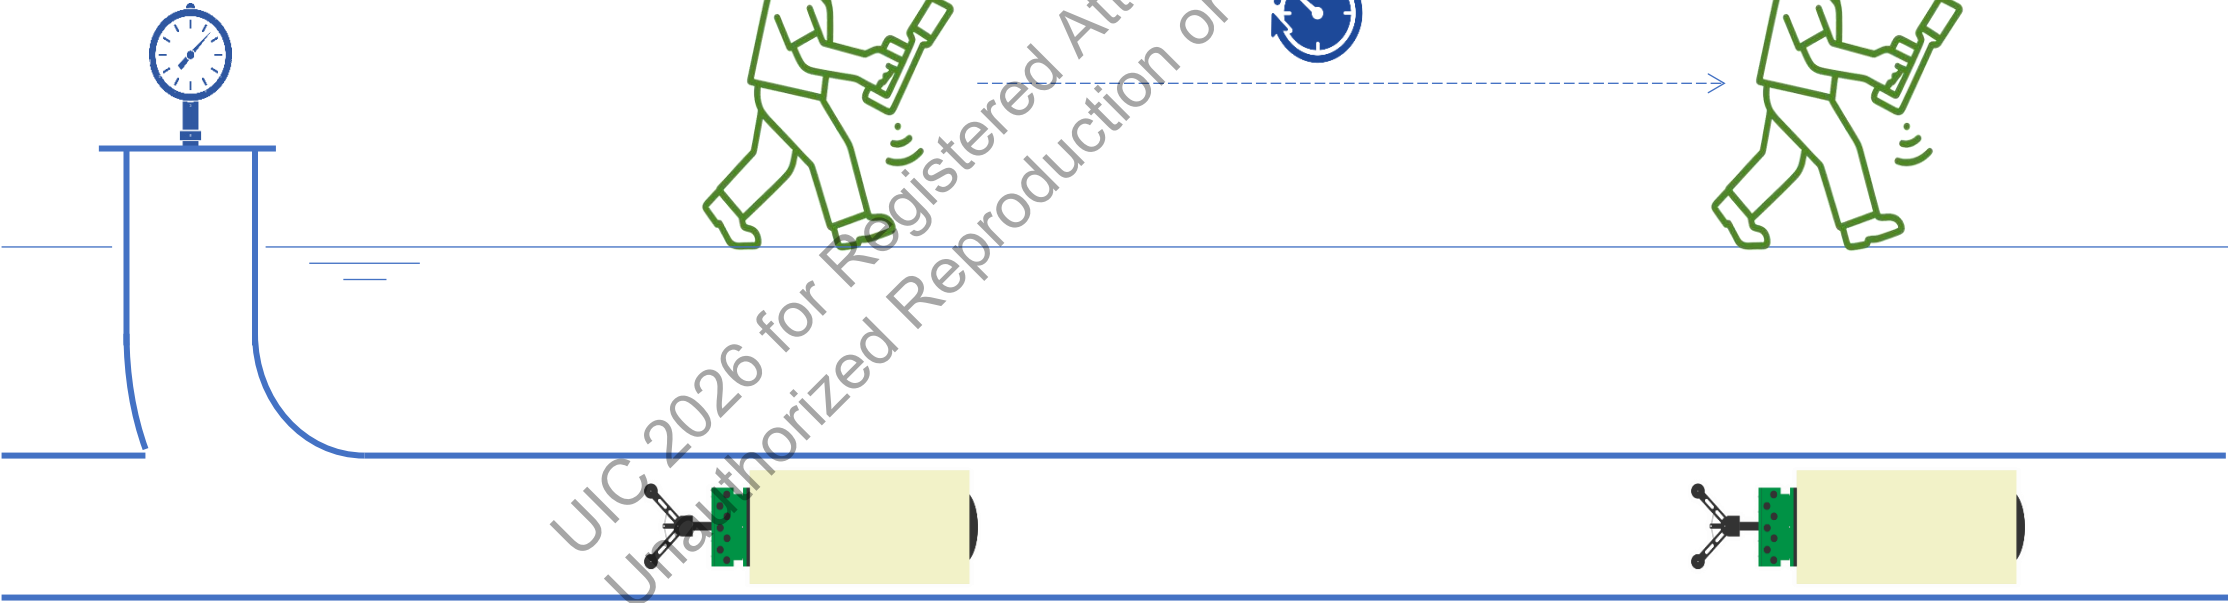
TRACKING PROCEDURE

Real-time flow and pressure monitoring at start of pipe trajectory

Live tracking of PIG/ACQUARIUS

Clacking the speed of PIG/ACQUARIUS

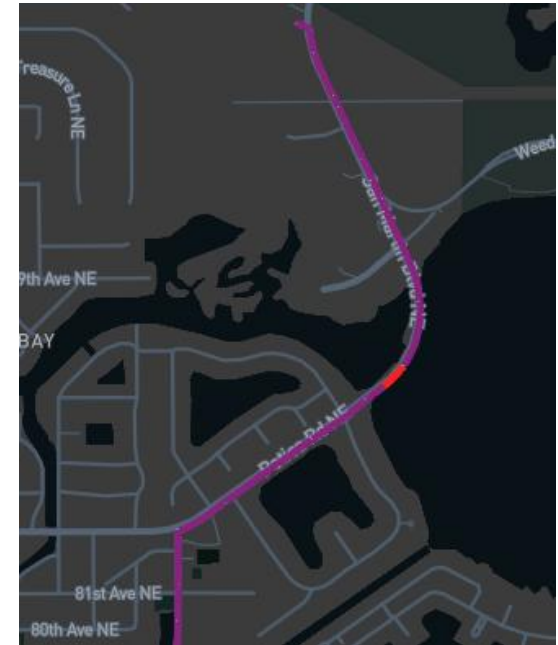
(1/2) RESULTS

Sewage Force Main 1980;
24" ductile iron pipe;
18,900 ft
40,000,000 \$ budget reserved for replacement

XYZ location corrected

Unknown material identified

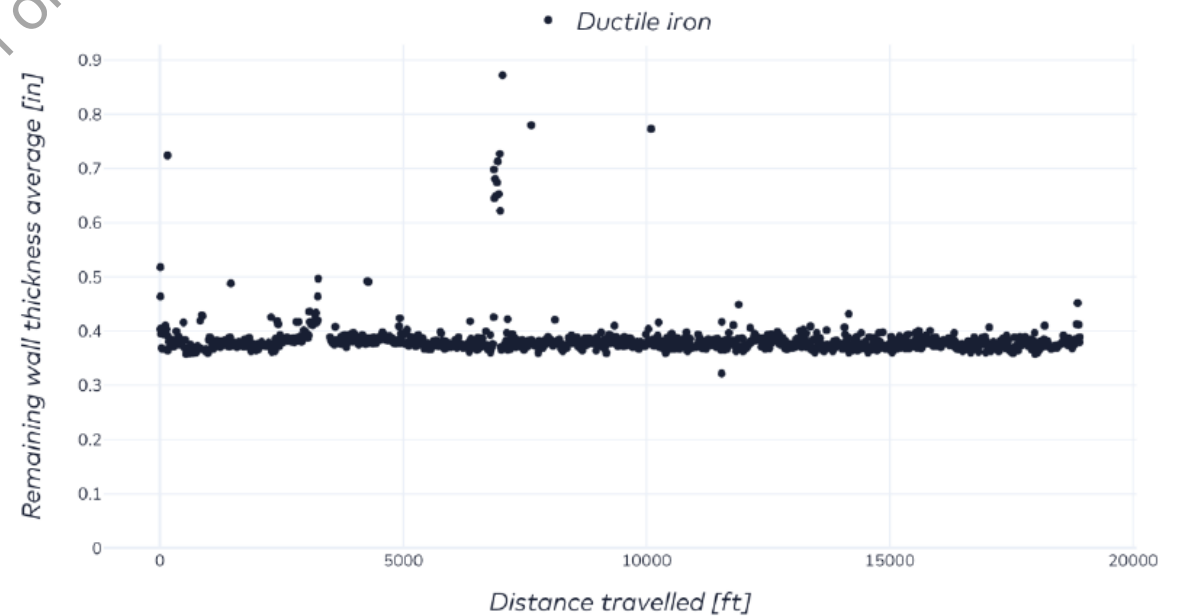
(2/2) RESULTS

- Validation of wall thickness measurement
- Investigation on unknown material
- 40M\$ investment put on hold

- ✓ Gas pockets identified
- ✓ Stable wall thickness showing little to no

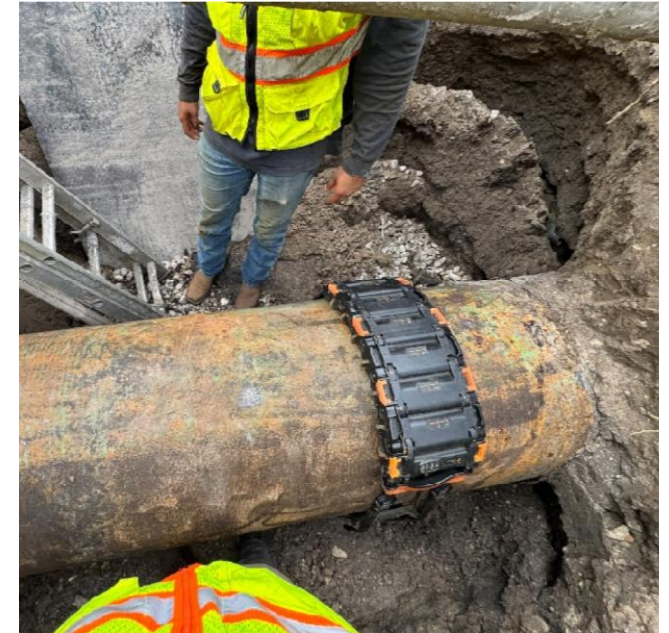
(2/2) FIELD VALIDATION

- Strong alignment between field UT & Acquarius inline UT
- Wall-loss patterns matched at both pits
- No change in factor of safety required by City

Location	UT avg [in]	Acquarius avg	Deviation
Pit 1	~0.42	~0.41–0.43	Low
Pit 6	~0.36	~0.35–0.37	Low

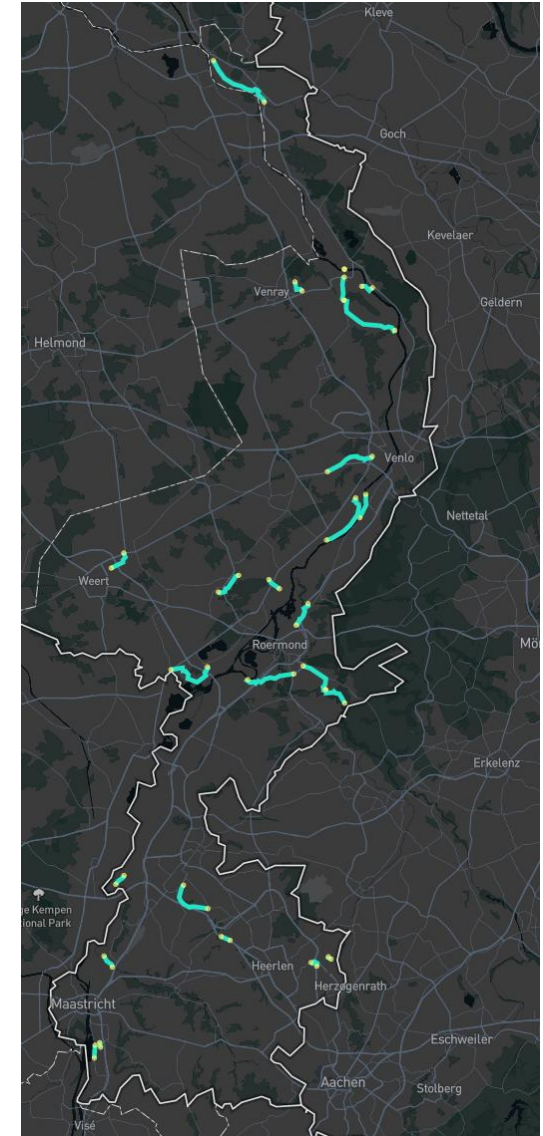
DATA INTERPRETATION

- Acquarius data delivered via the dashboard
- All inspected force mains visualized in one clear overview
- Consultant applied remaining life calculations using inspection data
- Benchmarked against theoretical lifetime assumptions... setting the stage for new insights
