COST-EFFECTIVE STRUCTURAL CULVERT POINT REPAIR

Project Name: Yosemite Drive Drainage Project

Location: Anchorage, Alaska

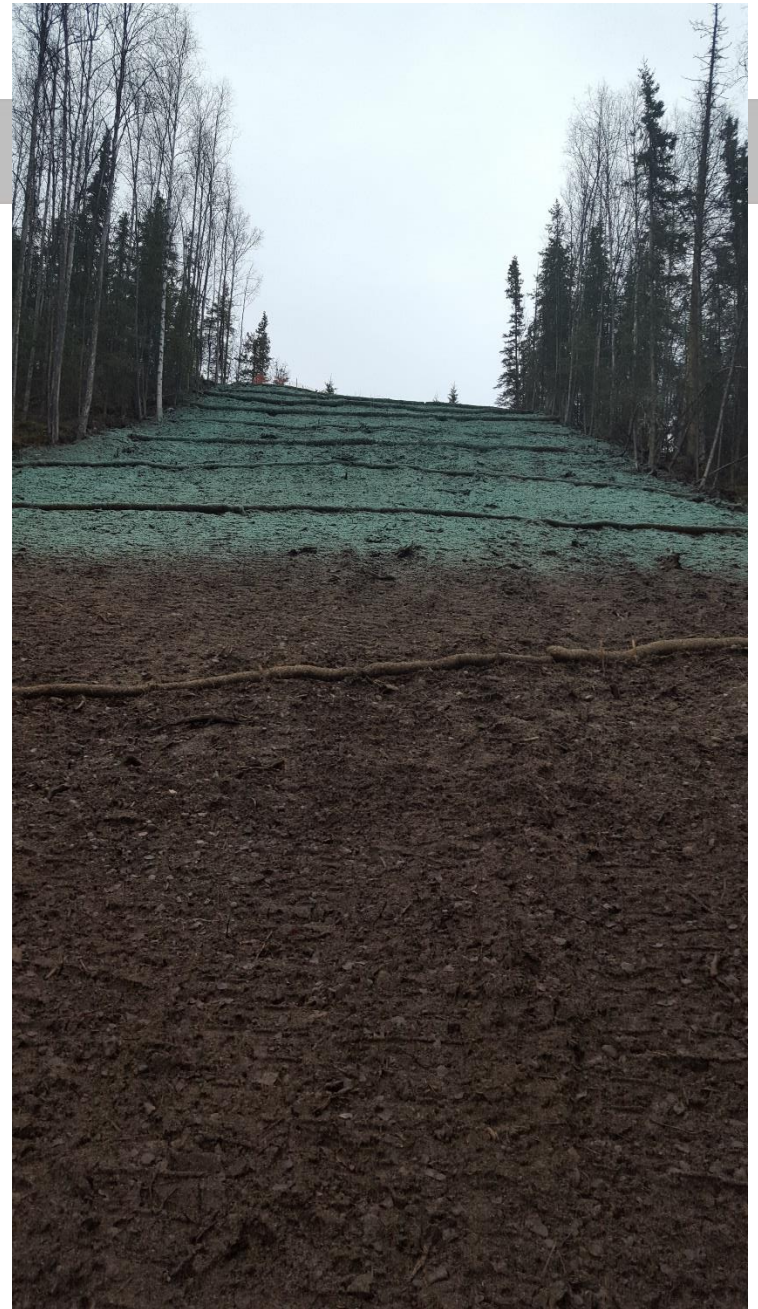
Location

- 200' Section of 24" corrugated HDPE Pipe
- Multiple disjointed and offset joints – 100% water loss over the 200' section.
- 60% grade made open trench repairs unfeasible
- Environmentally sensitive area
