# **PIPELINE CONDITION ASSESSMENT & CLEANING “DEVIL IS IN THE DETAILS” CITY OF DE SOTO, KANSAS RAW WATER MAIN**

**Lisa S. Douglas, PE  
Division Manager  
Water Services  
Ace Pipe Cleaning, Inc.**

## **CASE STUDY OVERVIEW**

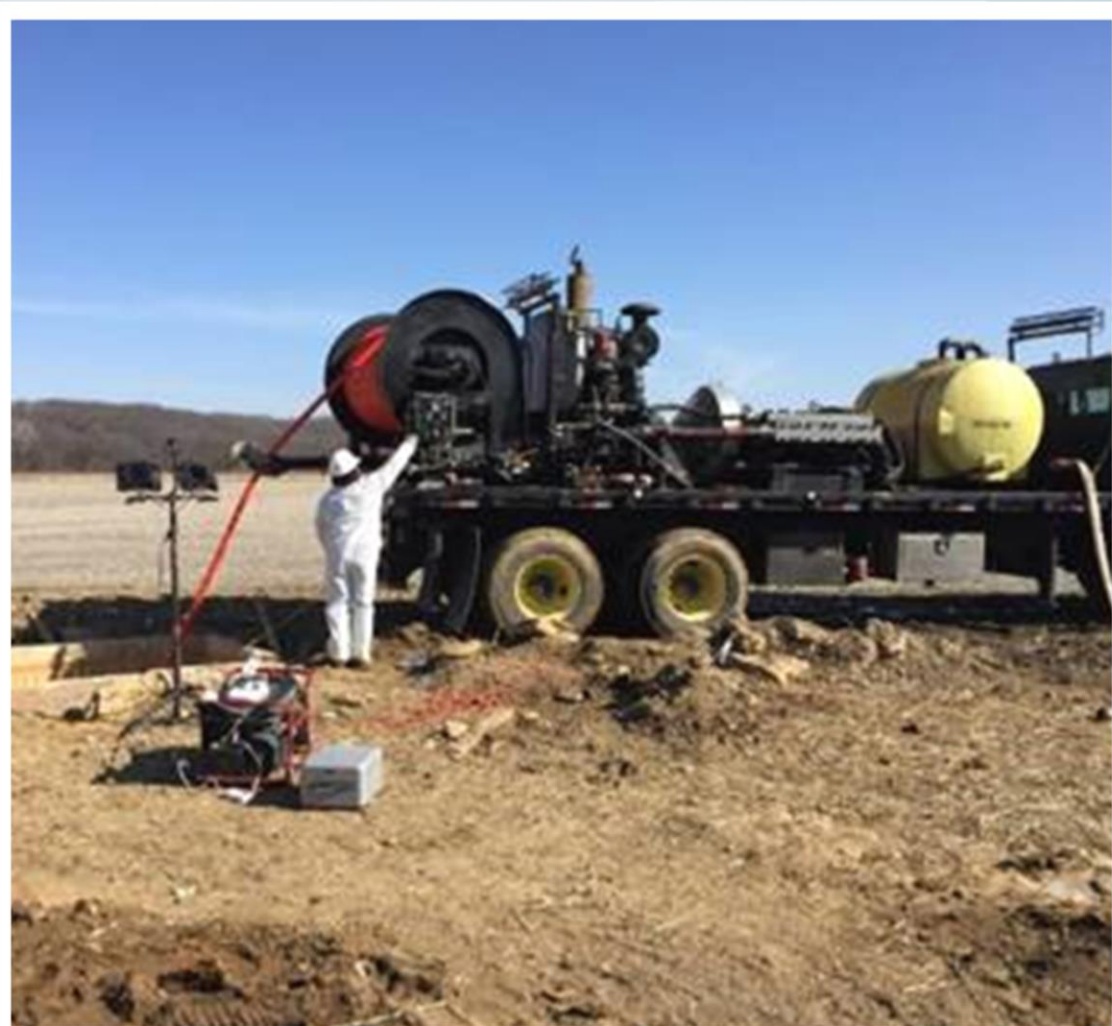
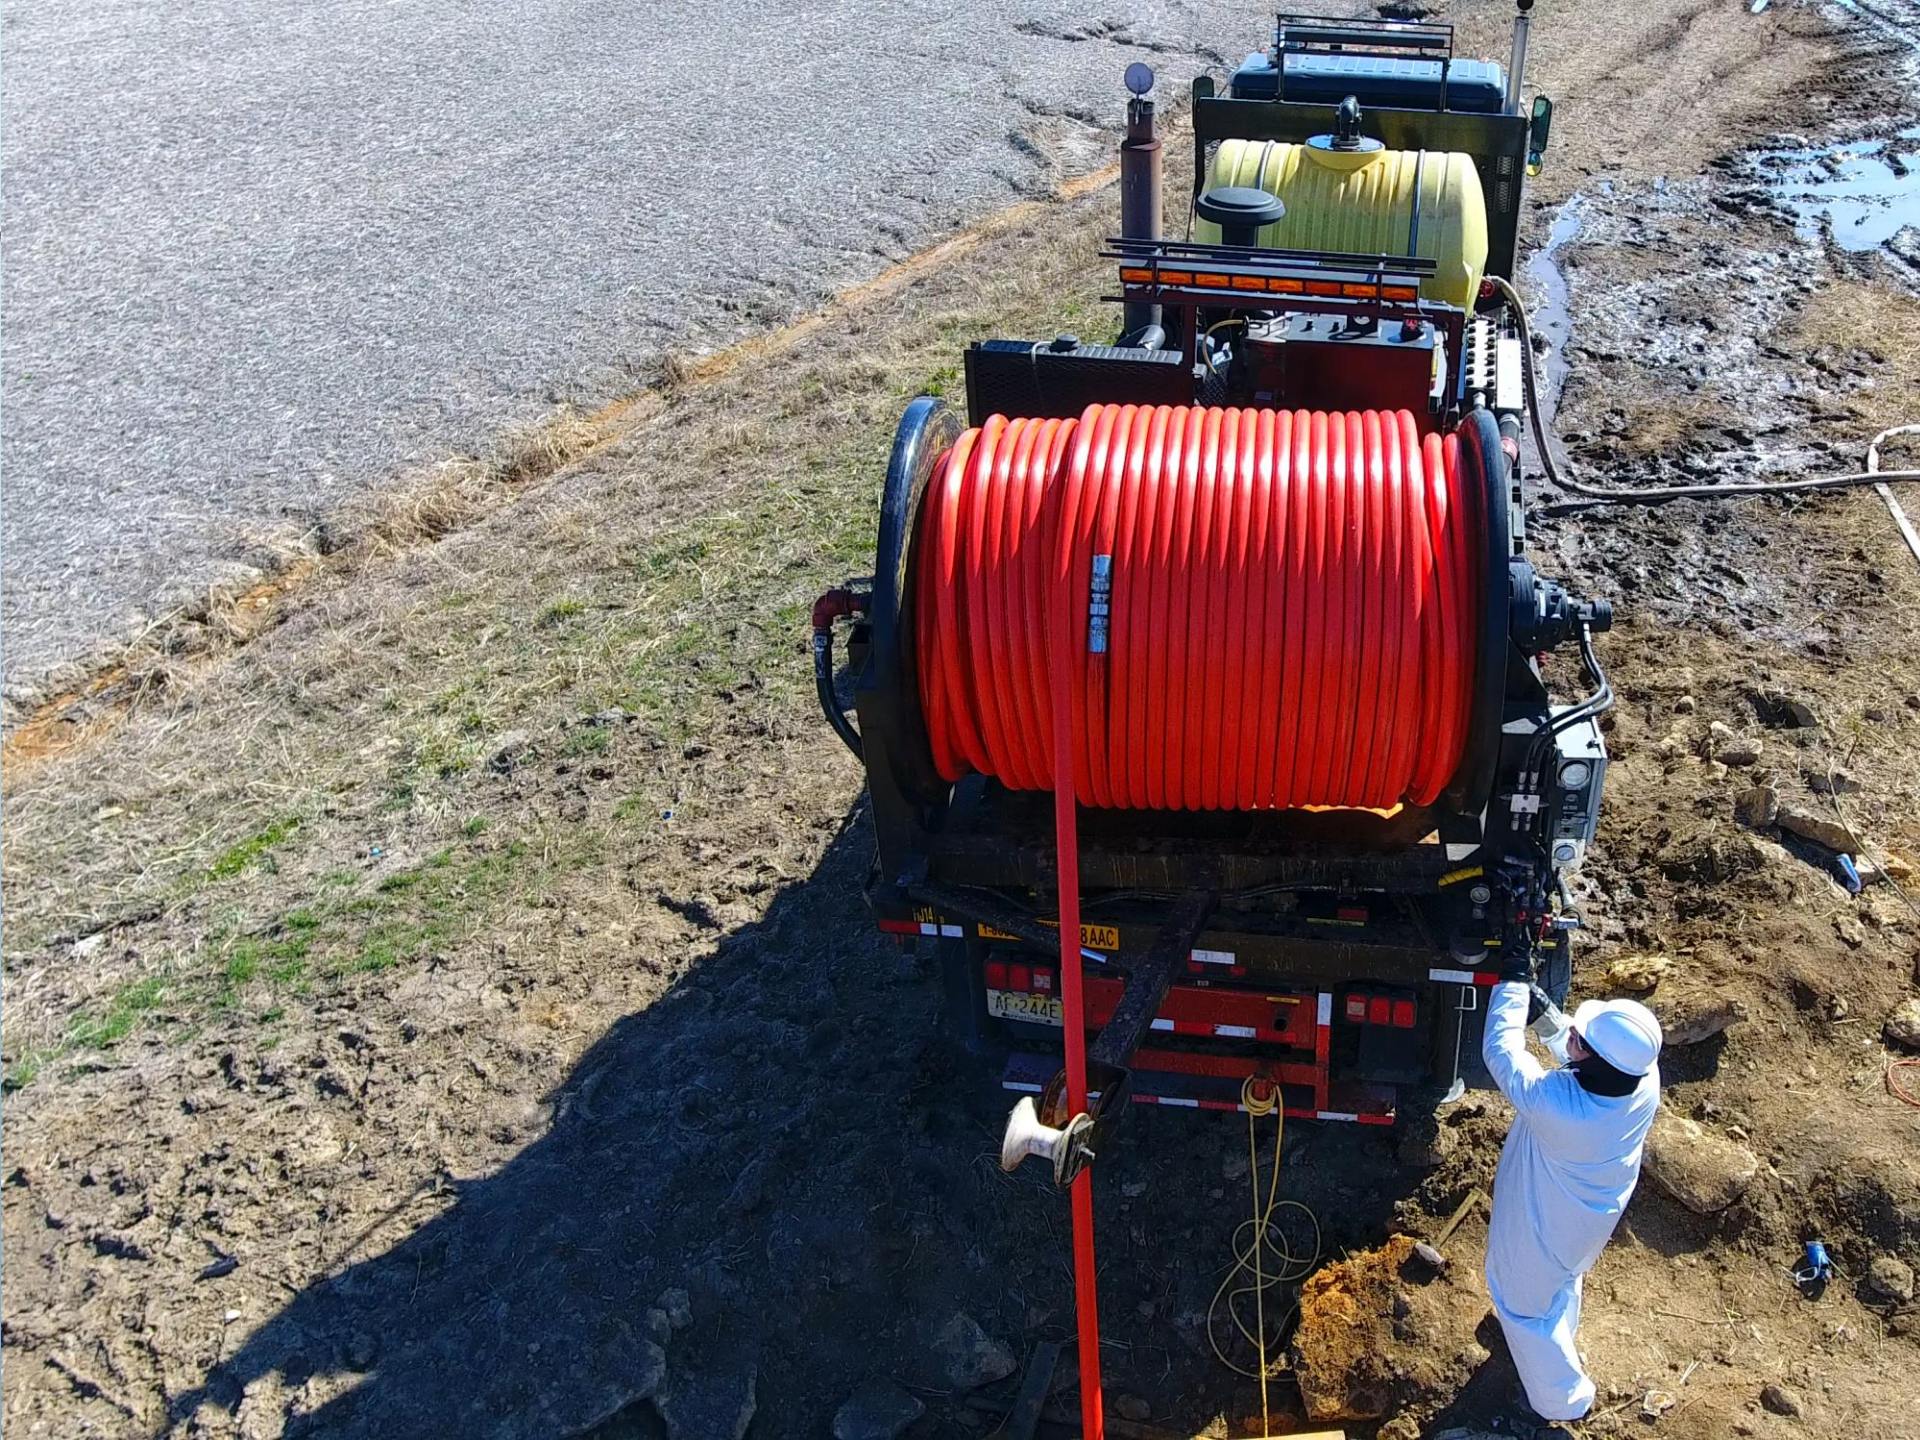
- 1800 FT JETTER HOSE
- 1.5 INCH ID HOSE
- 190 GPM
- PUMP FROM RIVER
- LIGHTER PROFILE NOZZLE
- “PENETRATOR NOZZLE”
- DRONE SURVEY

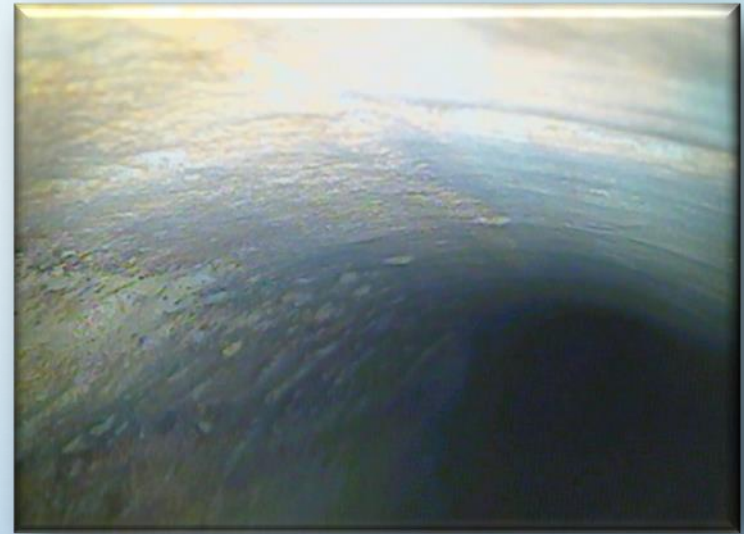
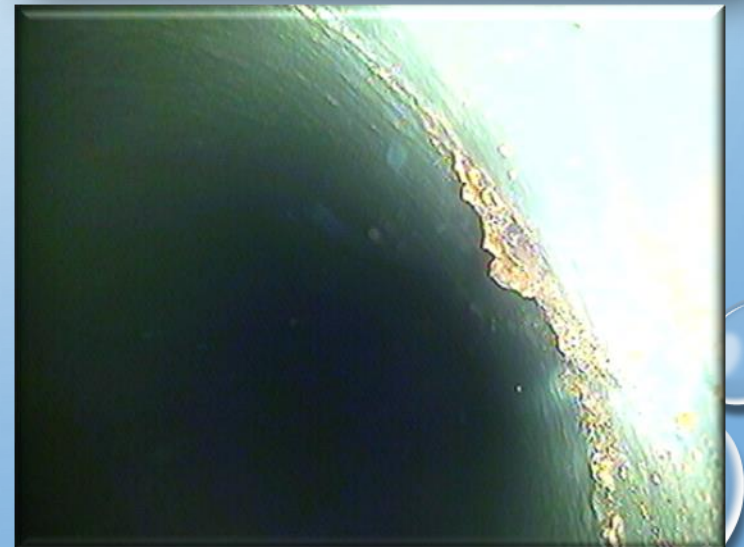
| Condition Category | Rating | RUL |
|---|---|---|
| Exterior of Pipeline | Very Good | >20 |
| Interior Pipe Wall/Barrel | Very Good | >20 |
| Interior Cement Lining | Good | 10-20 |
| Pipe Joints | Good | 10-20 |
| Well Laterals (north side) | Good | 10-20 |
| Valve Vault | Average | <5 |
| Hydraulics | Very Good | 160 psi |

| Condition Category | Rating | RUL |
|---|---|---|
| Modify north valve vault | 2017-18 | \$5,000 |
| Install permanent cleaning structures | 2017-18 | \$75,000 |
