MAIN AND CONGRESS

Slipline of a 20-inch Waterline in Historic Downtown Houston

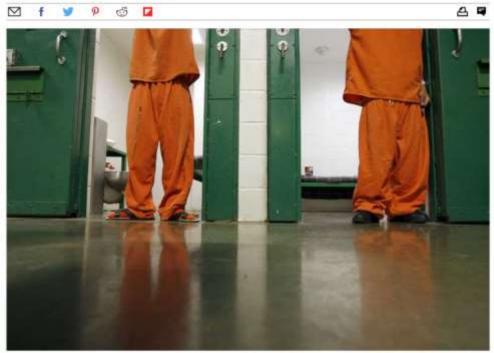
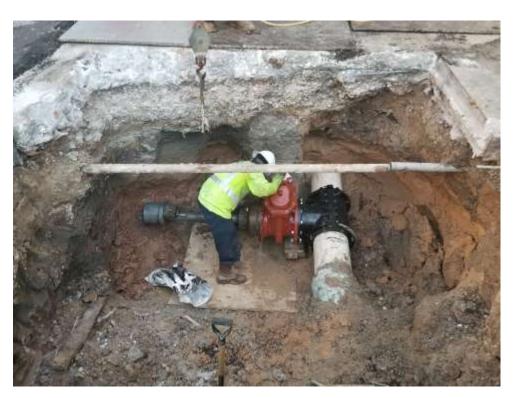
Due to the waterline along Main being shutdown, the county jail had water pressure issues.

Water problems at jail to be fixed Monday

An additional by pass was required to supply the jail house with sufficient water pressure.

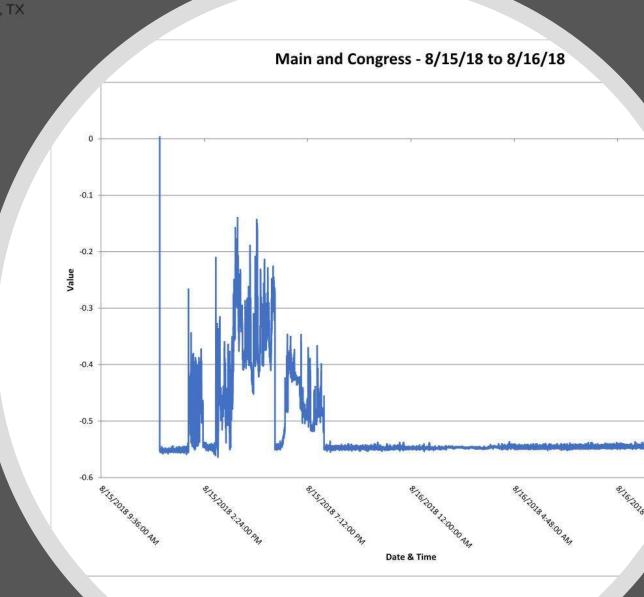
STRAY CURRENT

Pipe to Soil potential readings were measured and recorded.

Data showed an electropositive trend in potentials during the hours the rail was in operation

And a current discharge was measured in proximity to the leak location at intervals.

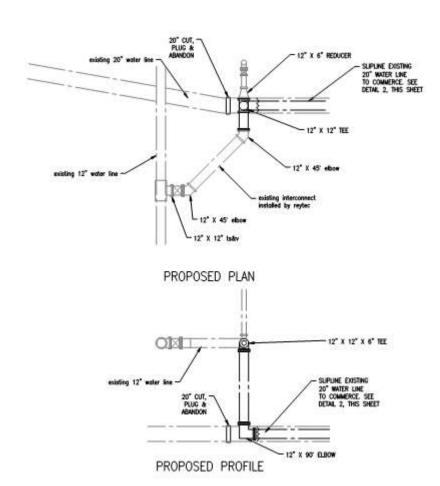
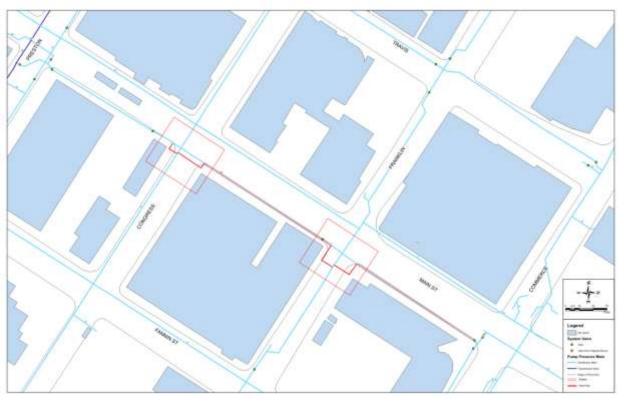
20-INCH WATERLINE TO 12-INCH SLIPLINE

City staff modeled the area and recommended a 12-inch diameter pipe was needed.

At intersections where offsetsets were recorded the proposed slipline was to be tied into existing distribution lines to prevent dead ends.
