Replacement of Failed Corrugated Metal Pipe (CMP)

- South Burlington – Colchester IM CULV
- XUMU 17-1098B1 2018 Coast Road Culvert Repair
- Storm Damage Repair to Patricks Point Drive (3N010) PM 1.90

UNDERGROUND CONSTRUCTION TECHNOLOGY

THE UNDERGROUND UTILITIES EVENT | JANUARY 25-27, 2022 | FORT WORTH, TEXAS

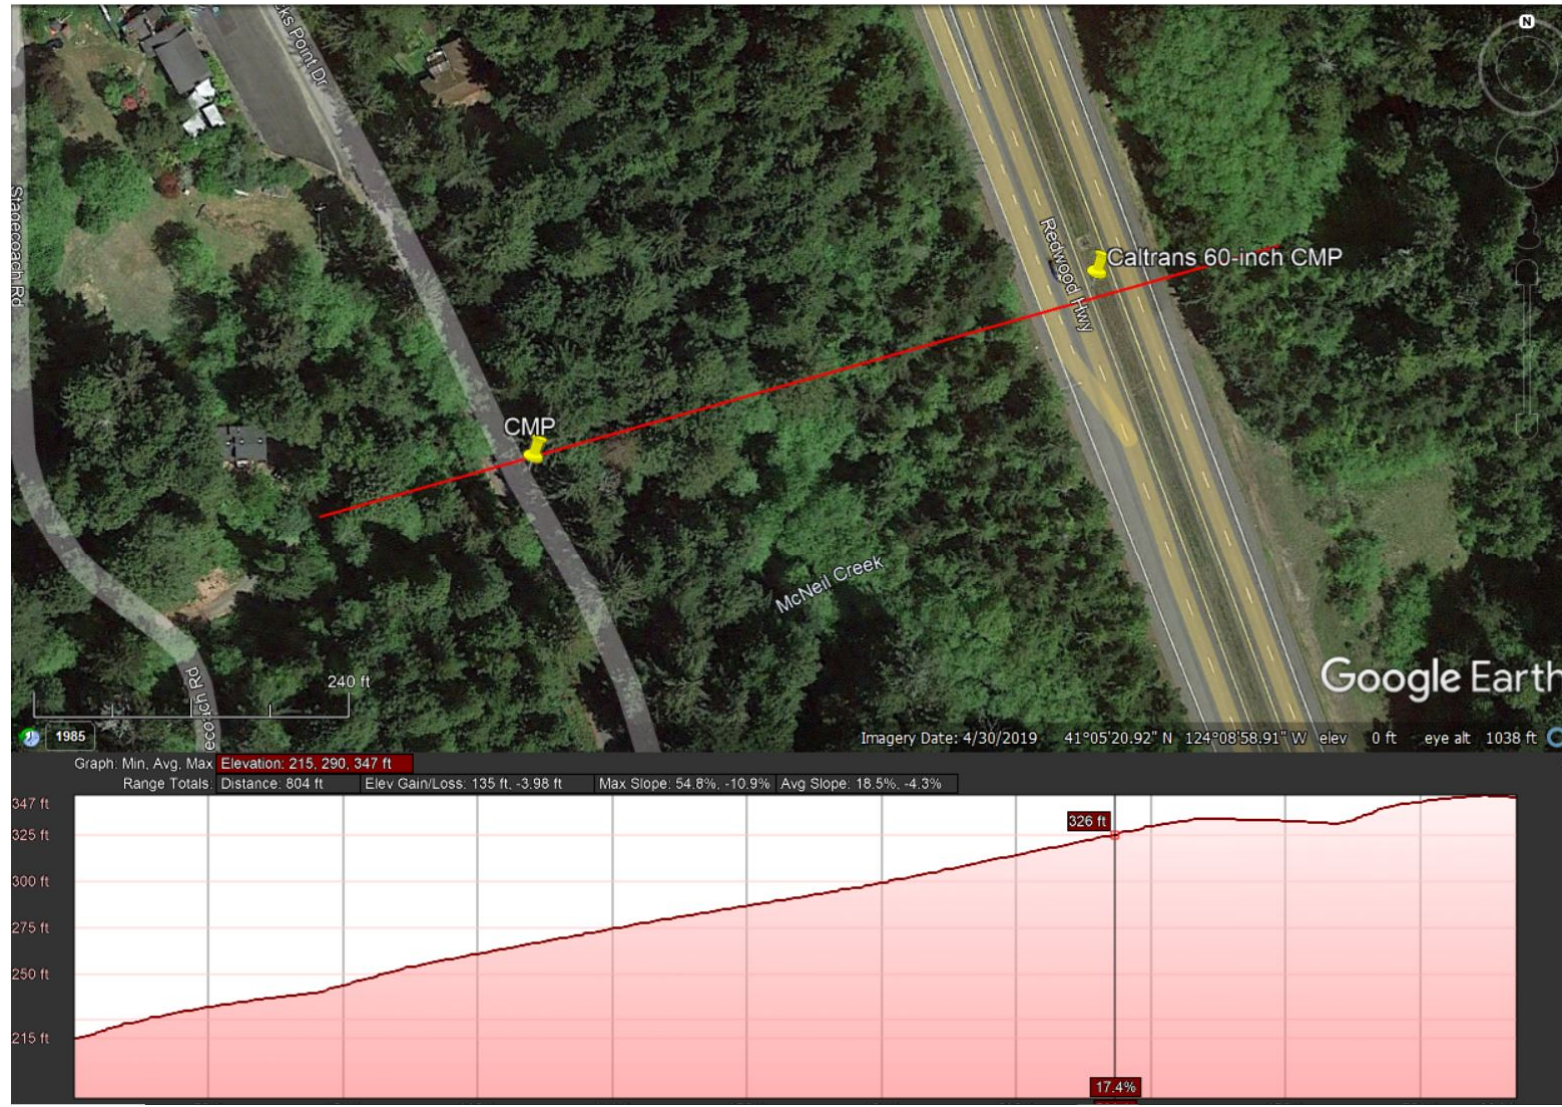
- No impact to Patricks Point Drive
- Culvert immediately upstream is 60-inch CMP
- Increase capacity of failed 48-inch CMP
- Existing CMP within artificial fill
- Possible Redwood tree stumps along alignment, outside CMP
- Recent massive wildfires in Northern California
- Rural County with very limited financial resources

- Replace with 60-inch welded steel casing with 1.0-inch sidewall
- No additional corrosion protection currently proposed, 100-year life
- Steel casing is at a steeper slope than upstream CMP
- Allowed Pipe Ramming or Tunneling over CMP
- No torch cutting of CMP due to zinc coating
- Project bid with construction to commence shortly
