Assessment of a Glass-Lined Digested Sludge Force Main

Kristopher Embry, PICA Corp.

Underground Infrastructure Conference

4.7-mile 8" Whites Creek DIP Sludge Force Main Inspection

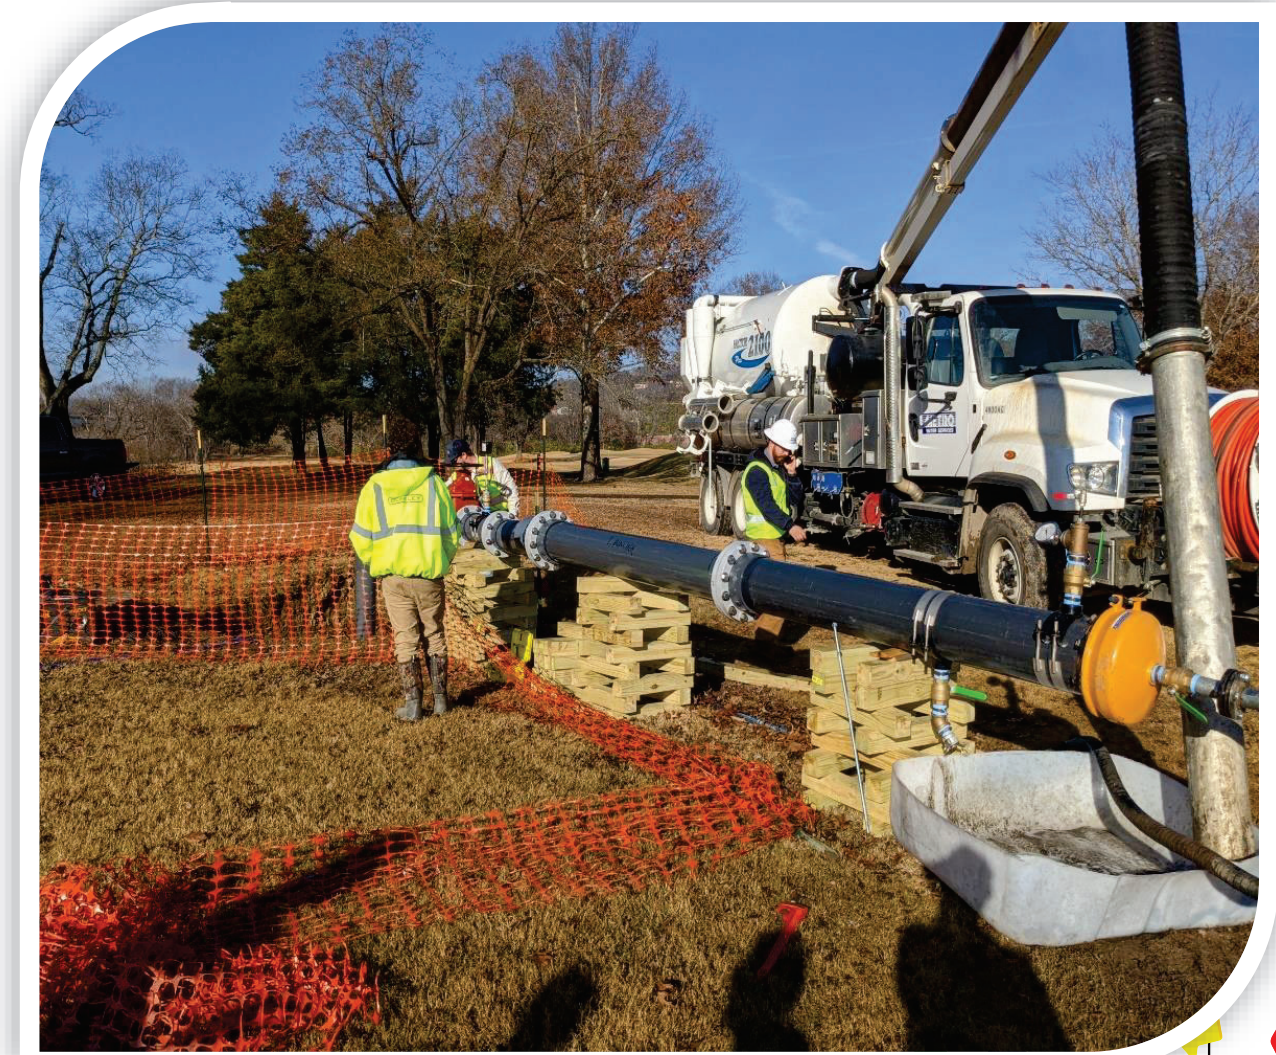
- Used plant water, treated plant effluent (non-potable), to propel tool
- Tracked tool
- PICA noticed the tool initially moved through the pipeline faster than expected
- Adjusted to target inspection speed (approx. 17' per minute)

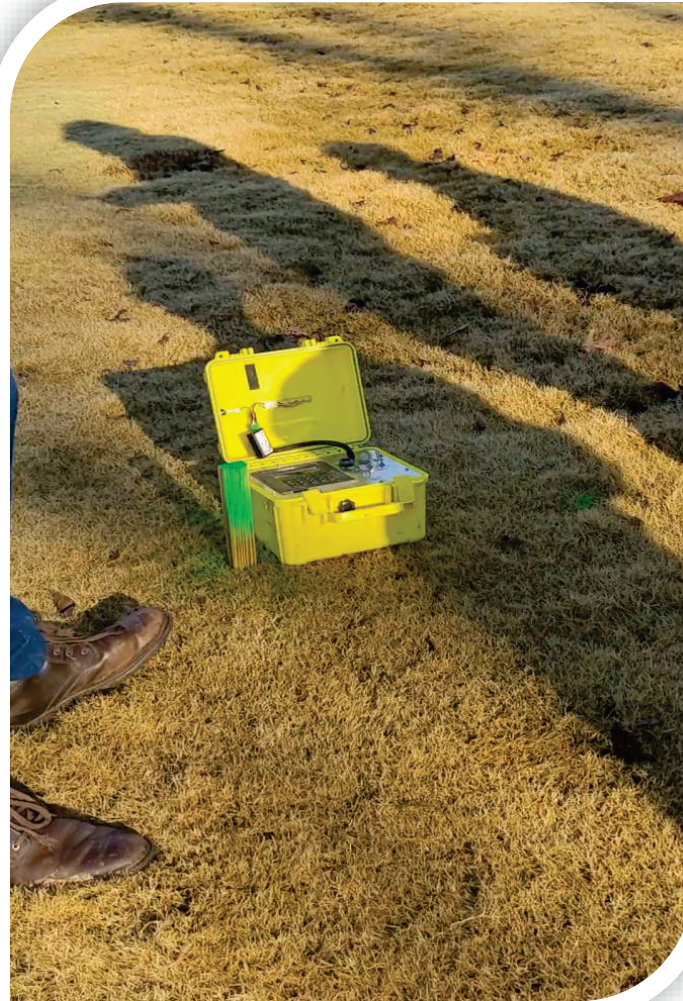
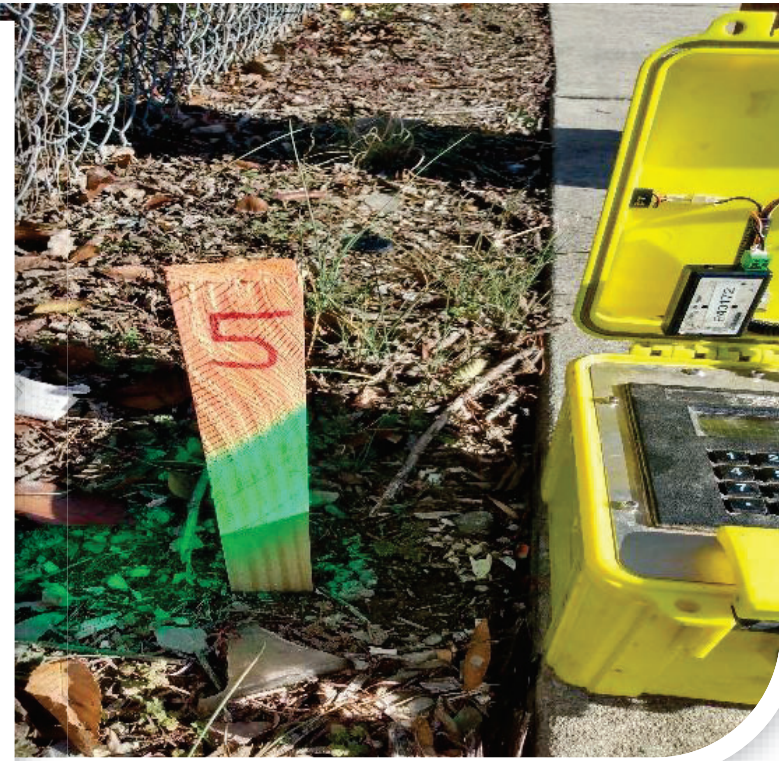
- Tracked tool w/ stakes every 500'
- Tracking through the golf course and along densely populated areas
