Let's Go Deeper DWU's Cedar Crest Water Line Replacement

Justin Reeves PE, LEED AP

- 72-Inch AWWA C301 (PCCP) Pipe
- 1989 Installation
- Located in South Dallas
- Crossing of the Trinity River
- Catastrophic Pipeline Failure

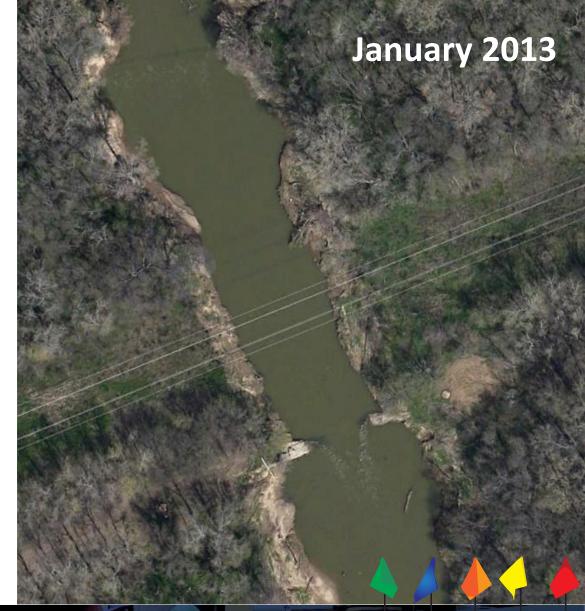
- 72-Inch AWWA C301 (PCCP) Pipe
- 1989 Installation
- Located in South Dallas
- Crossing of the Trinity River
- Catastrophic Pipeline Failure

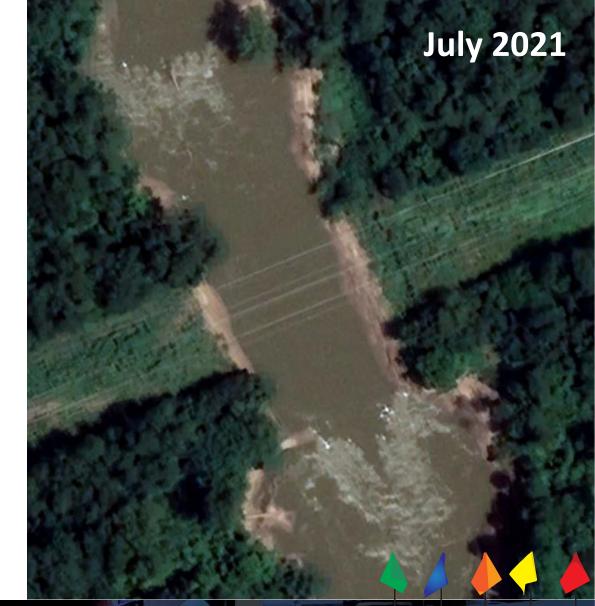
- 72-Inch AWWA C301 (PCCP) Pipe
- 1989 Installation
- Located in South Dallas
- Crossing of the Trinity River
- Catastrophic Pipeline Failure

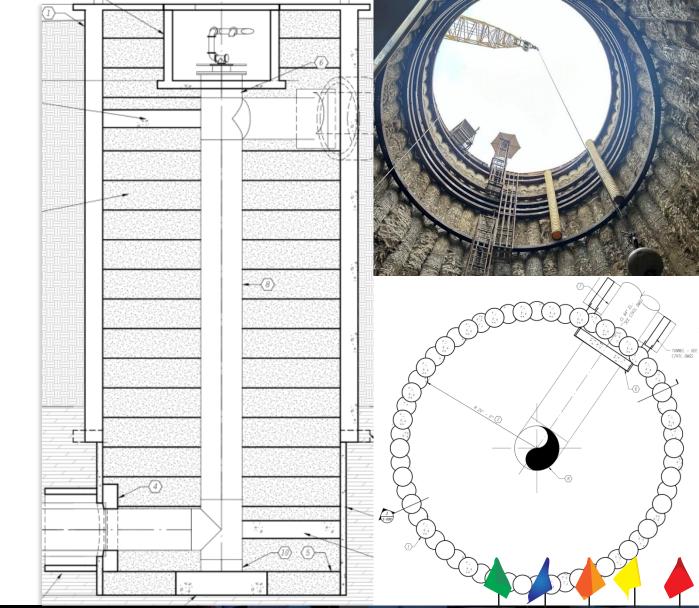
Vertical Drop

- Clayey Sands to 40-ft
- Seams or Fractures to 70-ft
- Stable Material at 85-ft
- Secant Pile Shafts

- Short Lifts of CLSM Backfill
- Lean Concrete Behind Tees

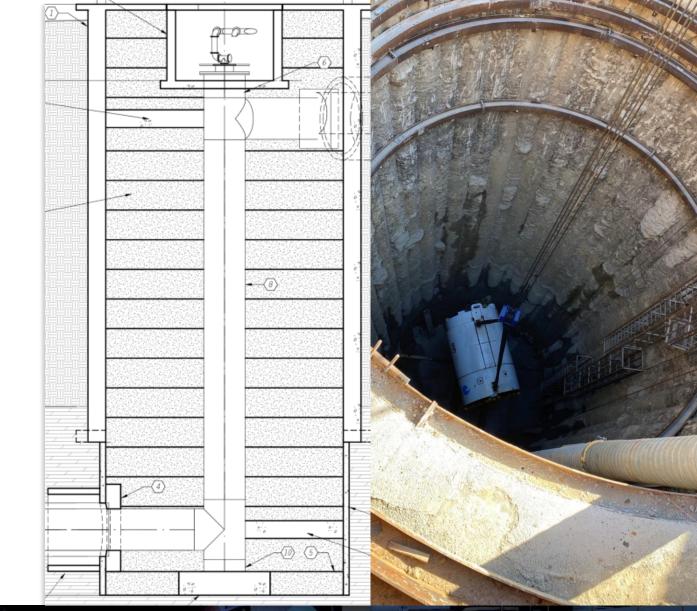
Vertical Drop

- Clayey Sands to 40-ft
- Seams or Fractures to 70-ft
- Stable Material at 85-ft
- Secant Pile Shafts

- Short Lifts of CLSM Backfill
- Lean Concrete Behind Tees
