Preserving Casper's Infrastructure: Large-Diameter Pipeline Trenchless Rehabilitation Project

Mark G. Wade, P.E.
BlueWater Solutions Group, Inc

Underground Infrastructure Conference

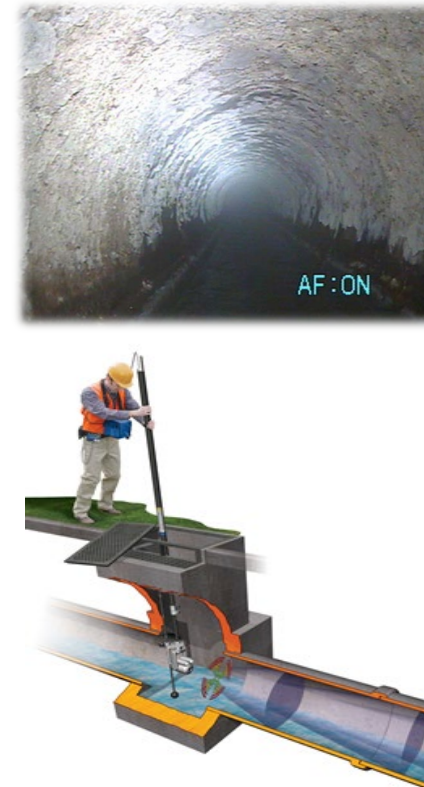
- Pipeline vs. manholes
- 1" + concrete loss
- Atmospheric H₂S levels (up to 20 ppm)
- Effect of groundwater injection evident

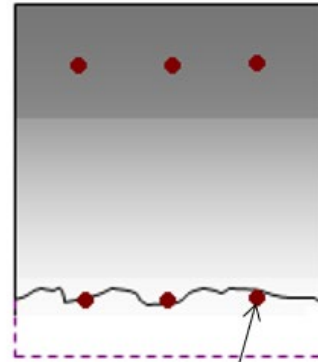
Exposed rebar will corrode and provide no structural support
