India Street Force Main Condition Assessment

India Street Force Main

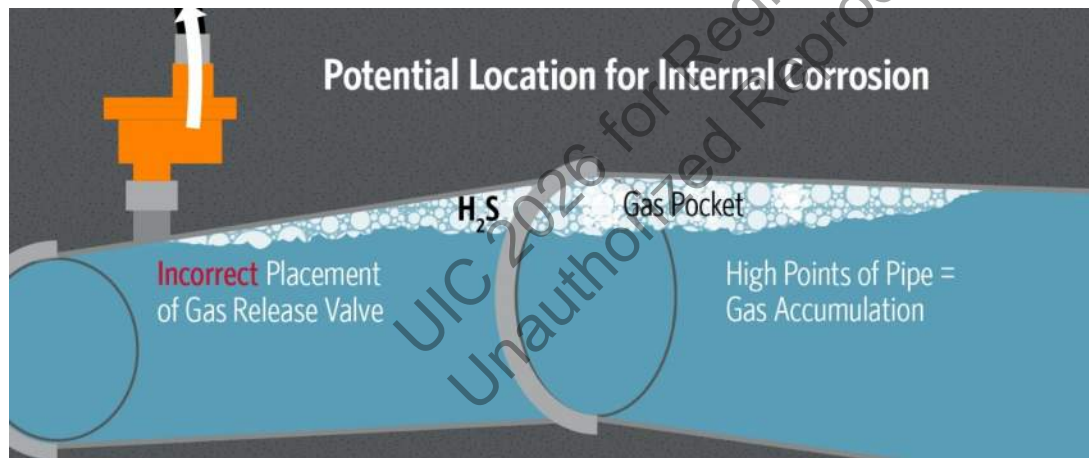
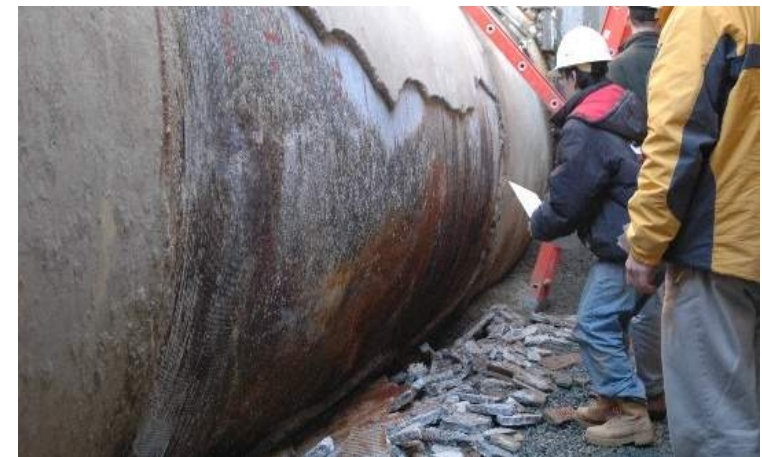
- External deterioration: Corrosion and hydrogen embrittlement related damage of prestressing wire (wire breaks)
- Internal corrosion: H₂S corrosion at gas pocket locations
- Overloading: Excessive overburden or excessive pressure loading
- Debris: Debris up constricts pipeline flow

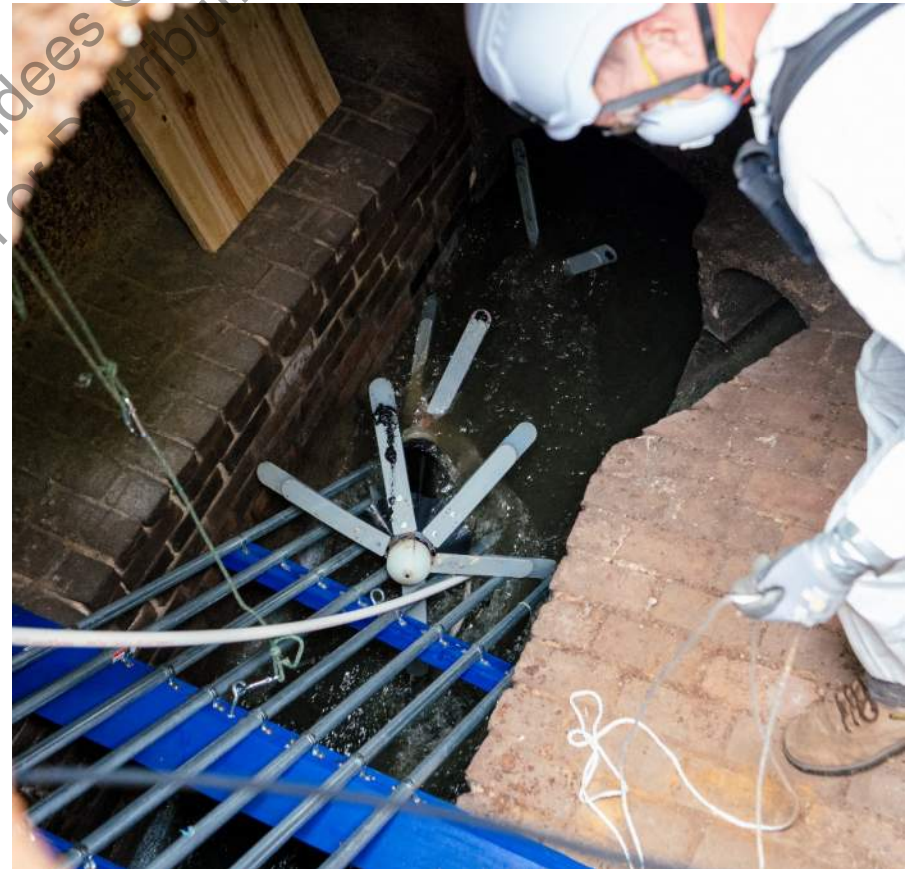
Inspection device arrives at extraction
