# Preserving Mid-Century Water Infrastructure:

## CFRP Upgrade of 1949 Cast Iron Pipe Beneath Cedar Springs Road Culvert

MIKE LARSEN, ASSOC. DBIA

January 27 – 28, 2026

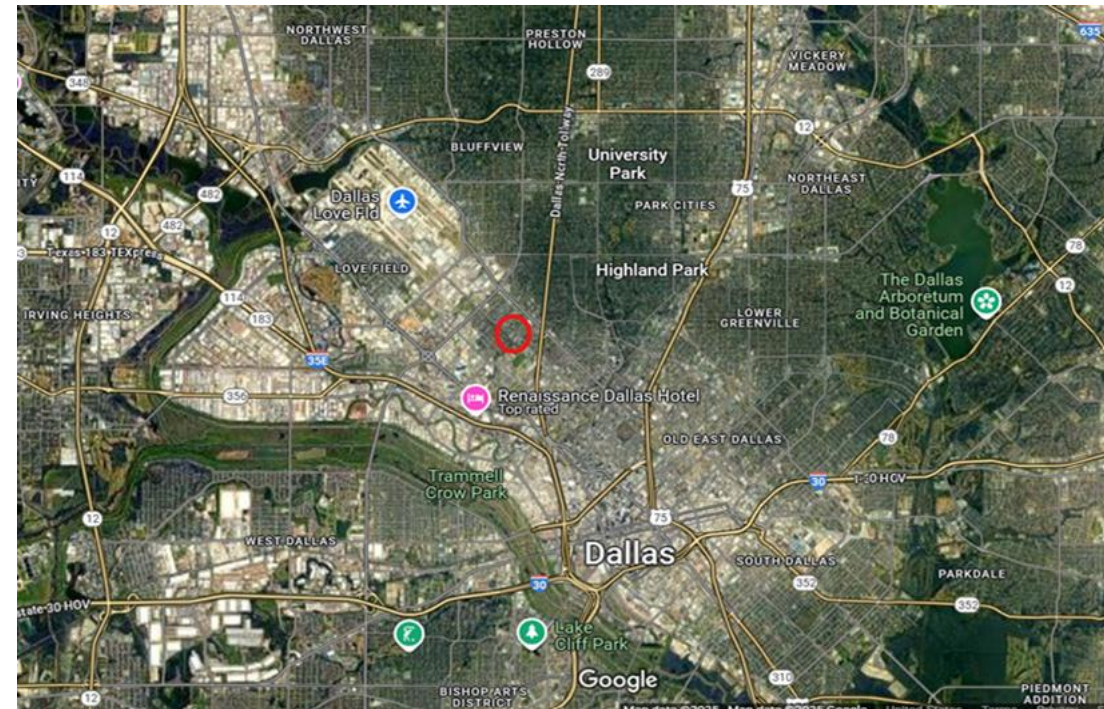
- Manufactured in 1949
- 42" Cast Iron Pipe (CIP)
- 9/2021 Pure identified leak
- DWU constructed 2 new 24"-diameter manholes
