Underground Construction Technology International Conference & Exhibition

### Rehabilitation of Sewer Service Laterals Crucial to program success!

#### George Kurz, P.E., DEE

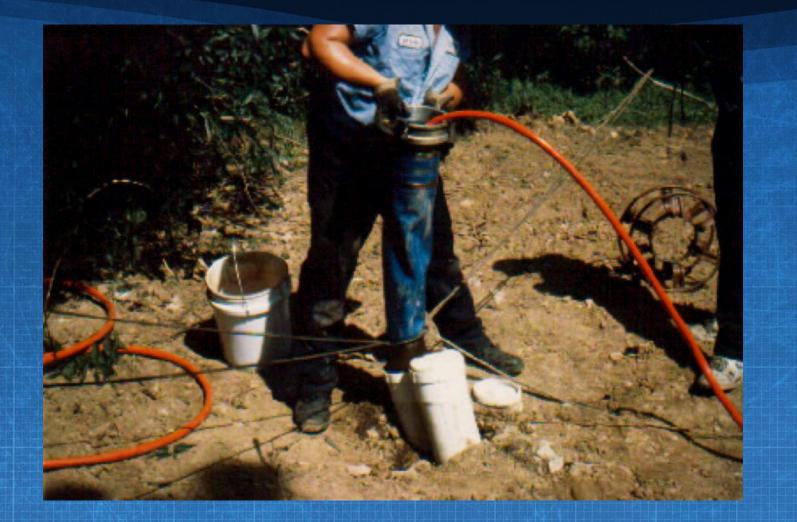
# **Insert CIP Liner from Cleanout**

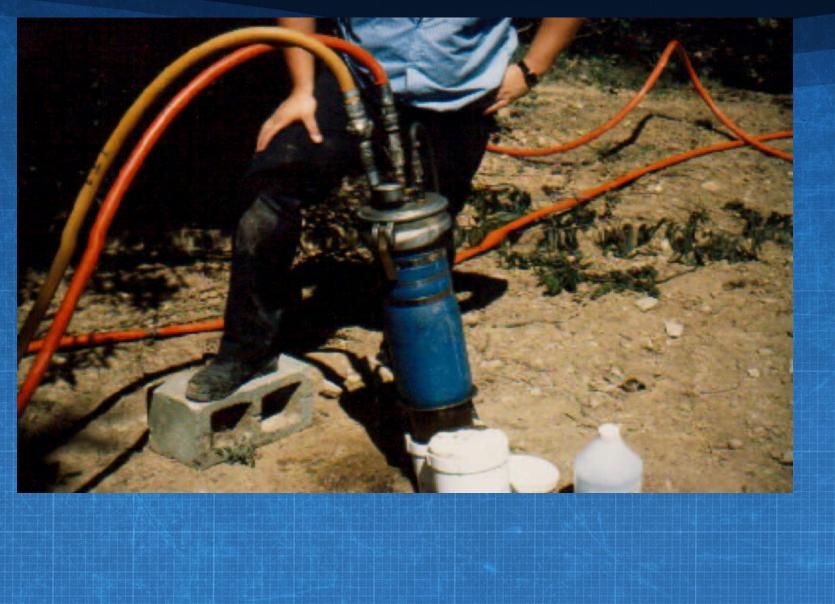
# **Cure the Liner with Hot Water**

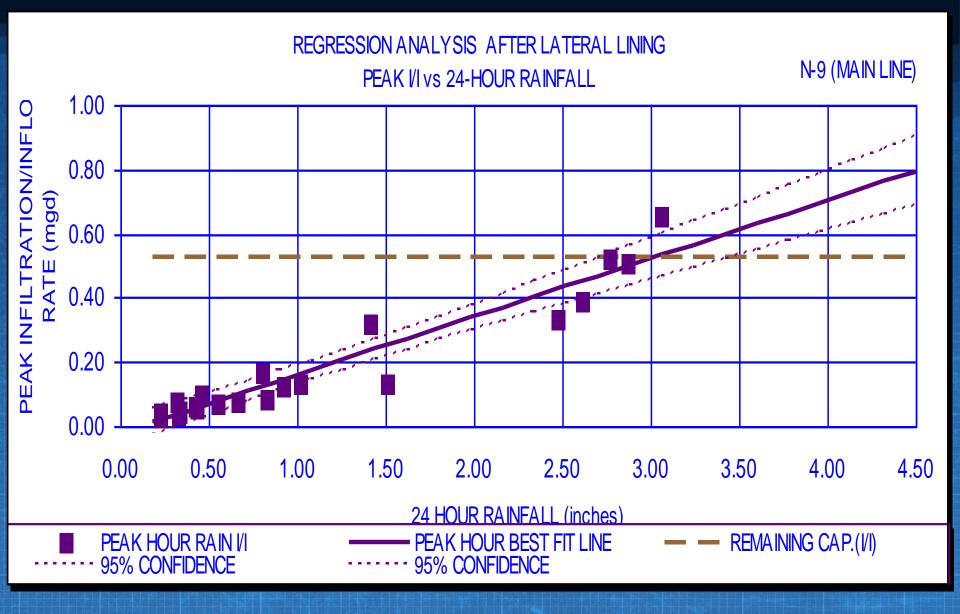
# **Oak Valley Lateral Renewal**

<b>Before</b>	After M.L.	After Lat.
Peak Q (mgd)	1.8	0.6	0.5
ADF (mgd)	0.2	0.13	0.13
SSO (mgd)	0.16	0	0
24 hr rain (in)	1.67	1.58	2.46
Prev. 48 hr.(in)	0.4	0.38	0
Prev. 21 days (in)	2.11	2.32	3.53

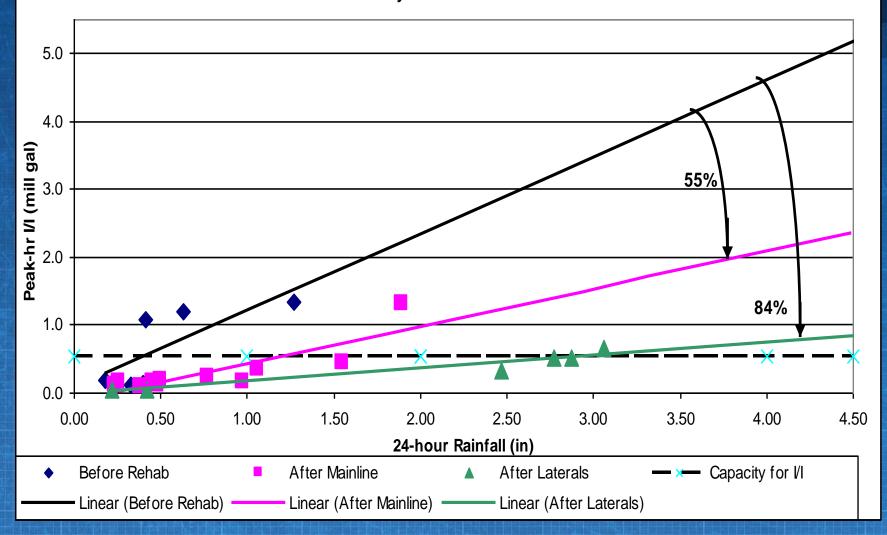
# Peak Hour I/I Reduction

Oak Valley Peak-hour I/ Reduction

# ~ 20% additional I/I removal for ~ 10% contract cost

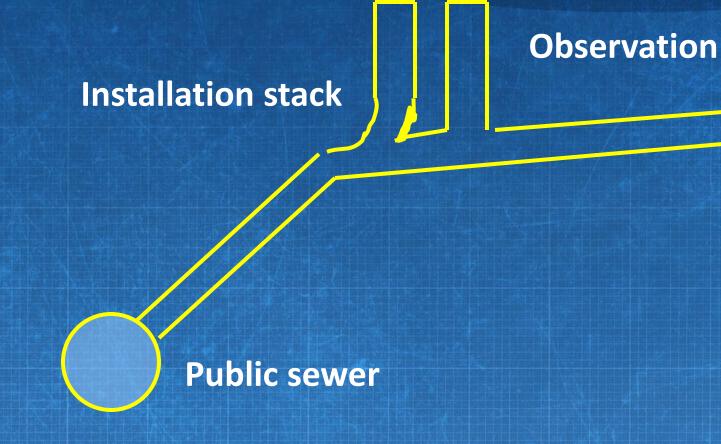
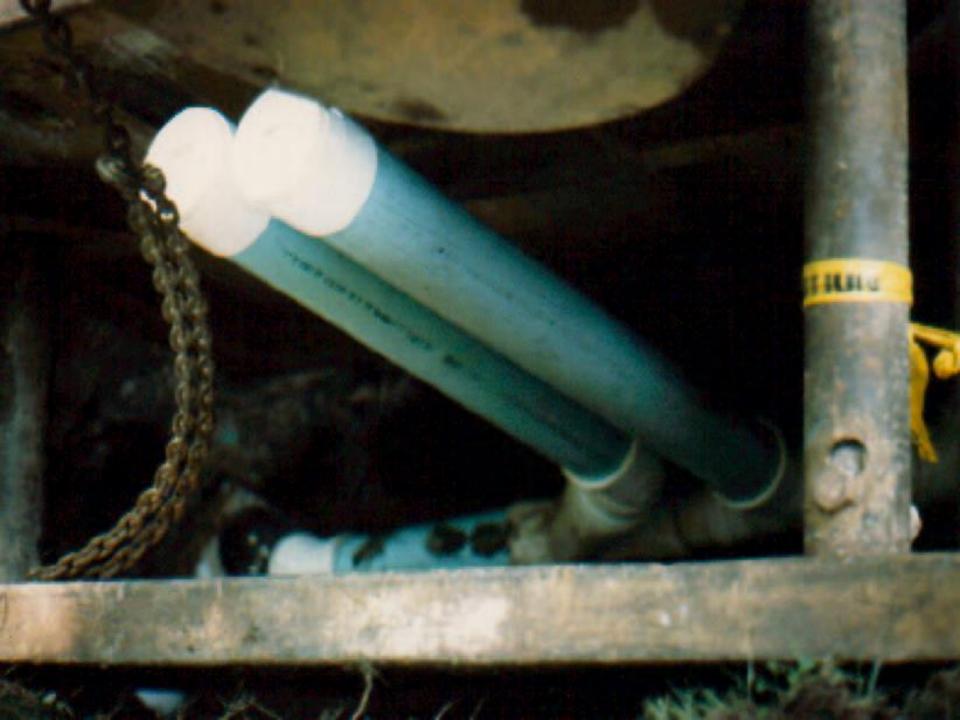
## **Double Stack Clean-out**

Flow metering – verify effectiveness
 Direct observation during wet weather – double stack clean-out

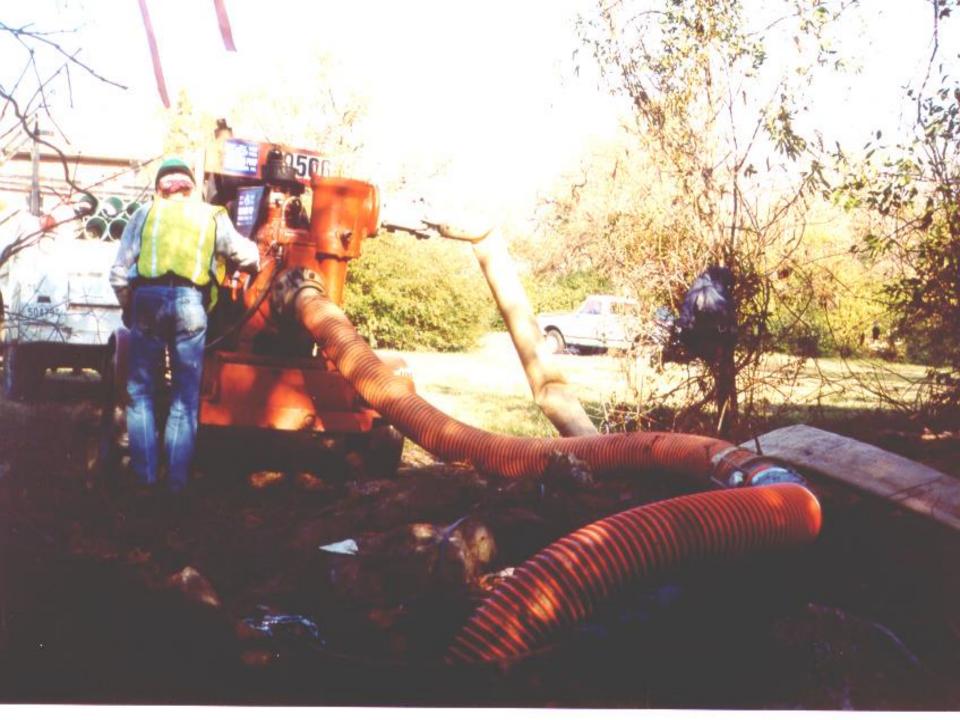
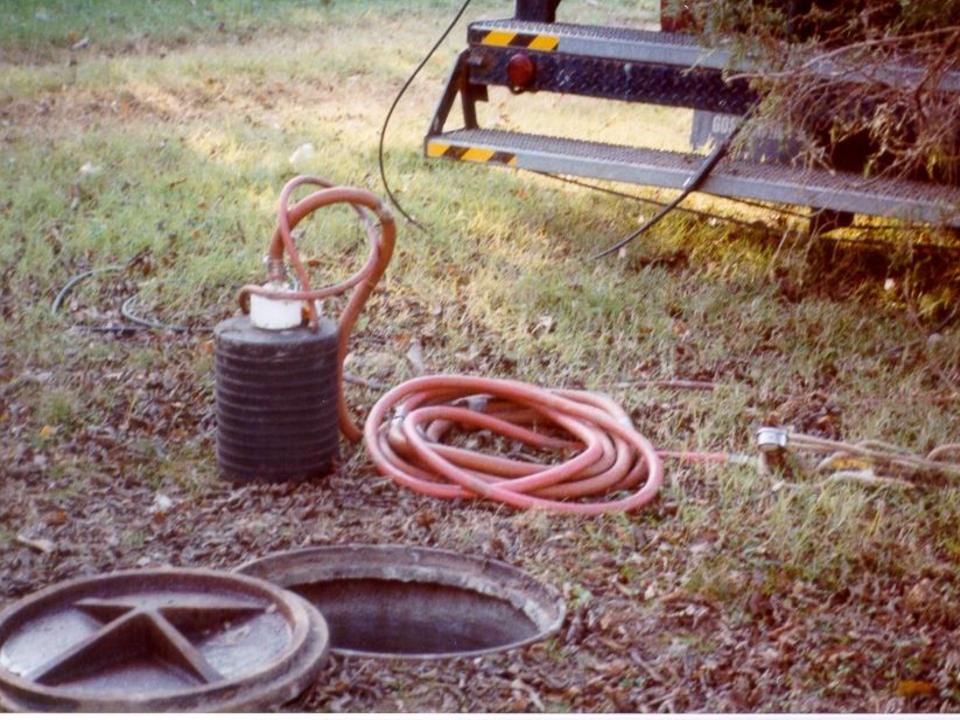
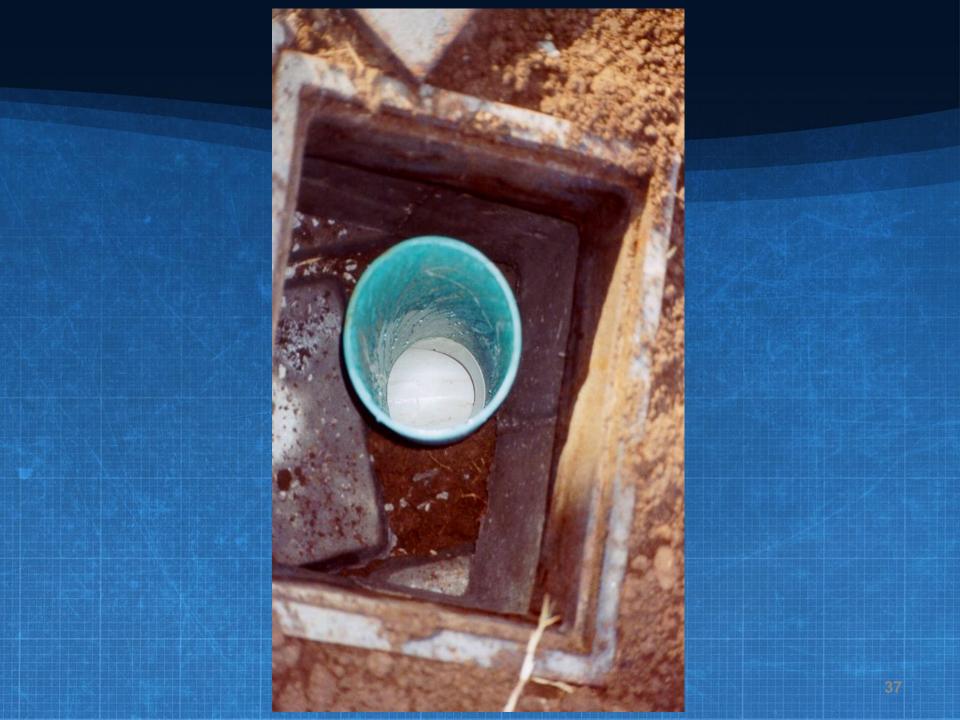
# **Lateral Air Testing**

#### **Test after lateral opening cut !**

- Test full length line (manhole to manhole and plugs in laterals)
- Test each individual lateral plug lateral and 2 plugs in pipe

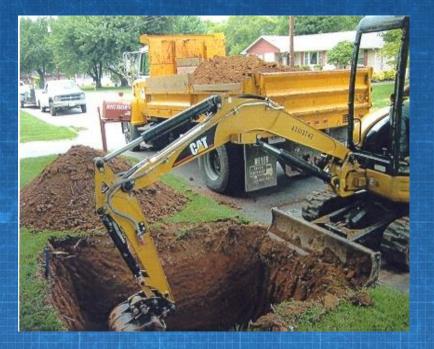
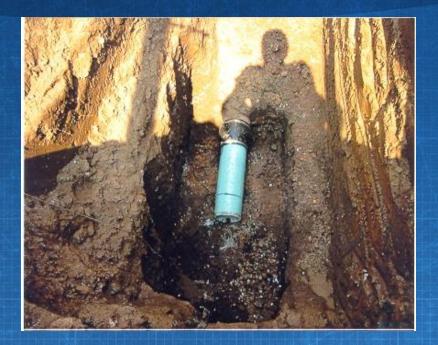
# **Traditional Point Repairs**

May be disruptive and not prevent flow migration to other defects

but may be needed for structural repair before lining.
